September 1, 2004

Final Report

SERDP Pollution Prevention Project 1137

Non-Destructive Testing of Corrosion Under Coatings

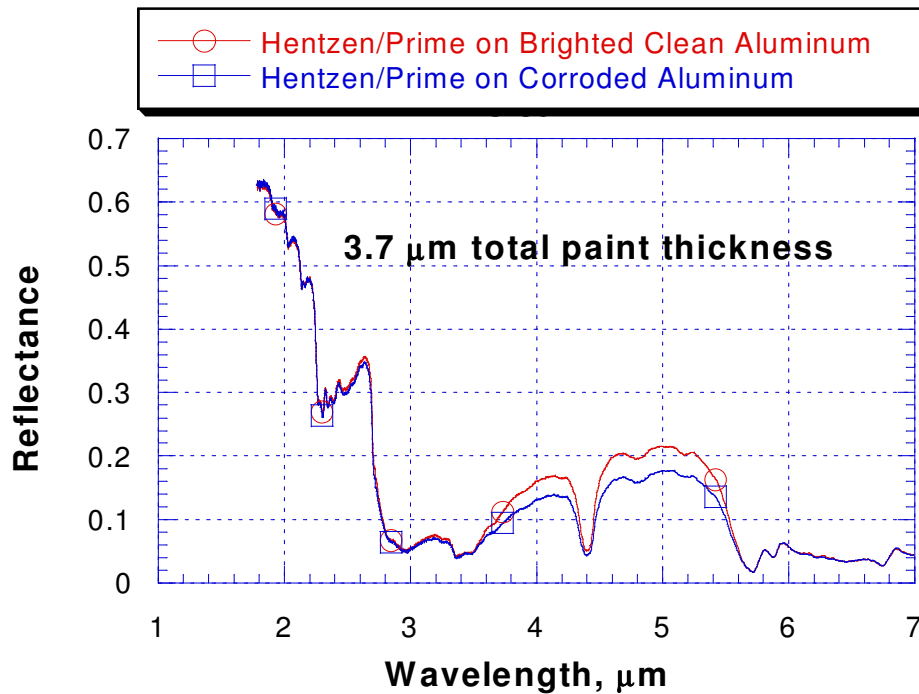
Figure 7 Reflectance of Hentzen paint system on a partially corroded aluminum coupon. Significant reflectance difference seen in the 3.6 to 5.4 μm range between corroded and uncorroded areas

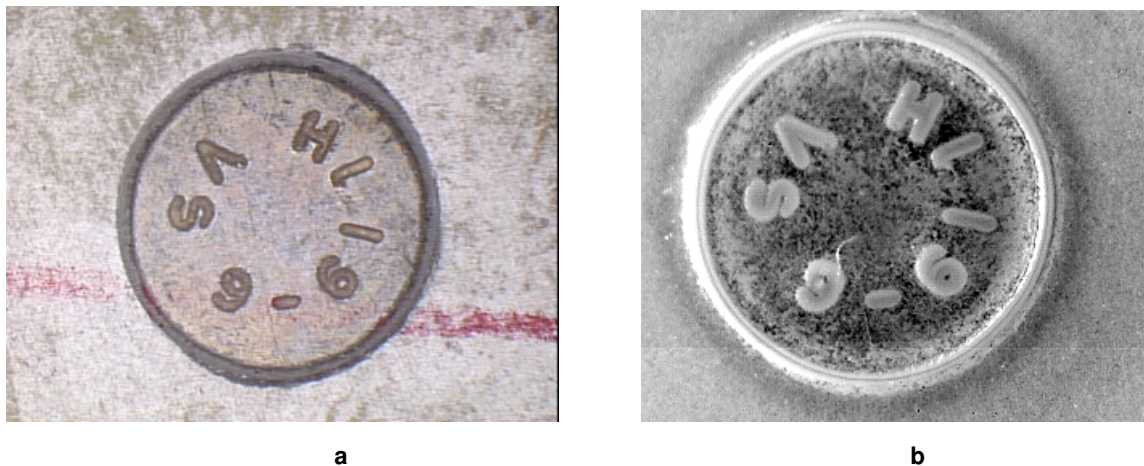
Figure 59 shows a visual image on an unpainted fastener head next to an IR image of the same fastener covered with 3 mil of primer and topcoat. The fastener markings can be clearly seen through the coating.

Figure 59 A visible image (a) of an unpainted fastener head, an IR image (b) of the same fastener covered with 3 mils of primer and topcoat.

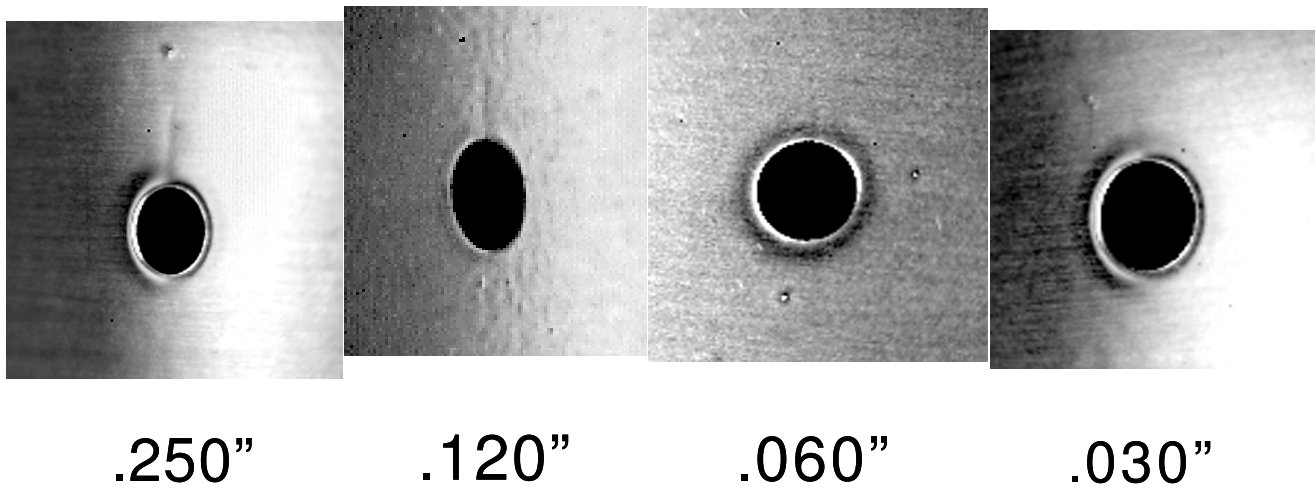
Figure 63 Successively smaller length fatigue cracks imaged under 3.5 mil primer and topcoat using a 25 mm IR lens.

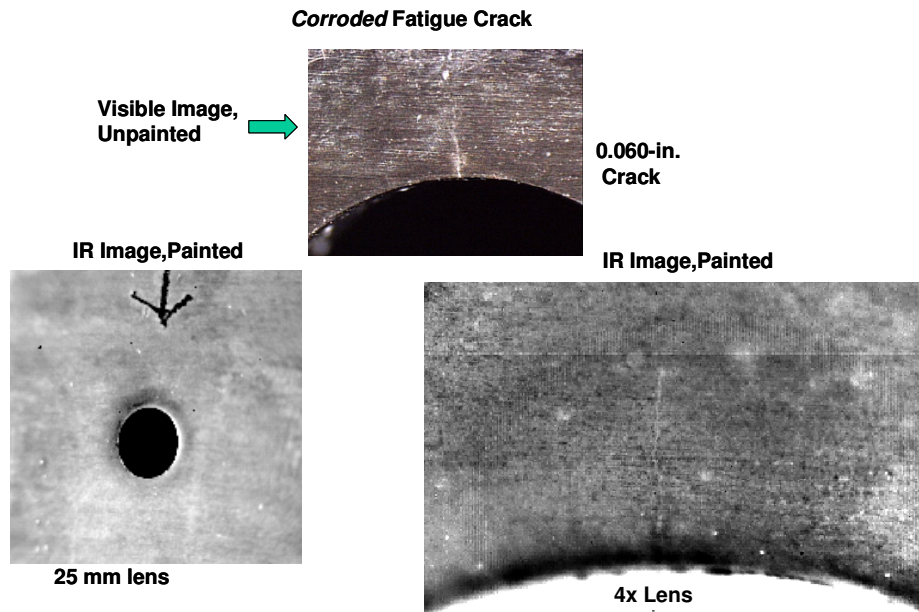
Figure 82 Corroded crack (photo No. 1) produced in the lab by placing the 2024-T3 bare, aluminum specimen in salt water for a number of days. This specimen although not totally realistic maybe more indicative of a more open crack. Photos No. 2 and No. 3 are of painted bare panels under IR illumination.

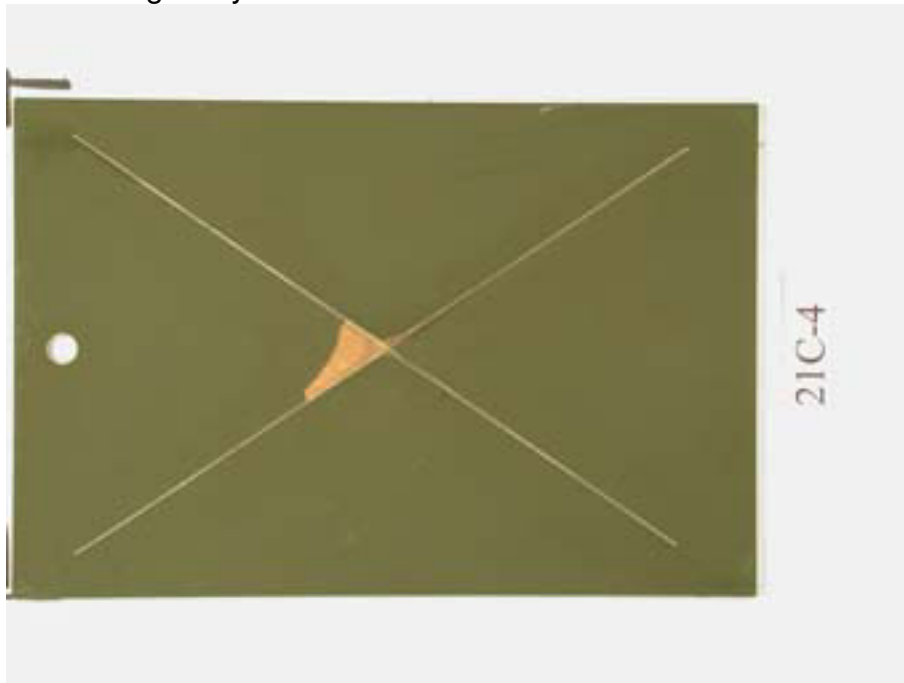
21 C4

Indicates Paint Peeling away from the substrate and corrosion in the scribe zone.

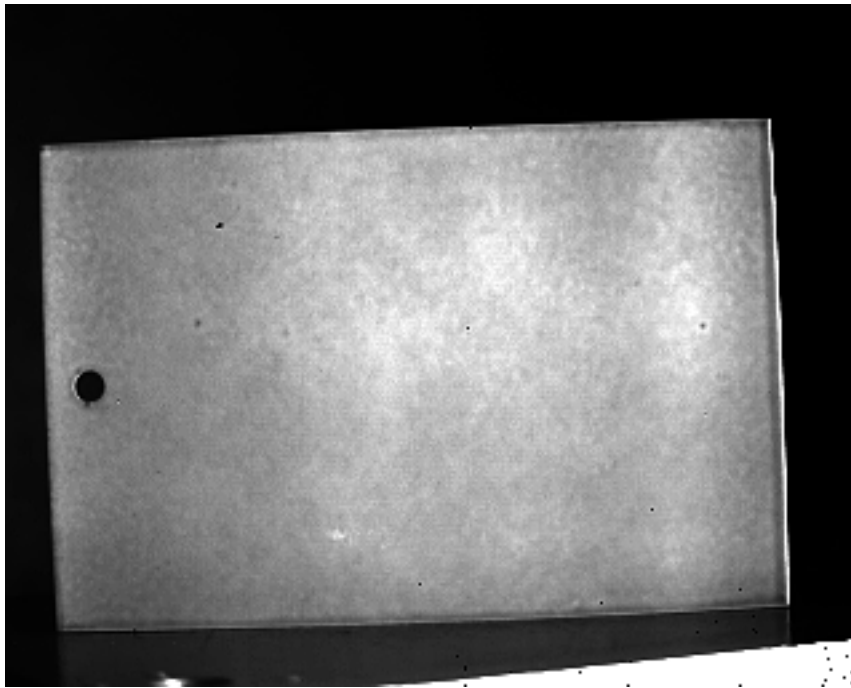
21 j5

IR Photograph does not indicate the presence of corrosion.

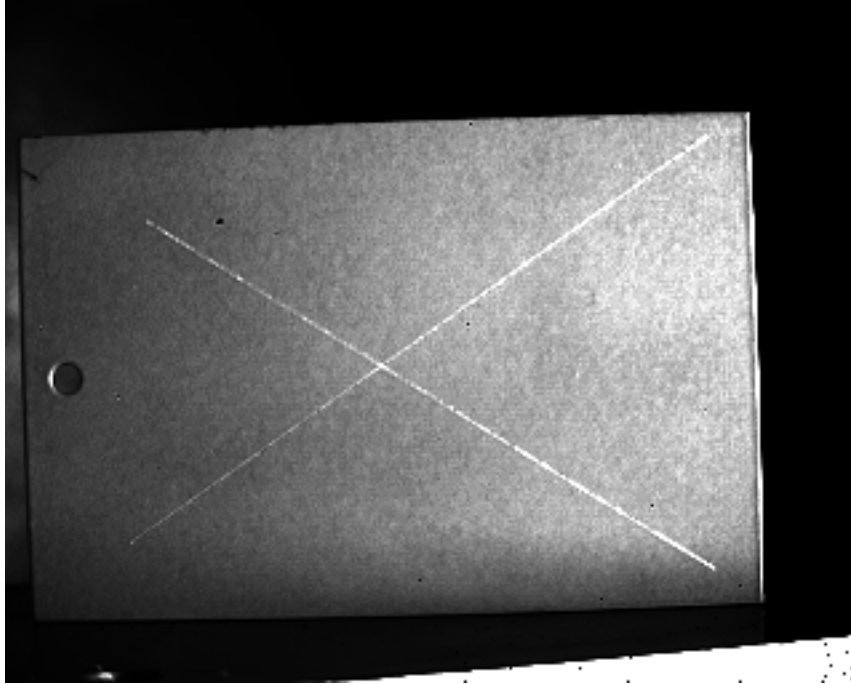
31 C4

IR Photograph indicates minor corrosion in scribed zone.

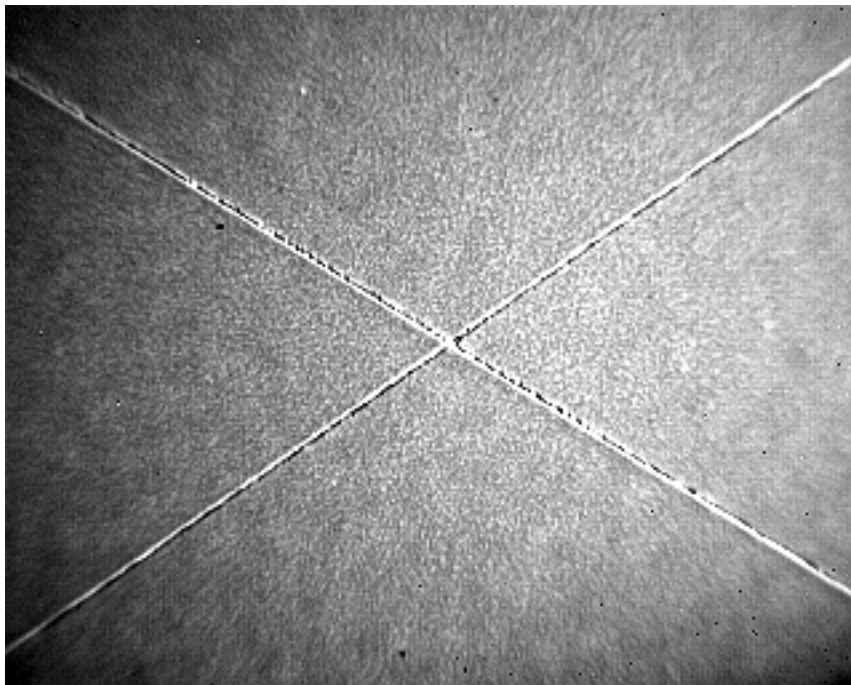
31 C4 (CLOSE)

Observations same as 31 C 4.

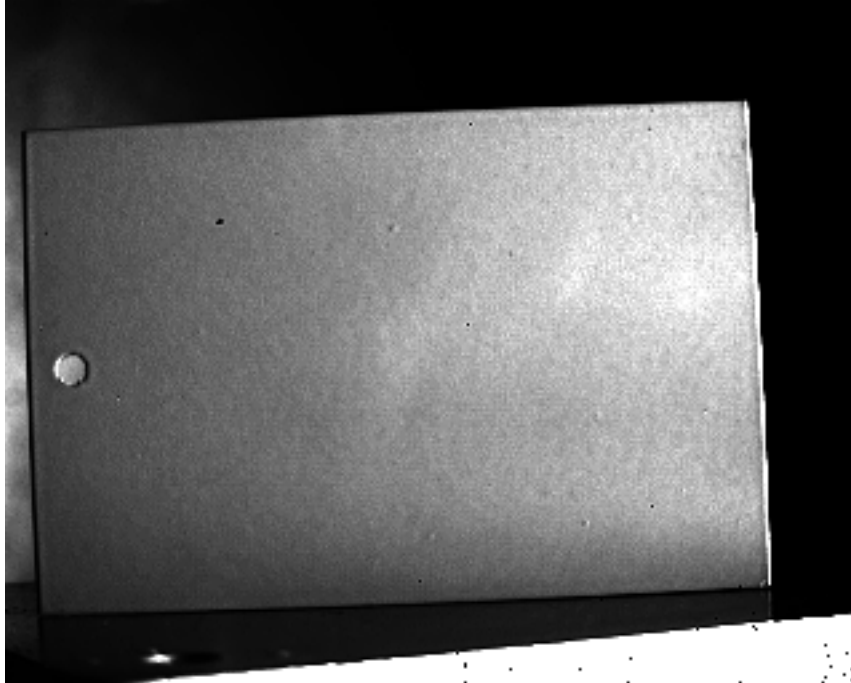
31 j1
IR Photograph
No corrosion observed

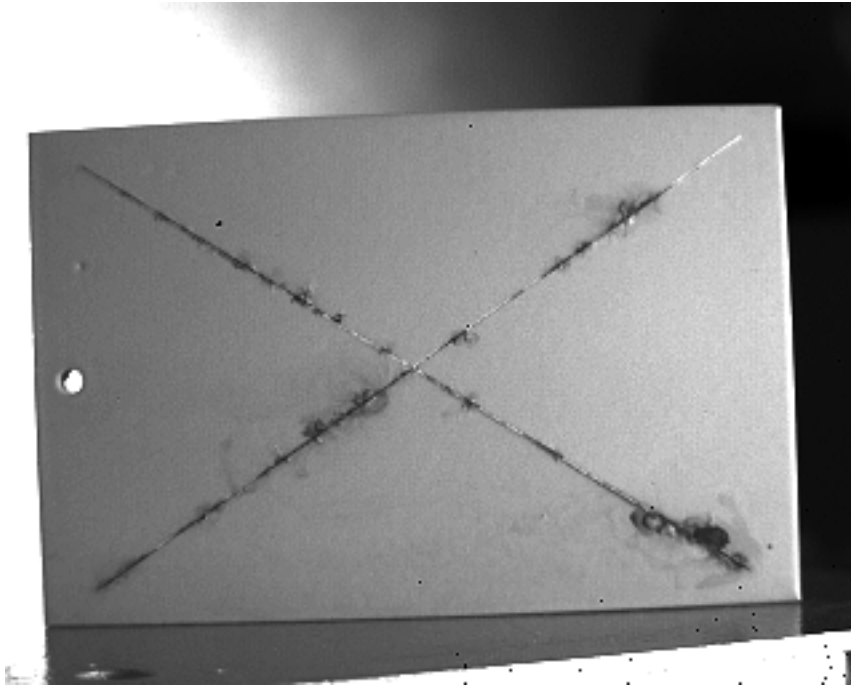
47 C4

Extensive corrosion in scribed area with corrosion under coatings extending from scribed area. Additionally there are indications of corrosion under the coating in areas that are not yet peeling.

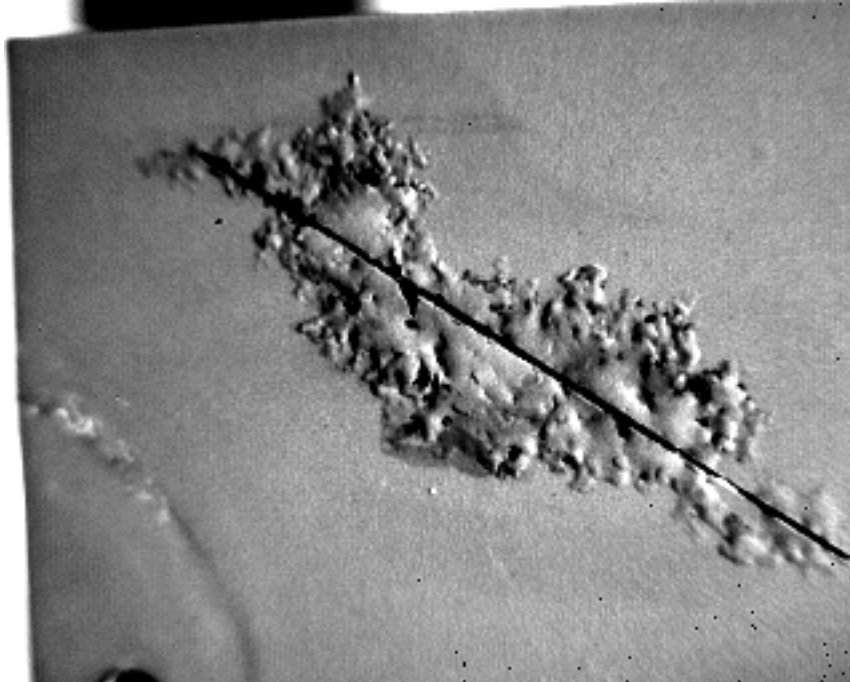
47 e1 Close 1

IR Photograph indicates extensive corrosion seen under coating, as well as corrosion in scribe.

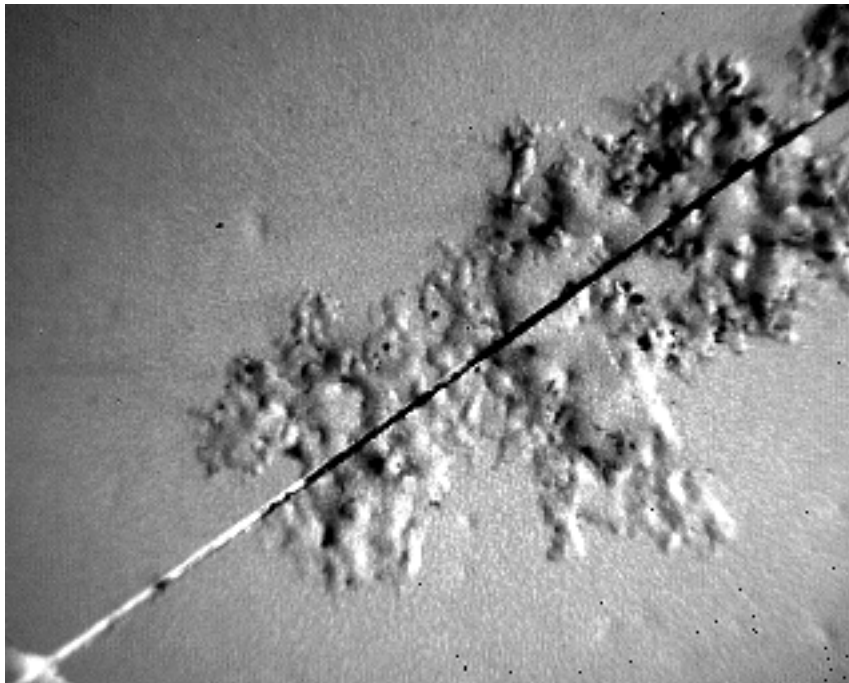
47 e 1 Close 2

Comments same as 47 e1 close 1 above. Note: Corrosion under coating by corroded scribe. The non-corroded scribe area did not show indications of corrosion under the coating.

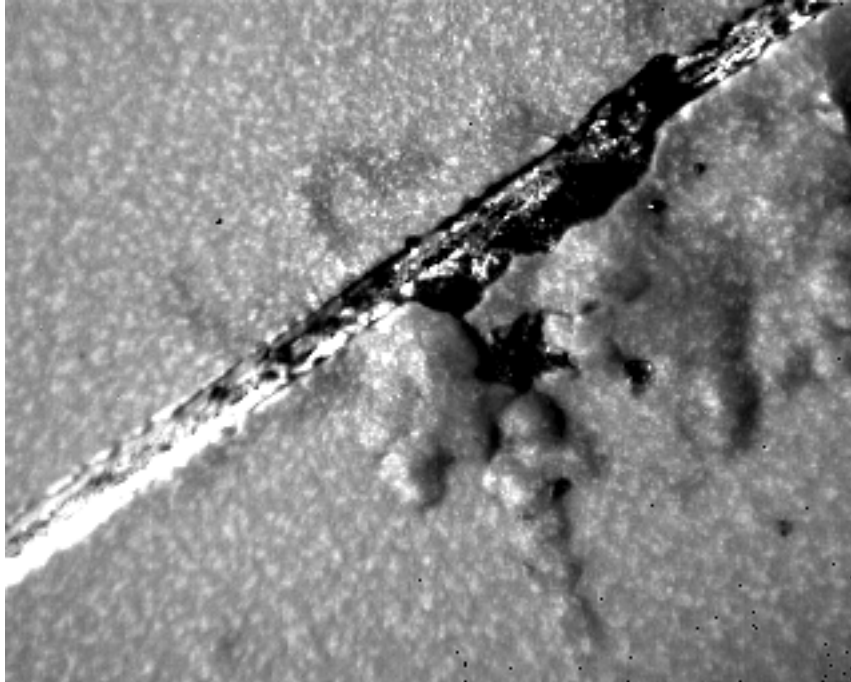
47 e4 (1X Mag.)
IR Photograph

Corrosion clearly visible under coating adjacent to corroded scribe area.

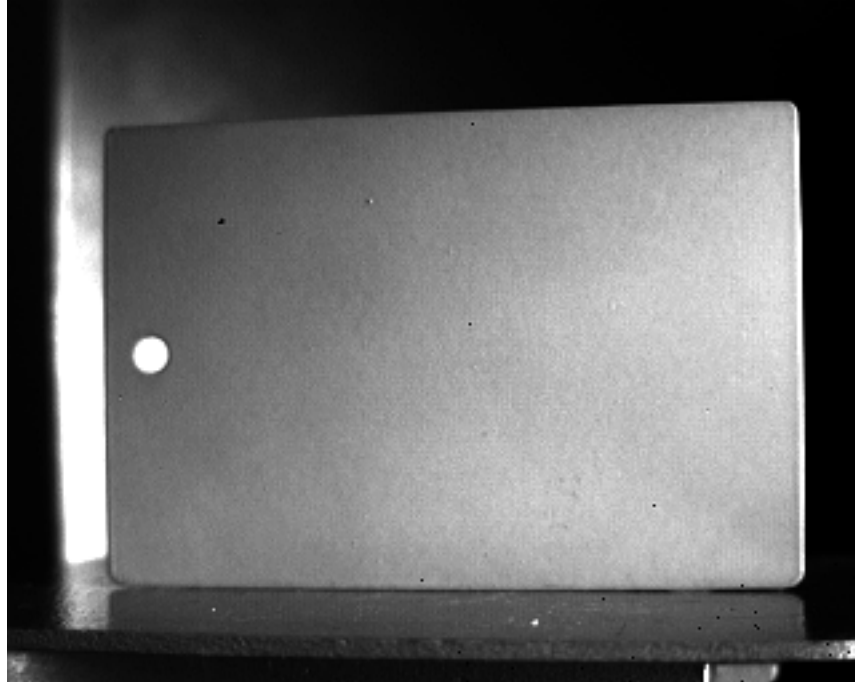
7i 1
IR Photograph
Indicates no corrosion present.

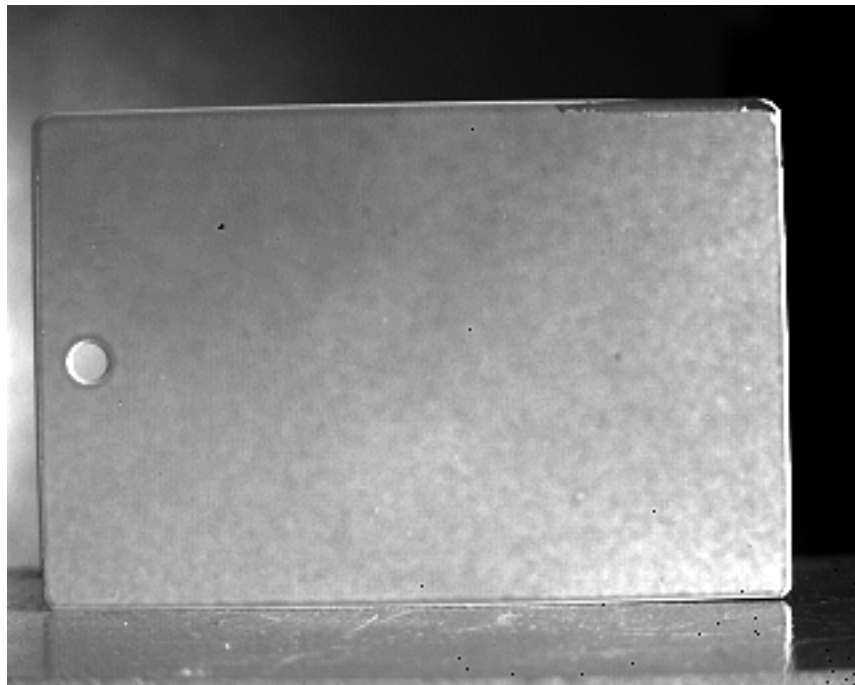
7i b
IR Photograph
Indicate potential for corrosion under coating or possible surface roughness.

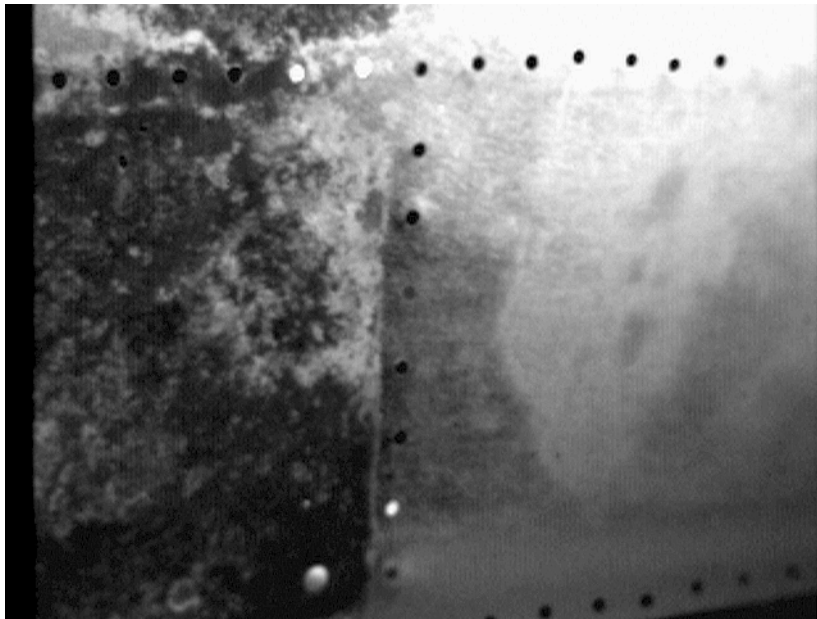
Visible and IR images of belly skin. One side is corroded, the other side has primer on surface.
