A SURVEY OF JAPANESE SHIPYARD  
APPLIED MARINE COATINGS PERFORMANCE

November 1985

John W. Peart  
Avondale Shipyards Inc.

Benjamin S. Fultz  
Bechtel National, Inc.  
Job Number 17856

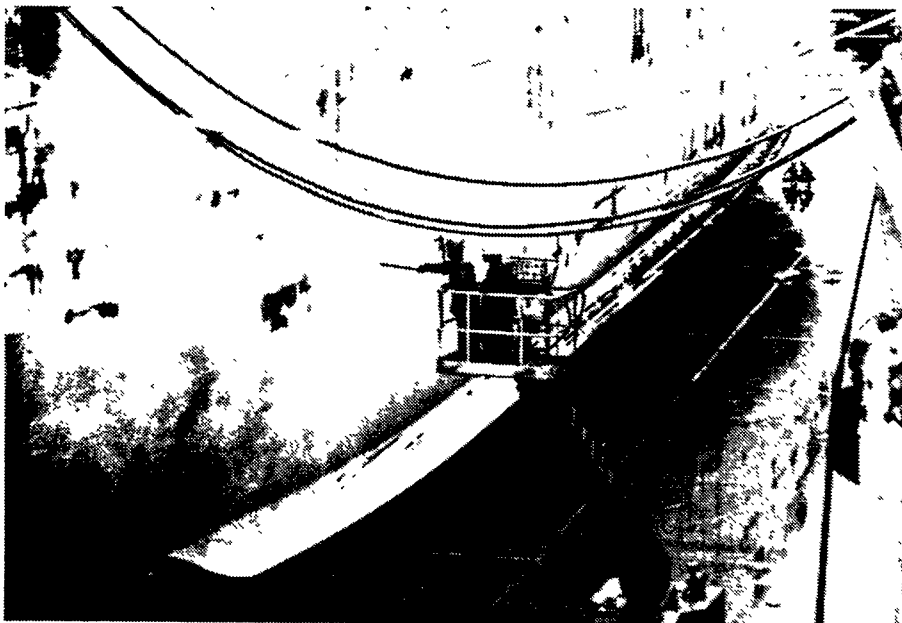
The coatings failure on the underwater hull and freeboard was primarily limited to mechanical damage resulting from anchor chains and fenders. There was no fouling except in areas where the antifouling (AF) was removed due to mechanical damage. There was no undercutting at the damaged areas. Some inorganic zinc shop primer could be seen at the edges where the coatings were removed. This finding seems to support the suitability of use of inorganic zinc primers as undercoats for immersion service; however, it must be remembered that the film thickness was limited to 0.6 mils and the material is modified with a reduced zinc loading and an organic resin. See Figure 3.1 for overall view of underwater bottom.

Figure 3.1: View of Foul Free Bottom

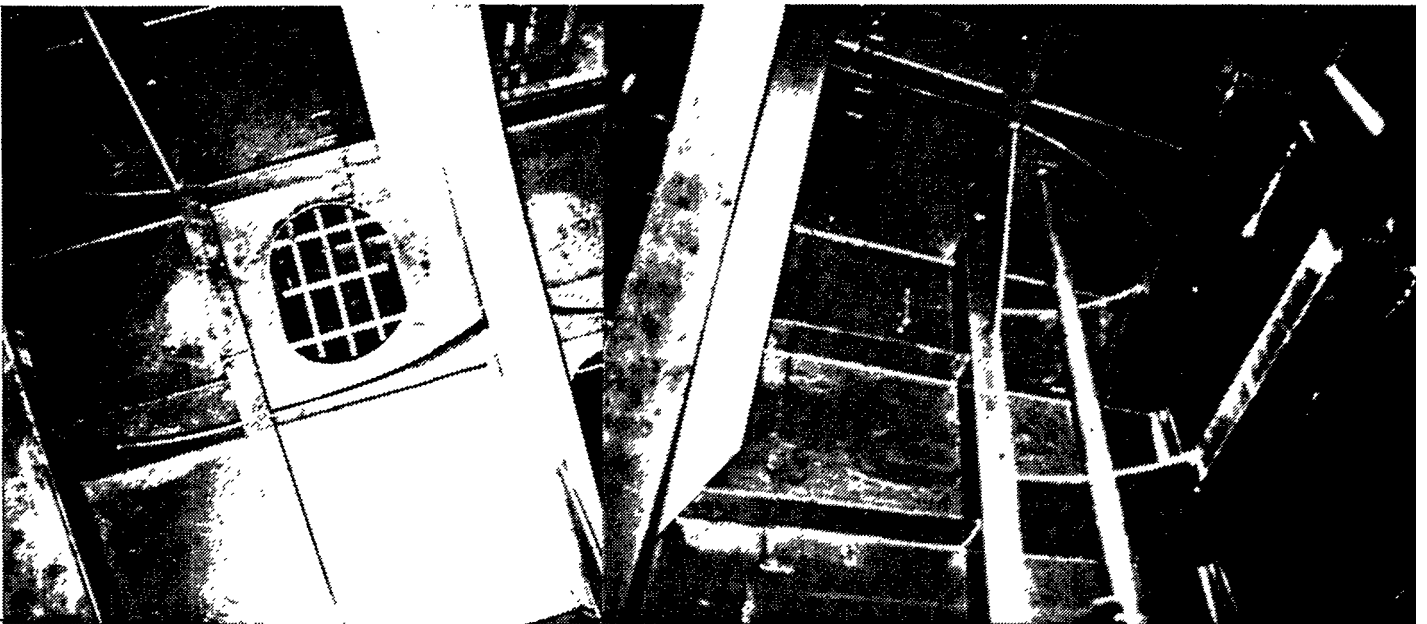
Figure 3.9: Evergiant Tank

The forepeak tank was selected for tank coating inspection. The applied system consisted of one coat of coal tar epoxy applied over shop primer. The weld and damaged areas were repaired with power grinders but no primer was reapplied to repaired areas. Swirl marks from the secondary surface preparation was visible through the coating. The actual measured thickness varied from 18 to 20 mils. The overall condition of the tank coating was good

with no blistering but with some minor failure of weld areas. It also appeared that the tank had not been fully pressed up during ballast. (See Figure 3.9) The tank coating was supplemented with one 10 to 15 pound zinc anode in each tank cell. The anodes did not appear to have been activated, therefore, exhibiting little or no consumption. This could be attributed to the anode mounting method which consisted of mechanical fastening of the round anode bar to a round "C" clamp. Rust was observed on the anode rod and the bare area of structural steel immediately around the anode. Additionally, no calcareous deposits were noted on the bare steel which would indicate the lack of electrical continuity between the anode and the steel.

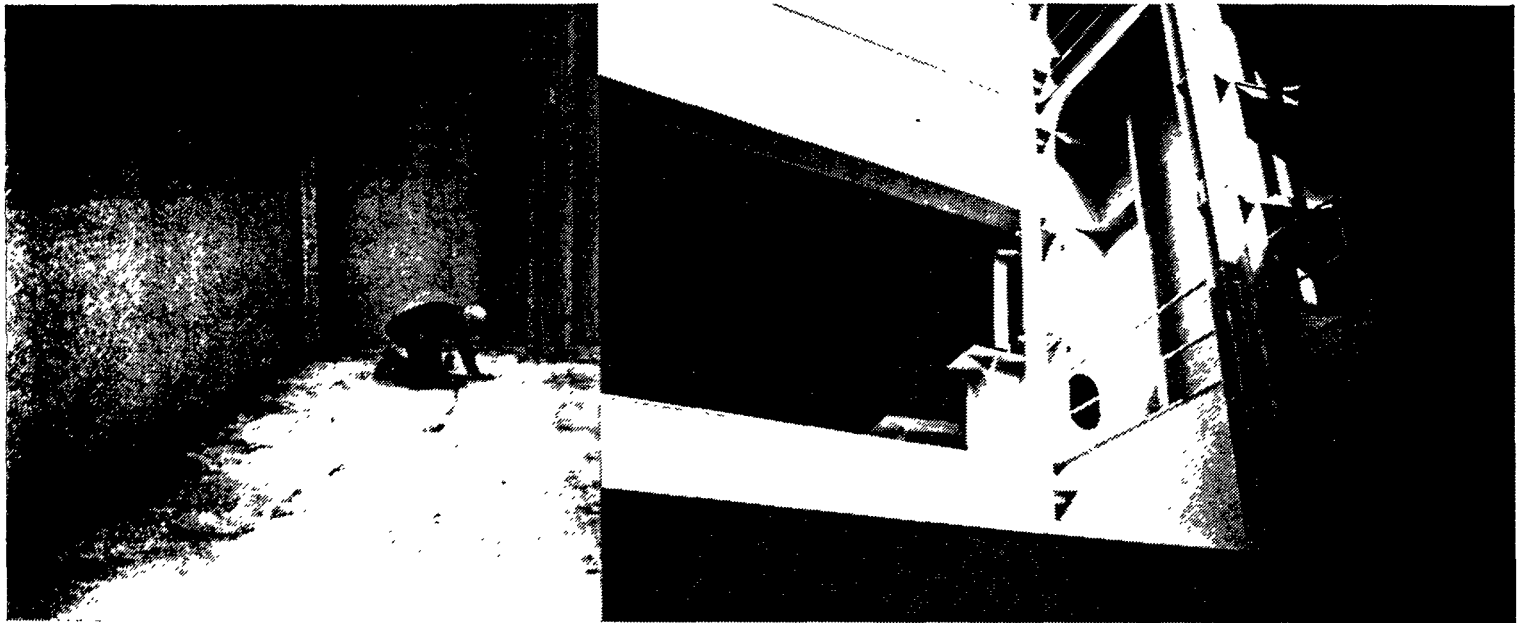
Figure 3.10: Evergiant Cargo Hold

The bleached tar epoxy system in the dry cargo holds was in excellent condition. There was some checking of the coating in areas of measured high film build - 13 mils. (See Figure 3.10) The checking did not extend to the steel substrate. The condition of the alkyd system in the Forecastle area was also excellent with no failure.

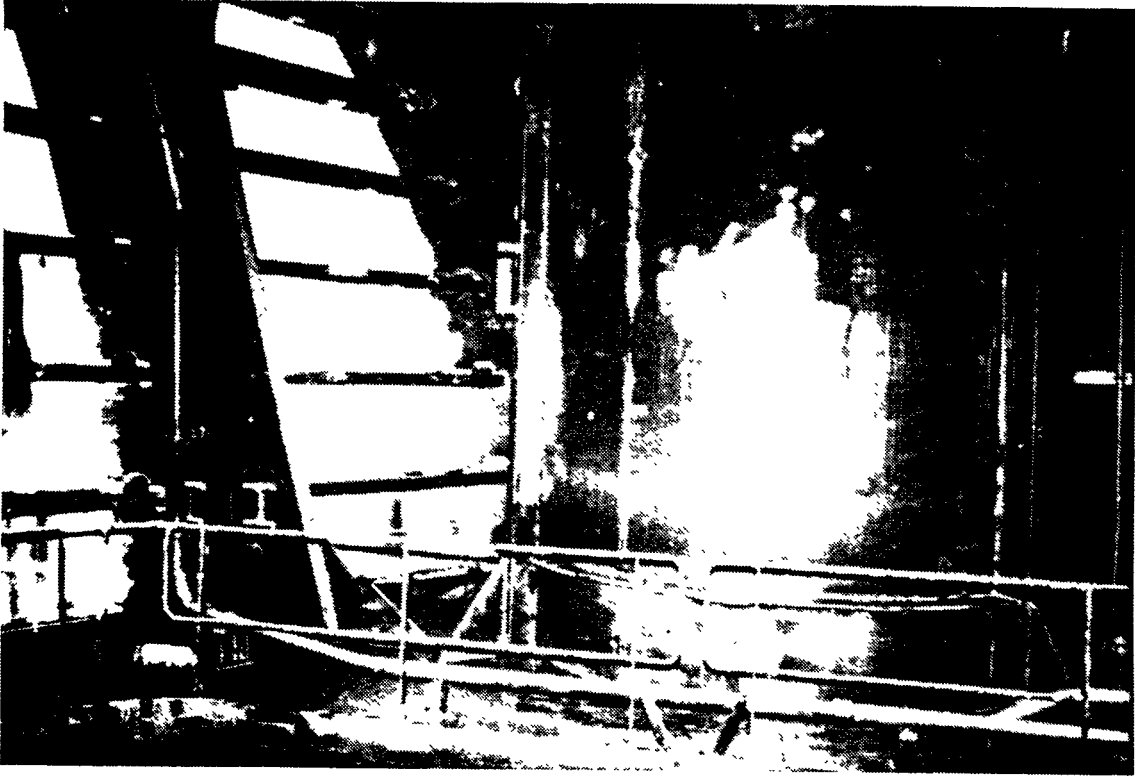
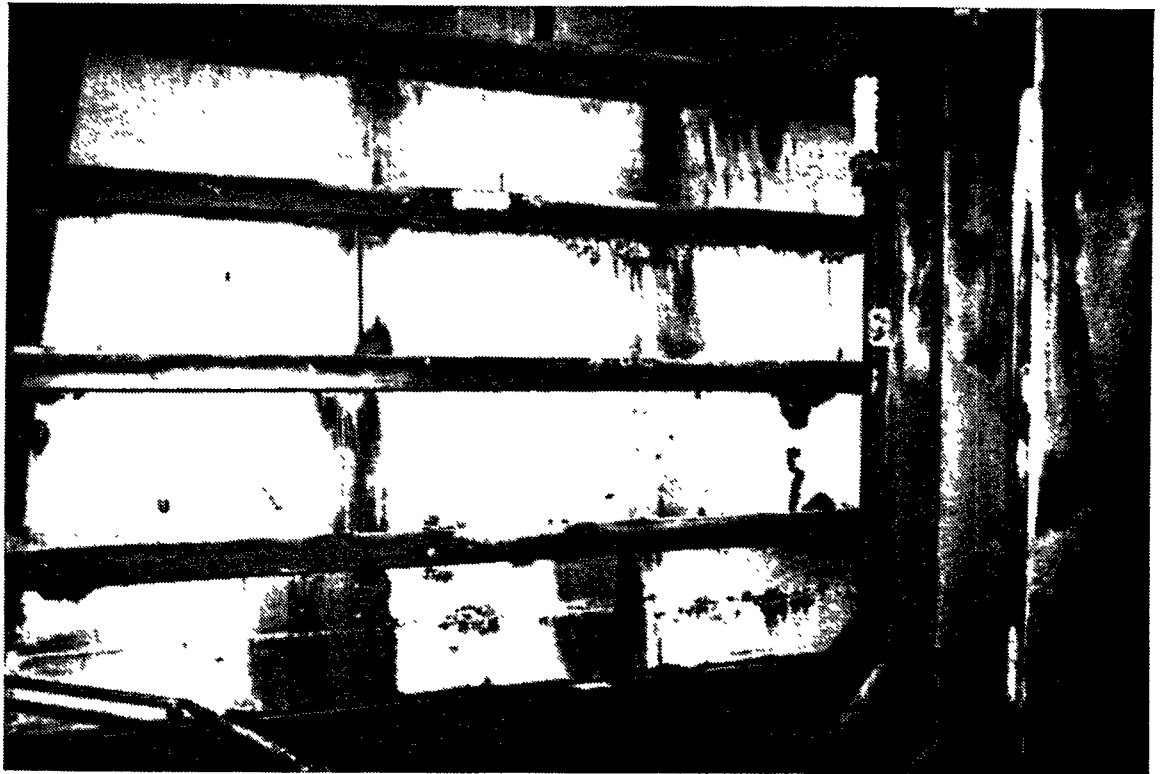
Figure 3.11: Shoi Maru TEAC Tank

The forepeak tank was selected for coating inspection. As opposed to the one year old ship tank coatings, the coatings in this tank were judged overall to be poor. There was extensive corrosion along the bottom edge of the tank top and bottom of the bulkhead where it joins the tank top (See Figure 3.11). One of the tank cells inspected was approximately 10 feet high by 30 feet wide by 20 feet long. This cell was representative of the others inspected. As with the one year ship, the coating system was reinforced with a zinc

sacrificial anode cathodic protection system. The representative tank was fitted with eleven, 20 pound anodes. The attachment technique was the same as discussed for the previous ship. Again very little calcite formation had taken place (See Figure 3.12). The coal tar epoxy had numerous large blisters. One which was approximately 5 inches in diameter contained water but no underfilm rust was evident. The measured coating film thickness ranged from 10 to 13 mils. Some isolated, exfoliation and attendant severe corrosion was also evident on cut plate edges. In these cases the steel had also exfoliated. There was also substantial loss of coatings due to a lack of adhesion. In flat areas the failure seems to start with blisters which rupture and then undercut. The overall coatings failure was 10% to 15%. Some pitting was observed on the bare flat surfaces but not on the verticals. The degree of coating failure was judged to be greater than would have been expected. Previous inspections of coal tar epoxy applied directly over blasted steel revealed very little coatings failure in comparison. The blistering and lack of adhesion could be a result of a compatibility problem with the vinyl butyral wash primer even though no definite conclusions can be made.

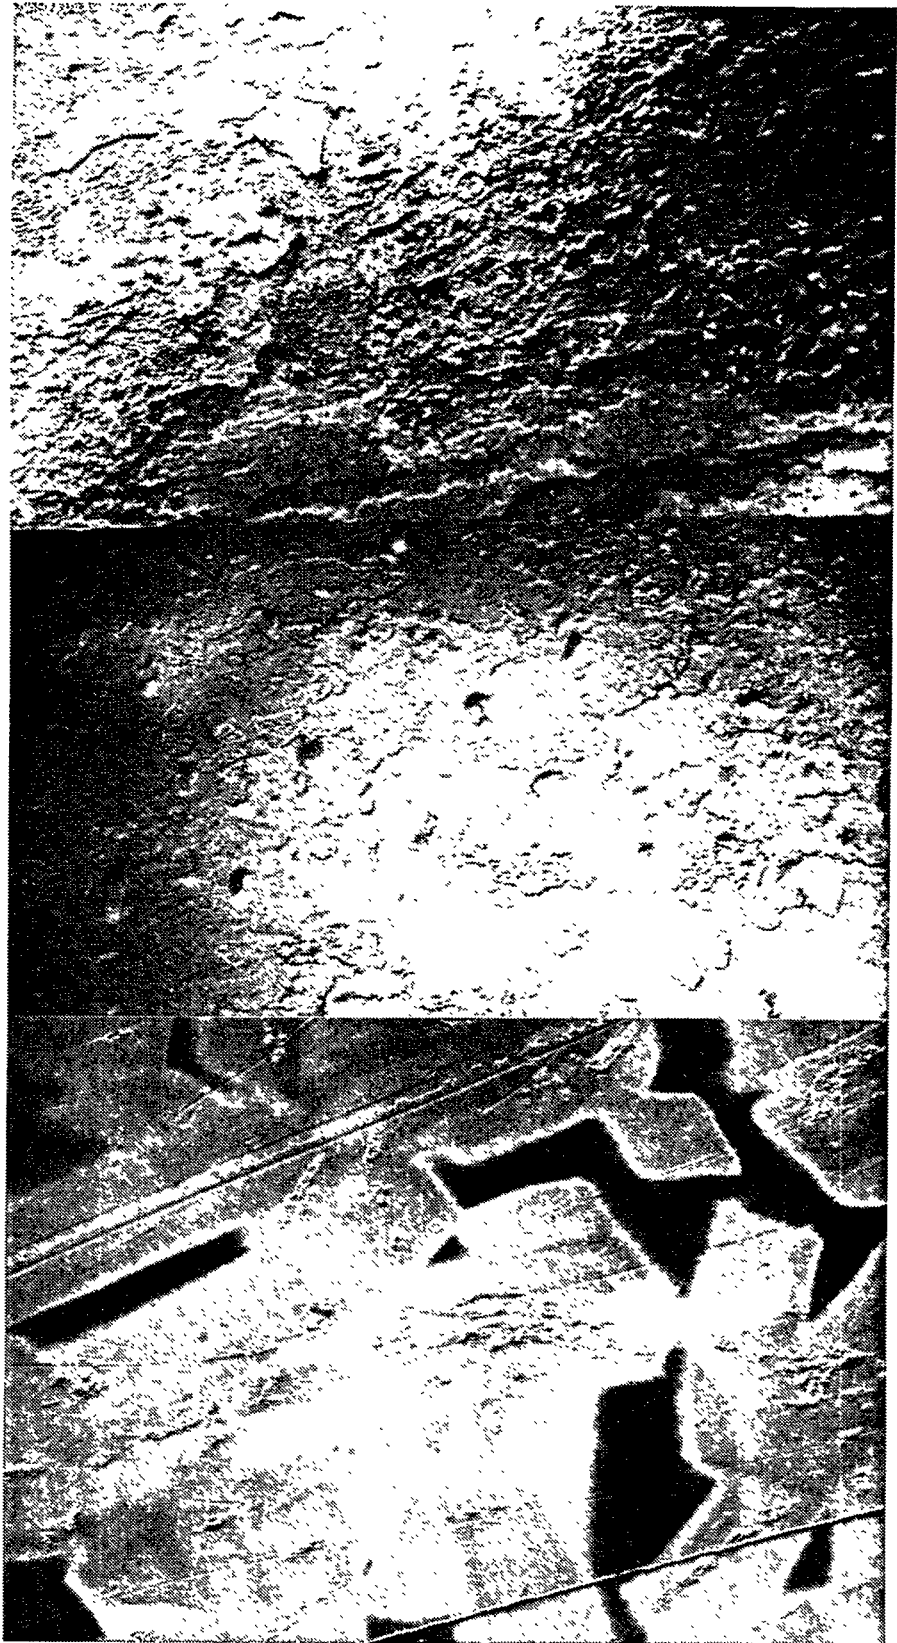
Figure 3.14: Southern Highway

The underwater bottom was not inspected prior to the beginning of surface preparation; however, judging from the amount of touch-up observed the next morning, the bottom probably had at least 50% failure. Figure 3.14 is a close up of the repaired area after spot priming immediately prior to topcoat application. Note that the chlorinated rubber is flaking, appears brittle and is showing signs of delamination. The spot priming and top coats of chlorinated rubber were applied over this condition. The resulting rough condition on the underwater bottom would be unacceptable to some ship owners due to increased fuel consumption.

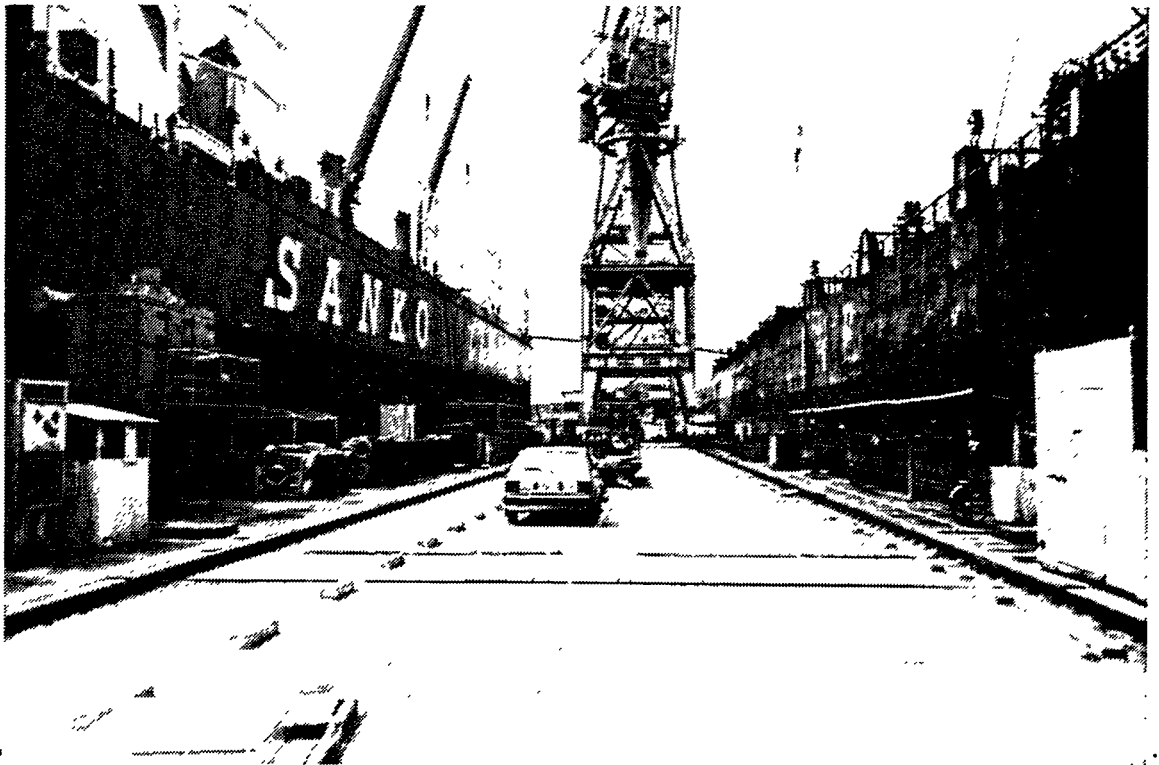
Figure 3.16: Golden Orchid

The ship was originally constructed at IHI Aioi and was inspected at IHI Aioi. As things happen, a new ship of the same type was at dock on the same quay as the surveyed ship. Figure 3.16 provides a good contrast between old and new.

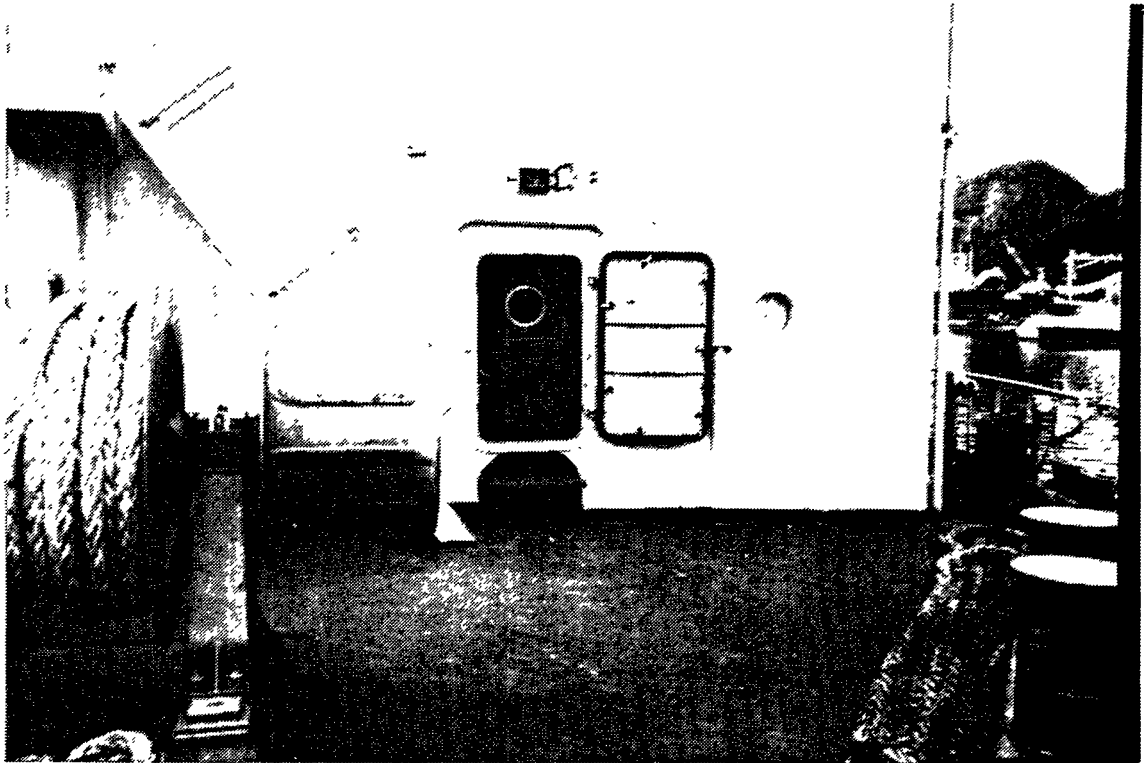
Figure 3.21: Golden Orchid

The interior of the engine room was in excellent condition. The exterior of the superstructure was in good condition and had apparently been painted numerous times. (See Figure 3.21) The measured film thickness ranged from 38 - 40 mils.
