Evaluation of New Surface Preparation and Coating Repair Techniques in Ballast Tanks - Phase III

**THE NATIONAL
SHIPBUILDING
RESEARCH
PROGRAM**

**NEW SURFACE PREPARATION &
COATING REPAIR TECHNIQUES IN
BALLAST TANKS**

EVALUATION OF
NEW SURFACE PREPARATION AND COATING REPAIR
TECHNIQUES IN BALLAST TANKS-PHASE III

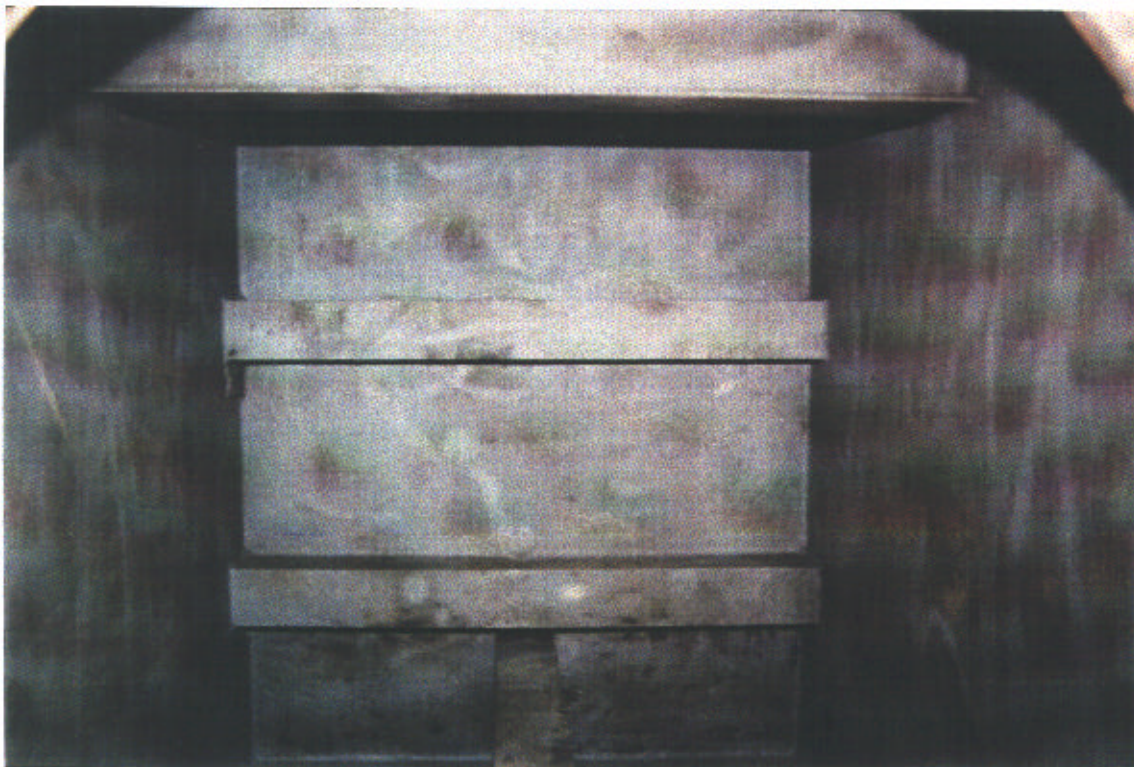
During abrasive blast surface preparation it was difficult to achieve a true SSPC-SP 10, "Near white Blast Clean" surface. Due to the high chloride contamination of the corroded steel, the blasted surface would flash rust within a matter of minutes. See Photograph 2. This statement holds true for all the tanks which were reblasted for this phase of the project.

PHOTOGRAPH 2-NEAR WHITE BLAST SHOWING FLASH RUST

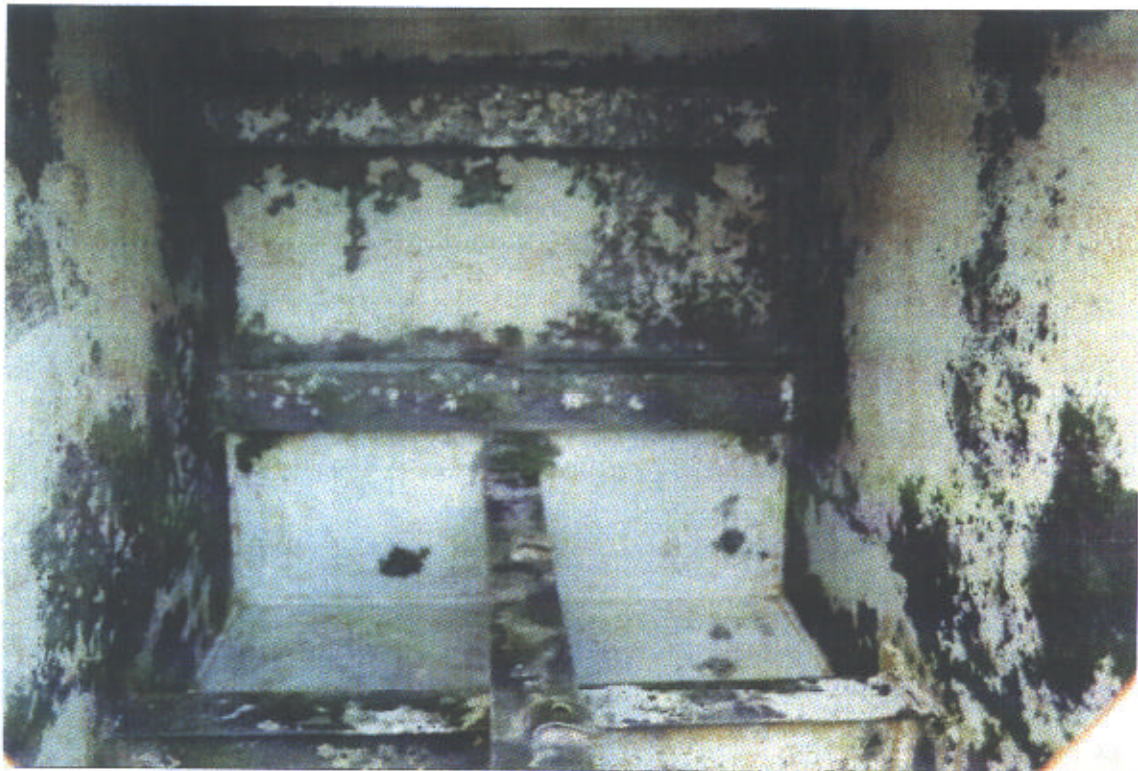
Hand (SSPC SP-2) and power tool cleaning (SSPC SP-3) consisted of chipping hammers, hand and power wire brushes, needle guns and power disc sanders. Hand sanding was used to feather the edge of intact remaining coatings. See photograph 4 for an example of the resultant surface preparation prior to the application Surface Tolerant Epoxy "A." Photograph 5 shows the repair surface preparation of the Mil-P-24441 system prior to spot priming and full refresher topcoat application.

PHOTOGRAPH 4-POWER/HAND TOOL CLEANED SURFACE PRIOR TO COATING

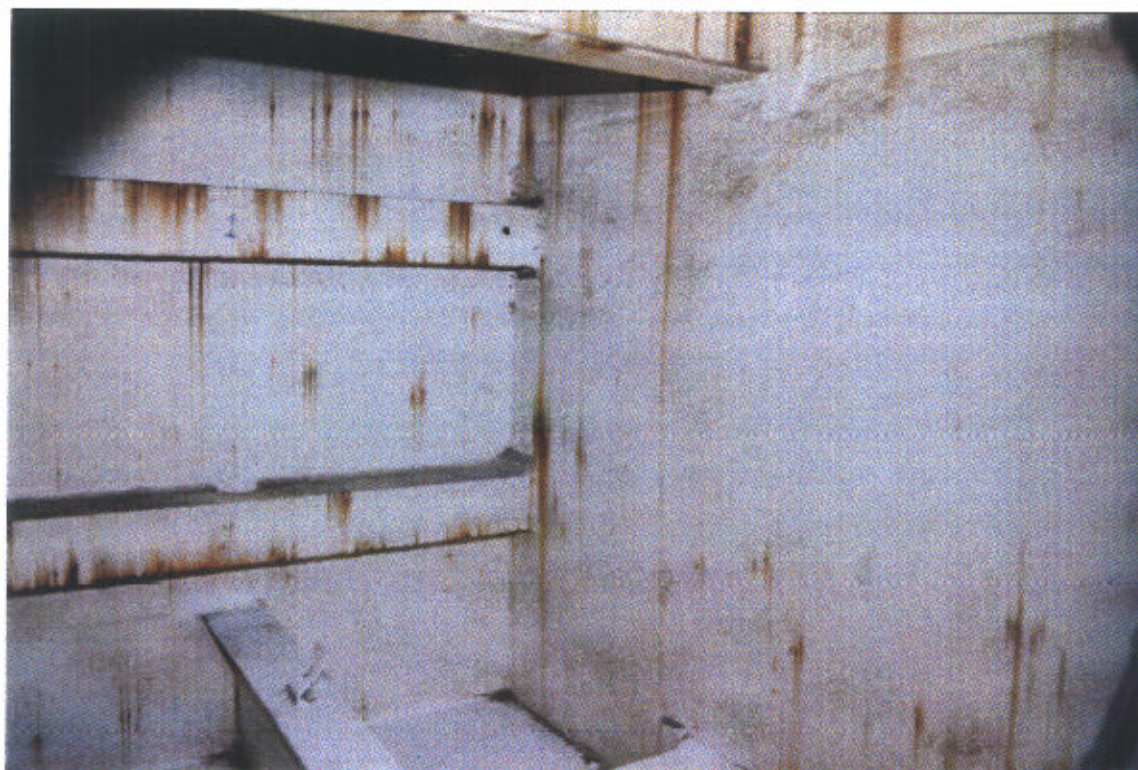
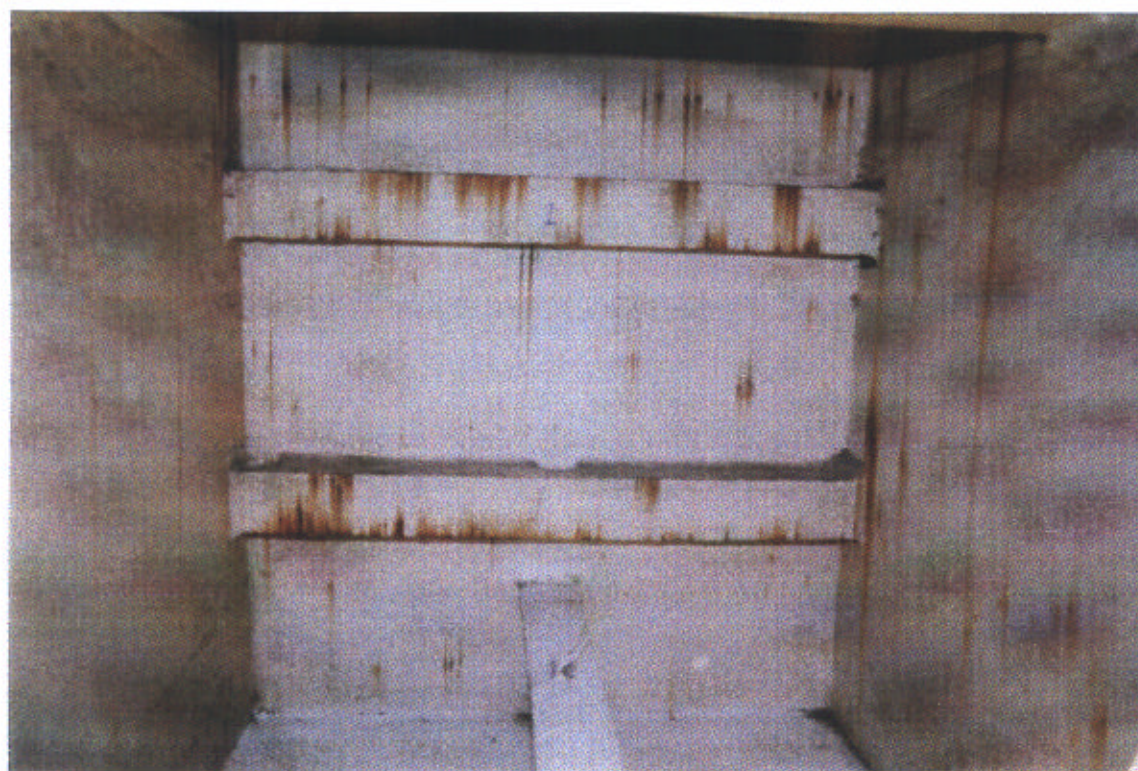
TANK ONE	COATING SYSTEM: SURFACE TOLERANT EPOXY A VOC COMPLIANT (AMERON 385P/385). (SYSTEM LIFE-3 YEARS) COATING NOT REPLACED IN OVERHEAD. SURFACE PREPARATION: SP-2/SP-3 PREVIOUS SYSTEM: SAME
TOP-FLAT DFT-N/A	RUST GRADE 8 CLER CONDITION # 2
TOP-STIFFENER DFT-N/A	EDGE BREAKDOWN, RUST GRADE 6 CLER CONDITION # 2
BACK-FLAT DFT-14.5 MILS	RUST GRADE 8 CLER CONDITION # 2
BACK-TOP STIFFENER DFT-9.8 MILS	RUST GRADE 7 CLER CONDITION # 2
BACK-BOTTOM STIFFENER DFT-26 MILS	RUST GRADE 7 CLER CONDITION # 2
BOTTOM-FLAT DFT-22.7MILS	RUST GRADE 9. FRONT RIGHT QUADRANT CRACKING AT WELD. CLER CONDITION # 2
BOTTOM- STIFFENER DFT-19 MILS	RUST GRADE 9. GOOD EDGE PROTECTION. CLER CONDITION # 2
BOTTOM-FRAME DFT-16.2MILS	RUST GRADE 9 CLER CONDITION # 2
RIGHT SIDE DFT-13.3 MILS	RUST GRADE 8 CLER CONDITION # 2
LEFT SIDE DFT-15 MILS	RUST GRADE 9 CLER CONDITION # 2

PHOTOGRAPH 8- SURFACE TOLERANT EPOXY "A" OVER HAND TOOL CLEANING

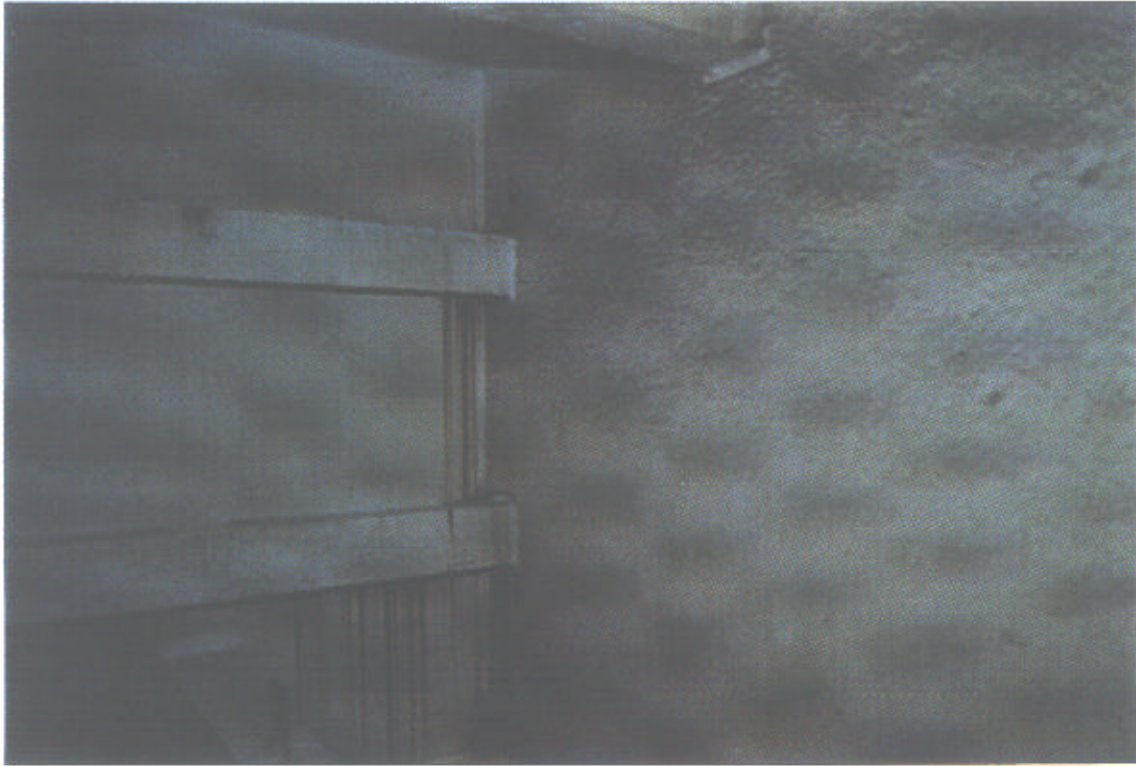
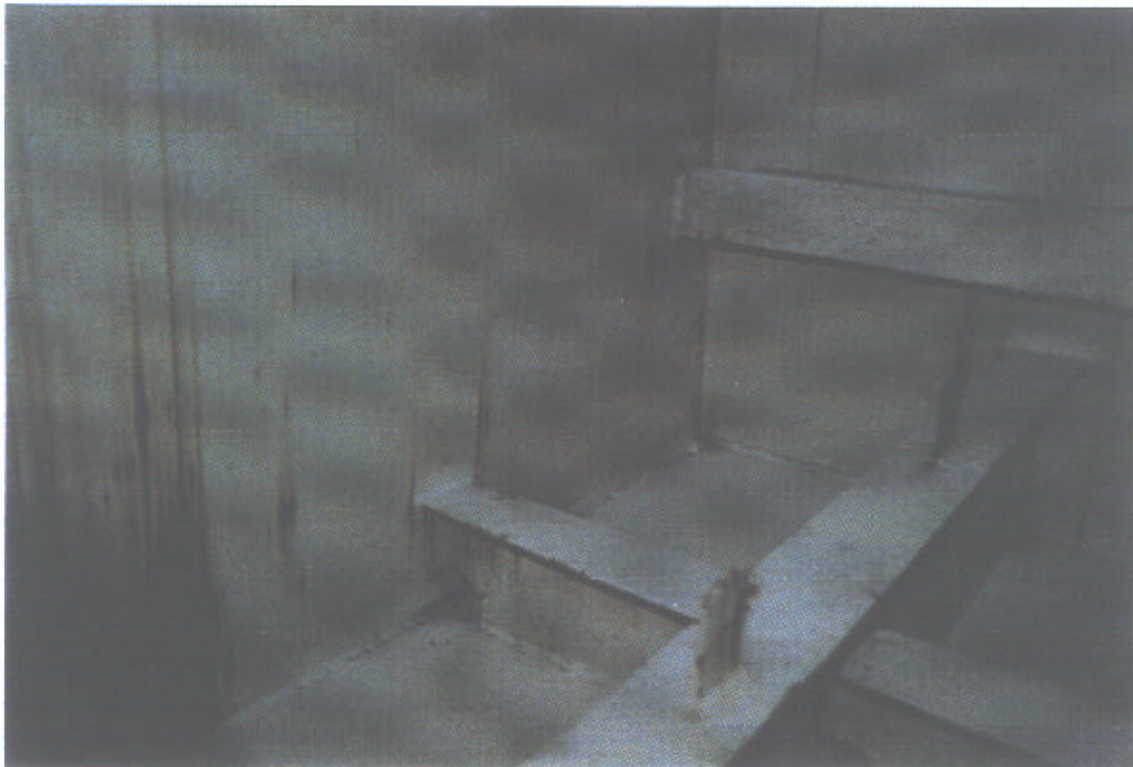
Tank 4 has an overall ASTM rating of rust grade 9 with one area on the left side, bottom front quadrant graded as a 7. The performance of this system over Sweep Blast Cleaned (SP 7) steel is marginally better than the same system applied over hand and power tool cleaned steel. See photograph 9.

TANK FOUR	COATING SYSTEM: SURFACE TOLERANT EPOXY A VOC COMPLIANT (AMERON 385P/385) (SYSTEM LIFE-3 YEARS) SURFACE PREPARATION: SP-7 PREVIOUS SYSTEM: SAME OVER SP-10
TOP-FLAT DET-16.2 MILS	RUST GRADE 10 CLER CONDITION # 1
TOP-STIFFENER DFT-13.6 MILS	RUST GRADE 9. NO EDGE BREAKDOWN. EDGE OF STIFFENER 1/8 INCH THICK TAPERING UP TO FULL THICKNESS. CLER CONDITION # 1
BACK-FLAT DFT-15.8 MILS	RUST GRADE 9. SOME RUST STREAKS. CLER CONDITION # 2
BACK-TOP STIFFENER DFT-18.2 MILS	RUST GRADE 9. 3/16 INCH THICKNESS REMAINING. CLER CONDITION # 2
BACK-BOTTOM STIFFENER DFT-14.4 MILS	RUST GRADE 9. 3/16 INCH THICKNESS REMAINING. CLER CONDITION # 2
BOTTOM-FLAT DFT-19.8 MILS	RUST GRADE 9 CLER CONDITION # 1
BOTTOM- STIFFENER DFT-17 MILS	RUST GRADE 9. MINOR EDGE BREAKDOWN. 3/16 INCH THICKNESS REMAINING. CLER CONDITION # 1
BOTTOM-FRAME DFT-15 MILS	RUST GRADE 9. 1/16 INCH THICKNESS REMAINING ON FLANGE EDGE; 3/16 INCH THICKNESS REMAINING ON WEB. CLER CONDITION # 1

RIGHT SIDE DFT-13.1 MILS	RUST GRADE 9 CLER CONDITION # 1
LEFT SIDE DFT-14.9 MILS	BOTTOM FRONT QUADRANT 7. BALANCE 9 CLER CONDITION # 2

PHOTOGRAPH 9-SURFACE TOLERANT EPOXY "A" OVER SWEEP BLAST CLEANING

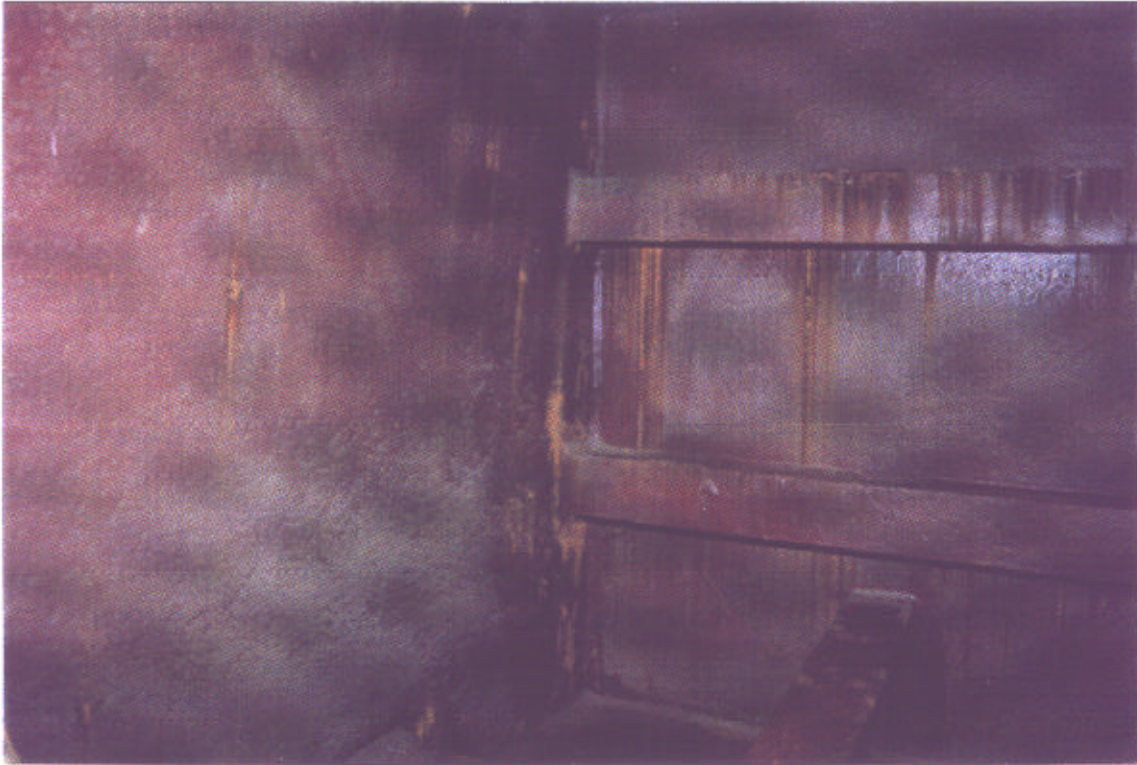
The Epoxy "B" coated tank 5 has been under test for a total of eleven years. Following the initial six years of testing, this system was beginning to show significant breakdown. The top of the tank had twenty-five to fifty percent failure. The right side of the tank had totally failed. The balance of the tank had between five and ten percent failure.

The system was repaired using hand tool cleaning (SSPC-SP 2). After another two years of testing, the overall failure was less than one percent with only minor breakdown on the edges of the overhead stiffener. No failure was observed on the balance of the structure. The coating system was only spot repaired at this time.

After three additional years of testing (eleven total), the top overhead and top back stiffener has major edge breakdown. The right side lower left quadrant has also failed. This is an interesting observation in that no matter which coating system has been applied to this tank, this exact location fails during each test project. The reason for this unique failure is not known but it is believed that microbiological influenced corrosion (MIC) may be the cause. See photograph 10.

TANK FIVE	COATING SYSTEM: SURFACE TOLERANT SYSTEM B (DEVOE 235) (SYSTEM AGE 11 YEARS) SURFACE PREPARATION : SP-2 MINOR AREAS ONLY @ 8 YEARS PREVIOUS SYSTEM: SYSTEM "B" W/SP-6. SP-2 REPAIRED @ 6 AND 8 YEARS.
TOP-FLAT DFT-14.4 MILS	RUST GRADE 10. CLER CONDITION # 1
TOP-STIFFENER DFT-15.3 MILS	EDGE BREAKDOWN. RUST GRADE 9 BALANCE. NO SIGNIFICANT METAL LOSS. 75% OF EDGE HAS FAILED. CLER CONDITION # 3
BACK-FLAT DFT-18 MILS	RUST GRADE 9. CLER CONDITION # 1
BACK-TOP STIFFENER DFT-21.8 MILS	TOP OF STIFFENER IS DELAMINATING AND LIFTING. BALANCE RUST GRADE 9. NO SIGNIFICANT METAL LOSS. CLER CONDITION # 3
BACK-BOTTOM STIFFENER DFT-22.4 MILS	RUST GRADE 9. NO SIGNIFICANT METAL LOSS. CLER CONDITION # 1
BOTTOM-FLAT DFT-16.4 MILS	RUST GRADE 9 CLER CONDITION # 1
BOTTOM- STIFFENER DFT-	RUST GRADE 9. NO SIGNIFICANT METAL LOSS. CLER CONDITION # 1
BOTTOM-FRAME DFT-24.9 MILS	RUST GRADE 9. NO SIGNIFICANT METAL LOSS. CLER CONDITION # 1

RIGHT SIDE DFT-16.7 MILS	RUST GRADE 7. LOWER LEFT QUADRANT FAILED. THIS SAME AREA HAS FAILED EACH TIME A NEW COATING SYSTEM HAS BEEN APPLIED. CLER CONDITION # 2
LEFT SIDE DFT-12.3 MILS	RUST GRADE 8 CLER CONDITION # 2

PHOTOGRAPH 10-REPAIRED SURFACE TOLERANT EPOXY "B"

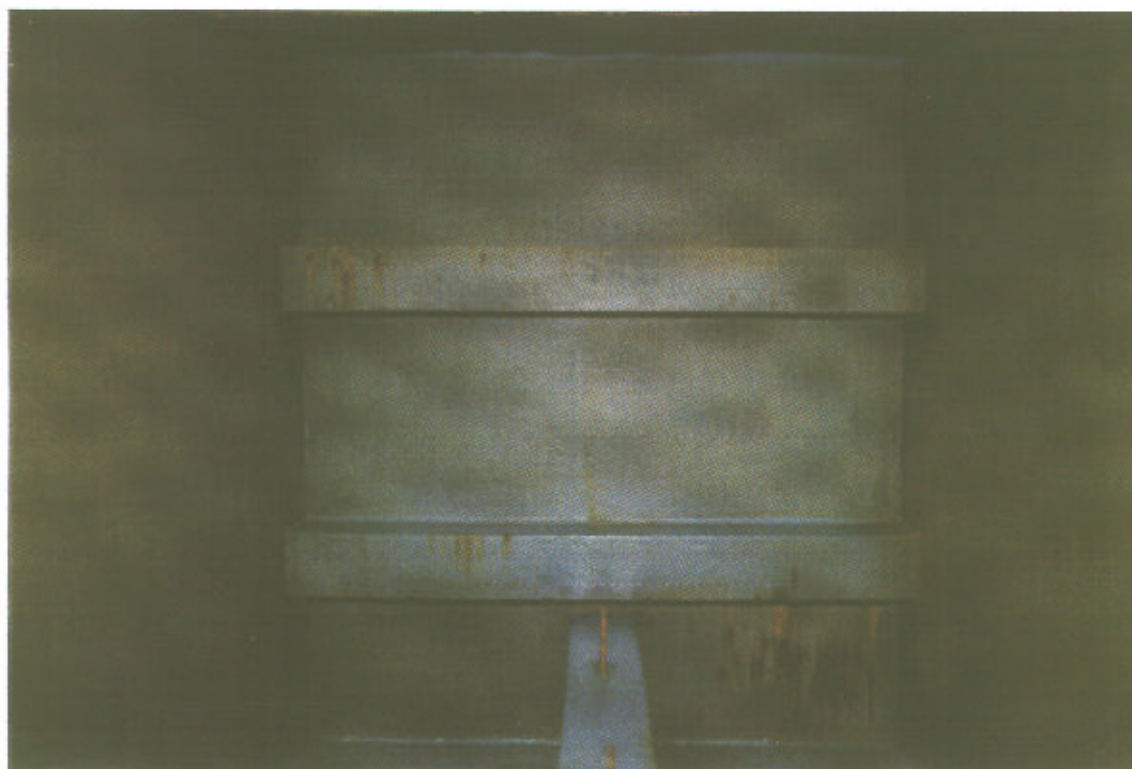
Except for some edge breakdown on the top overhead stiffener, the coating system in Tank 7 is providing corrosion protection after eight years of testing. The overall failure is less than one percent. See photograph 11.

TANK SEVEN	COATING SYSTEM : VOC COMPLIANT MIL-P-24441 REPAIRED W/MIL-P-24441 (AMERON ORIGINALLY; REPAIRED WITH DEVOE) (SYSTEM LIFE-ORIGINAL SYSTEM REPAIRED AFTER 5 YEARS. REPAIR AREAS 3 YEARS. TOTAL 8 YEARS) SURFACE PREPARATION: SP-2/3 PREVIOUS SYSTEM: SAME W/SP-10 SURFACE PREPARATION
TOP-FLAT DFT-7.7 MILS	RUST GRADE 9 CLER CONDITION # 1
TOP-STIFFENER DFT-11.8 MILS	BREAKDOWN ON EDGES. RUST GRADE 8 BALANCE. CLER CONDITION # 2
BACK-FLAT DFT-12.9 MILS	TOP AND CENTER-RUST GRADE 10. BOTTOM RIGHT-RUST GRADE 7. RUST GRADE 10 BALANCE OF BOTTOM. CLER CONDITION # 1
BACK-TOP STIFFENER DFT-14.6 MILS	RUST GRADE 8 CLER CONDITION # 2
BACK-BOTTOM STIFFENER DFT-17.3 MILS	RUST GRADE 9 CLER CONDITION # 1
BOTTOM-FLAT DFT-16.6 MILS	RUST GRADE 9 CLER CONDITION # 1
BOTTOM- STIFFENER DFT-13.6 MILS	RUST GRADE 9 CLER CONDITION # 1
BOTTOM-FRAME DFT-15 MILS	RUST GRADE 7 CLER CONDITION # 2
RIGHT SIDE DFT-15.8 MILS	RUST GRADE 9 CLER CONDITION # 1

LEFT SIDE DFT-14.9 MILS	RUST GRADE 9 CLER CONDITION # 1

PHOTOGRAPH 11-REPAIRED AND OVERCOATED MIL-P-24441

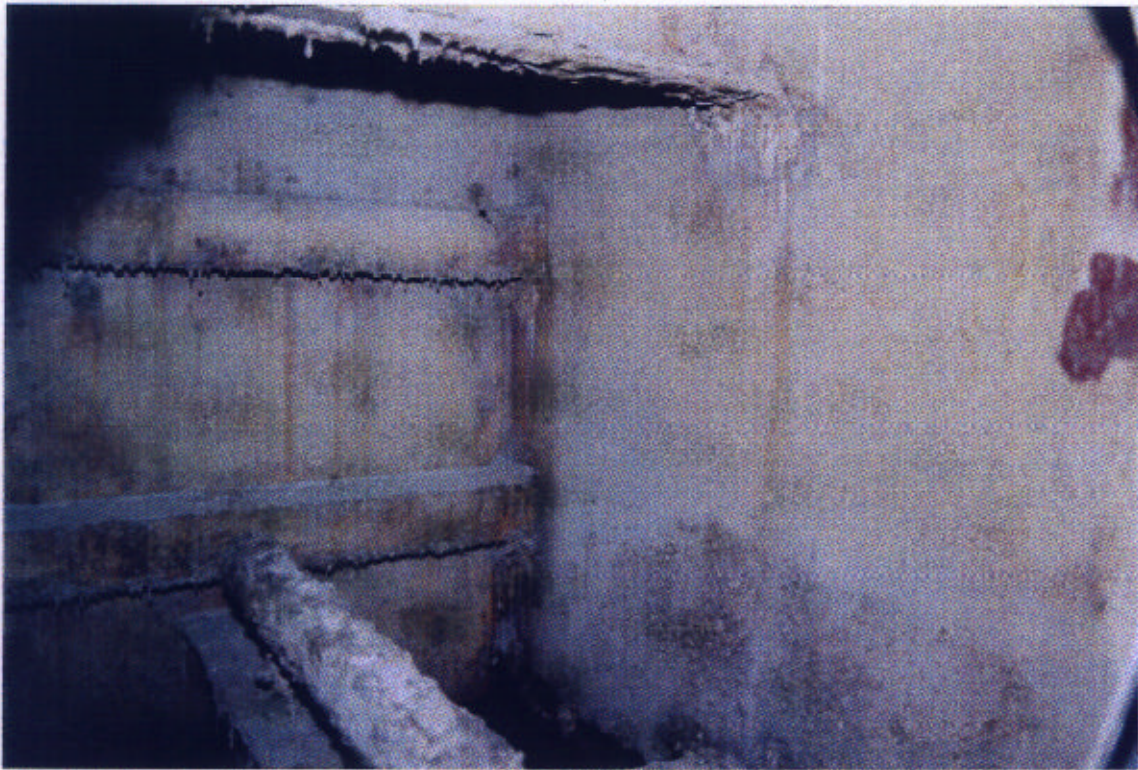
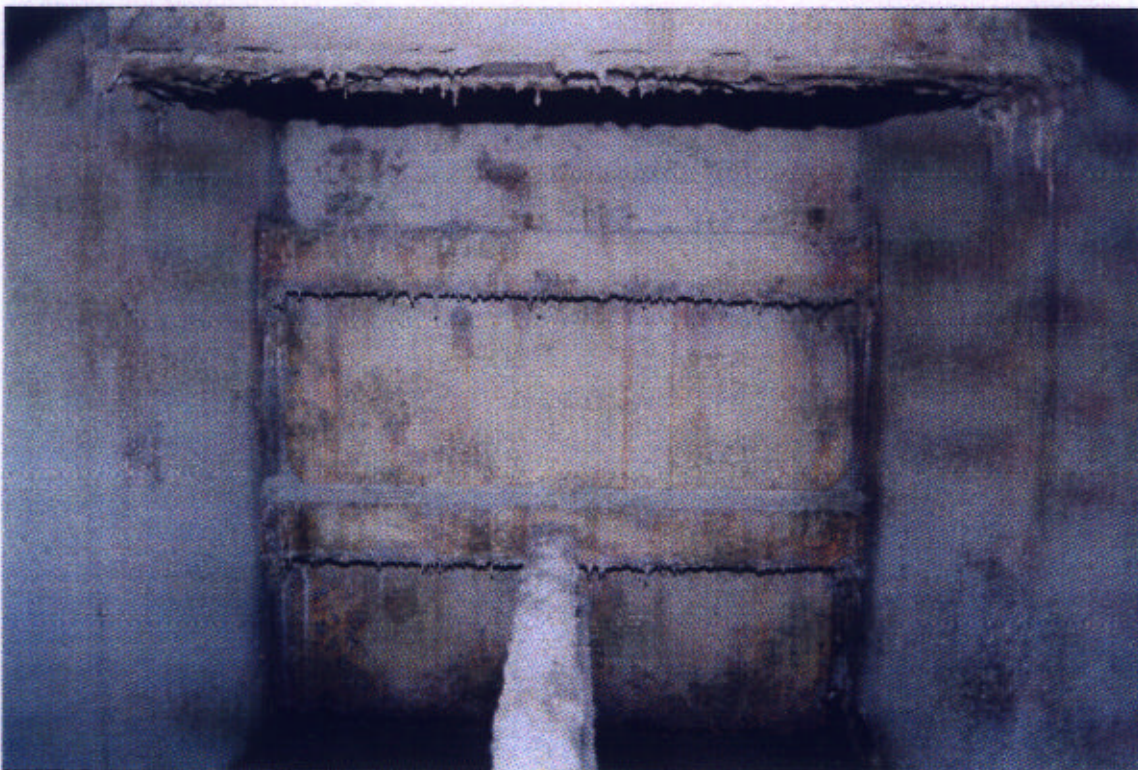
No change was noted in Tank 2 since the last report. No new coating failure was detected. Calcareous deposits continue to increase. Very little anode consumption was noted. This system is sixteen years old. A zinc anode was added after six years. See photograph 12.

TANK TWO	COATING SYSTEM: MIL-P-23236 COATING WITH ZINC ANODE (SYSTEM LIFE-15 YEARS) ORIGINAL DRY FILM THICKNESS RECORDED AS 6.5 to 8.5 MILS. SURFACE PREPARATION: SP-10 PREVIOUS SYSTEM: ANODE ADDED AFTER 6 YEARS OF TESTING
TOP-FLAT	NO DETECTABLE CHANGE FROM LAST GRADE PERIOD. CLER CONDITION # 4
TOP-STIFFENER	NO DETECTABLE CHANGE FROM LAST GRADE PERIOD. 3/16 INCH THICKNESS REMAINING CLER CONDITION # 4
BACK-FLAT	NO DETECTABLE CHANGE FROM LAST GRADE PERIOD. CLER CONDITION # 4
BACK-TOP STIFFENER	NO DETECTABLE CHANGE FROM LAST GRADE PERIOD. NO SIGNIFICANT METAL LOSS. CLER CONDITION # 4
BACK-BOTTOM STIFFENER	NO DETECTABLE CHANGE FROM LAST GRADE PERIOD. NO SIGNIFICANT METAL LOSS. CLER CONDITION # 4
BOTTOM-FLAT	BEGINNING TO SCALE. SCALE WORSE THAN LAST GRADE PERIOD. NEEDS REPAIR. CLER CONDITION # 4
BOTTOM-STIFFENER	NO DETECTABLE CHANGE FROM LAST GRADE PERIOD. 3/16 INCH THICKNESS REMAINING. CLER CONDITION # 4

BOTTOM-FRAME	NO DETECTABLE CHANGE FROM LAST GRADE PERIOD. 1/8 INCH THICKNESS REMAINING. CLER CONDITION # 4
RIGHT SIDE	NO DETECTABLE CHANGE FROM LAST GRADE PERIOD CLER CONDITION # 4
LEFT SIDE	NO DETECTABLE CHANGE FROM LAST GRADE PERIOD CLER CONDITION # 4

PHOTOGRAPH 12-AGED COATING (MIL-P-23236) WITH ADDED ZINC ANODE

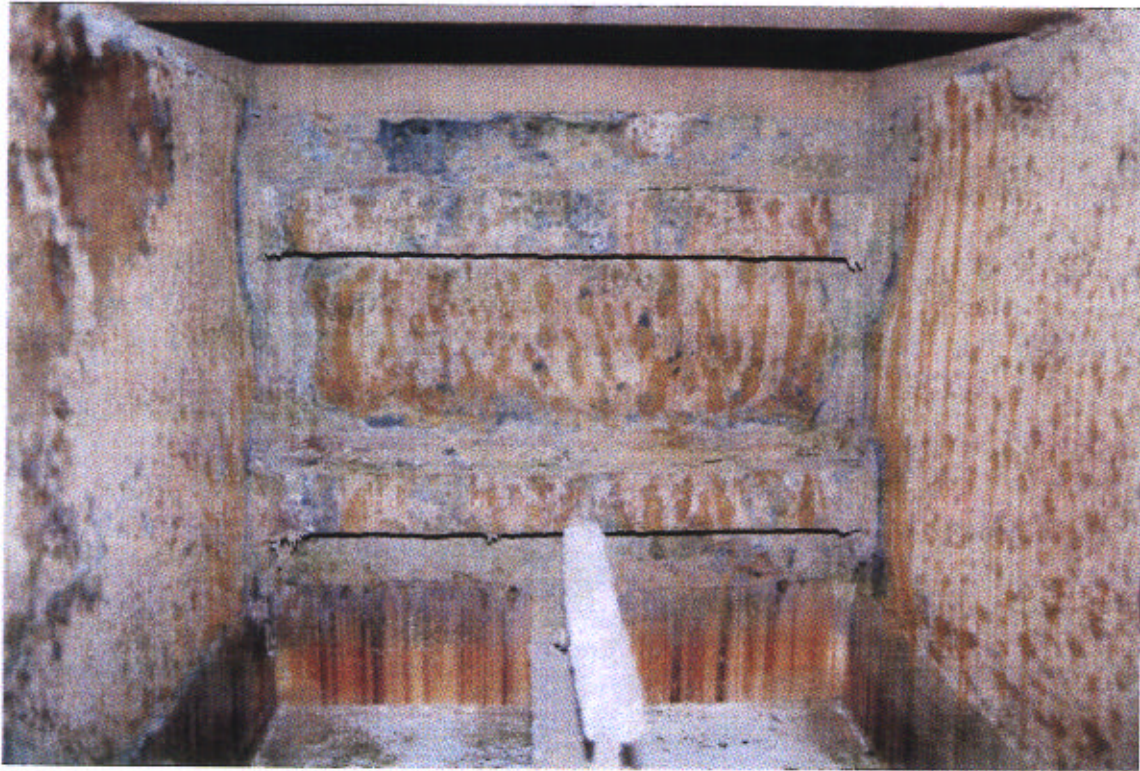
After sixteen years of testing, Tank 3 is still providing protection to the steel substrate. The zinc anode (50 pound) was replaced after twelve years with a new Thermal Reduction Company TRC-TZ-50-WC zinc anode (50 pounds). The color of the bare portion of the tank is the color of the calcareous deposit with possibly some red color being picked up due to the system beginning to fail. No significant metal loss was detected on the flat sides and overhead. The stiffener thicknesses loss ranged from 1/8 inch on the back top stiffener to 1/16 on the other stiffeners. The original thickness was 1/4 inch. See photograph 7 showing repaired and recoated bottom prior to re-exposure. Photograph 13 shows performance results to date.

TANK THREE	COATING SYSTEM : MIL-P-23236 PARTIAL WITH ZINC ANODE (SYSTEM LIFE-16 YEARS). DRY FILM THICKNESS FOR COATED AREAS RECORDED AS 6 TO 9.5 MILS. SURFACE PREPARATION: SSPC-SP-10 INITIAL/SP-2 REPAIR OF BOTTOM PREVIOUS SYSTEM: ANODE REPLACED TWELVE YEARS. REPAIRS MADE TO FLAT BOTTOM
TOP-FLAT	NO DETECTABLE CHANGE FROM LAST GRADE PERIOD. CLER CONDITION # 2
TOP-STIFFENER	NO DETECTABLE CHANGE FROM LAST GRADE PERIOD. CLER CONDITION # 1
BACK-FLAT	NO DETECTABLE CHANGE FROM LAST GRADE PERIOD. UNPAINTED AREA (CALCAREOUS SCALE)-CLER CONDITION # 4, PAINTED AREA-CLER CONDITION # 1
BACK-TOP STIFFENER	NO DETECTABLE CHANGE FROM LAST GRADE PERIOD. 1/8 INCH THICKNESS REMAINING. UNPAINTED AREA (CALCAREOUS SCALE)-CLER CONDITION # 4
BACK-BOTTOM STIFFENER	NO DETECTABLE CHANGE FROM LAST GRADE PERIOD. UNPAINTED AREA (CALCAREOUS SCALE)-CLER CONDITION # 4
BOTTOM-FLAT	RUST GRADE 9 CLER CONDITION # 1
BOTTOM-STIFFENER	NO DETECTABLE CHANGE FROM LAST GRADE PERIOD. SOME EDGE EXFOLIATION. 3/16 INCH THICKNESS REMAINING. CLER CONDITION # 3

BOTTOM-FRAME	NO DETECTABLE CHANGE FROM LAST GIUDE PERIOD. SOME EDGE EXFOLIATION. 3/16 INCH THICKNESS REMAINING. CLER CONDITION # 3
RIGHT SIDE	NO DETECTABLE CHANGE FROM LAST GRADE PERIOD. UNPAINTED AREA (CALCAREOUS SCALE)-CLER CONDITION # 4. PAINTED AREA CLER CONDITION # 1
LEFT SIDE	NO DETECTABLE CHANGE FROM LAST GRADE PERIOD. UNPAINTED AREA (CALCAREOUS SCALE)-CLER CONDITION # 4. PAINTED AREA CLER CONDITION # 1

PHOTOGRAPH 13-PARTIAL COATINGS (MIL-P-23236) WITH ZINC ANODE

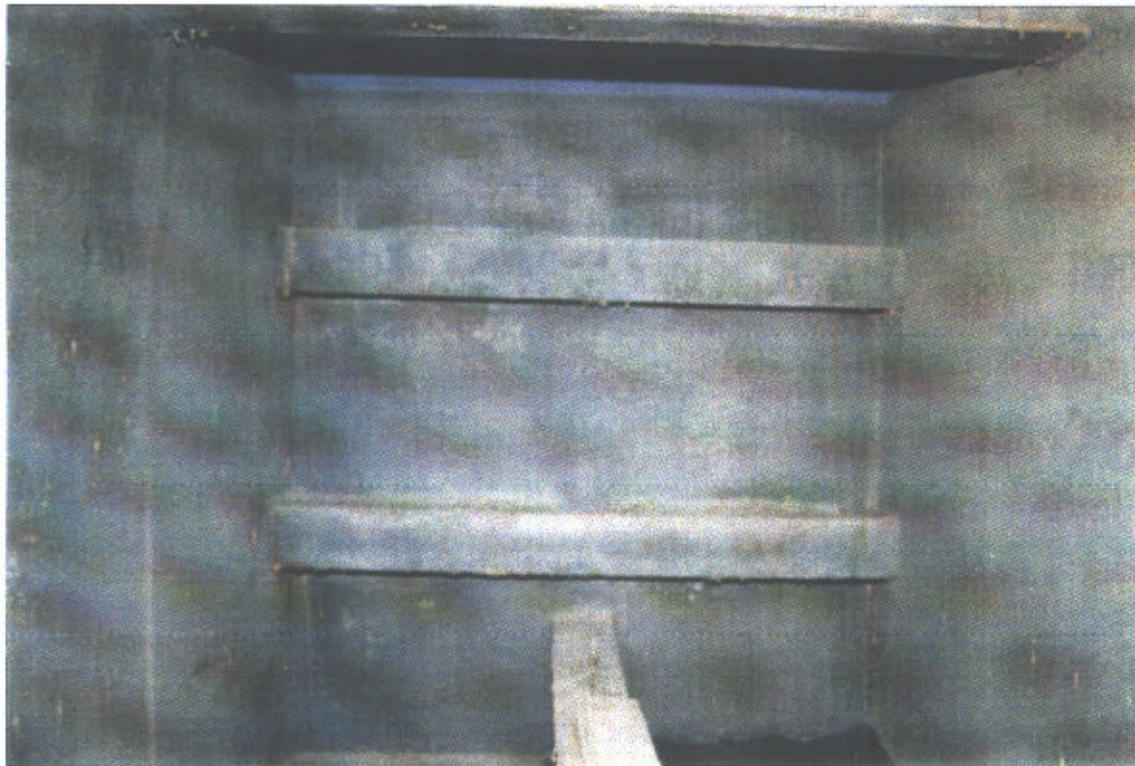
TANK SIX	COATING SYSTEM : VOC COMPLIANT INORGANIC ZINC W/ ZINC ANODE (CARBO ZINC 11HS) (SYSTEM LIFE-3 YEARS) SURFACE PREPARATION: SP-10 PREVIOUS SYSTEM: PRECONSTRUCTION ZINC PRIMER W/ZINC ANODE (SIGMA)
TOP-FLAT DFT-13 MILS	RUST GRADE 10 WITH SOME CALCARIOUS DEPOSITS. SOME OF THE DEPOSITS ARE FLAKING OFF WITH ZINC VISIBLE UNDER THE FLAKED AREA. NO RUST. CLER CONDITION # 1
TOP-STIFFENER DFT-9.5 MILS	RUST GRADE 10 WITH SOME CALCARIOUS DEPOSITS FORMING AT PINHOLES. CLER CONDITION # 1
BACK-FLAT DFT-13.3 MILS	RUST GRADE 10 WITH SOME CALCARIOUS DEPOSITS FORMING AT PINHOLES. CLER CONDITION # 1
BACK-TOP STIFFENER DFT-12.3 MILS	RUST GRADE 10 WITH SOME CALCARIOUS DEPOSITS FORMING AT PINHOLES. CLER CONDITION # 1
BACK-BOTTOM STIFFENER DFT-11.7 MILS	RUST GRADE 9 WITH SOME CALCARIOUS DEPOSITS FORMING AT PINHOLES. CLER CONDITION # 1
BOTTOM-FLAT DFT-9.5 MILS	RUST GRADE 10 WITH SOME CALCARIOUS DEPOSITS FORMING AT PINHOLES. CLER CONDITION # 1

BOTTOM- STIFFENER DFT-10.2 MILS	RUST GRADE 10 WITH SOME CALCARIOUS DEPOSITS FORMING AT PINHOLES. CLER CONDITION # 1
BOTTOM-FRAME DFT-7.6 MILS	RUST GRADE 10 WITH SOME CALCARIOUS DEPOSITS FORMING AT PINHOLES. CLER CONDITION # 1
RIGHT SIDE DFT-9.7 MILS	RUST GRADE 10 WITH SOME CALCARIOUS DEPOSITS FORMING AT PINHOLES. CLER CONDITION # 1
LEFT SIDE DFT-	RUST GRADE 10 WITH SOME CALCARIOUS DEPOSITS FORMING AT PINHOLES. CLER CONDITION # 1

PHOTOGRAPH 14-SOLVENT BASED INORGANIC ZINC WITH ZINC ANODE

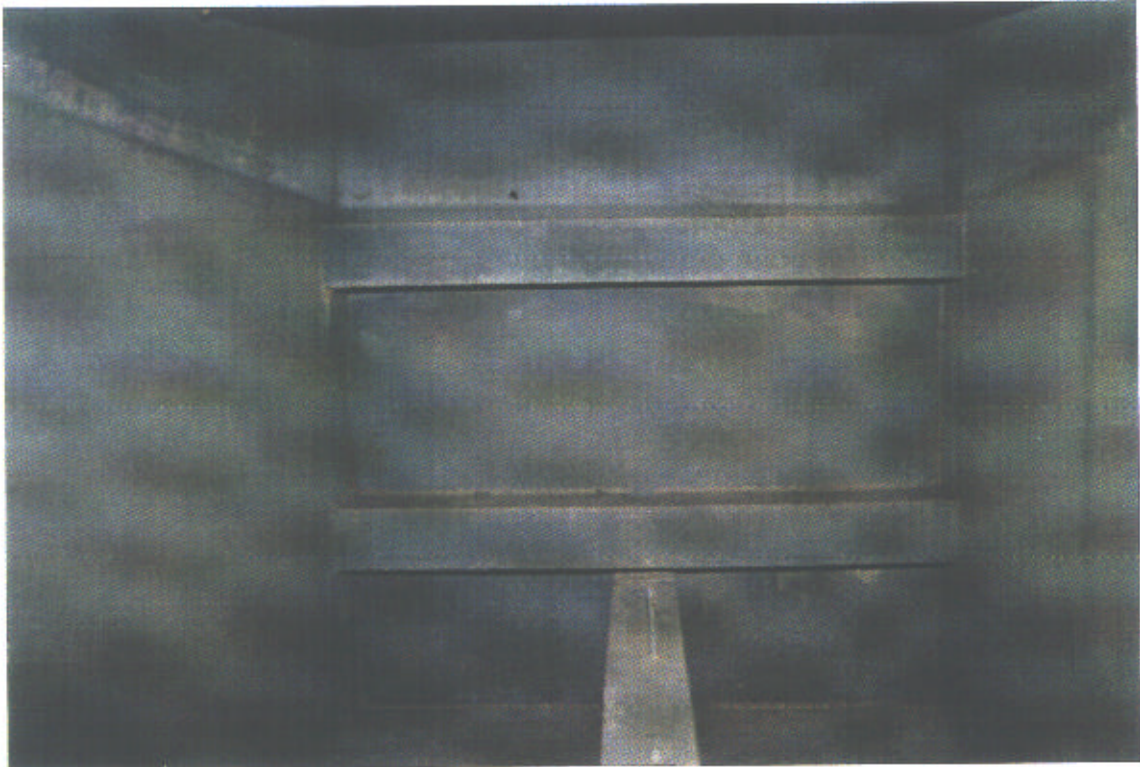
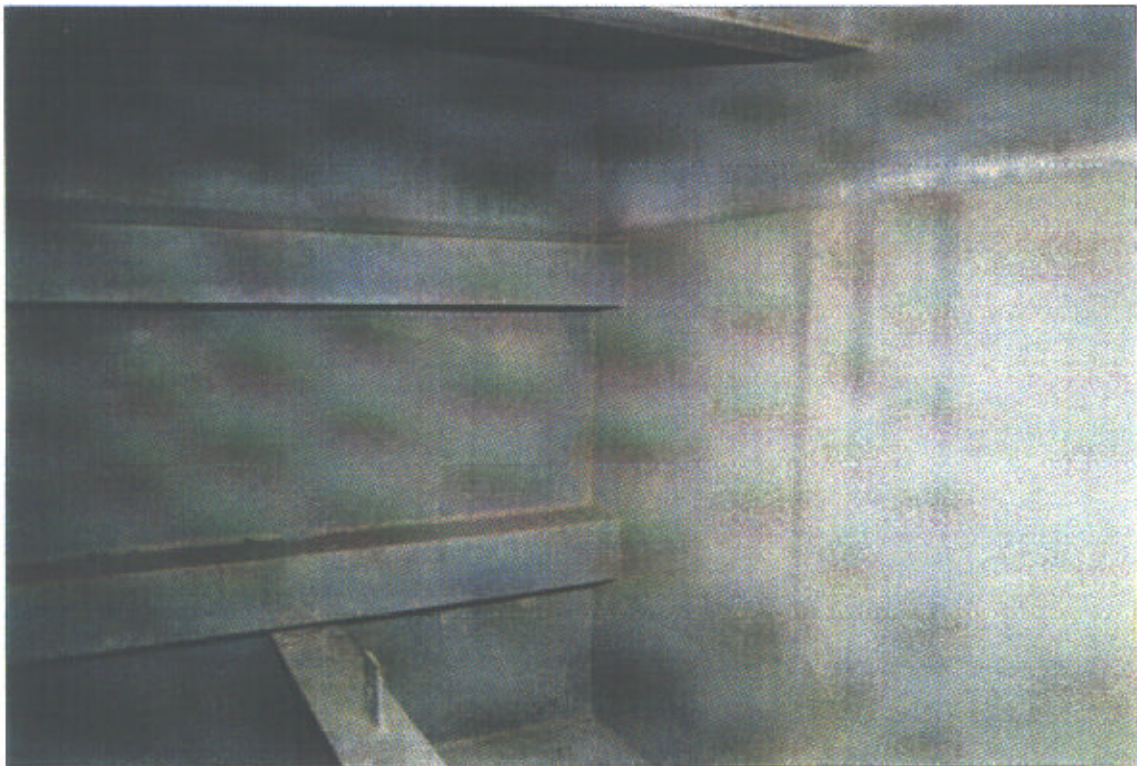
TANX NINE	COATING SYSTEM : VOC COMPLIANT INORGANIC ZINC (NO ANODES) (CARBO ZINC 11HS) (SYSTEM LIFE-3 YEARS) SURFACE PREPARATION: SP-10 PREVIOUS SYSTEM: SURFACE TOLERANT SYSTEM B
TOP-FLAT DFT-13.9 MILS	RUST GRADE 10 WITH SOME CALCARIOUS DEPOSITS FORMING AT PINHOLES. CLER CONDITION # 1
TOP-STIFFENER DFT-9.1 MILS	RUST GRADE 9 WITH SOME CALCARIOUS DEPOSITS FORMING AT PINHOLES. SOME EDGE FAILURE BEGINNING. CLER CONDITION # 2
BACK-FLAT DFT-9.2 MILS	RUST GRADE 10 WITH SOME CALCARIOUS DEPOSITS FORMING AT PINHOLES. CLER CONDITION # 1
BACK-TOP STIFFENER DFT-11.9 MILS	RUST GRADE 10 WITH SOME CALCARIOUS DEPOSITS FORMING AT PINHOLES. CLER CONDITION # 1
BACK-BOTTOM STIFFENER DFT-7.3 MILS	RUST GRADE 10 WITH SOME CALCARIOUS DEPOSITS FORMING AT PINHOLES. CLER CONDITION # 1
BOTTOM-FLAT DFT-11.7 MILS	RUST GRADE 10 WITH SOME CALCARIOUS DEPOSITS FORMING AT PINHOLES. CLER CONDITION # 1
BOTTOM-STIFFENER DFT-8.5 MILS	AREA APPROXIMATELY 6 INCHES BY 4 INCHES ON RIGHT SIDE DELAMINATED WITH CALCARIOUS DEPOSIT UNDER THE DELAMINATED AREA. ZINC VISIBLE UNDER DELAMINATED AREA. BALANCE RUST GRADE 10. CLER CONDITION # 2

BOTTOM-FRAME DFT-8.5 MILS	FRONT RUST GRADE 6. BACK RUST GIUDE 10 WITH SOME CALCARIOUS DEPOSITS FORMING AT PINHOLES. CLER CONDITION # 2
RIGHT SIDE DFT-8.2 MILS	RUST GRADE 9 WITH SOME CALCARIOUS DEPOSITS FORMING AT PINHOLES. CLER CONDITION # 1
LEFT SIDE DFT-8.4 MILS	RUST GIUDE 10 WITH SOME CALCARIOUS DEPOSITS FORMING AT PINHOLES. CLER CONDITION # 1

PHOTOGRAPH 15-SOLVENT BASED INORGANIC ZINC

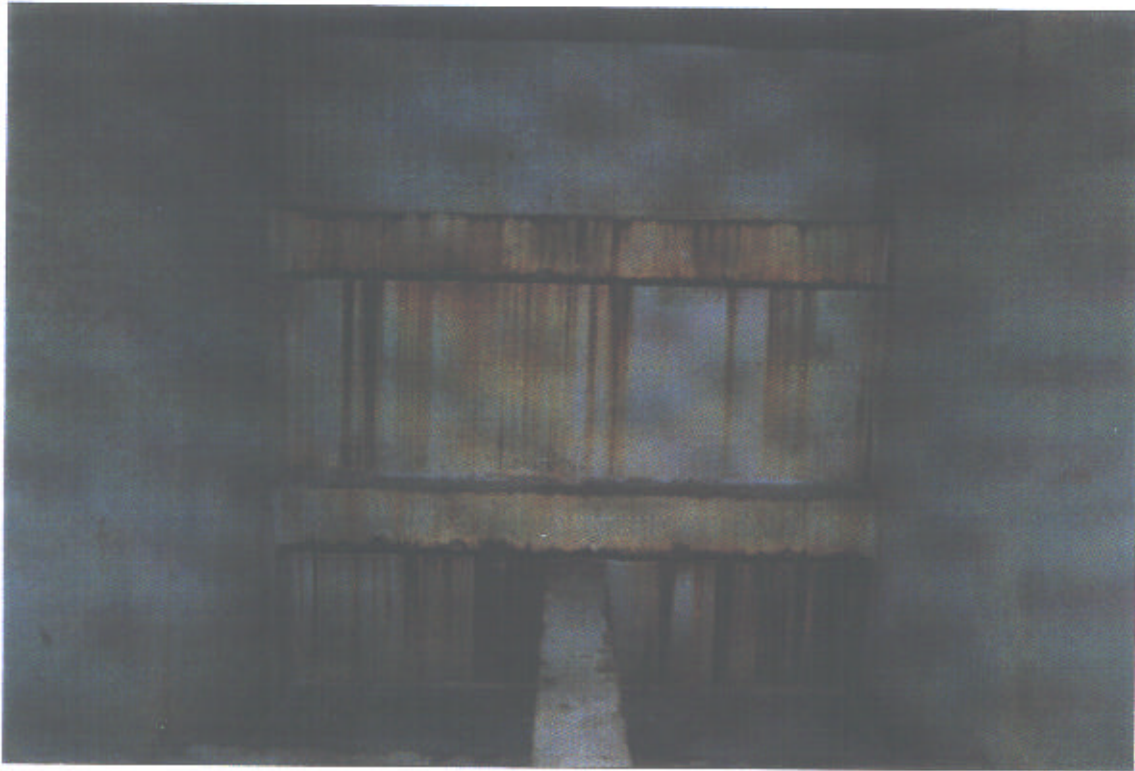
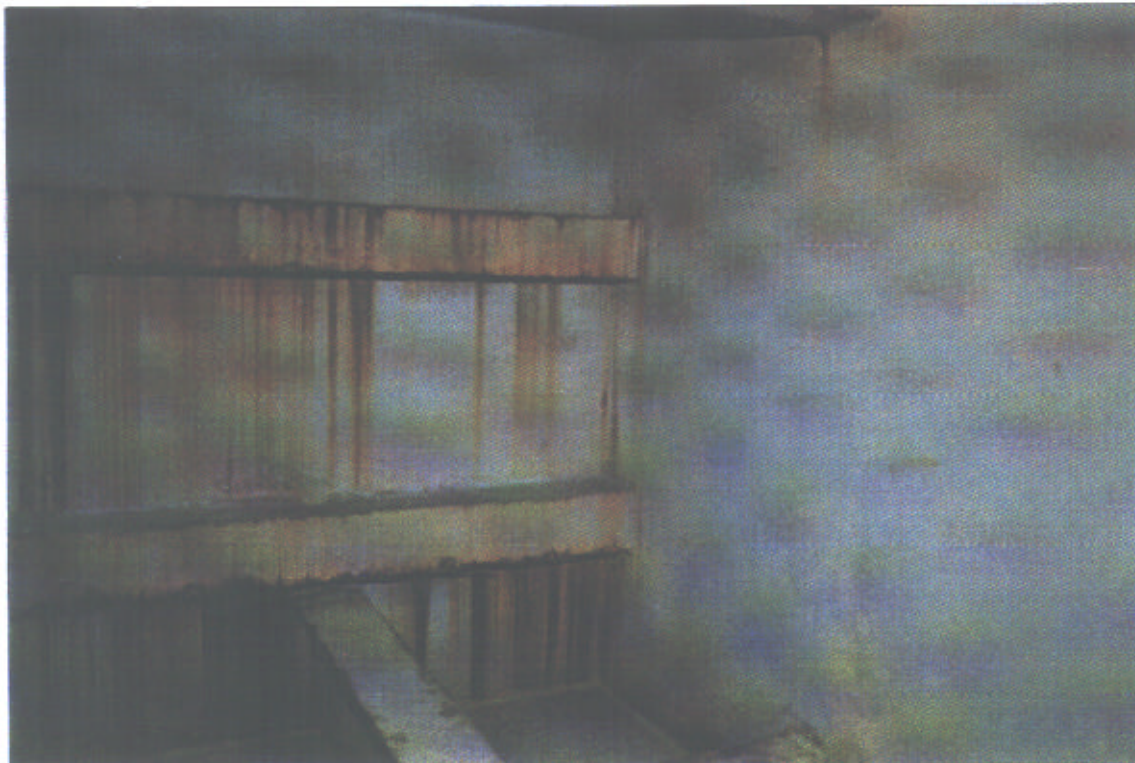
under test for five years. This system is beginning to fail. The top overhead stiffener has failed with edge exfoliation. The top back stiffener has also failed. The balance of the flats range from rust grade 7 to 8. See photograph 16.

TANK EIGHT	COATING SYSTEM: WATERBORNE HIGH RATIO INORGANIC ZINC (INORGANIC COATINGS) SURFACE PREPARATION: SP-10 PREVIOUS SYSTEM: SAME. (SYSTEM LIFE FIVE YEARS)
TOP-FLAT DFT-7.2 MILS	RUST GRADE 9 CLER CONDITION # 1
TOP-STIFFENER DFT-	EDGE BREAKDOWN WITH EXFOLIATION. LEFT HALF FAILED. RIGHT HALF AND BACK SIDE RUST GRADE 8. CLER CONDITION # 3
BACK-FLAT DFT-7.8 MILS	RUST GRADE 9 WITH RUST STREAKING. CLER CONDITION # 2
BACK-TOP STIFFENER DFT-	TOP FAILED. RUST STREAKING. STEEL DELAMINATION/EXFOLIATION FROM RUST UNDER INORGANIC ZINC COATING. CLER CONDITION # 4
BACK-BOTTOM STIFFENER DFT-	EDGE FAILURE. BALANCE RUST GRADE 8. CLER CONDITION # 3
BOTTOM-FLAT DFT-9.4 MILS	RUST GRADE 7 CLER CONDITION # 3
BOTTOM-STIFFENER DFT-	RIGHT SIDE FAILED. LEFT SIDE BEGINNING TO BREAKDOWN. BALANCE RUST GRADE 8 ON LEFT SIDE; RUST GRADE 4 ON RIGHT SIDE. CLER CONDITION # 4
BOTTOM-FRAME DFT-	BACK SIDE RUST GRADE 7. FRONT SIDE RUST GRADE 6. TOP RUST GRADE 10. UNDERSIDE OF FLANGE TOTAL FAILURE. CLER CONDITION # 3

PHOTOGRAPH 16-HIGH RATIO INORGANIC ZINC
