Paint Survey of Patriot Vehicles

ARL-TR-3909

September 2006

On the 24th and 25th of January 2006, a paint survey of Patriot vehicles was conducted at the Lower Tier Project Office, Fort Bliss facility located in El Paso, TX. The survey's intent was to inspect paint delamination at the seam line on an engagement control system (ECS), further document any paint defects on the other Patriot vehicles, and provide recommendations on materials and procedures to prevent, repair, and control the observed damage. The coating system on the ECS was the water-reducible wash primer Kem Aqua supplied by Sherwin-Williams; epoxy primer was MIL-DTL-53030 supplied by DEFT; and the topcoat was MIL-DTL-53039A supplied by Hentzen.

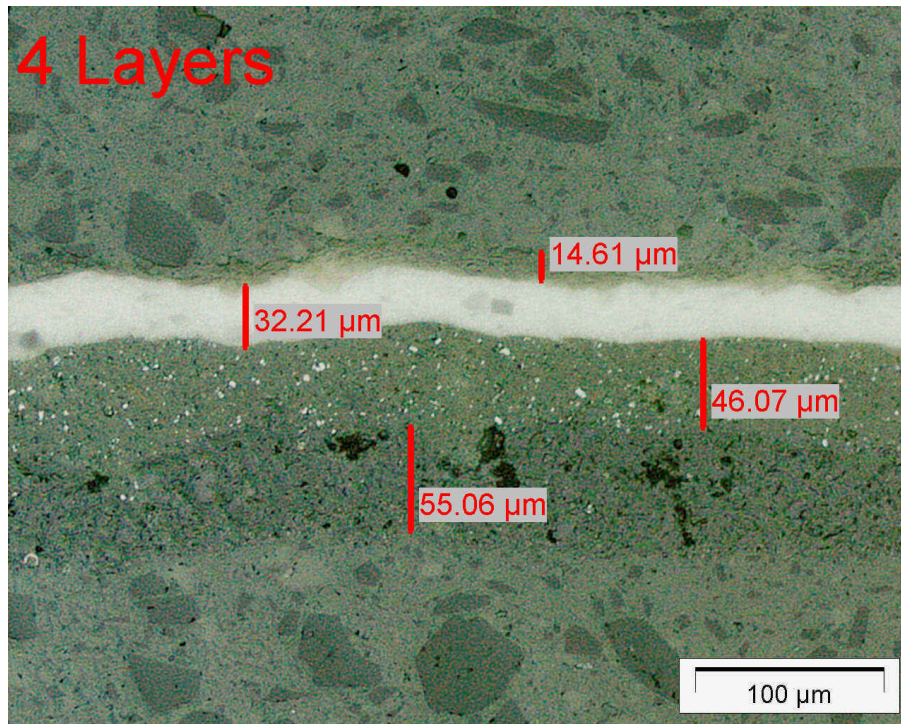
ARL analyzed samples of the paint chips using metallographic cross sections of the coating samples prepared in Bakelite. The coating system was cleanly fractured, mounted perpendicular to the fractured edge, and mechanically ground and polished through 0.02- μm colloidal silica. The mounted cross sections were then examined on a Nikon Epiphot 300 inverted metallograph. Digital micrographs were acquired of the coating system. The individual coating system layers were counted, and their respective thicknesses were measured. Figures 4–6 present the coating system cross-sectional photomicrographs. The coating system can be observed within the mounting media comprising the material at the top and bottom of the figures.

Figure 4. Micrograph of paint chip removed from Patriot ECS shelter with water-reducible wash primer.

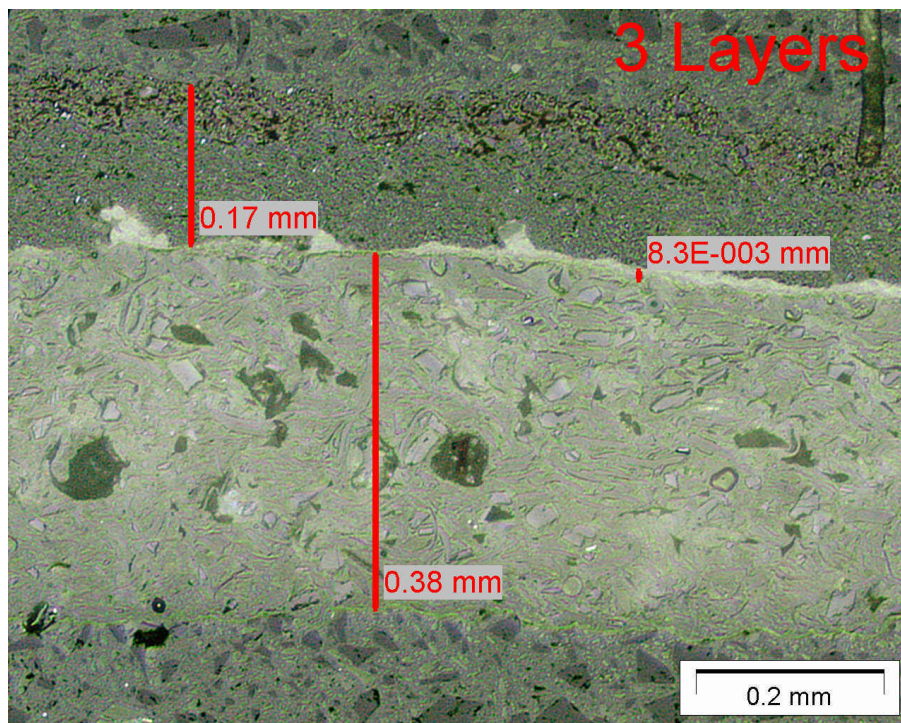
Figure 5. Micrograph of paint chip removed from Patriot communications relay group (CRG) shelter with control wash primer.

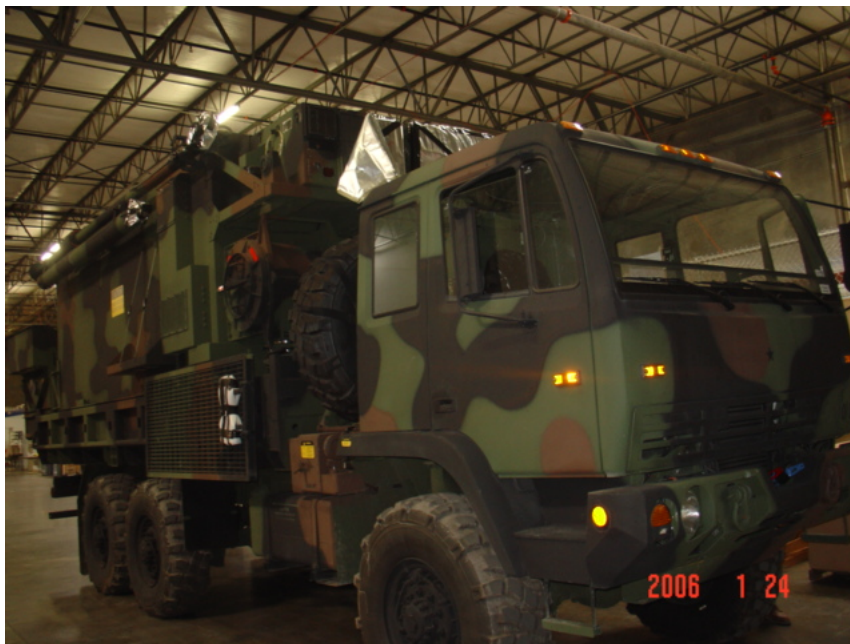
1. ECS, serial no. 720007, overhaul date 10/05 (figure 7). No paint failure was noted, and the overall impression of the vehicles was very good.

Figure 7. ECS; serial no. 720007; overhaul date 10/05.

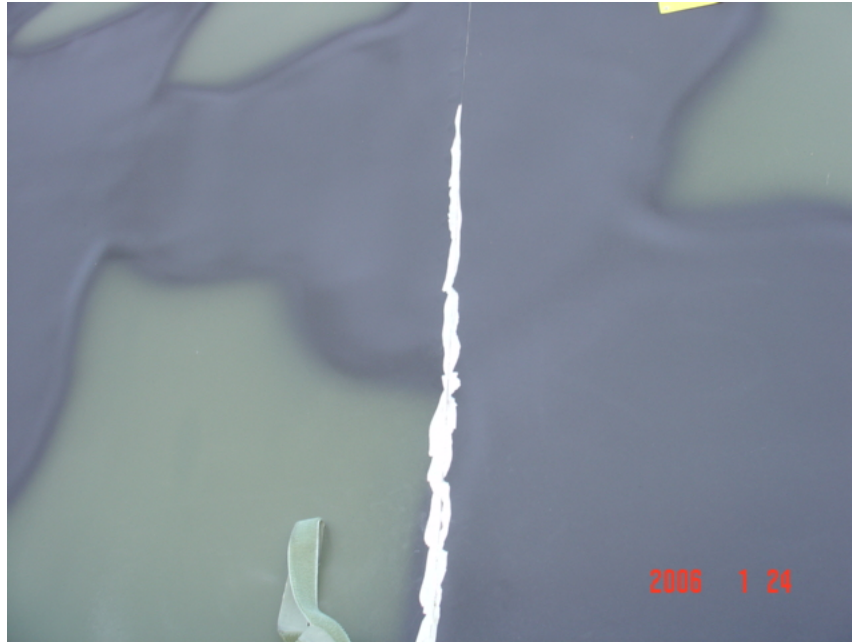
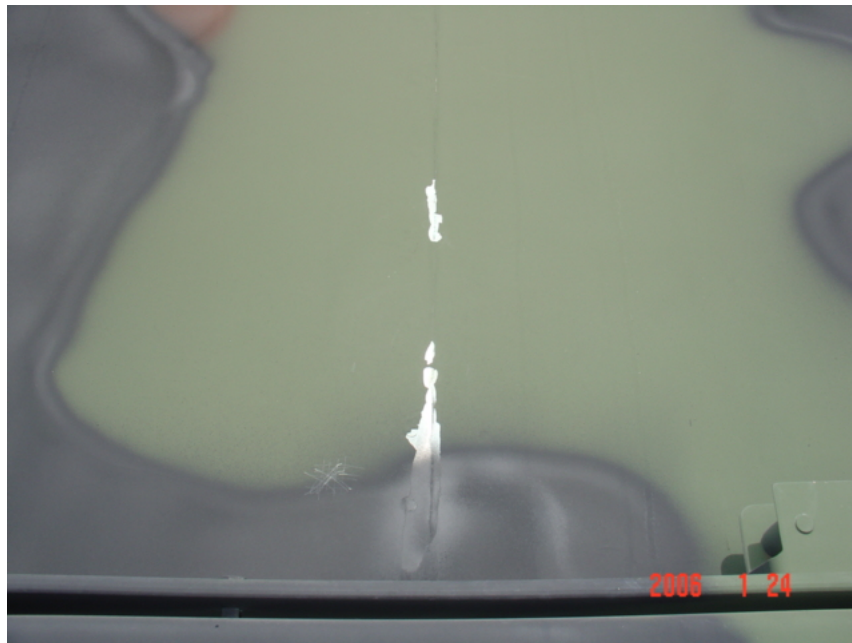
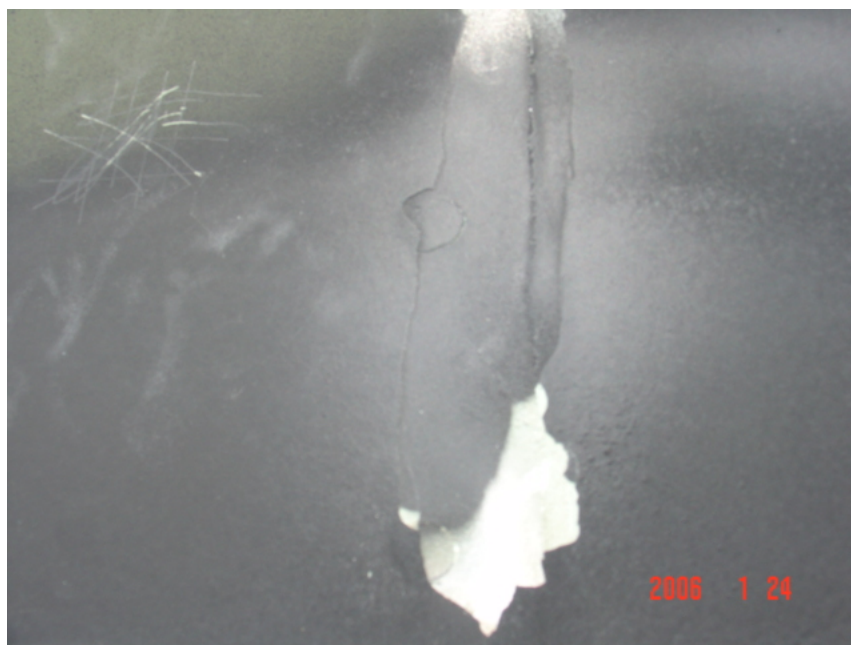
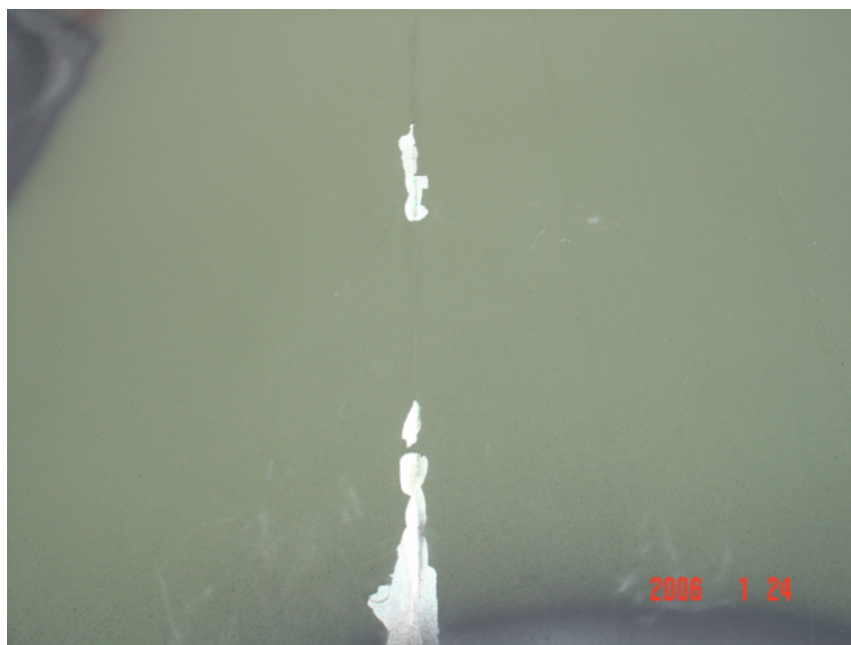
2. ECS, serial no. 630106, overhaul date 05/05 (figures 8–13). There were two areas of paint adhesion failure on the outside vertical seam where the paint (1/4 –1 in) had peeled away or delaminated. Film delamination occurred only at the seam and only where the polyester filler was applied. Rivet head outlines could be seen along the entire seams. Expansion and contraction forces along the butt seam may be a contributing factor. This failure appeared to be localized at the weakest interface along the butt seam (i.e., between primer and body filler or substrate and body filler). Mechanical forces causing flex of the substrate (evidenced by the rivet heads) distorted the coatings. The coatings then separated at the weakest interface that appeared to be the body filler – substrate interface. This Patriot ECS unit was painted using the low volatile organic compound (VOC) water-reducible wash primer at Letterkenny Army Depot, Chambersburg, PA, and fielded at Fort Bliss, TX. The two areas of concern were sections of the shelter where the walls were replaced. The walls were bonded using a polysulfide sealer and a polyester filler. The filler material appeared to have a heavy film. Dry film thickness measurements (1 mil = 0.001 in) were taken at four different areas, with data recorded in table 2. Due to high temperatures, the shelter walls expanded, causing the paint filler to crack and peel along the butt joints where replacement wall sections met older wall sections. A knife blade easily removed painted filler along the edges for laboratory analysis.

Figure 8. ECS right side; serial no. 630106; overhaul date 05/05.

Figure 9. ECS left side; serial no. 630106; overhaul date 05/05.

Figure 10. ECS after tape pulled off; serial no. 630106; overhaul date 05/05.

Figure 11. ECS before tape pulled off; serial no. 630106; overhaul date 05/05.

Figure 12. ECS area with bondo; serial no. 630106; overhaul date 05/05.

Figure 13. ECS before tape pulled off; serial no. 630106; overhaul date 05/05.

- It appears that the construction method where a damaged wall section is cut out and replaced using a butt seam is a potential weak link where expansion and contraction can cause cracking or peeling at the weakest place.

- In conclusion, an evaluation of the lap seam vs. the butt seam construction method should take place. It is too early to say definitively that the lap seam method will cure seam cracking, but early evidence may offer a possible solution. A test utilizing a lap seam construction on an ECS or CRG is recommended. It should be noted that out of all shelters, only two exhibited the butt seam cracking failure. Additional testing of the low VOC wash primer on full-size shelters would also assist in the overall data assessment. If additional testing is performed, some units with both the lap seam construction and the butt seam construction should be painted with the low VOC, water reducible wash primer.

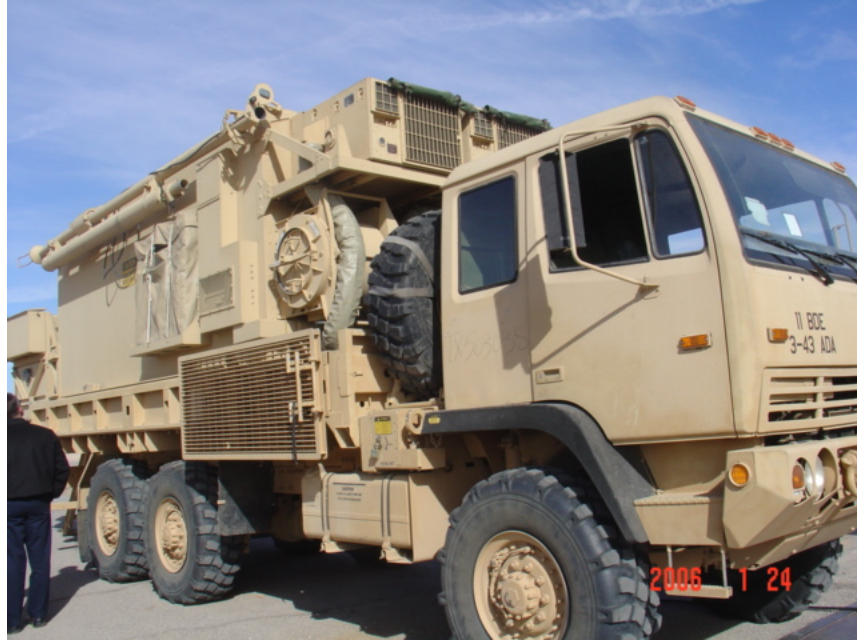
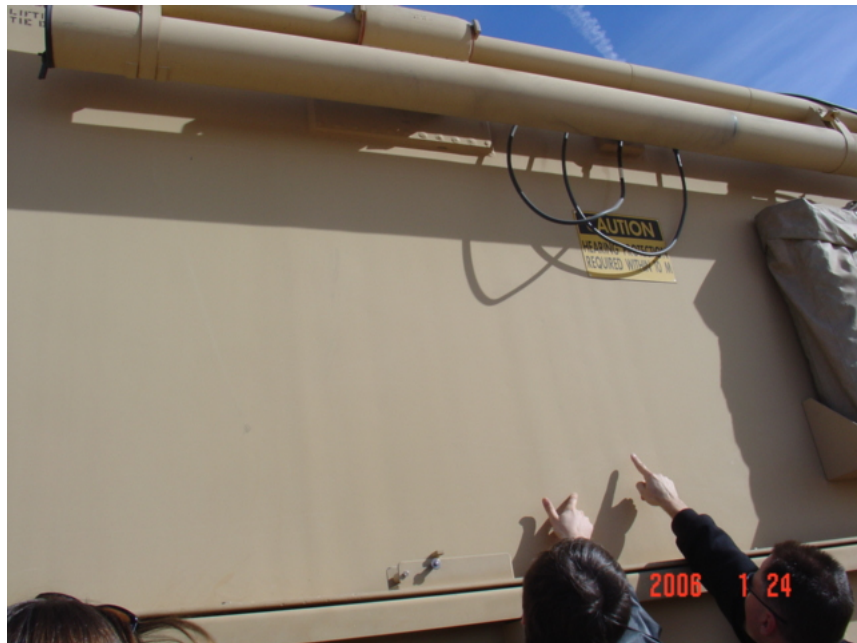
3. ECS, serial no. 700117, no overhaul date provided. No paint failure was noted, and the overall impression of the vehicle was good.
4. ESC, serial no. 810003, overhaul date 06/03 (figures 14–17). No paint failure was noted, and the overall impression of the vehicle was very good.

Figure 14. ESC rear images; serial no. 810003; overhaul date 06/03.

Figure 15. ESC full view; serial no. 810003; overhaul date 06/03.

Figure 16. ESC seam with cracks; serial no. 810003; overhaul date 06/03.

Figure 17. ESC; serial no. 810003; overhaul date 06/03.

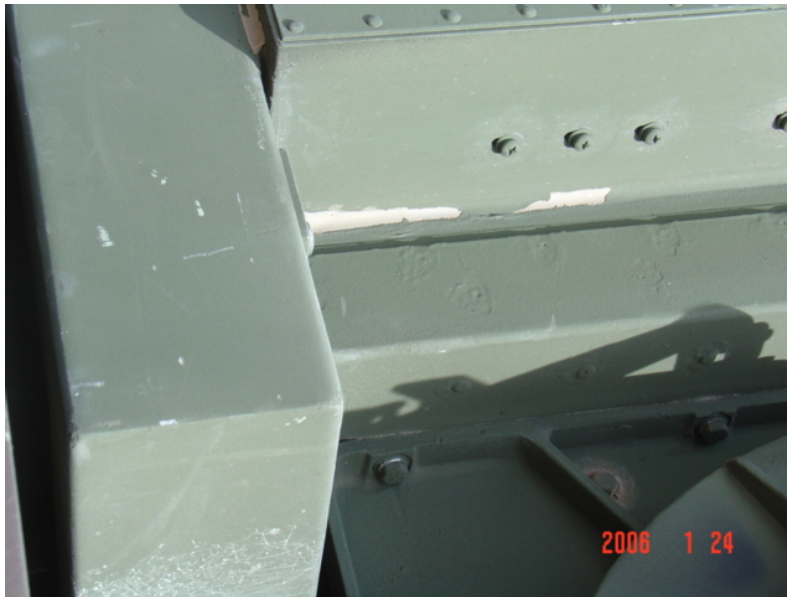
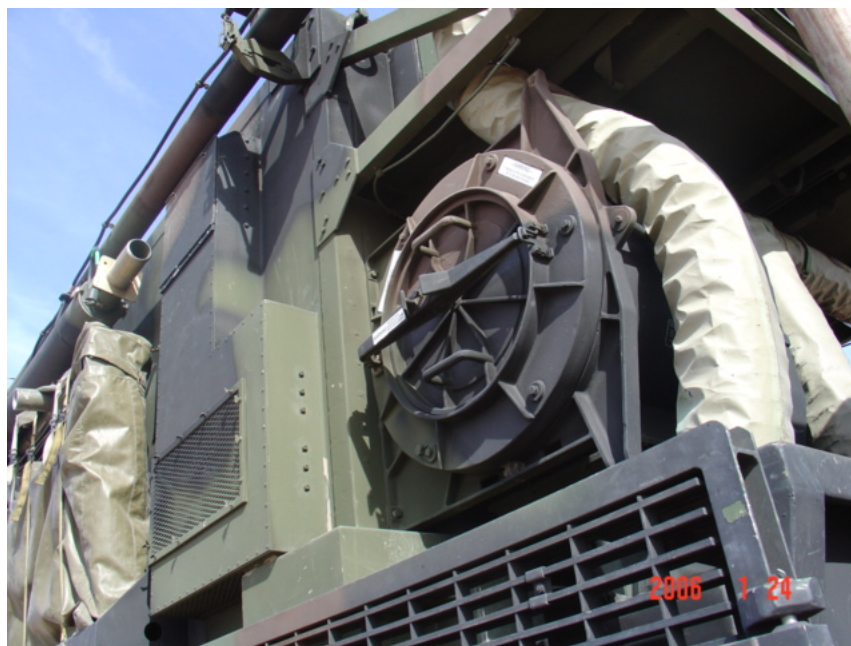
5. SRPT, serial no. 620453, overhaul date 09/05. No paint failure was noted, and no filler material was used.
6. Raytheon. Paint failure was noted along sealed edges.
7. CRG, serial no. 620456, overhaul date 02/05 (figures 18–21). No paint failure was noted, and the overall impression of the vehicle was good.

Figure 18. CRG; serial no. 620456; overhaul date 02/05.

Figure 19. CRG; serial no. 620456; overhaul date 02/05.

Figure 20. CRG left side; serial no. 620456; overhaul date 02/05.

Figure 21. CRG areas showing paint chip; serial no. 620456; overhaul date 02/05.

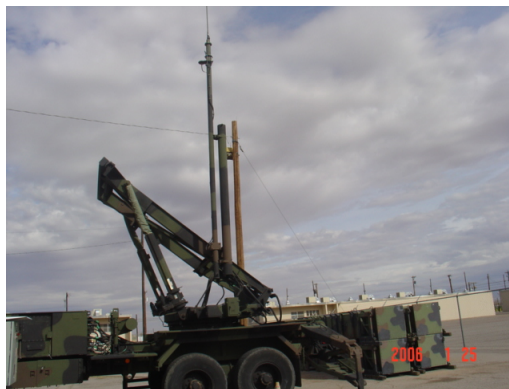
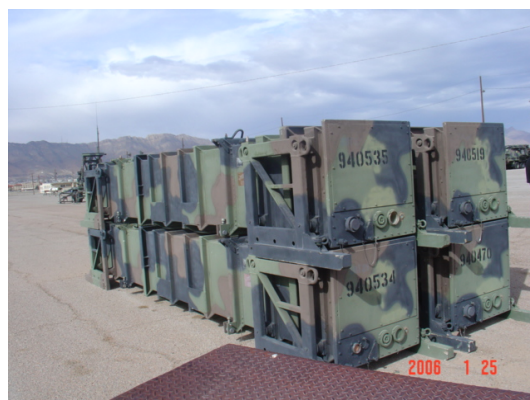
1. Fort Bliss uses Rexcel's Aqua Strip solvent, a hazardous air pollutants (HAPs)-free, water-soluble solvent for paint thinning and cleaning purposes, instead of MIL-T-81772.
2. For RECAP (RECAPITALIZATION), individual metal parts are sandblasted. Plastic media is used on aluminum and grit no. 50 for steel.
3. Fort Bliss specializes in RECAP of the Patriot launchers (figures 32–34). There was one instance where the launcher bed was heavily corroded. The area was exposed, water had settled, and there was no drainage.

Figure 32. Launcher bed.

Figure 33. Launcher cabinets.

Figure 34. Launcher.
