Evaluation of New Surface Preparation and Coating Repair Techniques in Ballast Tanks = Final Report

EVALUATION OF
NEW SURFACE PREPARATION AND COATING REPAIR
TECHNIQUES IN BALLAST TANKS-FINAL REPORT

JANUARY 1993

PREPARED BY:
ASSOCIATED COATINGS CONSULTANTS
IN COOPERATION WITH
NATIONAL STEEL AND SHIPBUILDING COMPANY
SAN DIEGO, CALIFORNIA

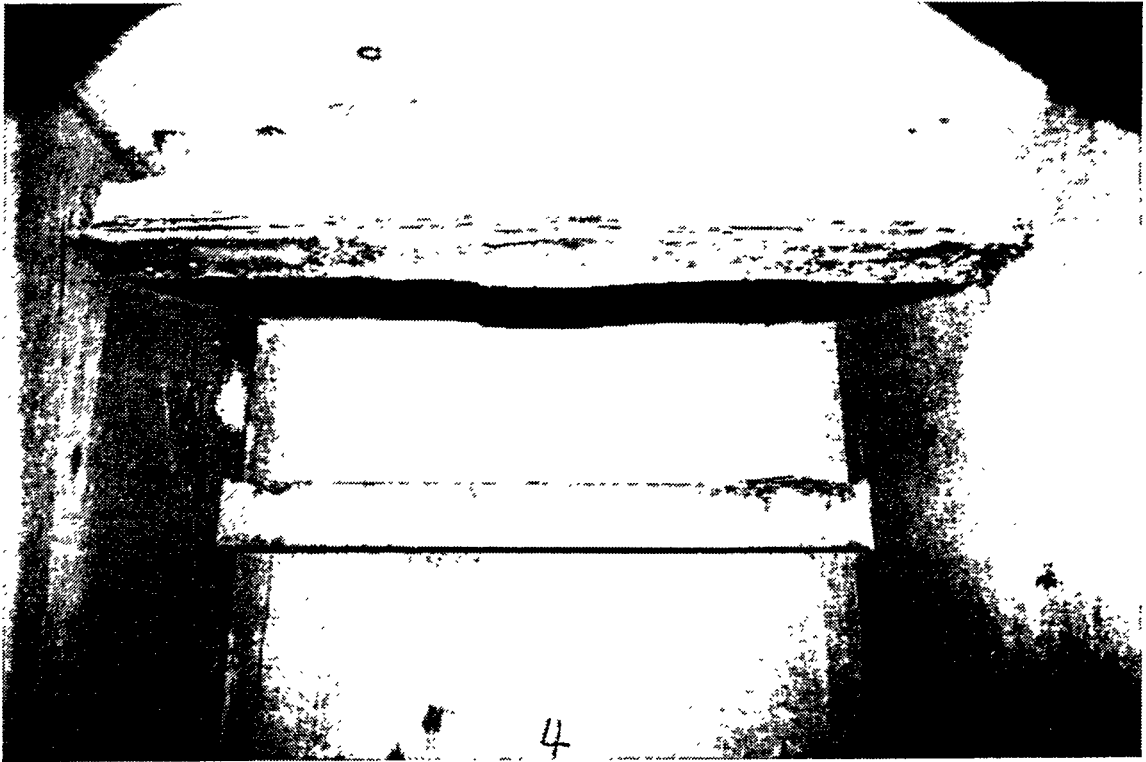
Tank 4 has reached the useful life of the coating system after five years of testing with the overall failure judged to be ten to twenty percent. The performance of this system over blast cleaned steel is marginally better than the same system applied over hand and power tool cleaned steel.

The back of the tank had twenty percent coatings failure with the top stiffener beginning to exfoliate due to massive rusting. The bottom stiffener had thirty percent failure but no exfoliation. The left side and flat top had ten percent coatings failure. The edge of center top stiffener was also exfoliating. The right side had five percent failure, and the flat bottom had one percent failure. The bottom built up frame was exfoliating on the edges but the flat surfaces had less than one percent failure.

In summary, this system provided good protection on flat surfaces but poor edge protection. As discussed in the section on surface preparation and application, all edges and welds were stripe coated.

Tank 4-Epoxy "A" Over Blast Cleaned Surface (5 Years)

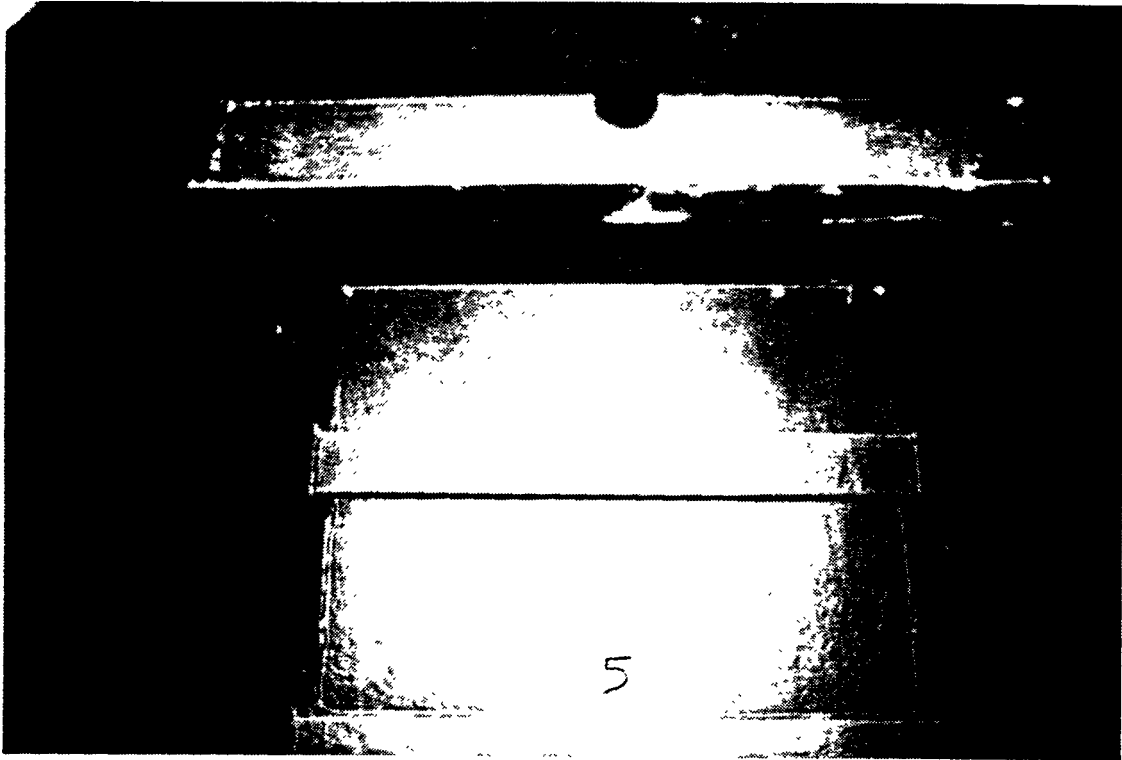
Tank 5 has been under test for a total eight years. After six years of testing, the system was repaired using hand tool cleaning (SSPC-SP 2) . Following the initial six years of testing, this system was beginning to show significant breakdown. The top of the tank had twenty-five to fifty percent failure. The right side of the tank had totally failed. The balance of the tank had between five and ten percent failure.

The repair system is two years old at the time of this report. The overall failure is less than one percent with only minor breakdown on the edges of the overhead stiffener. No failure was observed on the balance of the structure. The residue from the ballast operations should be disregarded when viewing the photograph of this tank.

Tank 5-Epoxy "B" Over Blasted (SP6) Surface (2 Years After Repair)

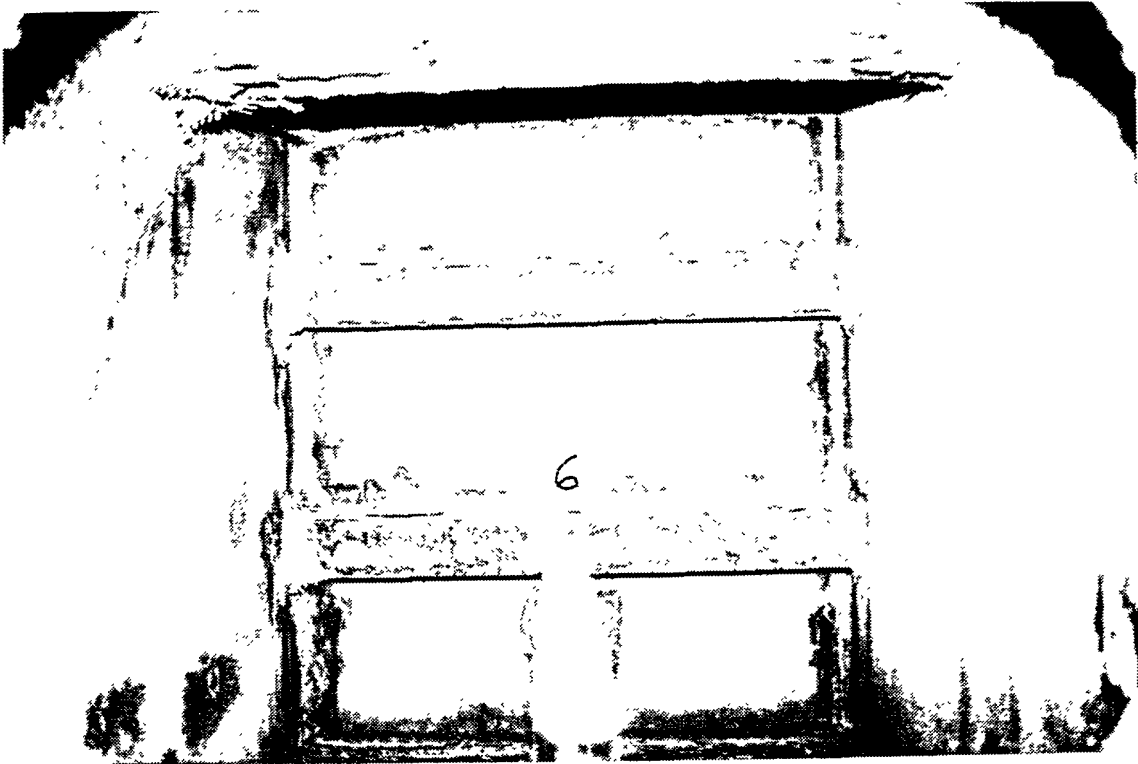
After eleven years Tank 6 has failed. The anode is depleted; however, some of the calcareous deposit is providing a degree of protection. Some metal loss was observed.

Tank 6-Preconstruction Primer with Zinc Anode (11 Years)

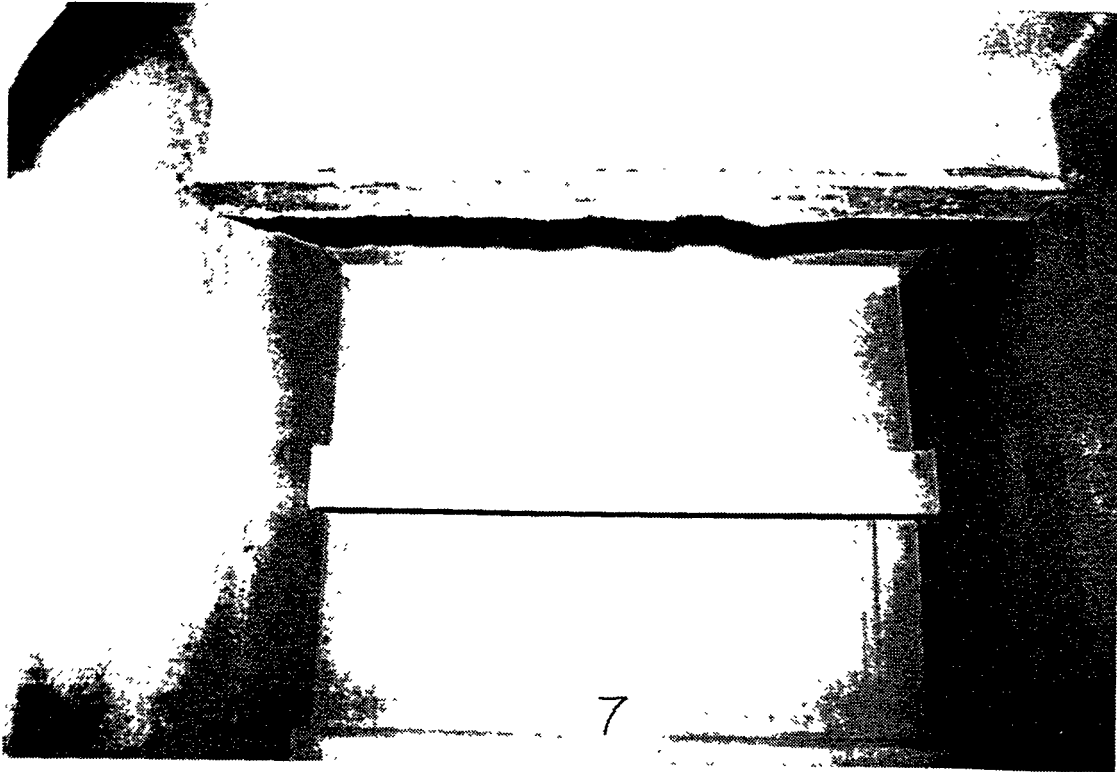
Except for some edge breakdown and the lower four inches on one side of the tank, the coating system in Tank 7 is providing corrosion protection after five years of testing. The overall failure is less than one percent. The top stiffener is beginning to exfoliate as is the edge of the bottom stiffener. The lower four inches on the left side has seventy-five percent failure.

Tank 7-VOC Compliant Mil-P-24441 Over Blast Surface (5 Years)

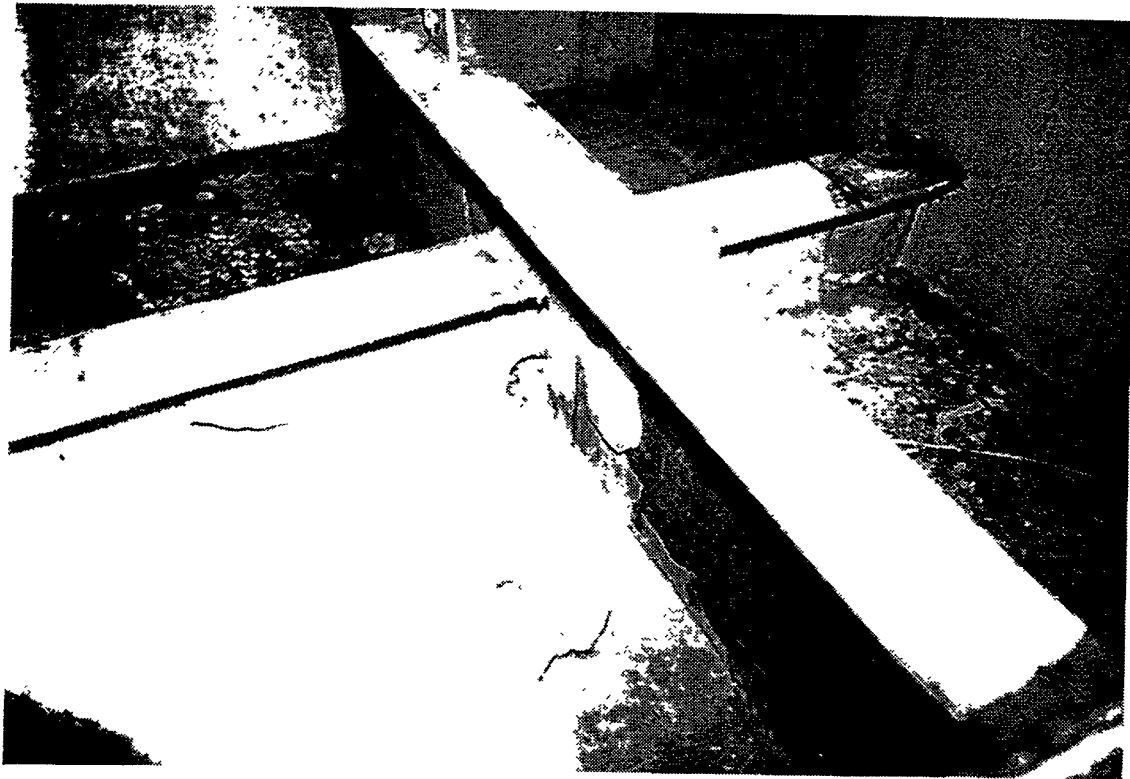
The system in Tank 9 has been in service for five years. At the end of three years of testing, this system had cracked and delaminated in some areas due to excessive dry film thickness (30 to 40 mils). No failure was observed except for these cracks and associated delamination.

At the conclusion of three years, a decision was made to repair this system. The failed portion of the coating was removed and the same material reapplied. After two additional years, the coating is again beginning to crack and delaminate though not as severe as the first time. Some minor edge breakdown was also noted. The overall failure is less than five percent.

Tank 9- Epoxy "B" Over Hand Tool Surface (2 Years After Repair)
