**AFRL-ML-WP-TP-2006-417**

**VIBRATION TESTING OF REPAIRED  
LEAD-TIN/LEAD-FREE SOLDER  
JOINTS (PREPRINT)**

**FEBRUARY 2006**

# Vibration Testing of Repaired Lead-Tin/Lead-Free Solder Joints

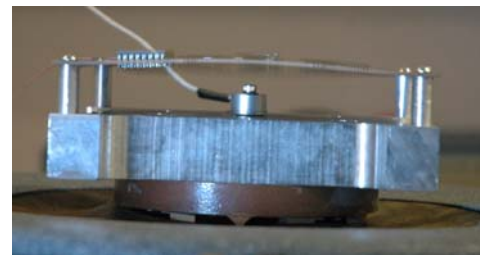
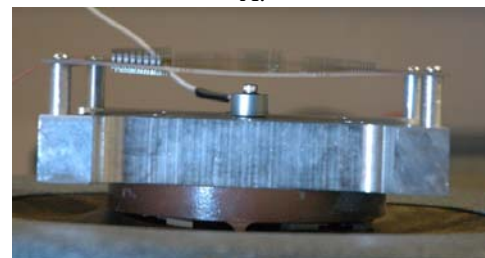
Within the first five minutes of vibration testing, the interconnect resistance for the BGAs and 1206 components and PCB resonant frequency were affected. The initial frequency sweeps showed that the average resonant frequency of the PCBs was ~167Hz. At the first mode, flexure was observed on the middle of the PCBs (Figure 3). Within 25 seconds of starting the resonance dwell, the flexure amplitude was observed to drop to about 50-66% of its initial level. After a 30 minute cumulative resonance dwell, the average resonant frequency dropped to ~160Hz.

Figure 3: PCB at first mode of vibration. The resonant frequency is ~167Hz.

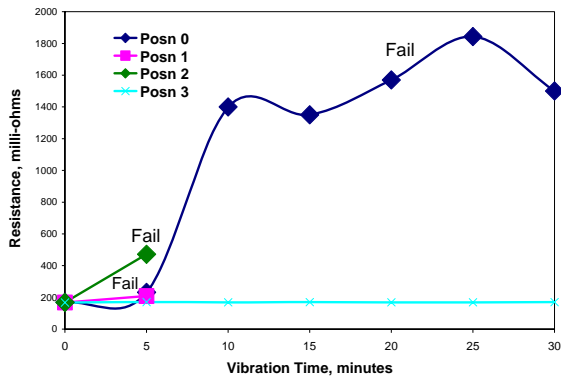
Opens were detected on the BGAs after the first five minutes of the resonance dwell. The BGAs were the first component to fail. This resulted in a drop in PCB resonant frequency, which was most likely caused by an overall drop in board stiffness. Failures or interconnect opens for the 1206 components were more likely to occur for the center components or positions 0, 1 and 2 (Figure 4 and Figure 1). Optical images for the failed 1206 components showed cracking in the bulk solder or delamination of the component from the solder (Figure 5).

A. Control PCB – All Pb-Sn solder joints

Figure 4: Interconnect Resistance for 1206 components during a resonance dwell test. Bold symbols represent open circuit.

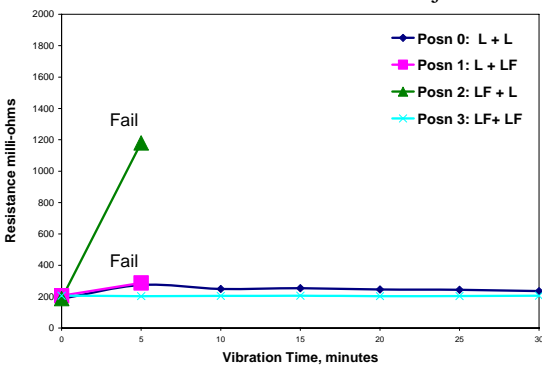
B. PCB R1 – L= Pb-Sn, LF = lead-free solder

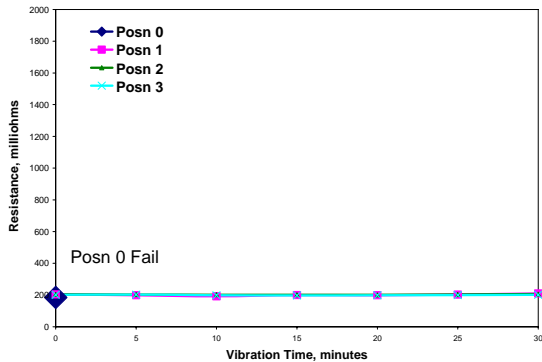
C. PCB MR – All LF solder joints, except 0 (Pb-Sn)

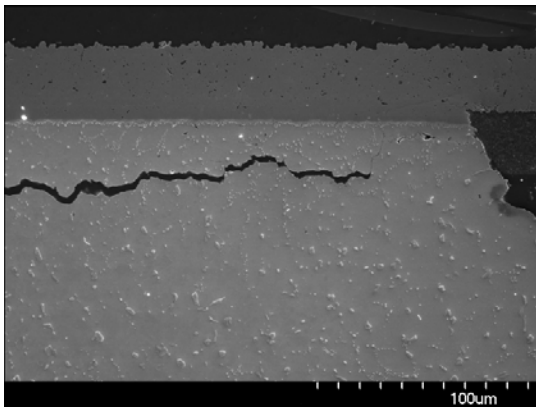
Edge balls or balls adjacent to the edge or corners of the BGA were likely to fail by cracking while the middle solder joints remained intact (Figure 6). This trend was observed for all BGAs regardless of solder type (Figures 7 and 8). The crack started at the region of the solder ball where the solder mask is applied. This region corresponds to the smallest diameter of the ball. The crack started on the outside and traveled into the solder bulk. This behavior was not always consistent since it was also possible for the crack to propagate into the intermetallic layer formed between the solder and the component pad (Figure 8A). The damaged was caused by higher tensile and compressive stresses experienced by the edges and corners of a BGA component as the PCB deflects during the first mode of vibration (Figure 9).

A. PCB R1 Edge BGA: L + L

Figure 7: SEM images (500X) of BGAs where the solder mask was applied. First letter corresponds to type of solder paste on pad and the second to solder type on the component.

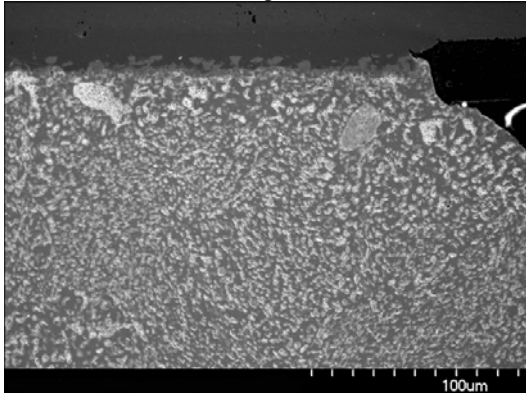
B. PCB R1 Middle BGA: L + L

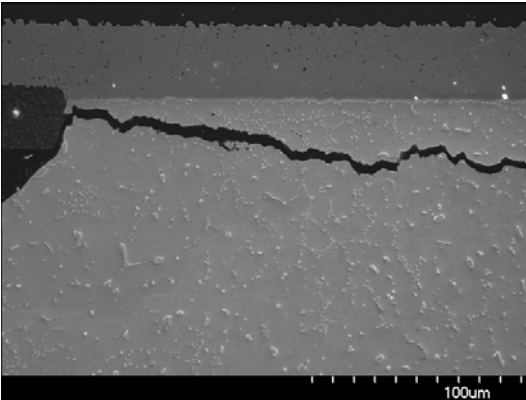
C. PCB R1 Edge BGA: LF + LF

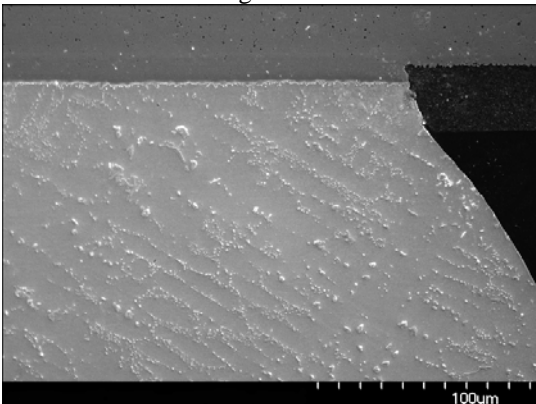
D. PCB R1 Middle BGA: LF + LF

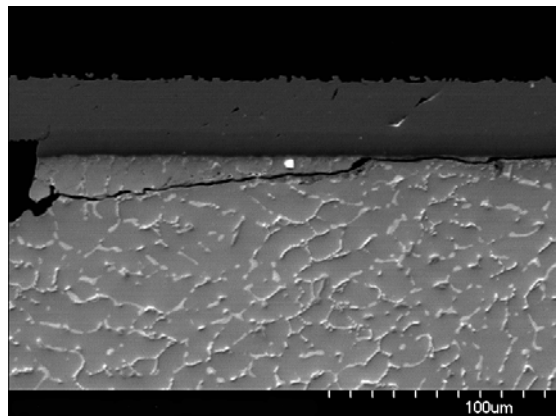
A. PCB R1 Edge BGA: L + LF

Figure 8: SEM images (500X) of BGAs where the solder mask was applied. First letter corresponds to type of solder paste on pad and the second to solder type on the component.

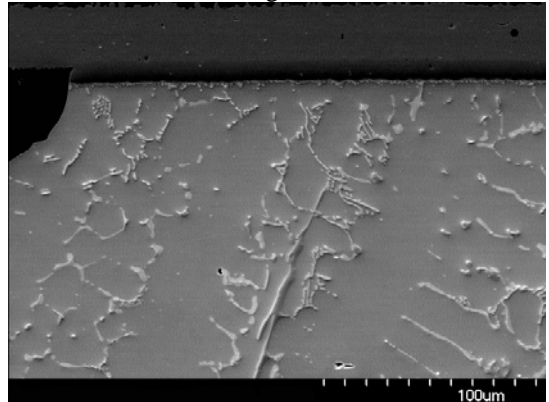
B. PCB R1 Middle BGA: L + LF

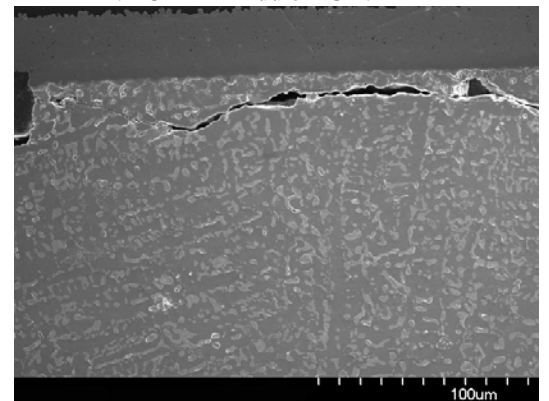
C. PCB R1 Edge BGA: LF + L

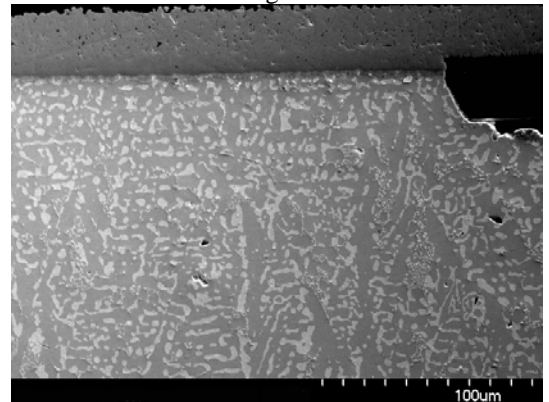
D. PCB R1 Middle BGA: LF + L

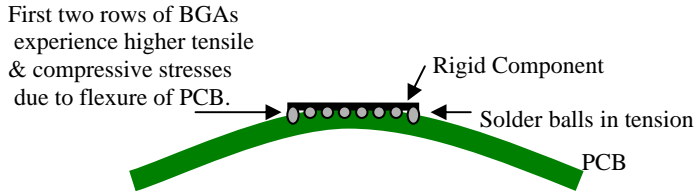
Figure 9: Exaggerated flexure of PCB and its effect on a BGA component at first mode of vibration.
