## Periodic Inspections of Coastal Structures with Stone Armor

*by Robert R. Bottin, Jr.*

**PURPOSE:** This Coastal and Hydraulics Engineering Technical Note (CHETN) provides information on the long-term structural performance of selected stone-armored navigation structures to their environment. Coastal structures at St. Paul Harbor, AK, and Burns Harbor, IN, are discussed herein. The response of concrete-armored coastal structures to their environment will be presented in a subsequent CHETN.

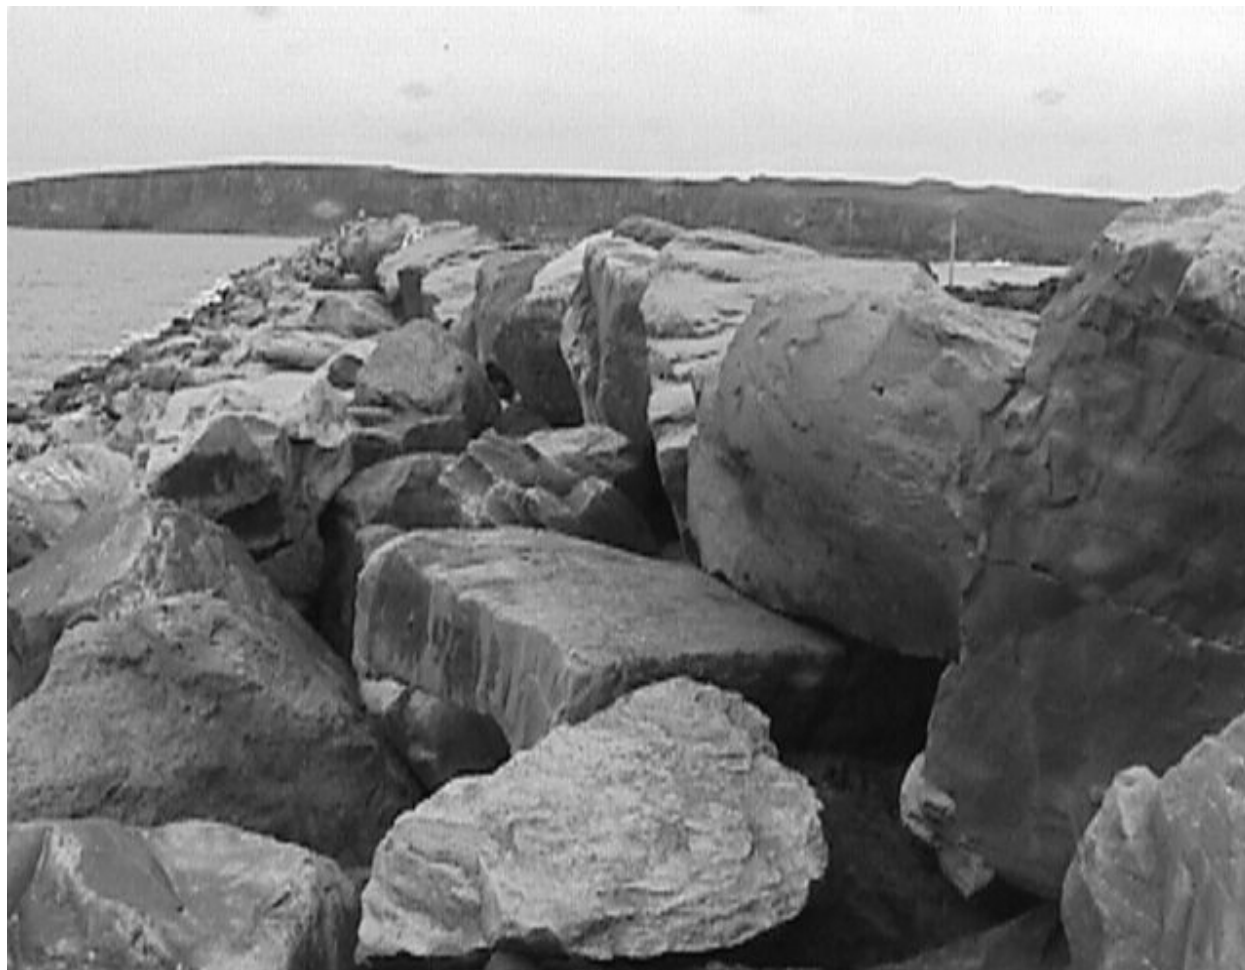
Figure 1. View of St. Paul Harbor breakwater trunk

The initial photogrammetric survey of May 1994 revealed low areas along much of the breakwater. Breakwater topography indicated only about 5 percent of the higher portion of the structure (sta 7+50-15+10) was at its design el +37, and 9 percent of the lower portion (sta 15+10-18+00) was at its design el +30. For the higher portion of the structure, the elevation of about 24 percent of the

length of the breakwater was within 0.3048 m (1 ft) of its design elevation, or between el +36 and el +37; and approximately 66 percent of the structure was between el +35 and el +37, or within 0.6096 m (2 ft) of its design elevation. About 29 percent of the structure length was below el +35. Most of the low area (that below el +35) was concentrated between stas 13+70 and 15+10. For the lower portion of the structure, the elevation of about 50 percent of the length of the breakwater was within 0.3048 m (1 ft) of its design elevation, or between el +29 and el +30; and approximately 89 percent of the structure was within 0.6096 m (2 ft) of its design elevation, or between el +28 and el +30. Only 2 percent of the structure length was below el +28. The initial broken armor unit survey of the St. Paul Harbor breakwater extension occurred during July 1993. The survey revealed 73 broken or cracked armor stones above the waterline. Of the 73 stones, 7 stones were located on the crest, 31 on the seaward slope, and 35 on the harbor side.

The May 1996 photogrammetric survey of the breakwater revealed very slight change in breakwater elevation relative to the 1994 survey. Contours showing the difference in elevations, indicated essentially no change along the crown of the structure. In the vicinity of sta 9+50, a change up to 0.9144 m (3 ft) occurred along the waterline on the sea side of the structure. In this area, however, emergency repairs were made in 1995. Other changes (between 0.3048 and 0.9144 m (1 and 3 ft)) generally occurred on the harbor side of the breakwater. The data indicated essentially no settlement of the structure between 1994 and 1996. Examination of cross section data revealed similar sections for both 1994 and 1996. A broken armor unit survey conducted during June 1996 revealed 230 broken/cracked armor stones on the main breakwater (versus 73 in July 1993). Of the 230 stones, 54 were located on the crest, 105 on the seaward slope, and 71 on the harbor-side slope. Broken stones, generally, were evenly distributed along the length of the structure. The survey indicated that 49 percent of the broken stones were located on the shoreward half of the breakwater extension, and 51 percent on the outer half.

Examination of breakwater topography for the June 2000 photogrammetric survey indicated that essentially no change had occurred in the crest elevation of the breakwater since 1996. Maps developed depicting changes in contours between 1996 and 2000 revealed some areas in the breakwater where voids or subsidence (on the order of 1.5 m (5 ft)) had occurred. Decreases in breakwater elevation were noted along areas on both the seaward and shoreward slopes. Difference contour maps also revealed voids in several areas where single armor stones had been displaced. In addition, breakwater cross sections developed revealed low areas in the structure at some locations. The overall shape and elevation of the breakwater appeared similar, but voids were noted in the 2000 survey that had not been present previously. A broken armor unit survey conducted during July 2000 revealed 221 broken or cracked armor stones above the waterline. Twenty-four new broken stones were noted since the June 1996 inspection, and 33 broken stones documented during the previous inspection could not be found. They could have been moved away by wave and/or ice action. Just fragments of most these stones remained. Of the 221 broken stones identified in the 2000 inspection, 56 were located along the breakwater crest, 96 on the sea-side slope, and 69 on the harbor-side slope. In general, broken stones were evenly distributed along the length of the structure with 54 percent located on the shoreward half of the breakwater extension and 46 percent on the outer half. An obvious void observed during the broken armor unit survey was in a stretch along the waterline on the sea-side slope between stas 8+80 and 9+70 where core stone was exposed in one area. The rate of breakage appeared to have declined at St. Paul breakwater. Only 24 new broken armor stones were observed in the 4-year period between 1996 and 2000 as opposed to 157 broken stones that occurred during the original 3-year monitoring period between 1993 and 1996.

To minimize further breakwater damage and reduce overtopping of the main breakwater, the construction of three submerged reef breakwaters seaward of the structure was completed by the U.S. Army Engineer District, Alaska, during the 2001 construction season. In addition, the void area between stas 8+80 and 9+70 was repaired. The 2000 periodic inspection of the breakwater extension not only determined changes in the armor unit field since previous studies, but established new base conditions since construction of the reef breakwaters. Subsequent inspections will evaluate the effectiveness and analyze the performance of the improved project.

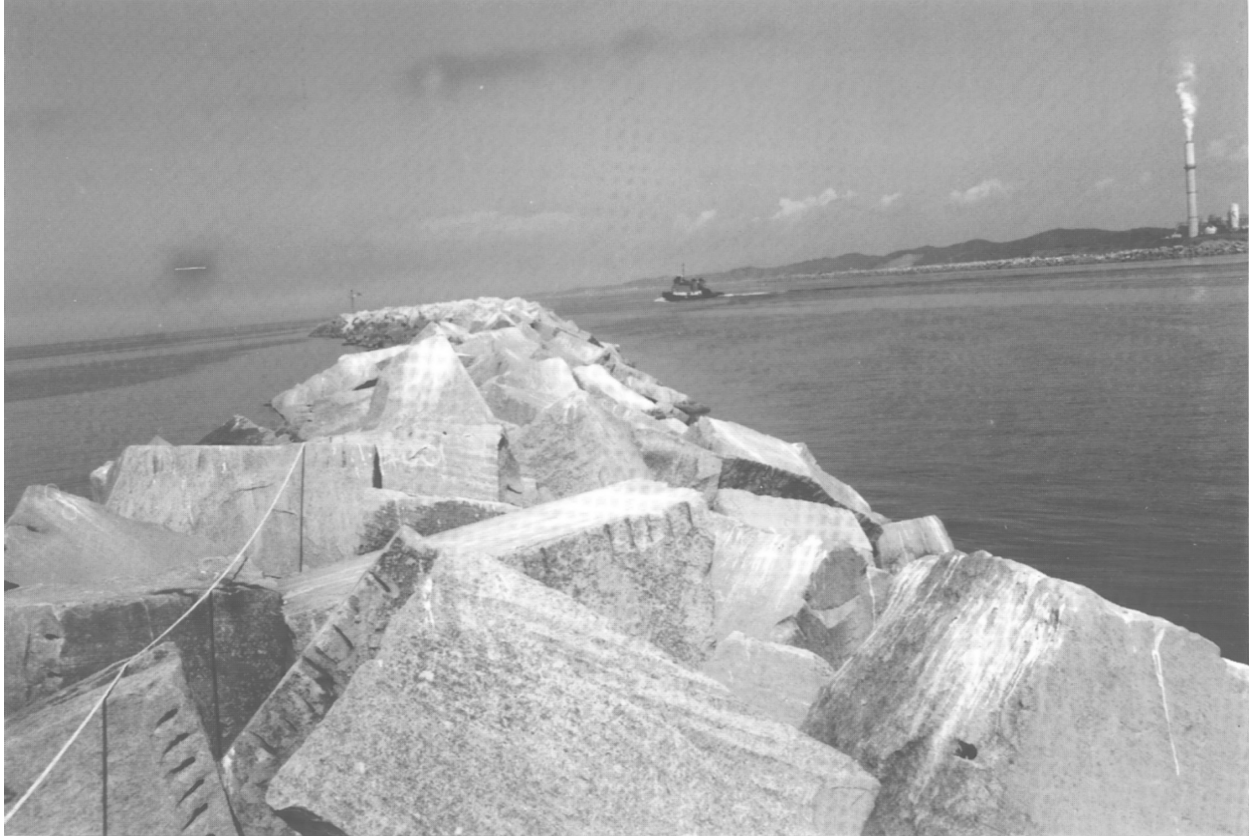
The initial photogrammetric survey of November 1994 revealed low areas along much of the breakwater. Breakwater topography indicated that, cumulatively, about 344.4 m (1,130 ft), or 24 percent, of the total breakwater length was below its design crest el +14. Most of the low areas ranged from el +12 to el +14. Only about 65.5 m (215 ft) cumulative length of the breakwater (4.6 percent) was below el + 12. Topography and cross-section data also revealed that the design width of el +17 was not maintained in many areas. In addition, on some portions of the structure, the slope of the harbor side of the breakwater was much steeper than the original 1V:1.5H design. The initial broken armor unit survey of the Burns Harbor north breakwater was conducted during July 1995. The survey revealed a total of 165 broken or cracked armor stones above the waterline. Of the 165 stones, 26 (16 percent) were located on the breakwater crest, 95 (57 percent) on the lake-side slope, and 44 (27 percent) on the harbor-side slope. No broken armor stones were observed around the head. Broken stones occurred along the entire breakwater, however in general, higher concentrations were found along the easternmost portion of the structure. About 50 percent of the broken units were located on the eastern one-third of the breakwater.

Examination of breakwater topography for the July 1999 photogrammetric survey indicated continued loss of structure elevation. Cumulatively, about 646.2 m (2,120 ft), or 46 percent, of the total length of the breakwater was below its design el +14 (versus 24 percent in the previous survey of 1994). About 152.4 m (500 ft) cumulative length of the breakwater (11 percent) was below

Figure 2. View of Burns Harbor north breakwater trunk

el +12 in July 1999 versus 65.5 m (215 ft) (4.6 percent) in July 1994. In July 1999, concentrations of low areas occurred between stas 8+40-15+65 and 30+70-37+80, however, sporadic areas of low elevation were noted along the length of the structure. Both the 1994 and 1999 surveys revealed the crest width less than the el 17 design and steep slopes (steeper than the 1V:1.5H design) on the harbor side of the structure. A broken armor unit survey conducted during July 1999 revealed 225 broken or cracked armor stones above the waterline (versus 165 in July 1995). Of the 225 stones, 34 were located on the breakwater crest, 96 on the lake-side slope, and 95 on the harbor-side slope. About 42 percent of the broken stones were observed on both the lake- and harbor-side slopes in 1999 versus 57 percent on the lake side and 27 percent on the harbor side in 1995. The survey revealed that between 1995 and 1999 most of the additional breakage occurred on the harbor-side slope. The percent of broken armor units on the breakwater crest remained relatively constant at 15 to 16 percent for both surveys. In 1999, about 44 percent of the broken armor stones were located on the eastern one-third of the breakwater versus 50 percent of the broken stones in 1995.

To minimize further breakwater damage and reduce transmitted wave heights in the harbor, a submerged reef breakwater was constructed lakeward of the north structure during the construction seasons between June 1995 and August 1998 by the U.S. Army Engineer District, Chicago. The 1999 periodic inspection of the breakwater not only determined changes in the armor unit field since the previous survey, but established new base conditions since construction of the submerged reef breakwater. Subsequent inspections will evaluate the effectiveness and analyze the performance of the improved project.
