# FIVE-YEAR REVIEW REPORT

First Five-Year Review Report  
for

Presidio of Monterey Landfill  
Monterey, California

September 2001

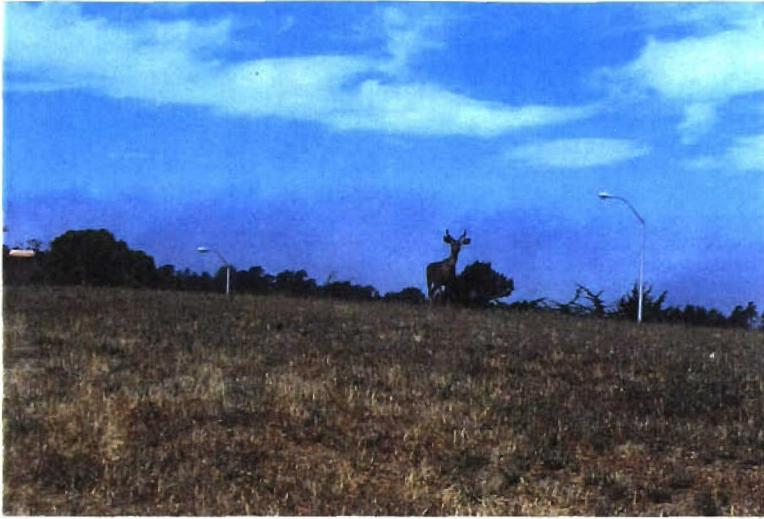
Photo taken from Ord Road looking NNW at lower cell

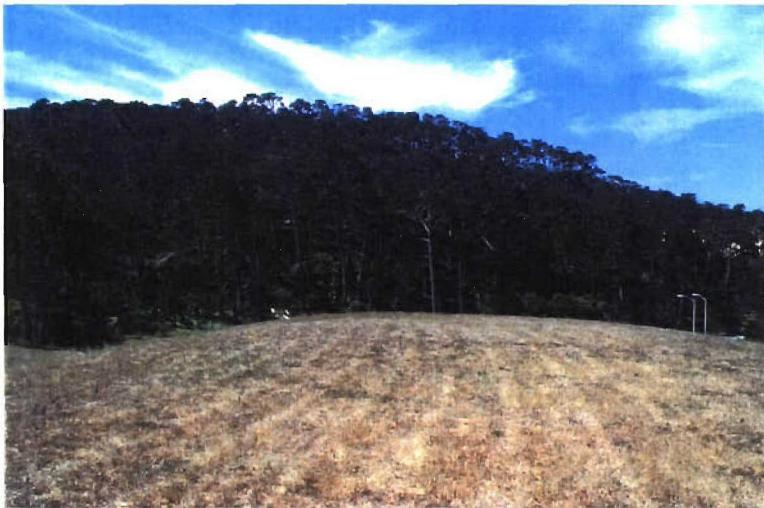
Photo taken on top of lower cell looking SSW

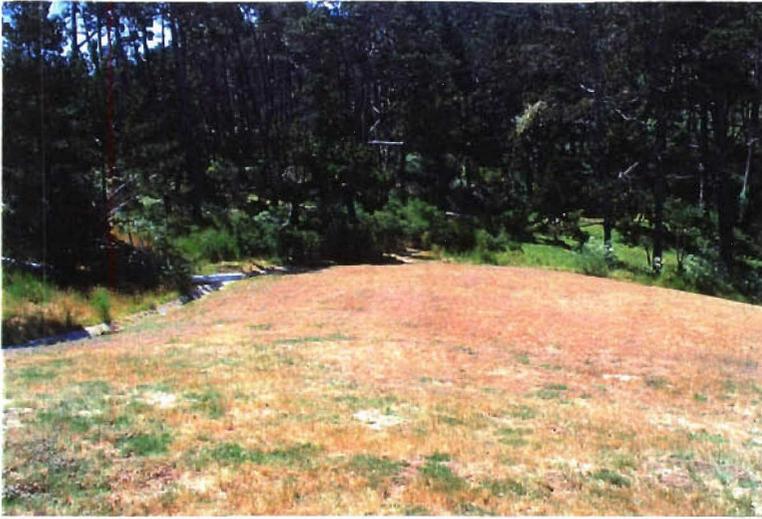
View of bottom half of lower cell looking South

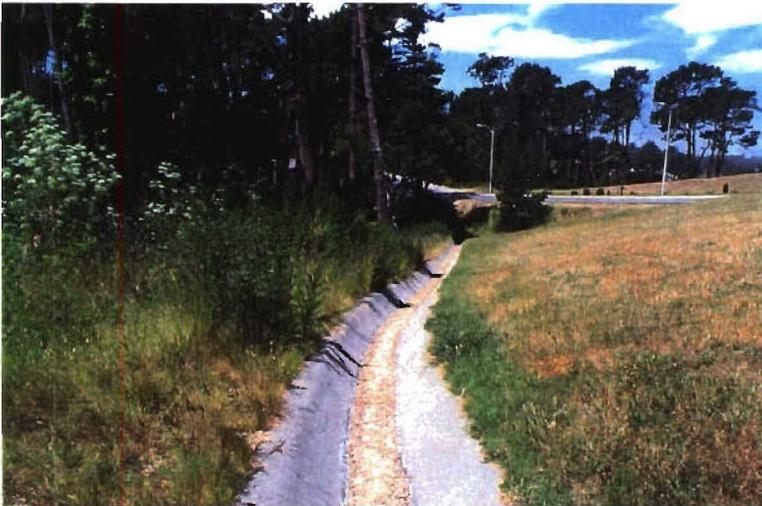
Photo taken of culvert on Southeast side of lower cell

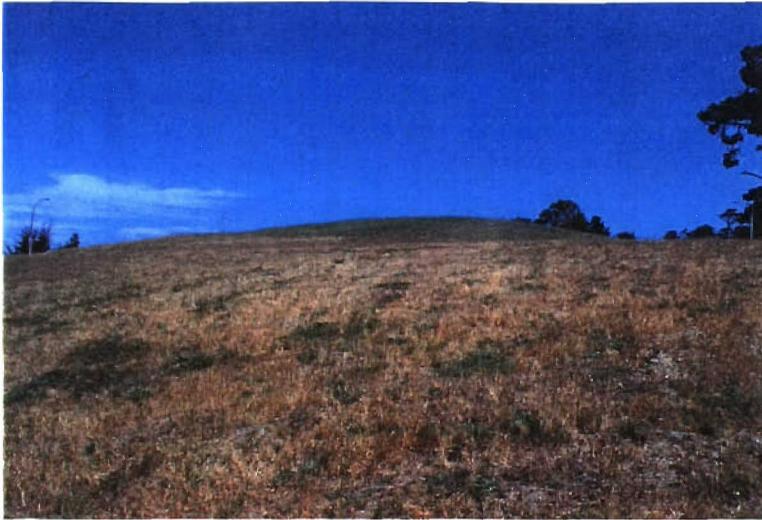
Photo looking from south to north in center of lower cell

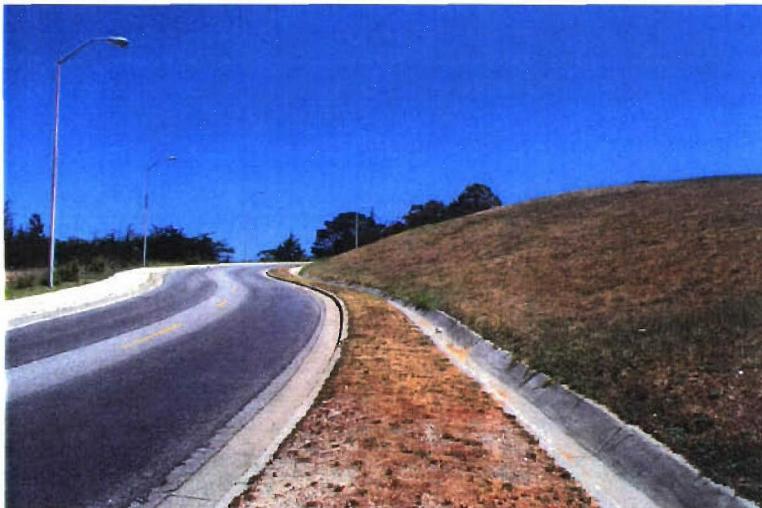
Mason Road looking north between both landfill cells

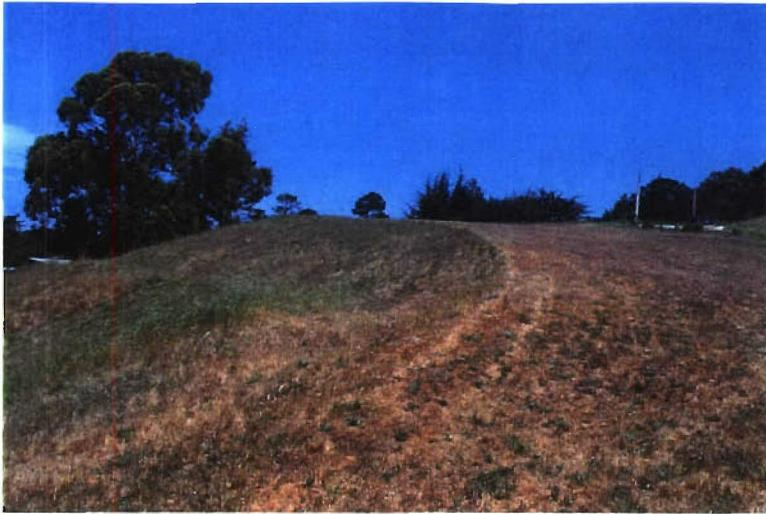
Photo of upper cell looking north

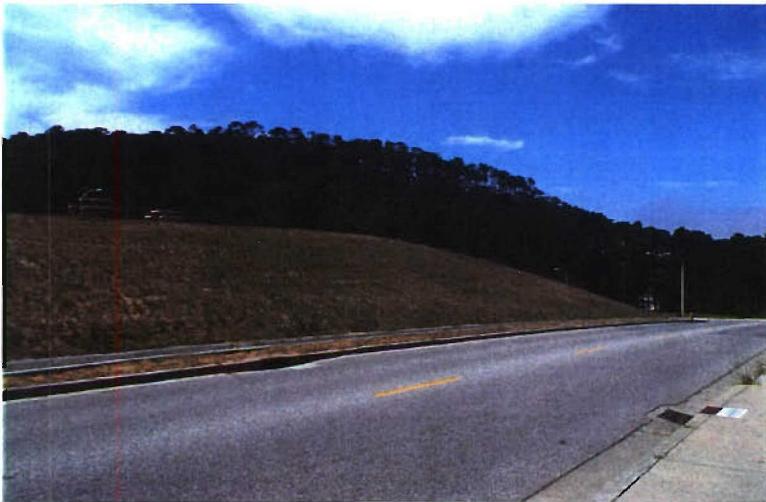
Mason road looking south at lower cell
