ARMY RESEARCH LABORATORY

Final Report on Alternative Chromate-Free Wash Primers

ARL-TR-3932

September 2006

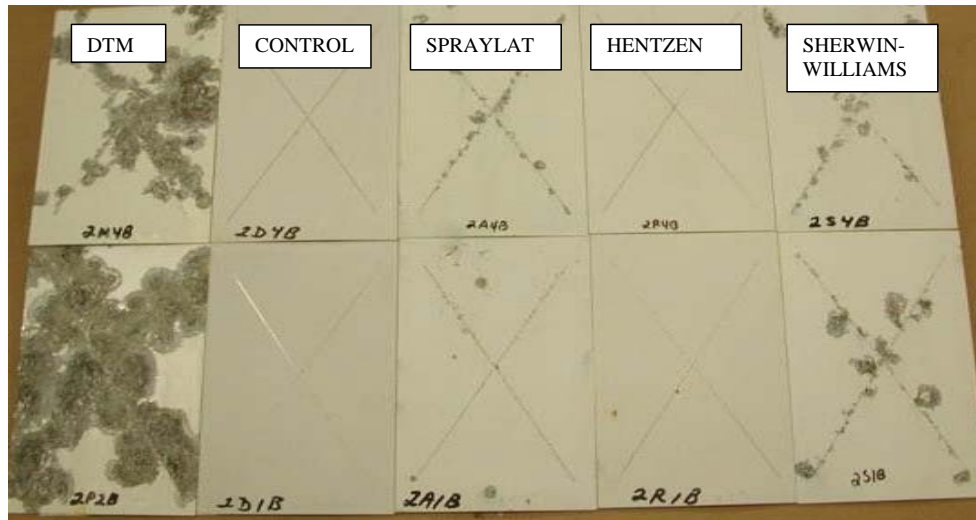
Al 2024-T3 is mainly used on aircraft and missiles and is the least corrosion resistant of the series. For Al 2024-T3, as shown in table 10, the alternative systems have 40–60% of the control protection after 1088 hr in salt fog, while DTM has 10%, and at 2088 hr, DTM has 0% protection. At 44 cycles in the GM 9540P, the control offers 90% protection, while the three alternative systems offer ~50%, and the DTM offers ~10%. The separation between 44 cycles and 100 cycles was marginal.

Figure 1. GM 9540P results for Al 2024-T3.

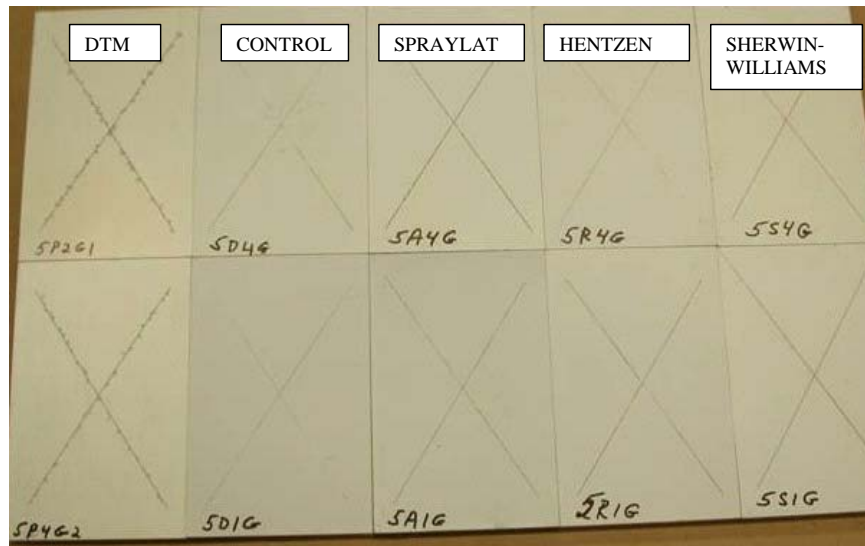
Al 5083-H231 does well in corrosion due to its protective oxide layer and is normally utilized on armor and tactical ground systems. In table 11, the slight change in data from 44 to 100 cycles in the GM chamber shows that two vendors are equal to the control. In ASTM B 117, the DTM offered 30% protection over the control after 2088 hr.

Figure 2. GM 9540P results for Al 5083-H231.

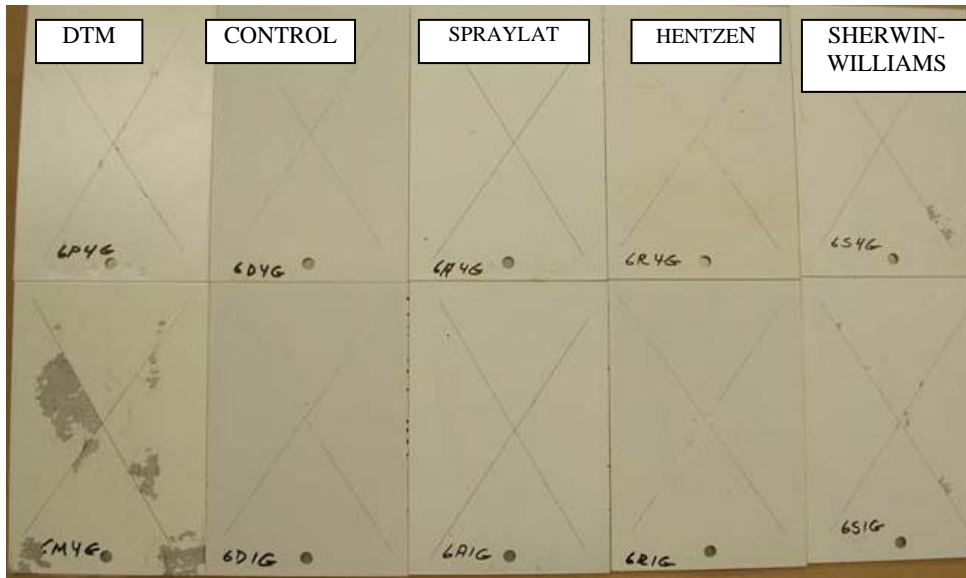
Al 6061-T3 is mainly used on components, and, as seen in table 12, all of the pretreatments performed well on Al 6061, showing little or no damage to the scribed region. DTM has 0% protection at 44 and 100 cycles, while the three vendors and the control offer 90% of corrosion protection. Additionally, the salt-fog environment demonstrates that the three vendors and the control provide 90% protection, while the DTM offers 50%.

Figure 3. GM 9540P results on Al 6061-T3.

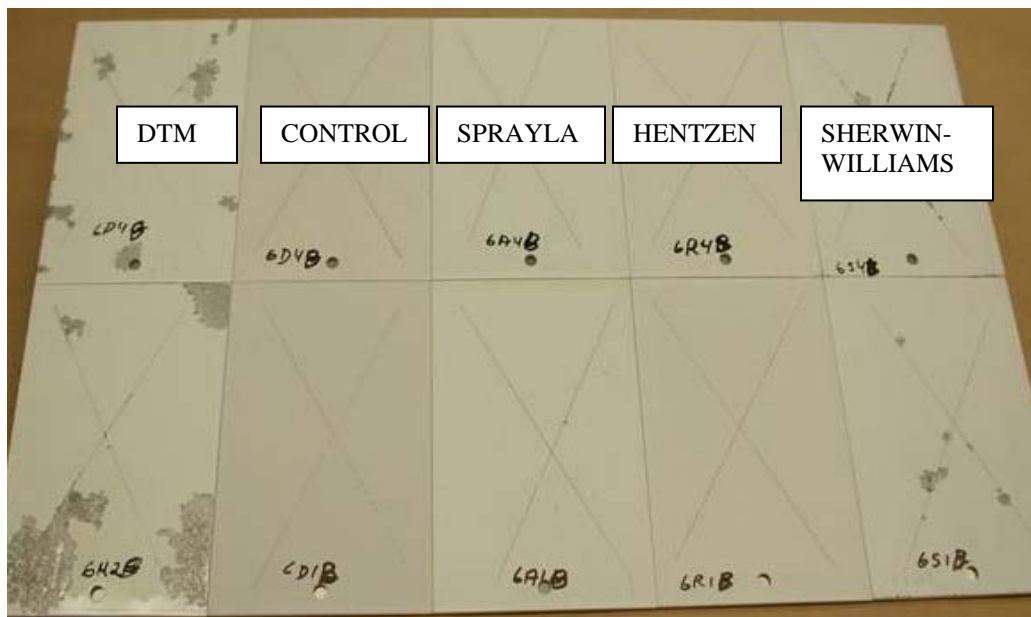
Figure 4. ASTM B 117 results on Al 6061-T3.

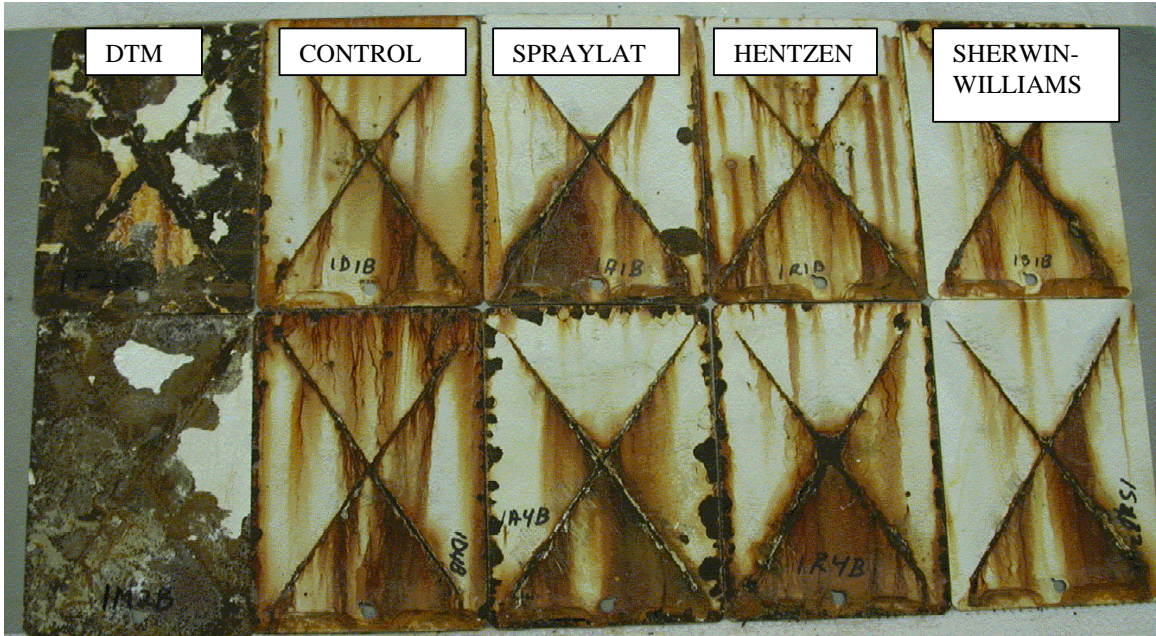
The coated steel panels performed differently from the aluminum alloys, showing greater rust and surface corrosion. The distinction is shown in table 14 for 1000 hr in salt fog, where the three vendors and the DTM are inferior to the control.

Figure 5. ASTM B 117 results on CRS 1080.

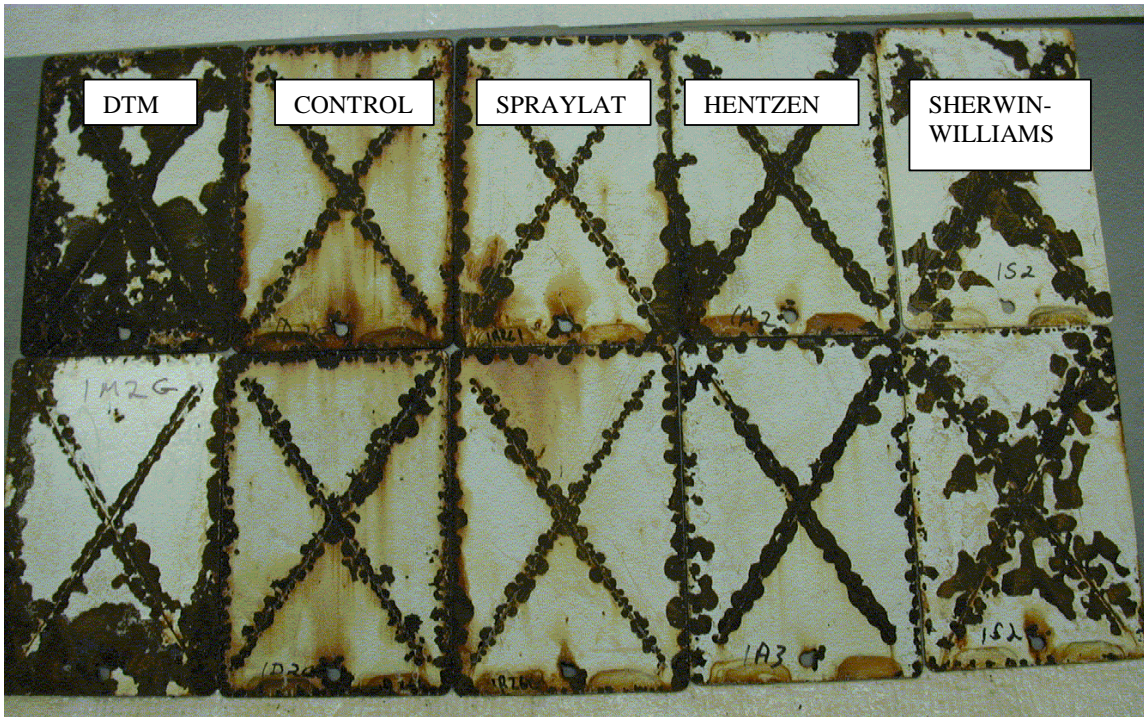
For the GM 9540P specification, 100 cycles was the best separator, with the DTM providing 0% protection. Therefore, the better performers on steel were easily observed. Most films were intact outside the scribed areas. The four treated surfaces showed similar corrosion degradation at the scribed areas and no evidence of blisters. The untreated surface (DTM) showed 90% delamination of the panel. Figures 1–6 show examples of samples exposed in both chambers.

Figure 6. GM 9540P results on CRS 1080.

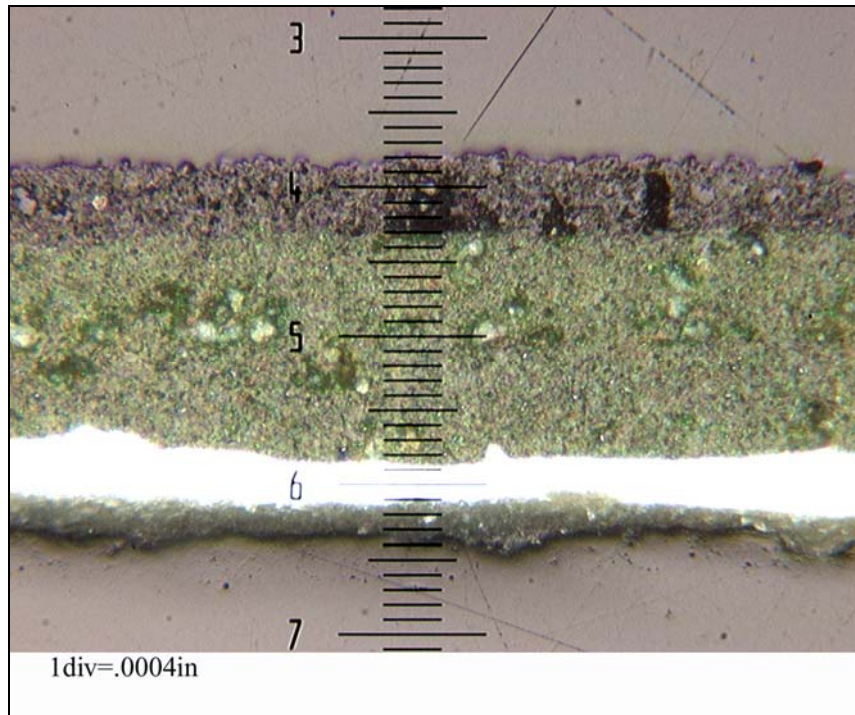
The micrographs presented in figures 22 and 23 depict the coating layers that are present on the paint chip. The top two layers appear to be black and green CARC topcoat. The third layer down

Figure 22. Micrograph of paint chip removed from Patriot ECS shelter with water-reducible wash primer.

appears to be a white primer, and the bottom layer appears to be the alternative wash primer (Sherwin Williams' Kem Aqua). No polyester filler appears to be present on the chip as noted by RDEC. In figure 22, each division of the ruler is equivalent to 0.0004 in. The average thickness of the alternative wash primer remaining on the chip is approximately 0.001 in.

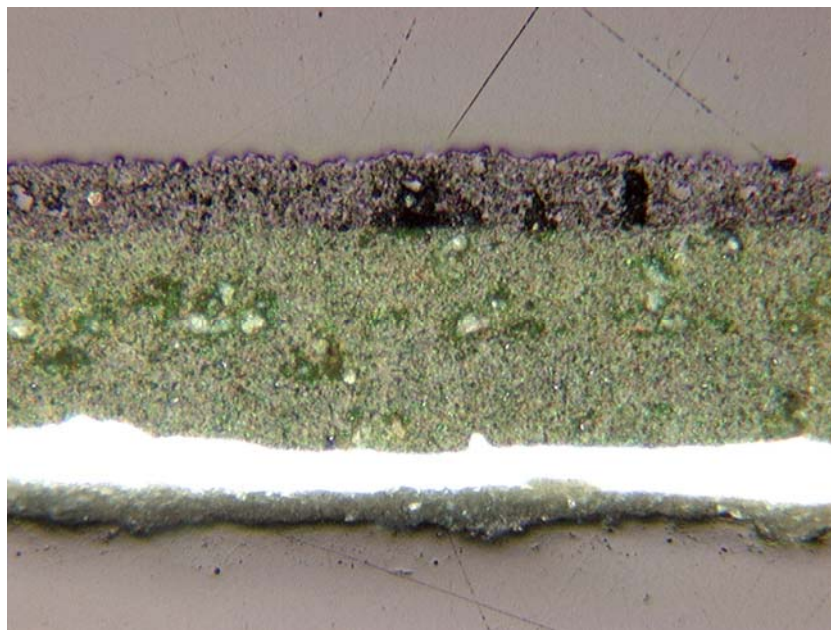
Figure 23. Micrograph of paint chip removed from Patriot ECS shelter with water-reducible wash primer.

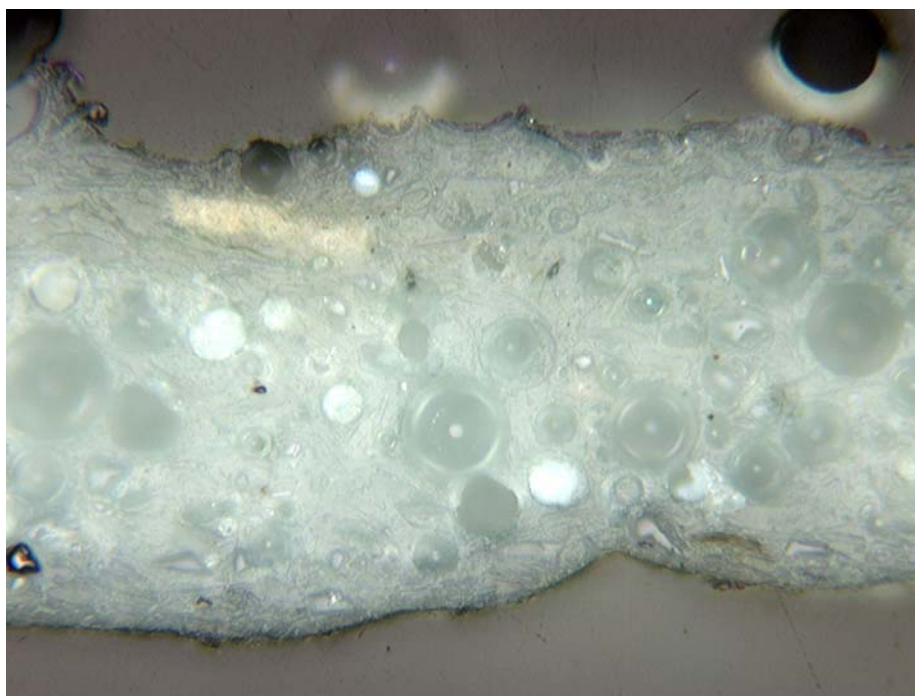
Figure 24 is a micrograph of the polyester filler. It does not appear that any of the polyester filler material shown in figure 24 is present underneath the wash primer layer on the paint chip. The absence of any polyester filler on the paint chip indicates a lack of adhesion between the alternative wash primer and the polyester filler material.

Figure 24. Micrograph of polyester filler removed from the Patriot ECS shelter with water-reducible wash primer.

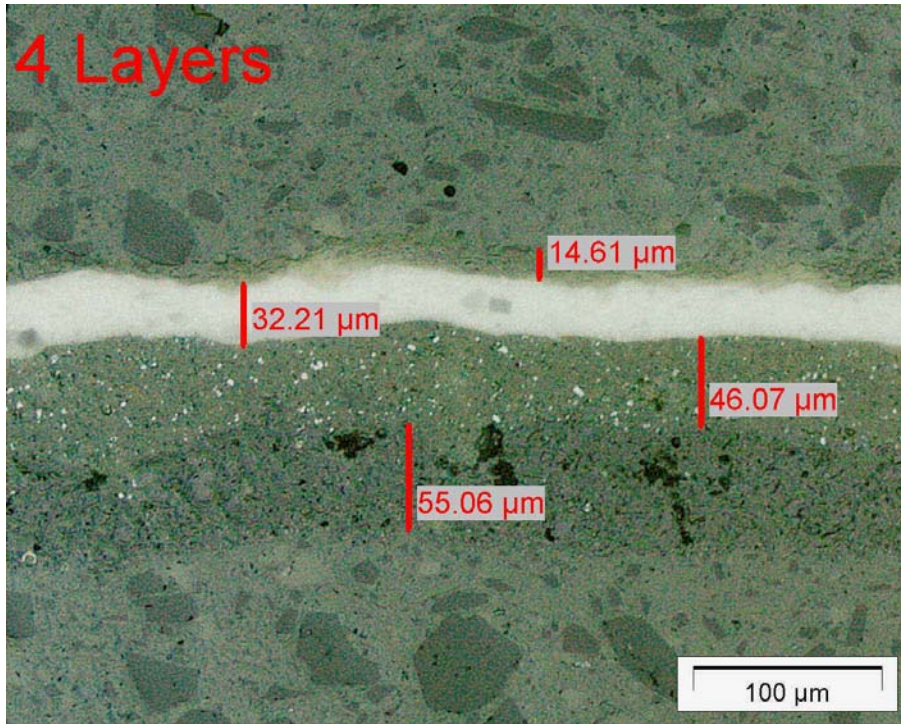
Figure 25. Micrograph of paint chip removed from Patriot ECS shelter with alternative wash primer.

The results of this analysis indicate an adhesive failure between the water-reducible wash primer and the polyester filler. Possible causes include material incompatibility between the water-reducible wash primer and the polyester filler or contaminants on the surface of the polyester filler prior to the application of the water-reducible wash primer. The paint chip from the new water-reducible wash primer showed four layers of coating while the control sample showed three coatings.

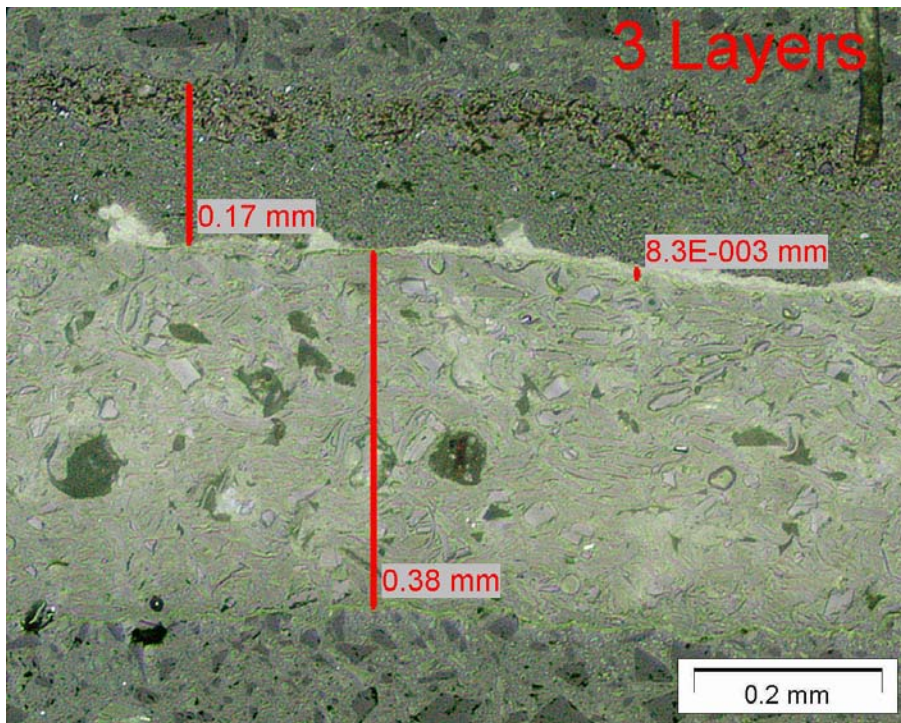
Figure 26. Micrograph of paint chip removed from Patriot CRG shelter with control wash primer.

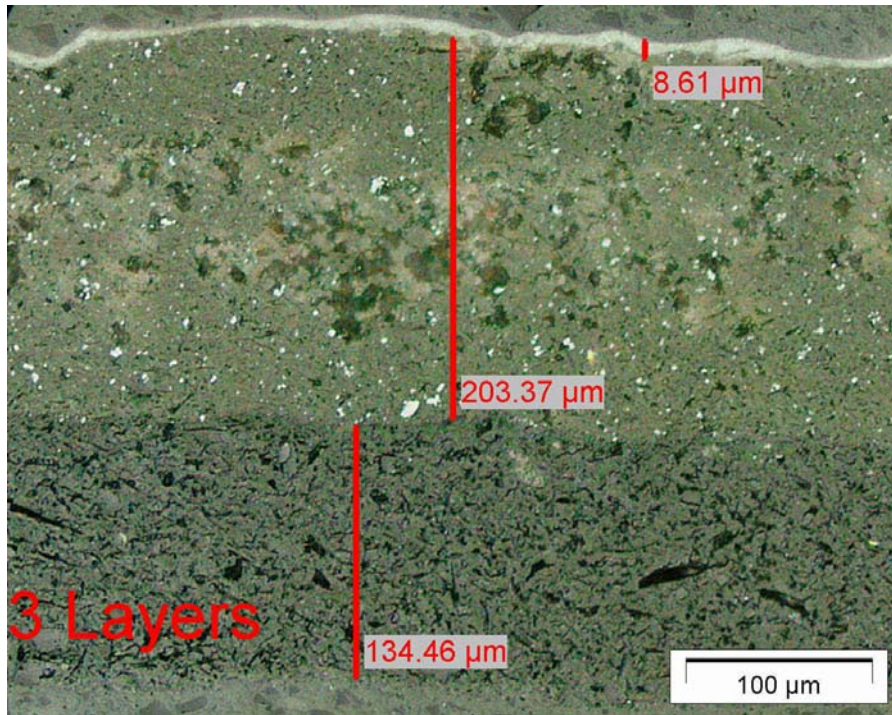
Figure 27. Micrograph of paint chip removed from Patriot ECS shelter with DOD-P-15328 wash primer.

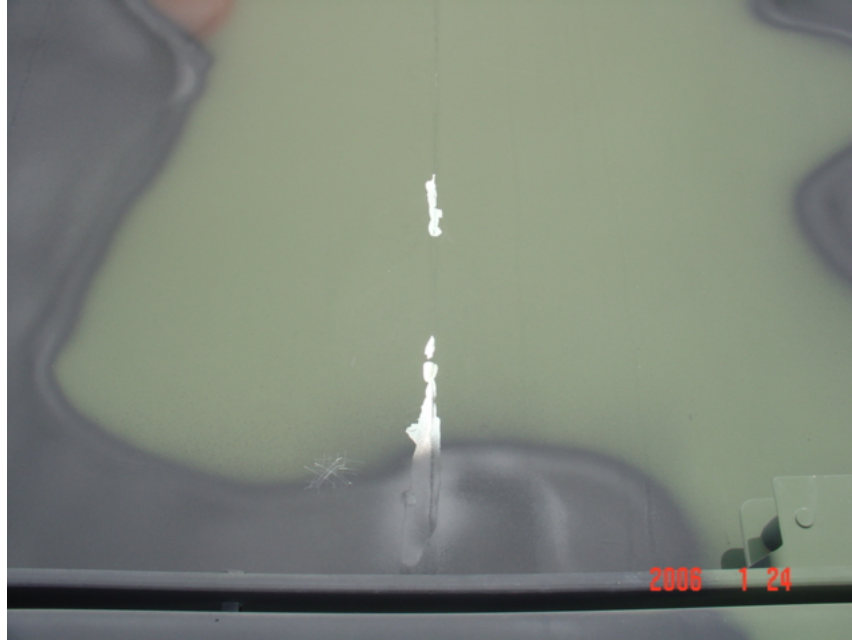
For the ECS serial no. 630106, overhaul date 05/05, there were two areas of paint adhesion failure on the outside of the vertical seam where the paint had peeled away or delaminated 1/4–1 in from the seam. Film delamination occurred only at the seam and only where the polyester filler was applied. Rivet head outlines could be seen along the entire seam. Expansion and contraction forces along the butt seam may be a contributing factor. This failure appears to be occurring at the weakest interface along the butt seam (i.e., between primer and body filler or substrate and body filler). Whatever forces are causing the flex of the substrate (evidenced by the rivet heads) distorts the coatings. The coatings are going to separate at the weakest interface, which appears to be the body filler/substrate interface (figures 28 and 29).

Figure 28. ECS before paint removal, serial no. 630106, overhaul date 05/05.

This Patriot ECS unit was painted using the low-VOC, water-reducible wash primer at Letterkenny, and fielded at Fort Bliss. The two areas of concern are sections of the shelter where the walls were replaced. The walls were bonded using a polysulfide sealer and polyester filler. The filler material appeared to have a heavy film. Dry film thickness measurements (1 mil = 0.001 in) were taken at four different areas. Data is recorded in table 42. Due to high temperatures, the shelter walls expanded causing the paint filler to crack and peel along the butt joints where replacement wall sections meet older wall sections. A knife blade easily removed painted filler along the edges for laboratory analysis.

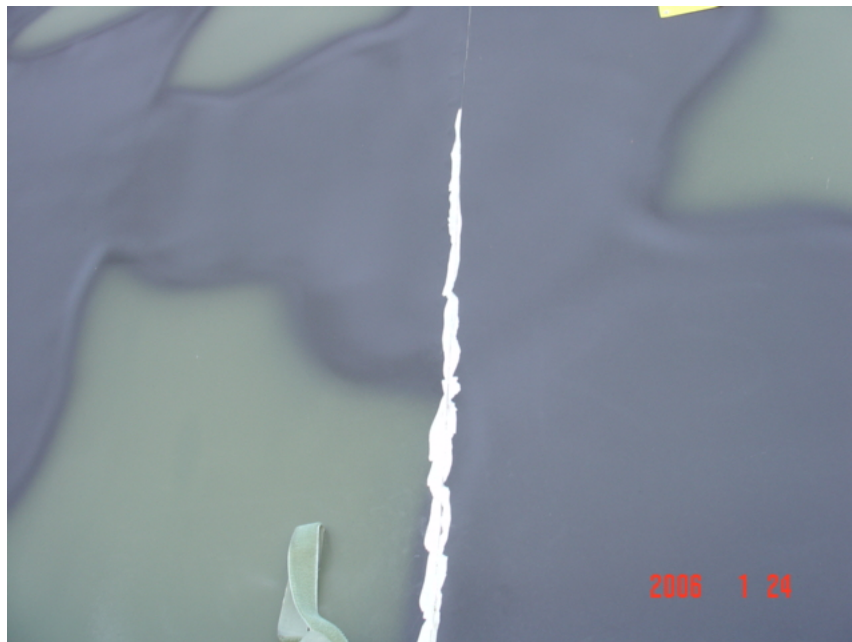
Figure 29. ECS after paint removal, serial no. 630106, overhaul date 05/05.
