# Feasibility Investigation into Strengthening of Timber Bridge Stringers

Anthony J. Lamanna, Arda Akbiyik, James C. Ray,  
and Gerardo I. Velázquez

May 2007

Final report

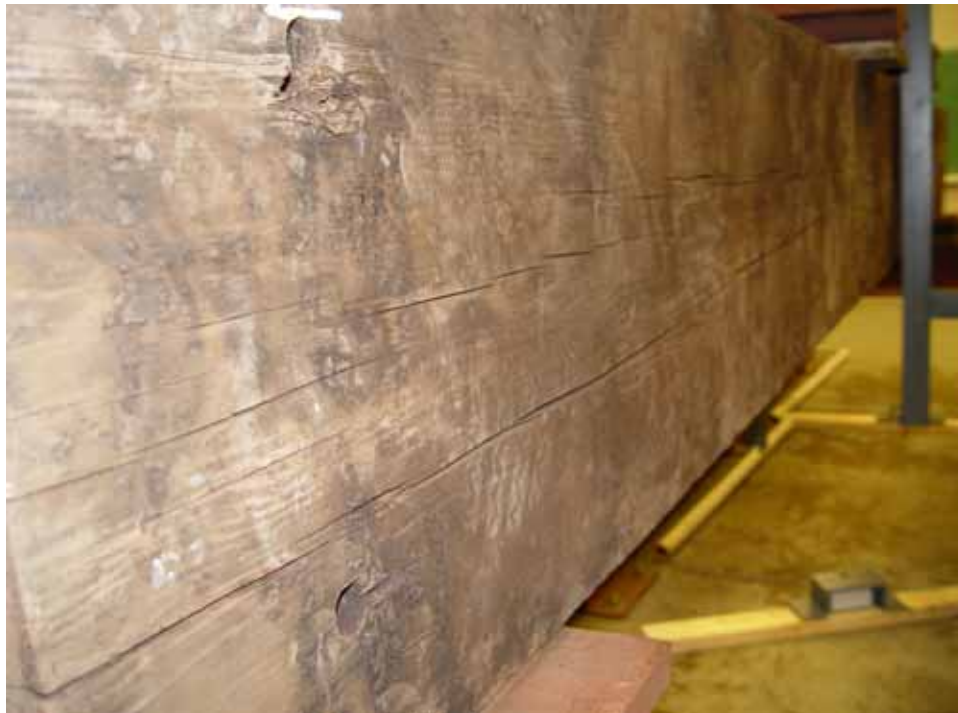
Specimen C2 was in good condition with only several checks along the length and at the ends, as shown in Figure 17. The stringer did not have any other major damage prior to testing except for the aforementioned checks.

Figure 17. Checks at the end and along the length of specimen C2.

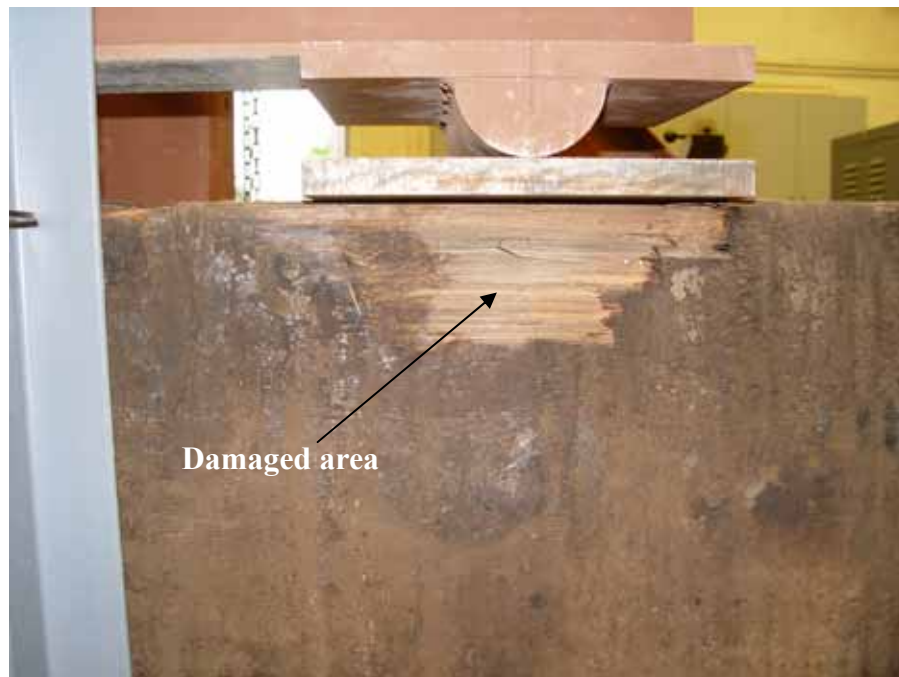
Specimen C4 was initially in good condition. There were no obvious signs of checking in specimen C4. The stringer had very slight surface cracks, but these cracks and checks were not as deep as the ones observed in specimens C1 and C2. The stringer had a wane that fell below one of the loading points, as shown in Figure 18. Since the damaged area was located in the compression zone, its effect on strength of the stringer was minimal.

Figure 18. Damaged area at the loading point of specimen C4.

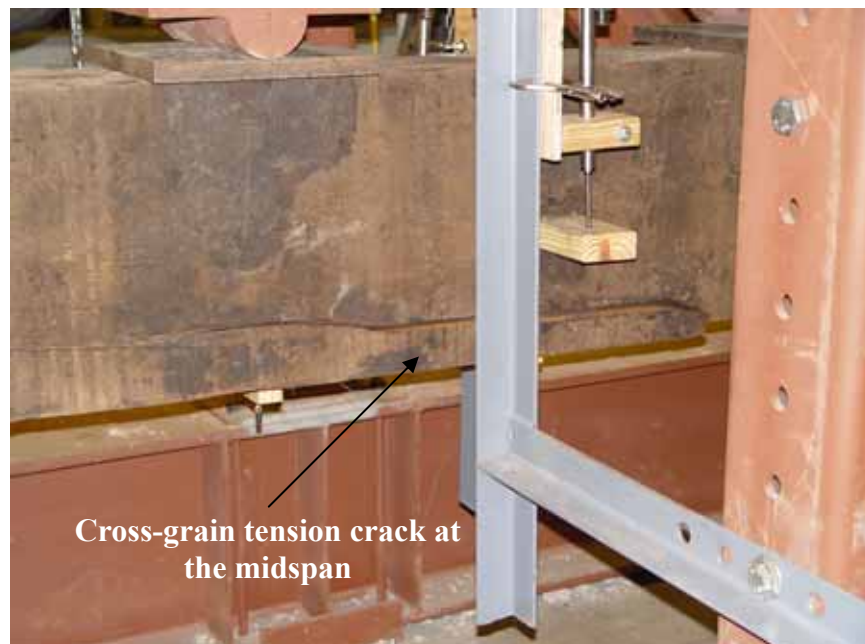
Specimen C7 was in good condition except for a cross-grain tension crack at midspan, as shown in Figure 22. The stringer also had several checks along its length. There was no other major damage observed in the stringer before testing.

Figure 22. Cross-grain tension crack on specimen C7.

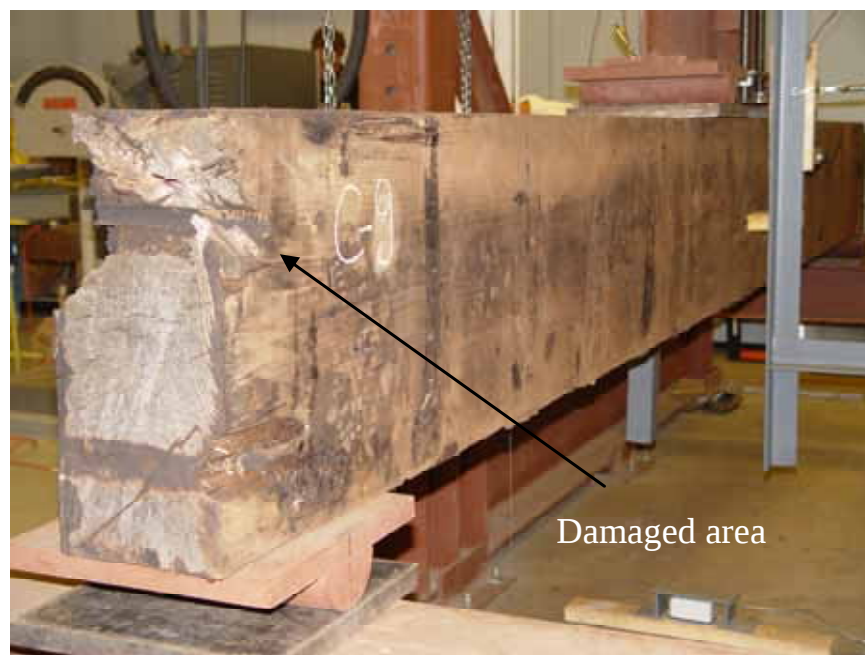
Specimen C9 had several knots and small checks along its length. The knots at the midspan were expected to reduce the strength of the stringer. There was also a damaged area at the support end, as seen Figure 23.

Figure 23. Damaged area at the end of specimen C9.

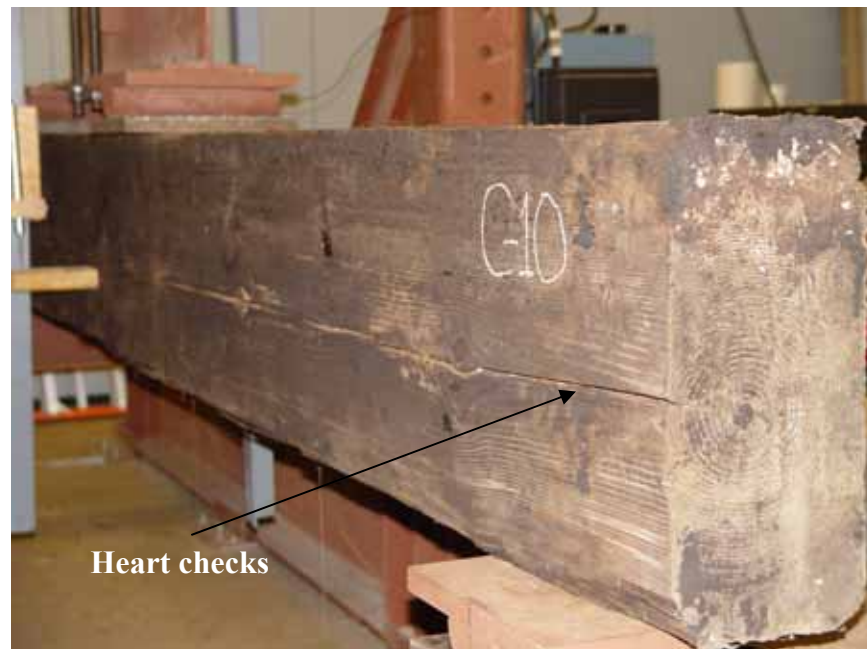
Specimen C10 had several heart checks observed along its length, as shown Figure 24. The heart checks were discontinuous and located close to the center of the stringer. Several shakes were also observed at the cross section of the support ends. C10 had several knots distributed close to the center along its length. The stringer did not show signs of decay in the tension zone and support points before testing.

Figure 24. Heart checks on specimen C10.

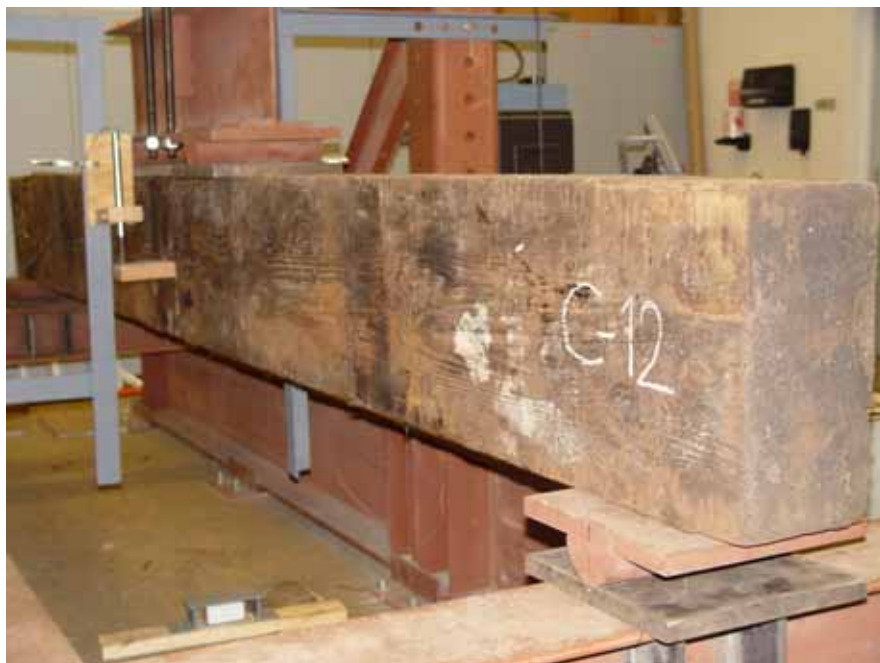
Specimen C12 was generally in good condition, as shown in Figure 27. It had cracks along its length and several knots. When the tension zone of the stringer was inspected more closely, some signs of rotting were detected. Rot was apparent on the surface of the stringer, but did not penetrate to the interior of the member.

Figure 27. A view of specimen C12.

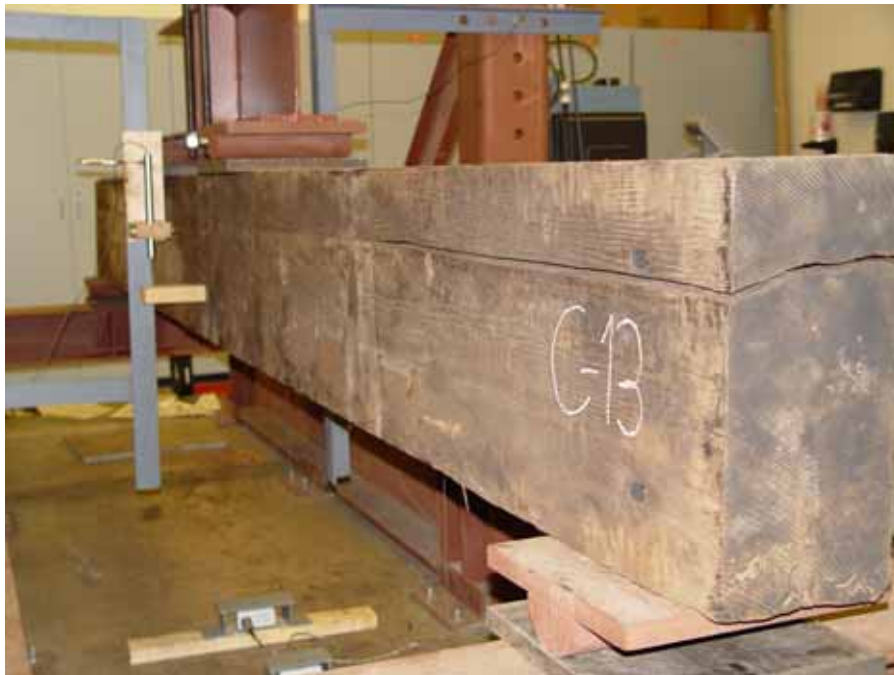
Specimen C13 had a severe end split. The end split was close to the top of the cross section, and it was extended to the midspan, shown in Figure 28. The stringer also had small surface cracks and checks. The other support face exhibited signs of splitting along the cross section. The stringer did not have any other deterioration that might affect the strength except for end splits.

Figure 28. End splitting on specimen C13.

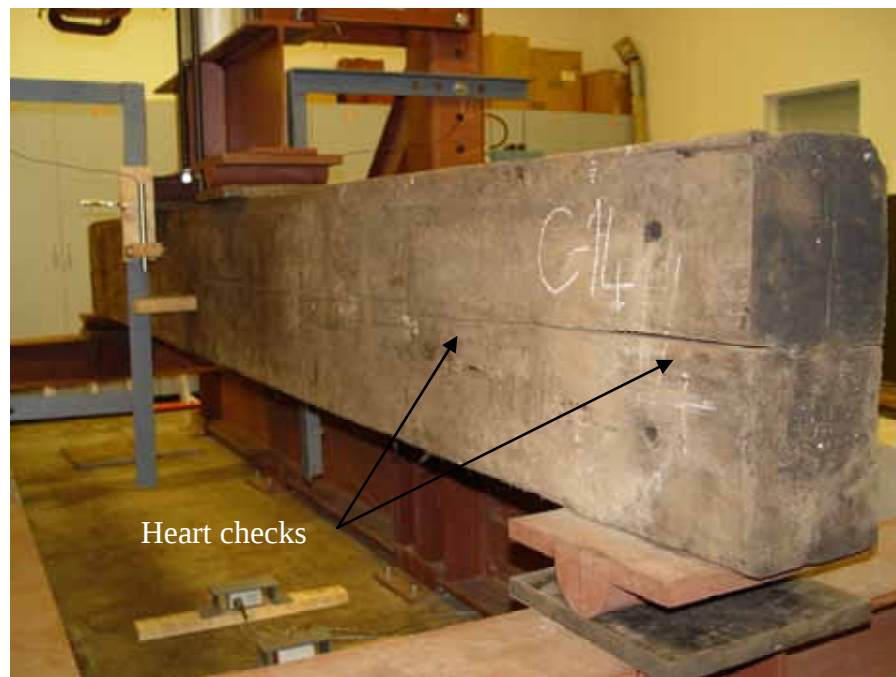
Specimen C14 had several heart checks observed along its length, shown in Figure 29. Heart checks were discontinuous and located close to the center of the cross section. The stringer did not have any other major deterioration that might affect its strength except for the heart checks at the ends and along the length.

Figure 29. Heart checks on specimen C14.

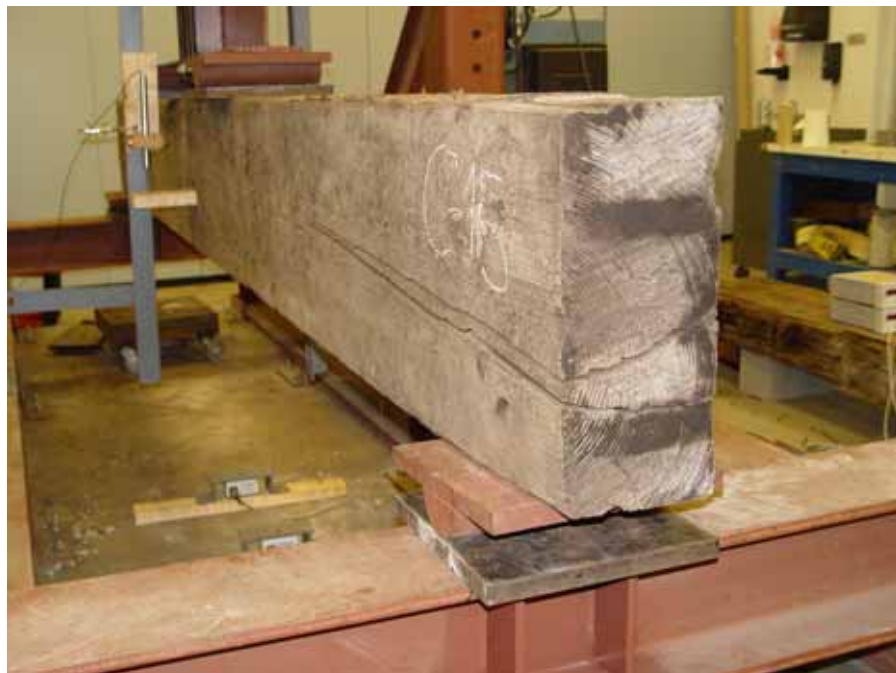
Specimen C15 had severe splitting at one end. Two separate splits were observed at the cross section along the length of the stringer, as shown in Figure 30. Several shakes were also observed on the support faces.

Figure 30. End splitting on specimen C15.

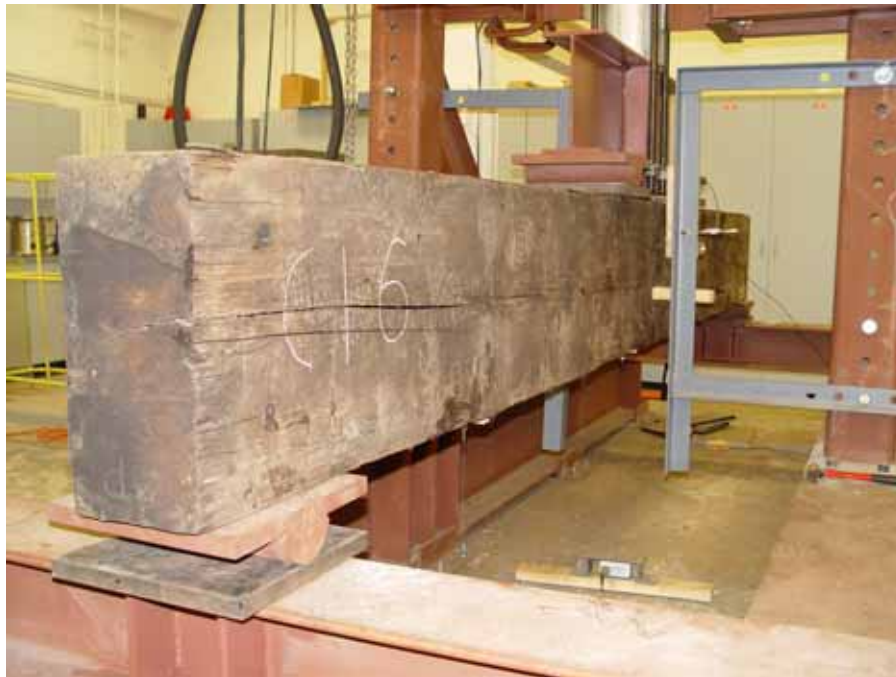
Specimen C16 had signs of severe checking and splitting along its length. There was continuous checking from end to the midspan of the stringer. Initiation of splits was observed close to the center of the cross section where the in-service shear stress was at a maximum, as shown in Figure 31.

Figure 31. Initiation of end splitting on specimen C16.

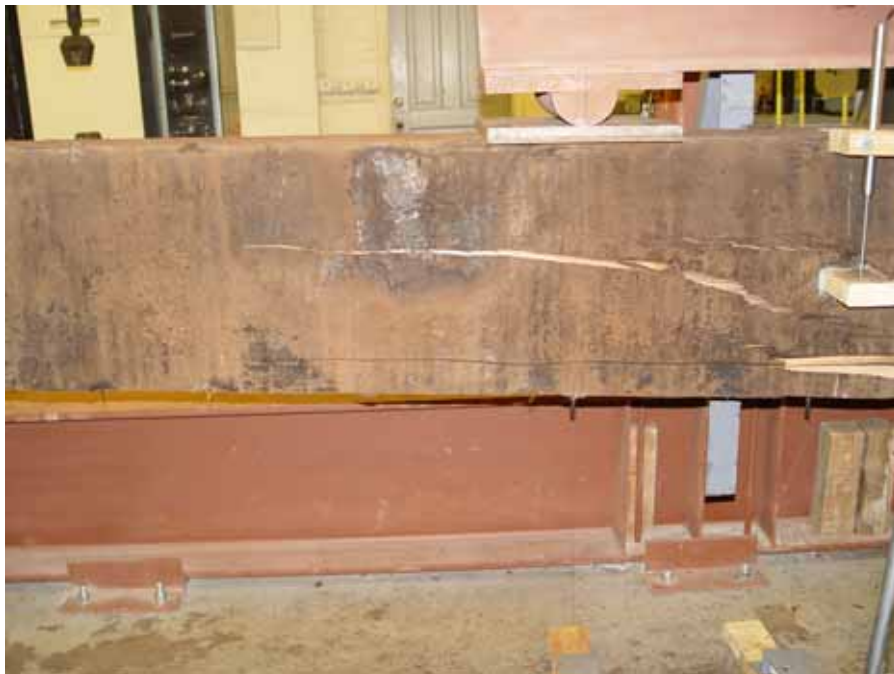
The initial slope of load-deflection curve for stringer C4, shown in Figure 72, was linear until the timber cracked in the tension zone at 182 kN (41 kips) causing a drop in the supported load to 173 kN (39 kips). The stringer underwent additional deflection with increasing load carrying capacity until the ultimate load was reached at 222 kN (50 kips). Several tension cracks and splinters were observed at the ultimate load. The ultimate load at failure was 222 kN (50 kips), and the midspan deflection was 46 mm (1.80 in.). The stringer had cross-grain tension failure at this ultimate load, and then the load dropped to 187 kN (42 kips). The failure split is shown in Figure 73. With a decreased stiffness, the load capacity again increased to 200 kN (45 kips) where the stringer had sudden horizontal shear failure, causing a drop in the supported load to 89 kN (20 kips). This was the unstrengthened postfailure capacity. The experiment was terminated after the horizontal shear failure. The horizontal shear crack was not directly across the width of the cross section, as shown in Figure 74.

Figure 73. Cross-grain tension failure at 222 kN (50 kips) on stringer C4.

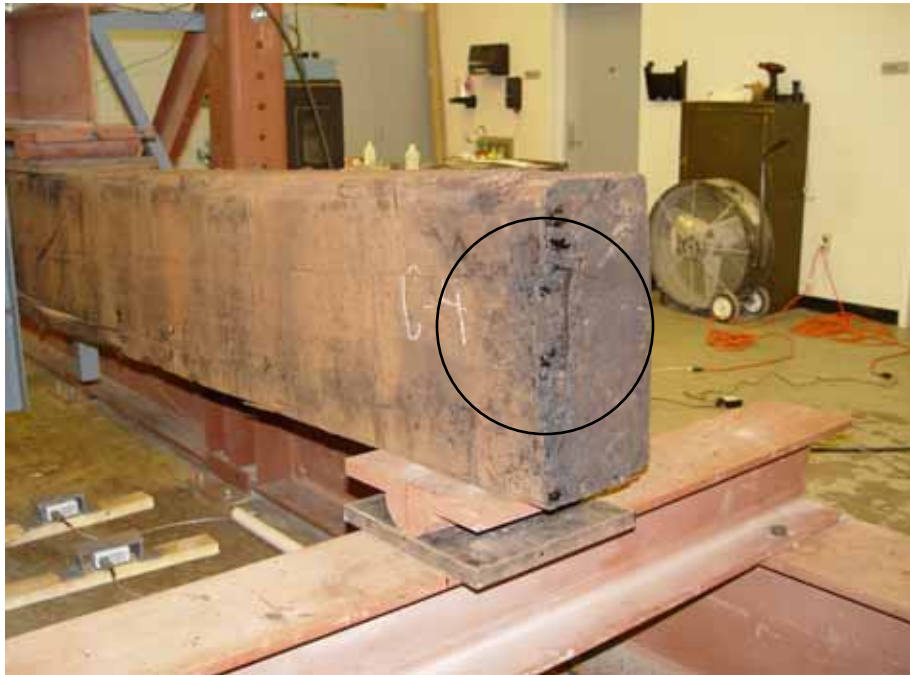
Figure 74. Horizontal shear failure on stringer C4.

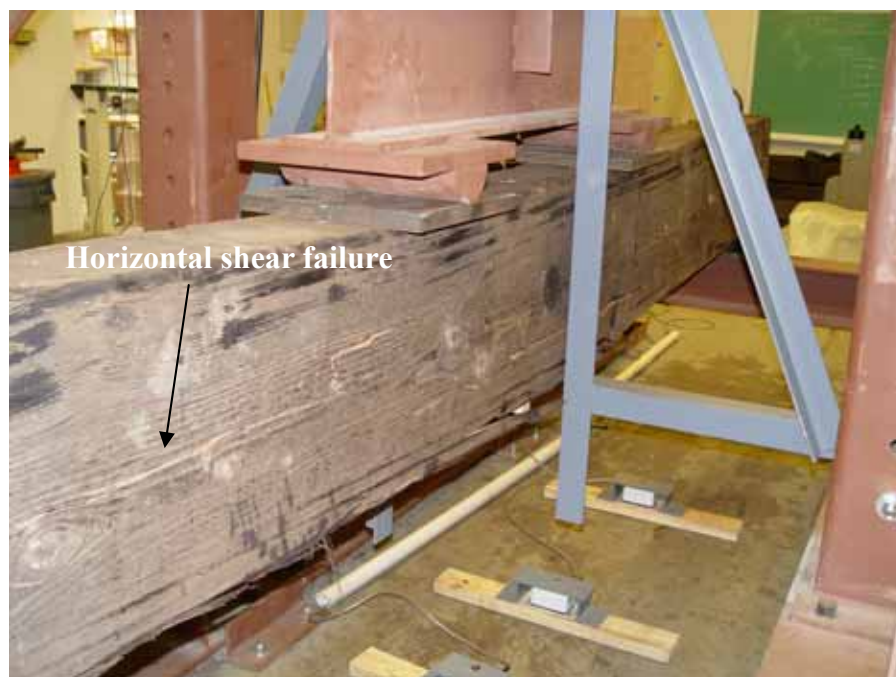
The initial slope of the load-deflection curve for stringer C5 is shown in Figure 75. The curve was linear until the timber cracked horizontally at 151 kN (34 kips), causing a drop in the supported load to 111 kN (25 kips). With the decreased stiffness, the stringer carried additional load while undergoing additional deflection until the ultimate load was reached and the stringer failed in simple tension. The failure pattern of stringer C5 is shown in Figure 76. The ultimate load was reached at 169 kN (38 kips) and at a deflection of 54 mm (2.12 in.). The unstrengthened postfailure capacity was 80 kN (18 kips).

Figure 76. Horizontal and tension cracks at failure for stringer C5.

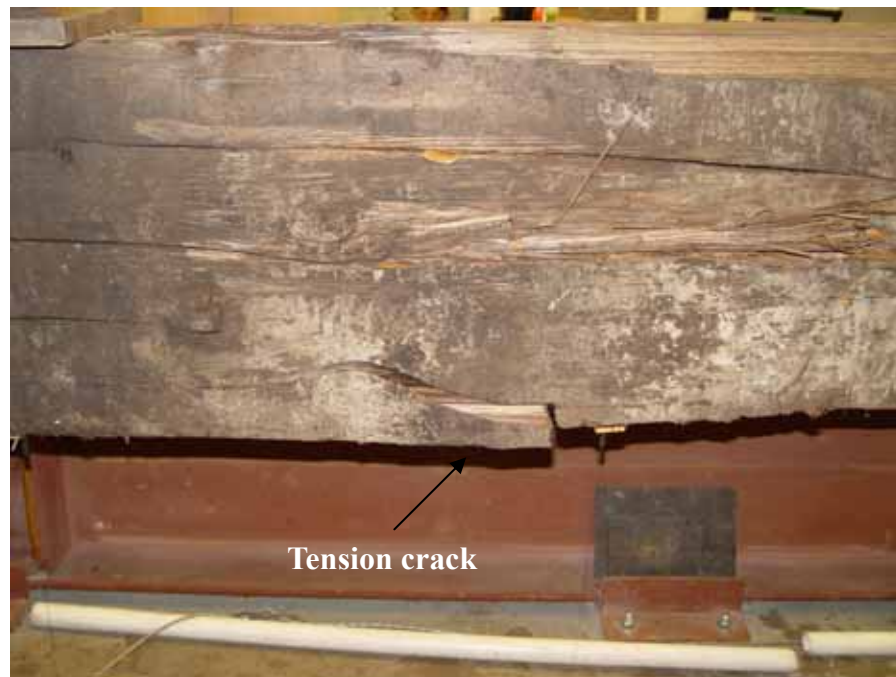
Horizontal sliding was observed at the support faces as the load increased, since stringer C6 had horizontal end splits prior to testing. The initial slope of the load-deflection curve for stringer C6, as shown in Figure 77, was linear until the timber cracked in tension at a load of 53 kN (12 kips). The stiffness in this portion was due to the sliding friction between the two sides of the horizontal splits. A tension crack formed at failure and is shown in Figure 78. At the ultimate load, the stringer reached the unstrengthened postfailure capacity, and then underwent additional deflection without any increase in load. The experiment was terminated when the postfailure capacity was reached.

Figure 78. Tension crack at failure for stringer C6.

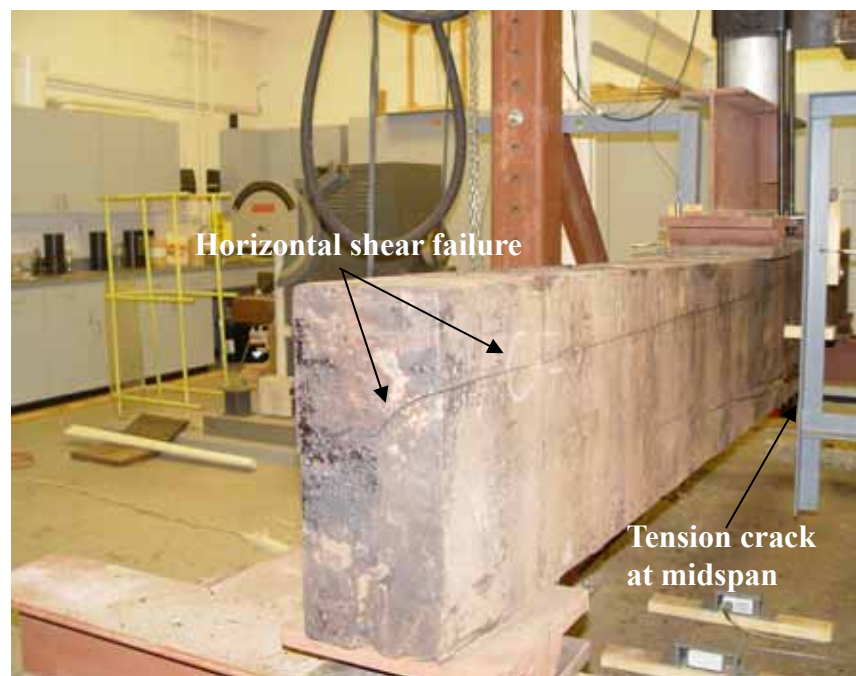
The initial slope of the load-deflection curve for stringer C7 is shown in Figure 79. It was linear until the timber cracked in tension at 222 kN (50 kips), causing a small drop in the load capacity to 214 kN (48 kips). As the load increased to failure, the stringer failed in horizontal shear, as shown in Figure 80. The ultimate load at failure was 227 kN (51 kips) at a displacement of 33 mm (1.29 in.). The unstrengthened postfailure capacity was 89 kN (20 kips).

Figure 80. Horizontal shear failure and tension crack on stringer C7.

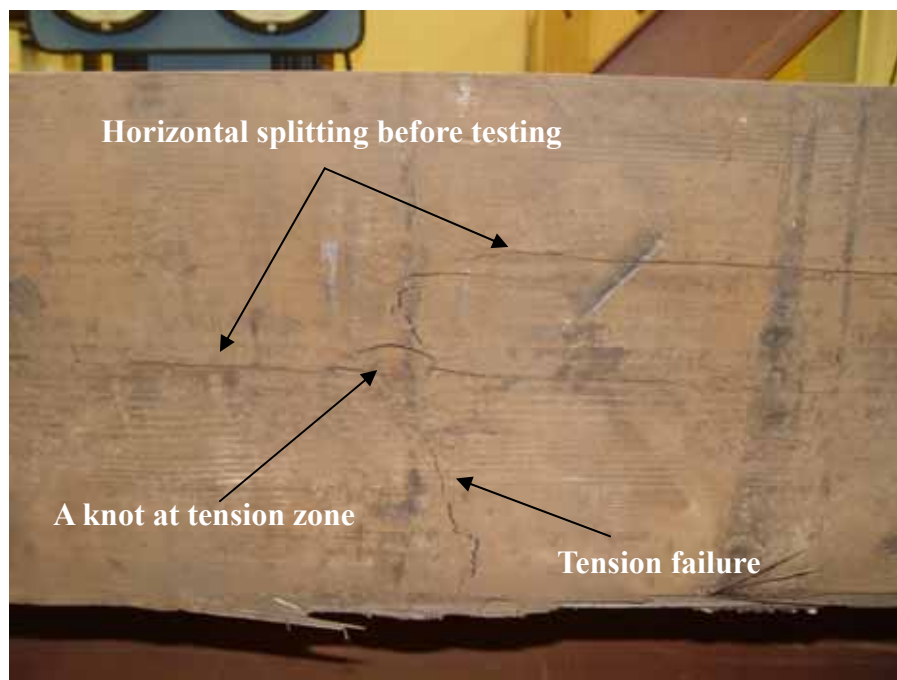
Failure was caused in stringer C8 by a tension crack initiated by a knot. The ultimate load at failure was 9 kN (2 kips), and the midspan deflection was 6 mm (0.24 in.), as shown in Figure 81. As it was explained in Chapter 2, “Literature review, Structural behavior of timber, Natural defects in wood,” the ultimate strength of the stringer was reduced due to the presence of knots. These knots are shown in Figure 82.

Figure 82. Tension failure initiated by a knot on stringer C8.

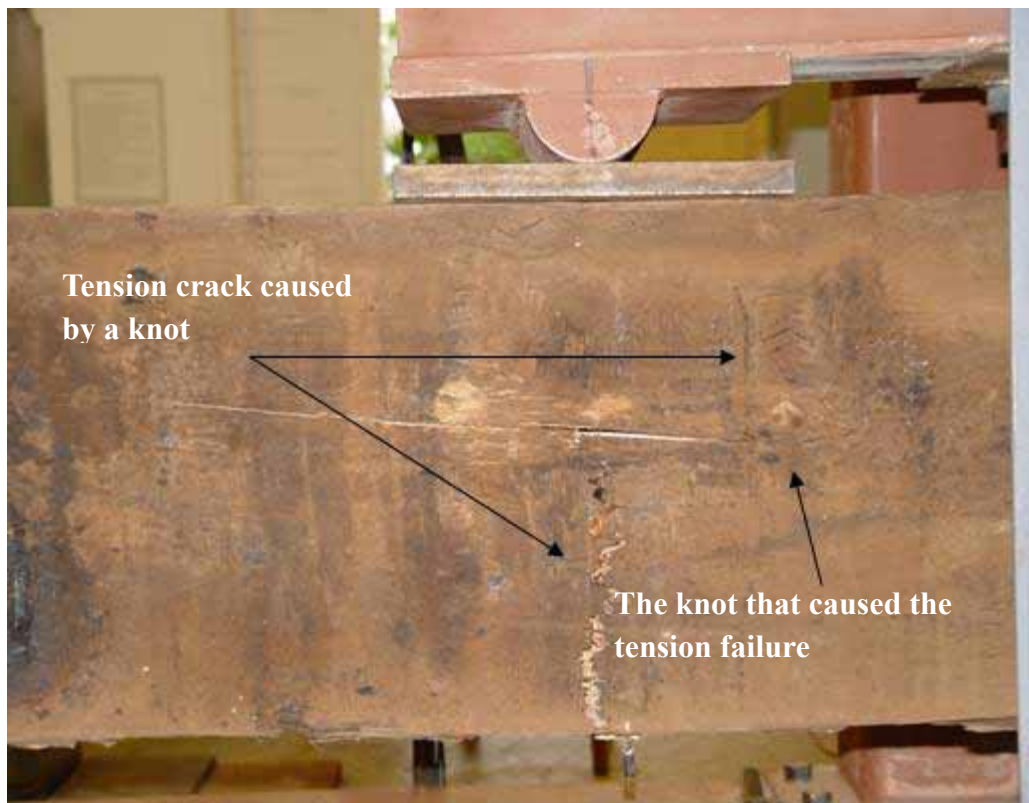
Figure 84. Tension failure caused by a knot on stringer C9.

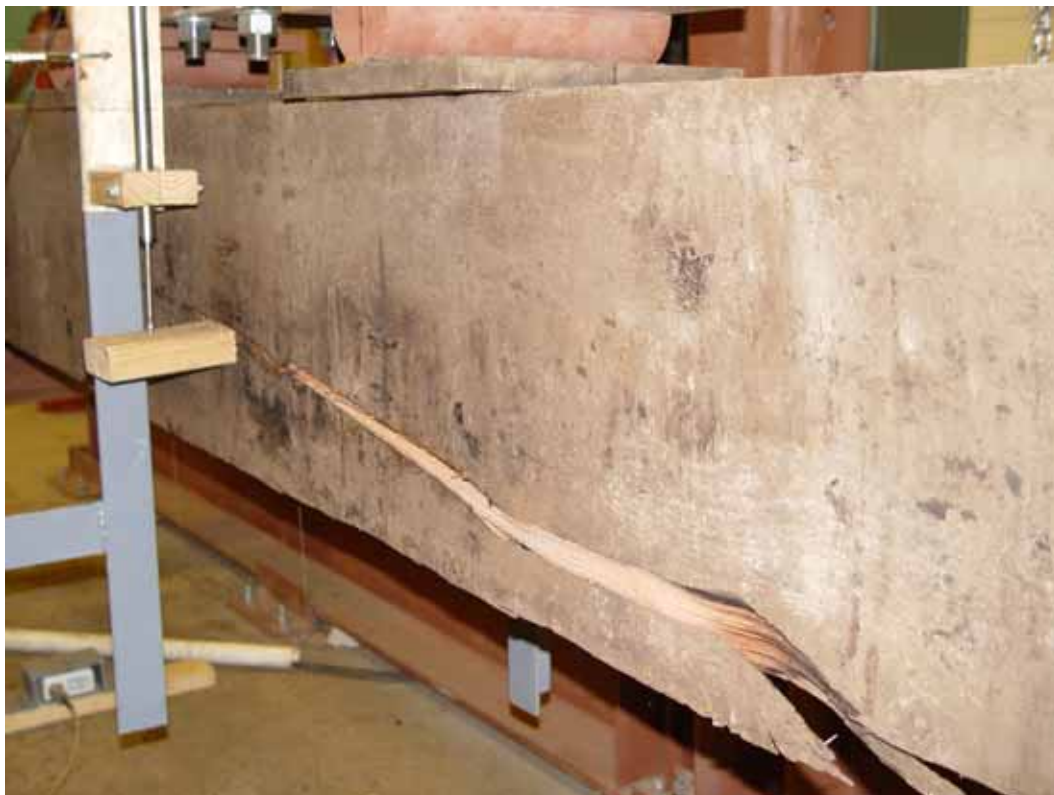
Figure 88. Cross-grain tension failure on stringer C12.

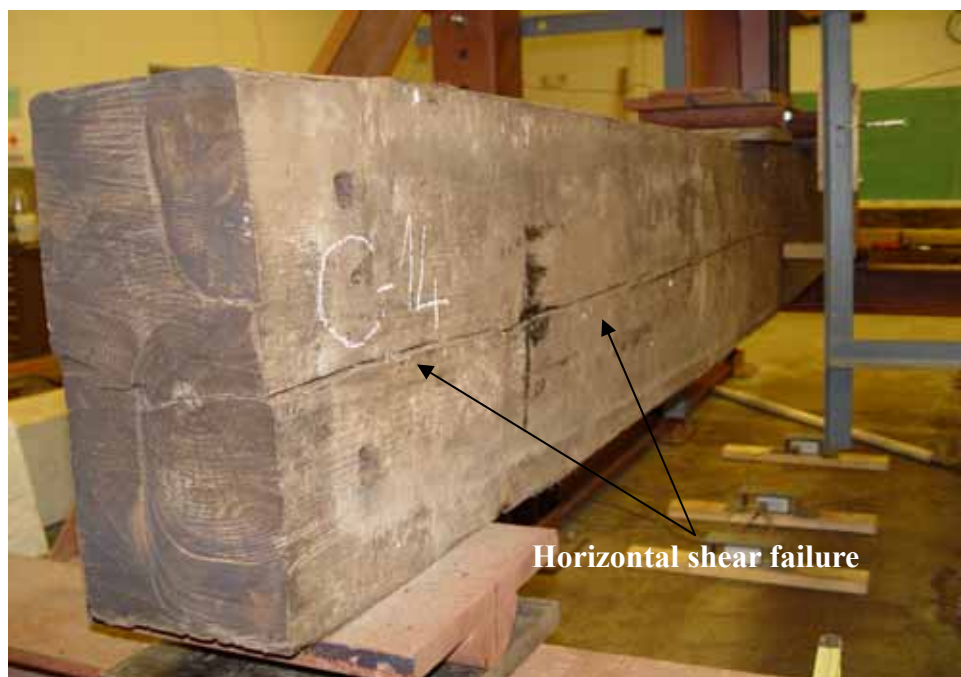
Figure 91. Horizontal shear failure on stringer C14.

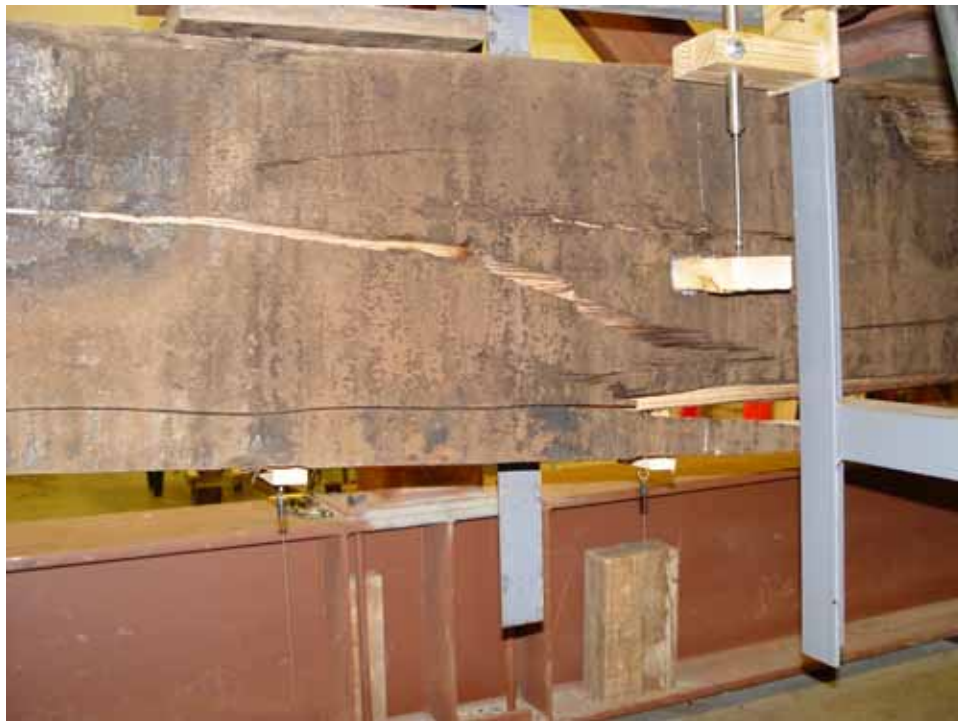
Figure 101. Cross-grain tension failure and tension splinters at the midspan on stringer C4-R.

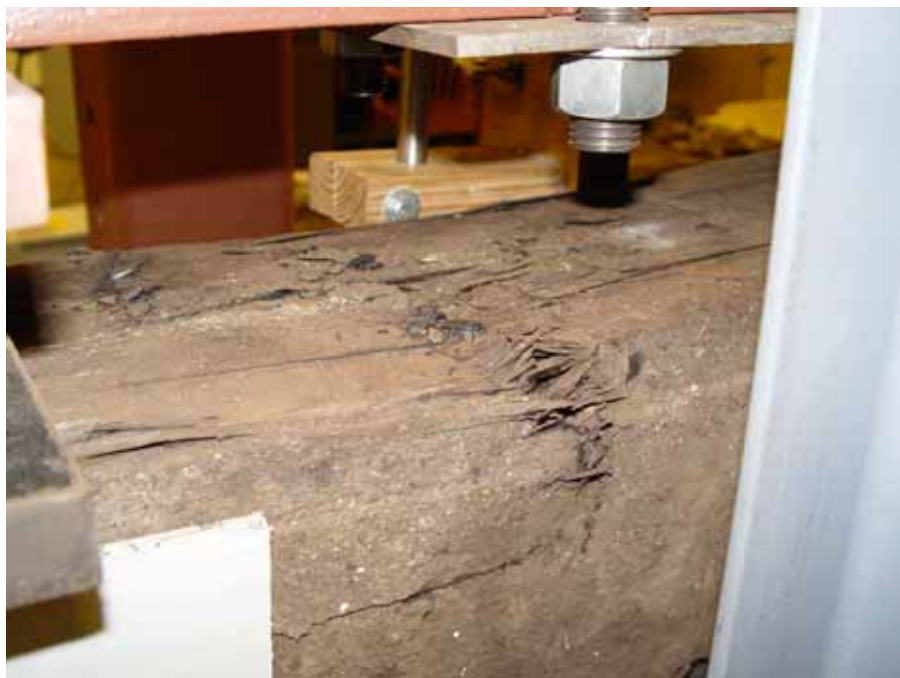
Figure 111. Compression failures due to excessive deformations on stringer C14-R.

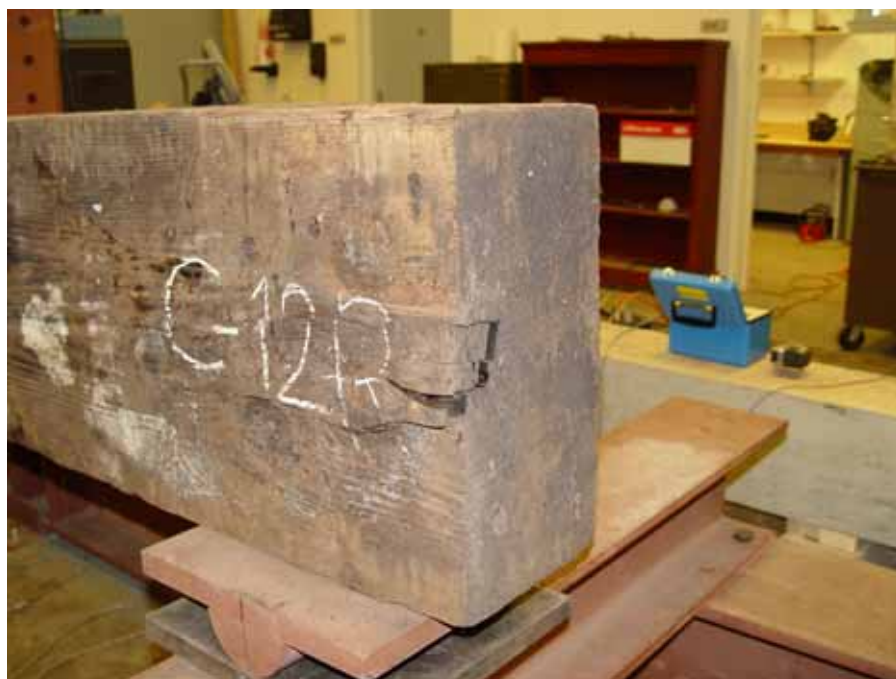
Figure 115. Horizontal shear crack after the failure of stringer C12-R.
