Metallurgical Analysis of Railgun Material

Khershed P. Cooper¹, Harry N. Jones¹ and Robert A. Meger²

¹Materials Science and Technology Division, ²Plasma Physics Division
Naval Research Laboratory, 4555 Overlook Ave., SW, Washington, DC 20375, USA

Abstract— The effect of number of shots on multiple launch railgun barrel material performance under significantly high current conditions was studied. Metallurgical analysis was conducted on rail samples from four sets of experiments involving increasing number of shots. Cross-sections of samples from two locations in the copper rail were examined using a variety of metallographic techniques. During each shot a thin film of molten aluminum from the armature deposited on the rail surface. The deposit became thicker and multi-layered with increasing number of shots and was consistently thicker in the bottom half of the vertically oriented rails than in the top half. Preferential removal of material occurred along the rail edges, which resulted in grooving over the length of the rails. Grooves were consistently deeper near the top edge of the rails compared to the bottom edge. A proposed mechanism for grooving is dissolution of the rail m

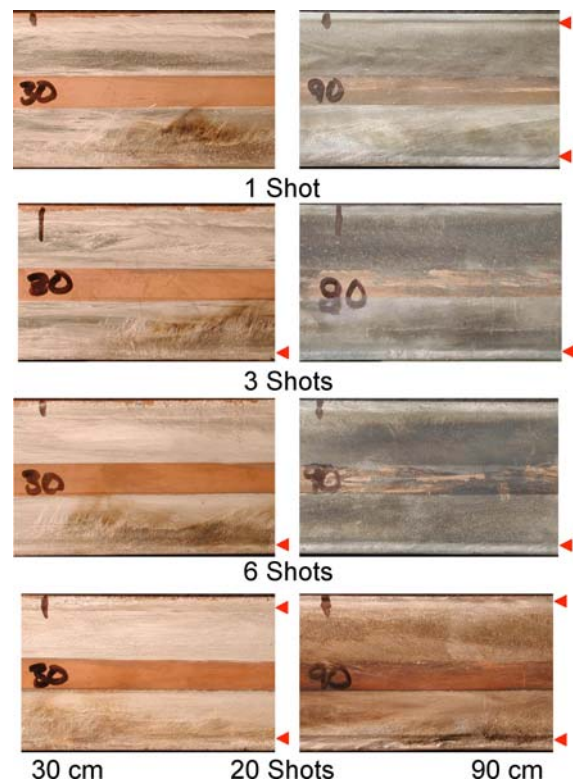
Fig. 1. Photographs of 30-36 cm and 90-96 cm copper rail sections showing appearance of rail surfaces. Arrowheads point to grooves near rail edges. (In these pictures, the armature is moving from left to right and the top edge of the rail is at the bottom.)

surface on either side for a bare central track. Flow patterns on the deposit show that the liquid film flow direction is from rail edge to rail interior. Some of the aluminum also appears to have flowed over the rail edges. In most sections, grooves (marked by arrowheads) are visible close to both rail edges. Grooving is localized removal or “erosion” of material from the rail surface and usually spans the length of the rail.

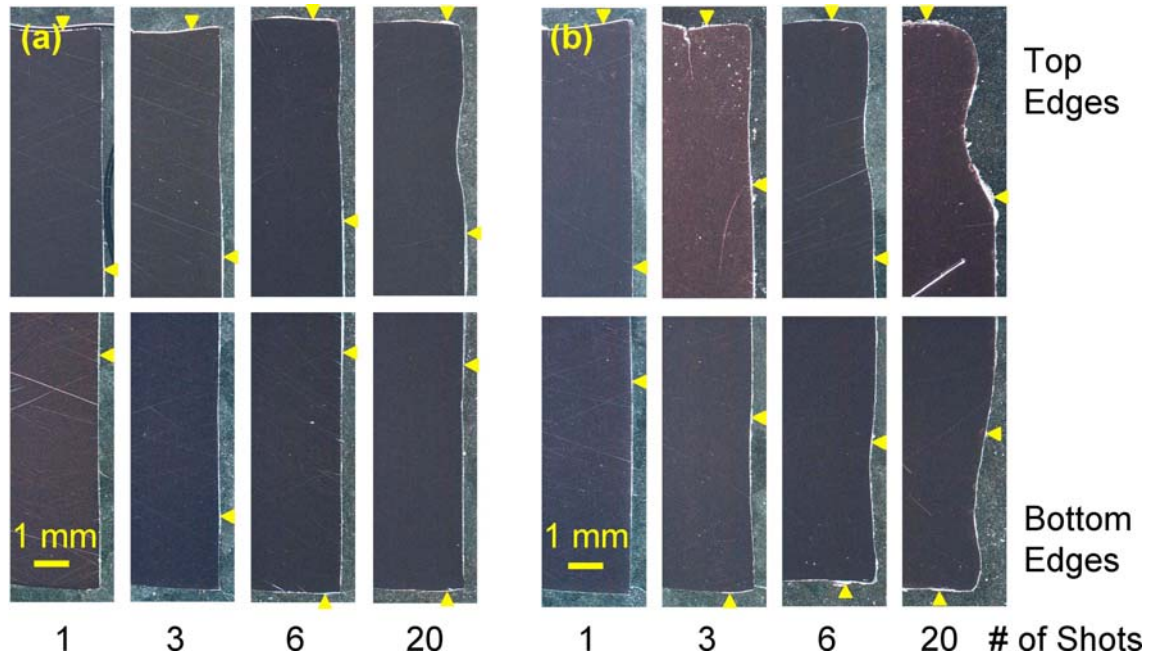
Fig. 2. Optical photomicrographs (Mag=20x) showing cross-sections near the top and bottom edges of the rails as a function of number of shots. (a) 36 cm sections. (b) 94 cm sections.

Optical photomicrographs of cross-sections near both rail edges are shown in Fig. 2. The thin silvery film (marked by arrowheads) along the edges of the cross-sections is the thin aluminum deposit. Using the relatively flat middle section of the rail surface as a reference point, groove depths were measured and the results are plotted in Fig. 3. Linear increasing trends in groove depth with increase in number of shots are evident. Grooves are 4 to 6 times deeper in the 94 cm samples than in the 36 cm samples. They are 1.5 to 2 times deeper in the top edge of both sets of samples than in the bottom edge. In the 94 cm samples, the increase in groove depth is proportional to the increase in number of shots, i.e., doubling the number of shots doubles groove depth. In the 36 cm samples, the increase in groove depth is not proportional to the increase in number of shots, i.e., doubling the number of shots increases the groove depth by less, 1.33 times. Using the deepest point in the groove, its location was measured from the rail edge and the results are

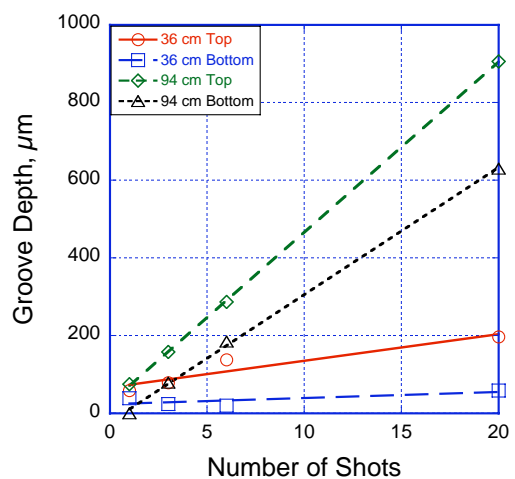
Fig. 3. Graph showing plots of groove depth as a function of number of shots.

Measurements show that doubling the number of shots doubles groove depth in the 94 cm samples, which is a strong cumulative effect. The same is not true for the 36 cm samples probably due to the transient nature of the grooving process early in the shot. There is variability in the groove position relative to rail edge from top to bottom of the rails and from the 36 cm section to the 94 cm section. This may be due to variability in armature starting positions, uneven armature deterioration or asymmetry in contact. The observed asymmetry in deposit thickness and groove depth across the rails is most likely a result of uneven gap formation between the armature and rail. It is well known that due to magnetic interactions with the steel support structure, there is an imbalance in forces and the armature tends to ride higher or closer to the top edge of the rail. This is confirmed by measurements of groove positions at 36 cm, which show that the top groove is closer to the edge and the bottom groove is farther from the edge.

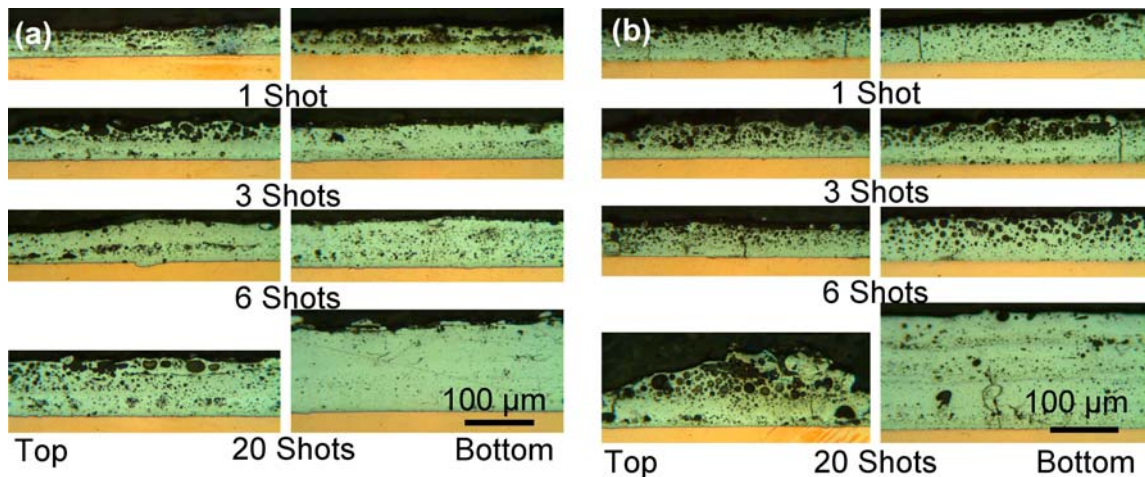
Fig. 4. Optical micrographs showing cross-sectional view of aluminum deposit in top and bottom halves of the copper rails as a function of number of shots. (a) 36 cm sections. (b) 94 cm sections.

Optical micrographs showing aluminum deposit thickness and multi-layering are given in Fig. 4. Multi-layers are defined by distinct interfaces. Micrographs are from the thickest portion in the deposit, which was typically halfway between the rail edge and rail axis. The thickness of the deposit and number of layers increase with increase in number of shots. However, the number of observed layers are much less than the number of shots. The deposit is thicker in the bottom half of the rails than in the top half. The average thickness of the deposit was measured and results are plotted in Fig. 5(a). Linear increasing trends between deposit thickness and number of shots are observed. However, the increase in thickness is not proportional to number of shots, i.e., doubling the number of shots increases thickness by 1.25 to 1.60 times. Also, thickness increases at a greater rate in the bottom half compared to the top half of both sets of

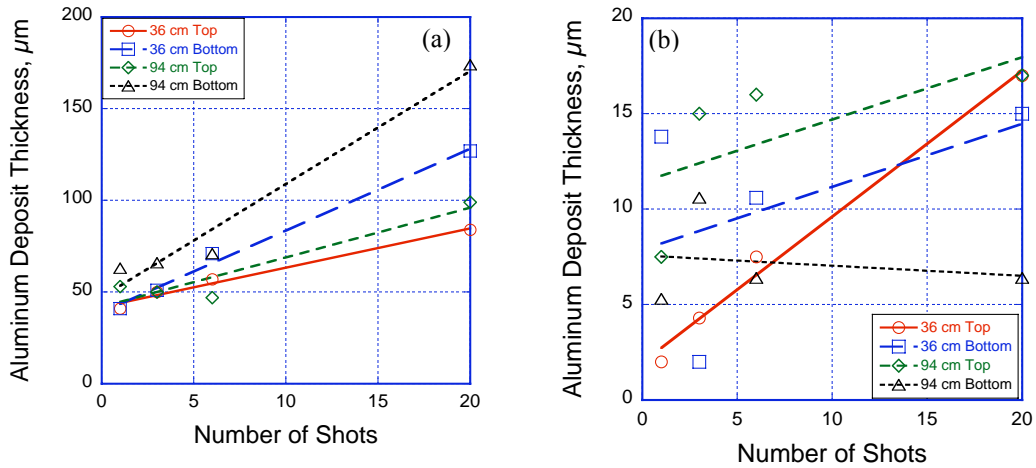
samples. The thickness of the residual deposit in the groove was also measured and the results are plotted in Fig. 5(b). The groove deposit is thin, varying from 2 and 17 μm . Except for the linear trend in the 36 cm top sections, the rest of the data shows random scatter and a lack of any trend in the groove deposit thickness with number of shots.

Fig. 5. Graphs showing plots of aluminum deposit thickness as a function of number of shots. (a) Thickest portion of deposit. (b) Deposit in groove.

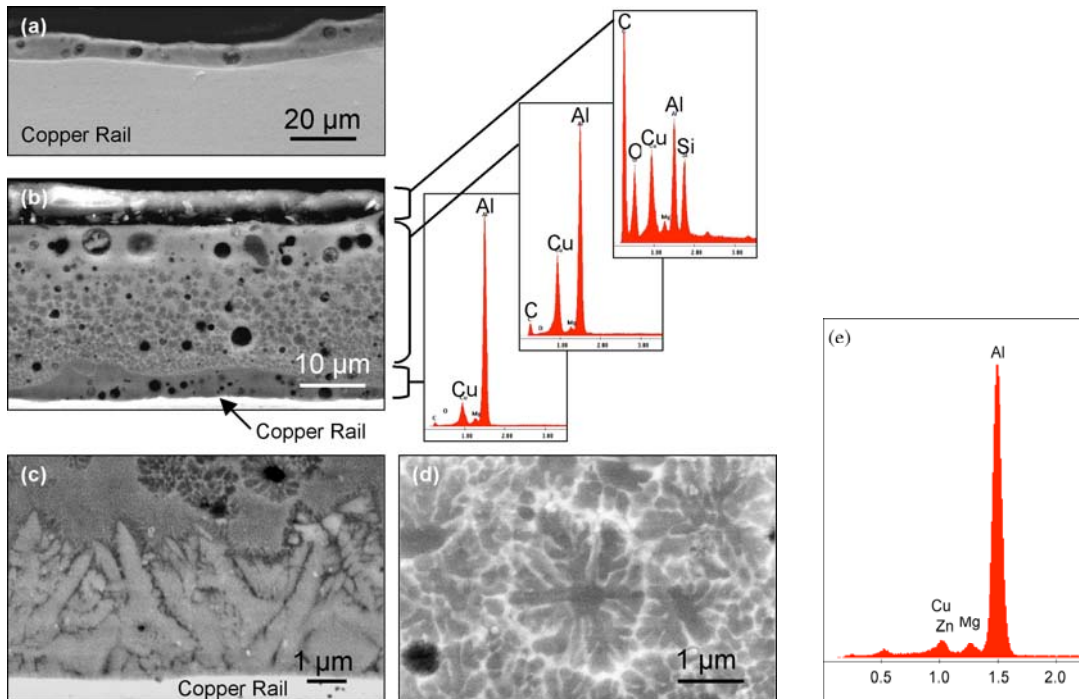
Fig. 6. SEM micrographs of deposit in the top half of 1-shot 36 cm rail sample. (a) Deposit in groove. (b) Multi-layer deposit in thick portion with EDS spectra of each layer. (c) Rail-deposit interface showing Cu-rich dendrites. (d) Cellular-dendritic microstructure in deposit. (e) EDS spectrum of 7075 aluminum armature reproduced for comparison.

SEM micrographs of the deposit in the groove and thick portions in the top half of the 1-shot and 20-shot 36 cm rail samples are given in Figs. 6 and 7, respectively. The groove deposits, shown in Figs. 6(a) and 7(a), are porous and single layer. The deposits in the thick portion, shown in Figs. 6(b) and 7(b), are also porous, but multi-layer. EDS spectra of the deposit in Fig. 6(b) show that in the multi-layer deposit, the layer closest to the rail has less copper than the layer above it. For comparison, the EDS spectrum of the 7075-Al armature is shown in Fig. 6(e), which shows very little copper. Hence, the copper reflections in the deposit spectra can only be due to alloying of the deposit with copper from the rail. The topmost layer in Fig. 6(b) is carbon-rich, which may be condensation of burnt organic byproducts. In the 1-shot sample, the rail-deposit interface, Fig. 6(c), shows copper-rich dendrites growing into the deposit. A high magnification view, Fig. 6(d), of the middle layer in Fig. 6(b) shows a microstructure of Al-rich cellular-dendrites and inter-cellular Al_2Cu . In the 20-shot sample, all three layers in the deposit, Fig. 7(b), have cellular-dendritic microstructures, but of varying scale. With large pores and fine microstructure, the topmost layer is very similar in appearance to the deposit in the groove.

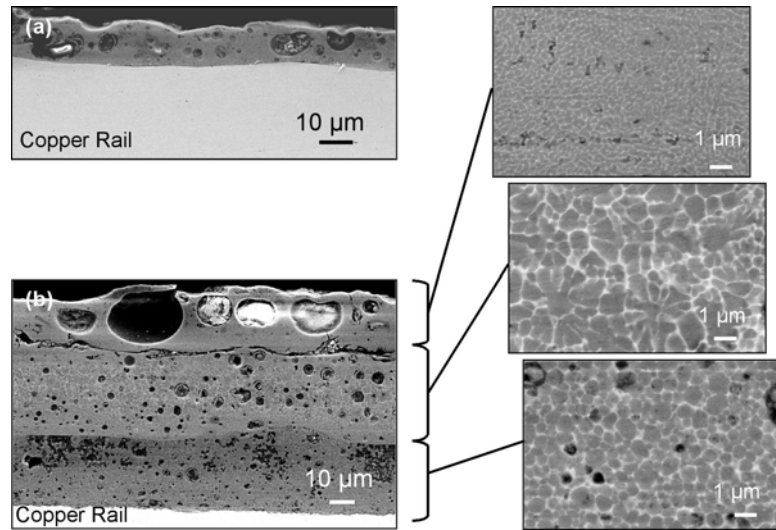
Fig. 7. SEM micrographs of deposit in the top half of 20-shot 36 cm rail sample. (a) Deposit in groove. (b) Multi-layer deposit in thick portion with microstructural detail in each layer.

Multiple shots in the 20-shot 36 cm sample result in multi-layering in the deposit. The differences in microstructural scale between layers are due to differences in solidification rates. The topmost layer has the finest microstructure and must have quenched most rapidly, the middle layer may have coarsened due to reheating. The observed two aluminum-rich layers in the 1-shot 36 cm sample are obviously not due to multiple shots. From the wavy nature of the layer closest to the rail surface and the fact that the two layers have different copper contents, it is likely that overlapping fluid flow patterns in the wake of the single shot may have occurred and resulted in the two apparent layers. The second layer is richer in copper and may have been dragged in from the groove region. The observations point to a rather complex fluid flow mechanism in railgun operation involving partial melting of the armature. The exact nature of film flow due to aerodynamic drag and surface tension effects in railguns needs to be determined and better understood.

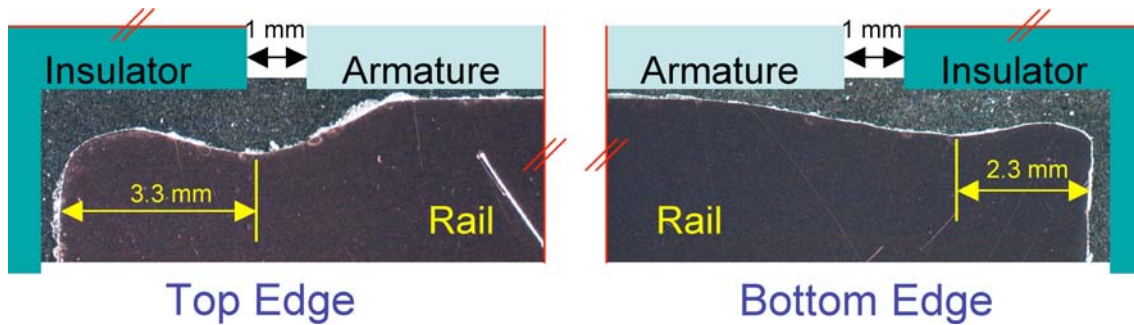
Dissolution of the copper into molten aluminum takes place as evidenced by alloying of the aluminum deposit with copper. While there is some dissolution of copper from portions of the rail adjacent to the grooves as evidenced by copper-rich dendrites at the rail-deposit interface, the most severe dissolution occurs near the rail edges where the grooves form. If one considers the measured location of the grooves and armature dimensions, most of the groove is outside the "footprint" of the armature as shown in Fig. 8. Hence, there is very little metal-to-metal contact in the groove

region, especially once the armature edges have started to erode away downstream. Plus, there is a liquid metal film, which acts as a lubricant and minimizes friction and wear. Thus the grooving cannot be related to mechanical or erosive wear from friction between the armature and rail. There may be localized scouring of the copper rail due to the presence of hard particles such as oxides in the liquid metal film, but no gross wear features of the magnitude of the grooves were observed anywhere else on the rail surface, especially where the armature was in contact with the rail.

Fig. 8. Positions of armature and insulator with respect to rail edges in 20-shot, 94 cm copper rail.
