Operational Evaluation Test Report on Beaver Micro-Vegetation Cutter

April 2005

Institute for Defense Analyses
4850 Mark Center Drive
Alexandria, VA 22311-1882

**Operational Evaluation Test Report
on
Micro-Vegetation Cutter**

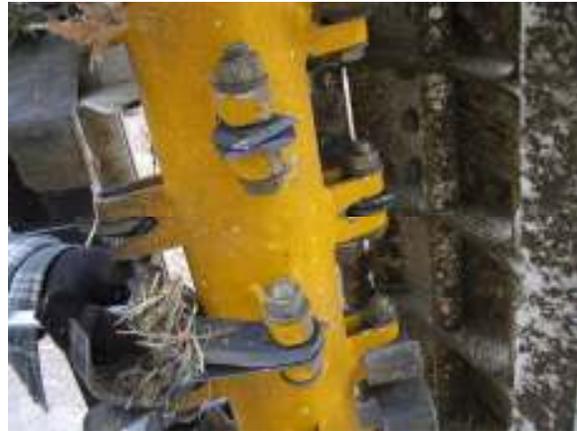
Figure 4: Broken Pre-Test Cutters

- The cutters were notched when they hit the inside bottom edge of the U-shaped cutter mounts. The notch propagated cracks and broke the cutters. The solution was to grind off the sharp shoulder on the U-shaped mount.
- Seven cutters were broken. The time to replace all seven of the cutters was 15 minutes.
- There was a delay between the operator command and the response of the MVC or the cutter. This led to over-control input from the operator. The solution was to adjust the SRCS to shorten the signal-response time.
- The operator had to keep the cutter in the line of sight to know the relation of the cutter to the ground.

- The engine clock for the MVC read 9.8 hours at the start of the day.
- The clearing of the slope continued. During the clearing process, eight cutters broke and one cutter cracked. This issue was resolved by replacing the damaged cutters with new cutters.

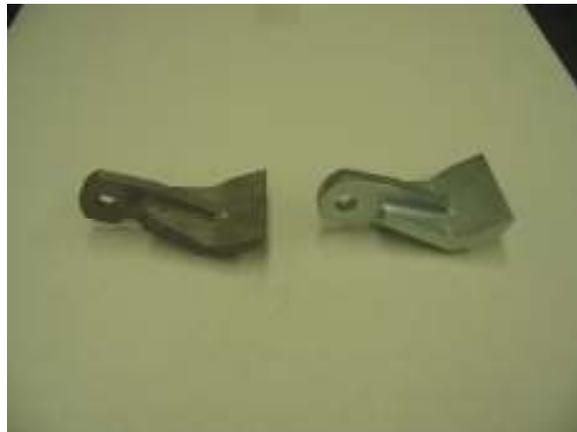
Figure 6: Machined and Cast Operational Evaluation Cutters

operational evaluation test (wt. = 634 grams); and Figure 6 shows the machined cutter (left) and the 4130 heat-treated cast alloy cutter (right) that will be used on future fabricated vegetation cutters (wt. = 756 grams). The weights and materials are shown for each of the cutters as an indicator of each cutter's strength and durability.

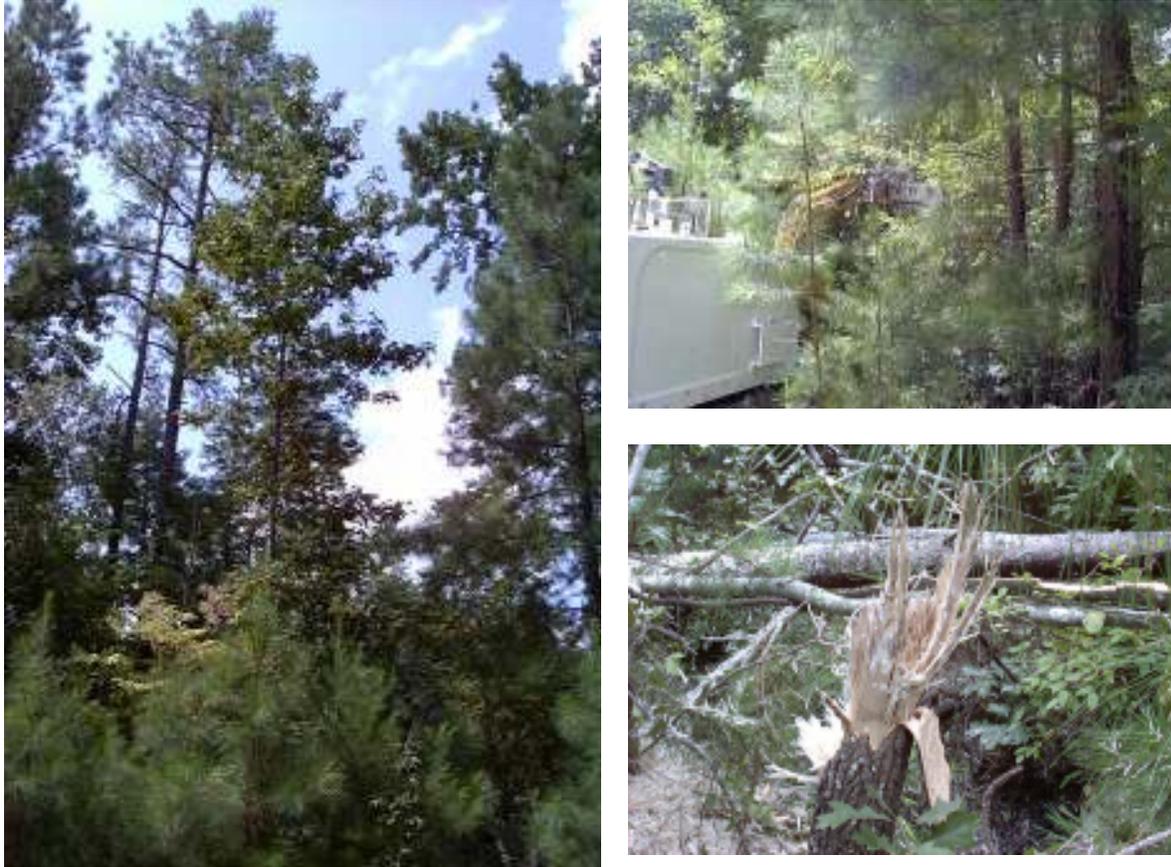
Figure 17: Tree to be Cut (left), Cutting (top right), Stump (bottom right)

A Category 4 deciduous, maple variety tree, 12 to 14 meters high and 15.4 cm in diameter, was selected for the Category 4 cutter operational evaluation test. The procedure followed with this tree was slightly different than followed with the two smaller trees in the Category 2 and 3 test. The tree was topped by cutting through the tree with the cutter at a height of 3–4 meters. The top fell behind the tree and the portion of the trunk left standing was then chewed down to ground level. Total time for this operation was 10 minutes. See Figure 17.

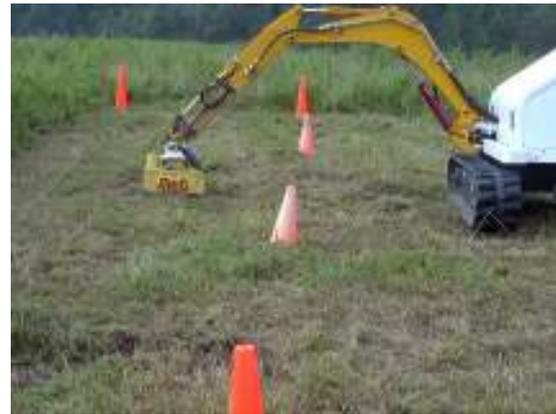
Figure 19: Magnet Sweep

To test the effectiveness of the magnet, seven various pieces of the scrap were selected and placed on a flat area of ground. The magnet was raised above the scrap, turned on, and slowly lowered until the first piece of scrap was picked up. The distance was measured. The lowering of the magnet was continued until all pieces were picked up, with measurements being made as each piece was pulled to the magnet. The test was run twice. The results are presented in Table 6. The difference in pickup height for the same object in the two trials is attributed to the attitude of the electromagnet presenting a changed magnetic field. Figure 19.

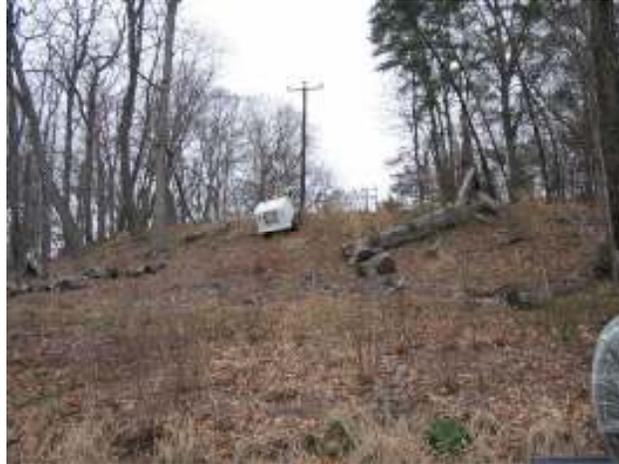
Figure 20: Off-Road Mobility

The off-road mobility test for the Beaver was conducted in three different areas in order to provide a satisfactory range of terrain environments. See Figure 20. One was a watershed track through a hilly, wooded expanse of the military reservation housing the test site. The most critical parts of the test were the ingress and egress. Once into the track, which was rough and gullied from rainwater runoff, neither the Beaver nor the Duck vehicles encountered any operating problems. The maximum slope encountered by the Beaver in entering and departing the run-off gully, which consisted of a mix of raw clay and sand, did not exceed 27 degrees. On a vegetation and mulch-covered slope, the Beaver climbed and descended slopes up to 32.5 degrees. During the vegetation cutting on a hillside, the maximum side slope traversed by the Beaver was 24.5 degrees.

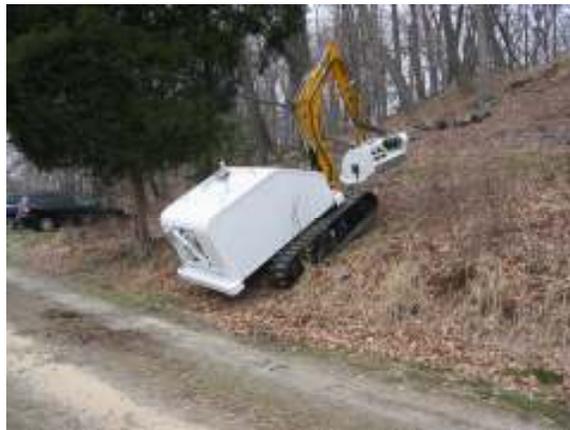
Figure 21: Angle of Approach/Departure

This test was only conducted with the Beaver. The surface cover for the slope climbed was loose soil and gravel intermittently covered with leaf mulch, sparse grass, and low shrubs. The approach and departure angle negotiated, without losing traction, was 32.5 degrees. The Beaver continued to climb the hill, with subsequent grades up to 28 degrees, to a height of about 60 feet without any problems. See Figure 21.

- Hydraulic reservoir filler cap leaked oil in angle of approach and departure test. It is recommended that a redesign be considered.
- The gap at the top of the Duck's front windscreen allows dust to blow in and into the operator's face.

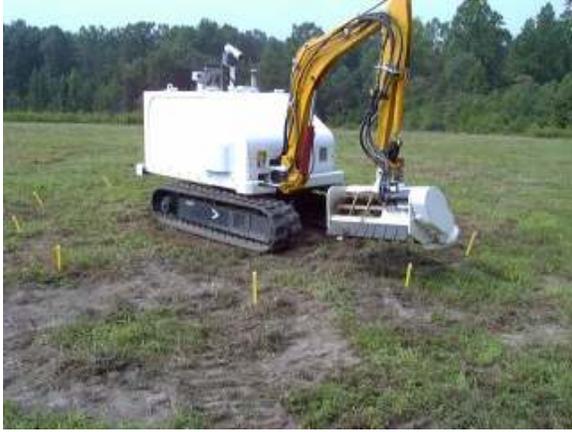
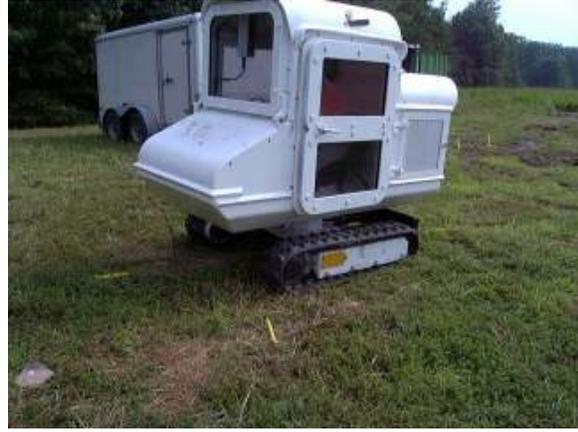
Since both vehicles are tracked vehicles, the minimum turning radius will be that achieved by pivoting in a “zero-radius turn,” that is, turning by having one track move forward while the other track moves backwards. By so doing, a tracked vehicle will turn on a point midway between the vehicle’s track system. The minimum turning radius measured for the Beaver was 16.25 feet (4.96 meters) and for the Duck was 8.8 feet (2.69 meters). See Figures 22 and 23.
