Technical Findings, Lessons Learned, and Recommendations Resulting from the Helios Prototype Vehicle Mishap

NASA Langley Research Center
Hampton, VA 23681
USA

The Helios Prototype was originally planned to be two separate vehicles, but because of resource limitations only one vehicle was developed to demonstrate two missions. The vehicle consisted of two configurations, one for each mission. One configuration, designated HP01, was designed to operate at extremely high altitudes using batteries and high-efficiency solar cells spread across the upper surface of its 247-foot wingspan. On August 13, 2001, the HP01 configuration reached an altitude of 96,863 feet, a world record for sustained horizontal flight by a winged aircraft. The other configuration, designated HP03, was designed for long-duration flight. The plan was to use the solar cells to power the vehicle's electric motors and subsystems during the day and to use a modified commercial hydrogen-air fuel cell system for use during the night. The aircraft design used wing dihedral, engine power, elevator control surfaces, and a stability augmentation and control system to provide aerodynamic stability and control. At about 30

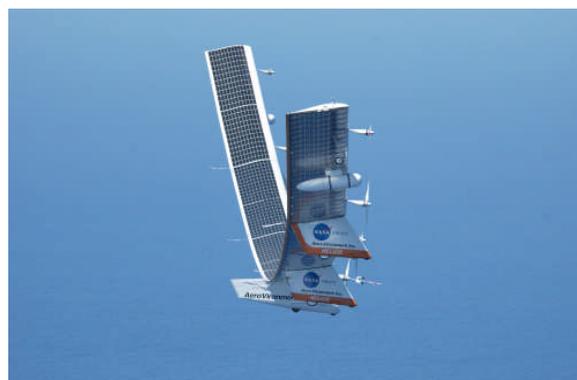
At 10:19am, the Stationary Pilot (SP), located in a trailer near the runway, noted that instrumentation and the aircraft were behaving as though it was in turbulence (noted later as the 1st encounter with turbulence). At 10:22am and again at 10:24am the aircraft again encounter some turbulence. The aircraft's wing dihedral became larger than normal and mild pitch oscillations occurred; the wing dihedral during both events returned to normal without any pilot inputs, and the oscillation damped out. These events both occurred during the time when the Stationary and Mobil crews were focused on the handoff procedure. Neither crew was aware of the high wing dihedral or the pitch oscillations. At 10:35am, at approximately 2,800 feet altitude, the aircraft began experiencing airspeed excursions of around ± 2 ft/sec. The persistent high wing dihedral (Figure 5) and the subsequent loss of pitch control, the aircraft became very unstable in a highly divergent pitch mode in which the airspeed excursions from the nominal flight speed about doubled every cycle of the oscillation. During the final nose down dive (approaching 90°) the aircraft exceeded the maximum allowable speed by over a factor of two. The resulting high dynamic pressures caused progressive failure of the wing leading edge secondary structure on the outer wing panels. Soon thereafter, the solar cells and skin on the upper surface of the wing began to rip off. These failures destroyed the aircraft's ability to generate lift and sustain flight; as a result, the aircraft fell into the ocean (Figure 6). The aircraft impacted the ocean within the confines of the PMRF test range and was destroyed.

Figure 5: HP03-2 with high wing dihedral

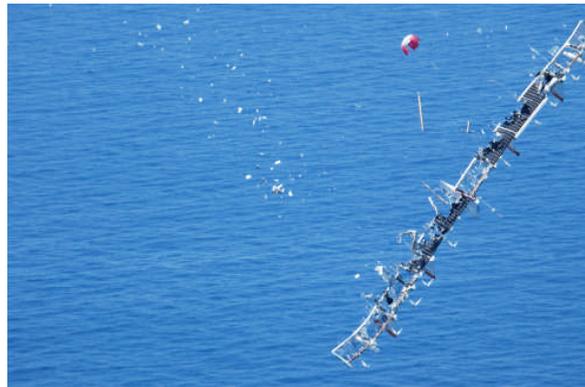
Figure 6: HP03-2 falling towards the Pacific Ocean

The aircraft impacted the ocean in mile-deep water 10 miles off the coast of Kauai. The vehicle structure including the main load carrying composite wing spars were severely damaged. The elapsed time from the first effort to diagnose and correct the high wing dihedral condition to the point at which the airplane began to break up in the air was 91 seconds. Figure 7 provides time histories of the aircraft's pitch rate and airspeed, and the wing dihedral for the 30-minute flight.

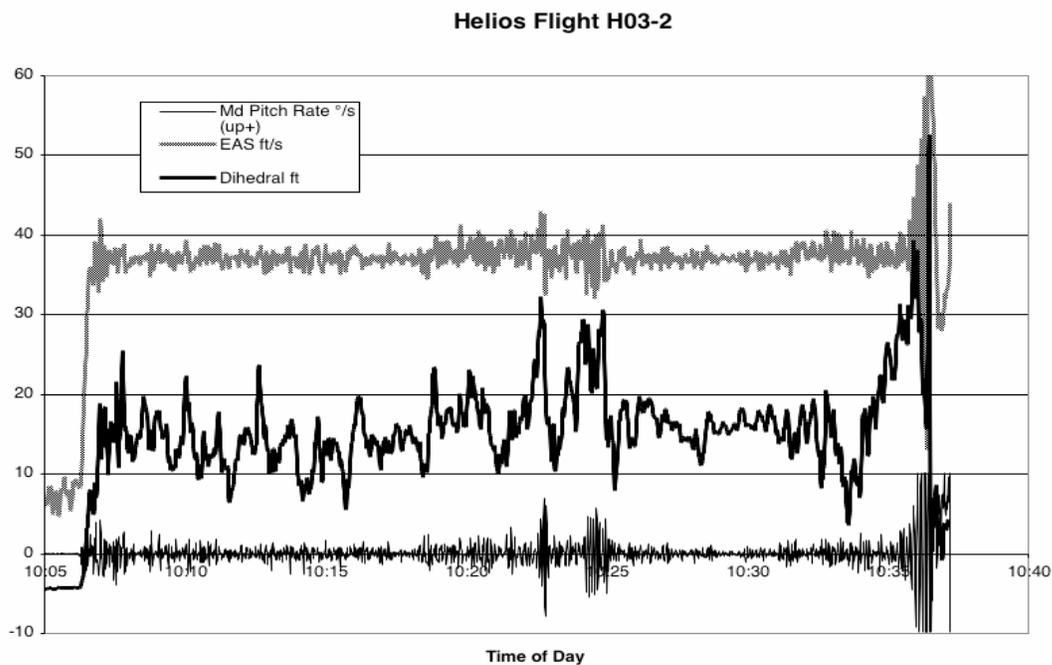
Figure 7: Wing dihedral, pitch rate, and airspeed history during mishap

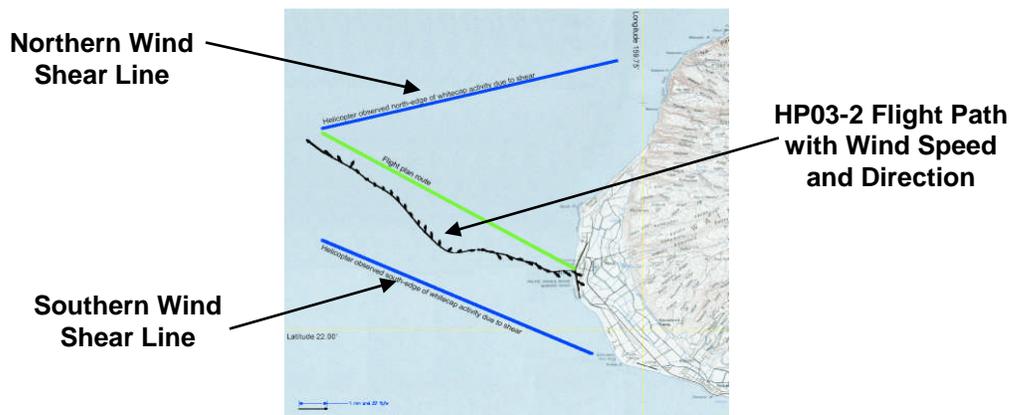
In earlier years the strategy on climb-out for the Helios vehicles was to avoid the shear lines until the airplane achieved sufficient altitude to get above the most significant turbulence. Aircraft measurements and flow simulations in the area of the mishap indicated that this altitude is about 4000 to 5000 feet. Because HP03-2 flew at a somewhat higher equivalent airspeed than previous solar-powered configurations without an increased rate of climb, the slope of the climb-out trajectory was lower than previous flights. This meant a longer flight trajectory over which the airplane was exposed to the greater turbulence at lower levels, and at the same time, trying to avoid the north and south shear lines (Figure 8). Regardless of these concerns, the weather conditions on July 26, 2003 were within the bounds required for performing flights from the PMRF.

Figure 8: Helicopter observed turbulence shear line

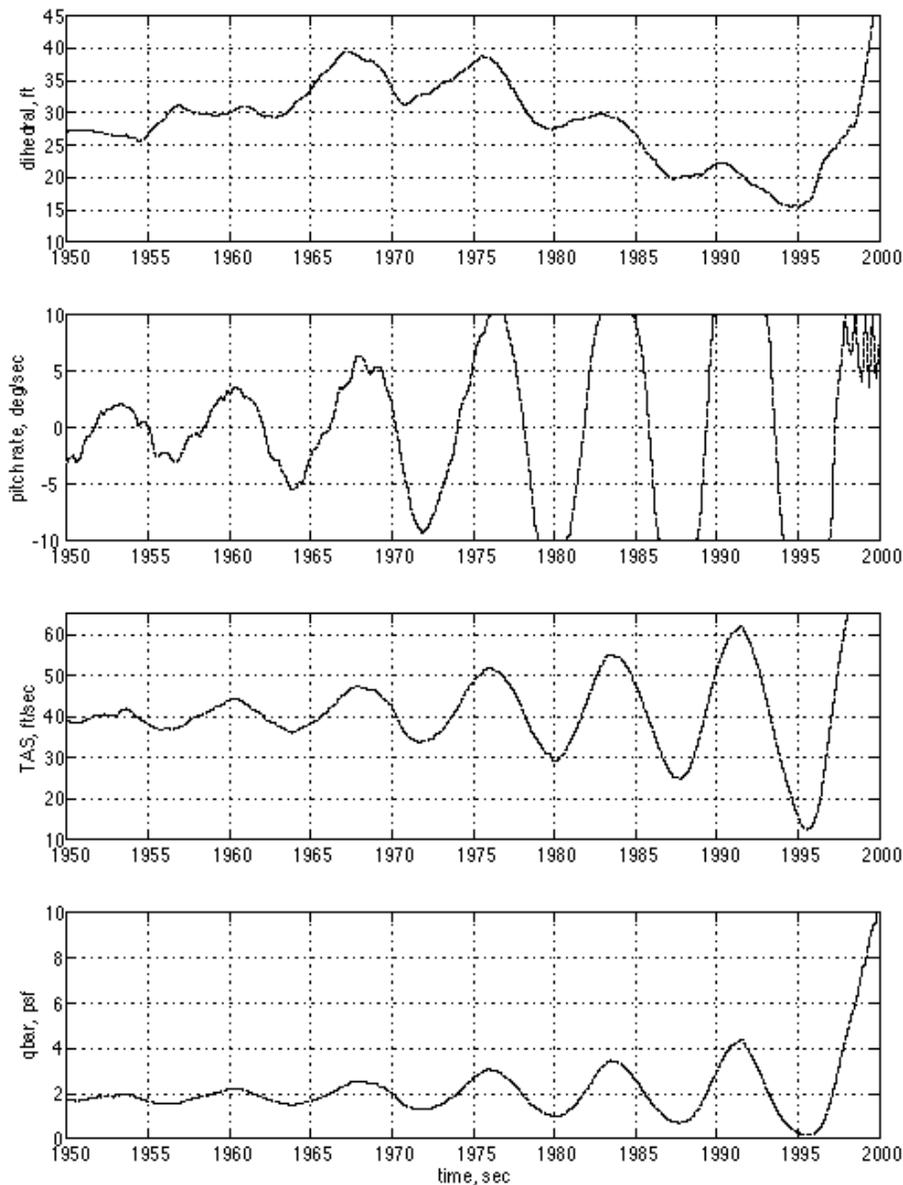
The 1st encounter with turbulence did not cause high wing dihedral. The next two encounters occurred in the space of three minutes. The aircraft developed high dihedral deflections of about 30 feet, began to oscillate in pitch, and then recovered on its own without pilot interaction. Since this type of pitch oscillation was a known flight dynamic characteristic of the Helios class of vehicles that had been predicted, observed, and controlled several times in prior flights with predecessor configurations, the MP and SP pilots and flight crews did not interpret the airspeed variations associated with the events as serious periodic oscillations, but rather as typical responses due to turbulence. On the 4th encounter with turbulence (Figure 9), the dihedral increased to an even higher magnitude of about 40 feet, and the pitch oscillation diverged rapidly.

Figure 9: Dihedral, pitch, vehicle airspeed, and dynamic pressure for mishap event

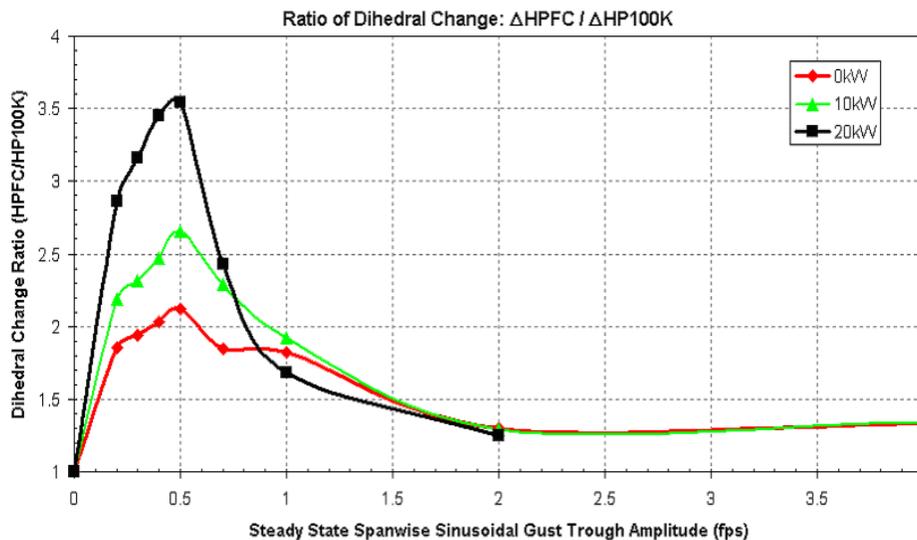
Turbulence Effects: In terms of the environmental effects, turbulence was determined to have initiated the high wing dihedral, however it was also determined the turbulence was not necessary to maintain it. Post mishap analysis revealed that spanwise lift redistribution (from the center of the aircraft to the outboard wing panels) was very sensitive to small amplitude gusts (Figure 10). It had been the experience of the Helios type aircraft that its dihedral varied as local airflow varied along the wingspan. Figure 11 provides a comparison of the wing spanwise lift distribution for the HP01 and HP03-2 aircraft configurations with a superimposed 0.5 ft/sec gust. For this study, it was assumed that the aircraft encountered a gust exhibiting a 0.5 ft/sec downward flow at the centerline and 0.5 ft/sec upward flow at the wing tips. Although the probability of the aircraft encountering such a gust is very low, the intent of the analysis was to show the sensitivity of the aircraft to gusts, even small gusts. The HP03-2 configuration has noticeably more lift outboard and less lift inboard. The increased lift outboard would be expected to lead to considerably increased dihedral. It is important to remember that the modeled sensitivity to local variations in sectional airflow is primarily a consequence of the aircraft's reactions to increasing dihedral, trailing edge up elevator, and wing tip leading edge twisting up, not the first-order effects of airflow change. The airflow variation is only the transitory force. It was determined that elevator response and the change in wing twist contributed to the wing's slow return to nominal dihedral conditions. In the absence of a gust that flattens the wing (for example, a momentary gust having relative downward air motion on the tips and upward near the airplane centerline), these aerodynamic effects slowed the return to nominal dihedral.

Figure 10: HP03-2 increased sensitivity to small gusts

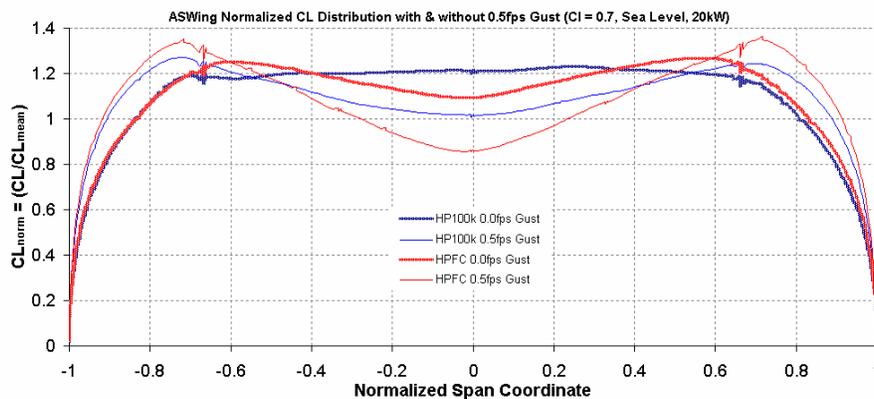
Figure 11: Variation of spanwise lift distribution with gust velocity

Aeroelastic and FCS Effects: It was determined that wing twist and lift loss due to elevator deflection, consequences of the aeroelastic characteristics of the aircraft and the FCS, contributed to causing the persistent high wing dihedral. It was also determined that the FCS's response and the wing's aeroelastic response to perturbations were found to not only increase wing dihedral, but also to sustain the dihedral. These two effects oppose the wing's return to lower, wing tip deflections. The FCS reacts to the wing dihedral increase by deflecting the elevators trailing edge up. The elevators on the outer 40 feet of each wing are fixed. For any control law command requiring an elevator trailing edge up response, more lift is lost in the center of the aircraft than at the wing tips.

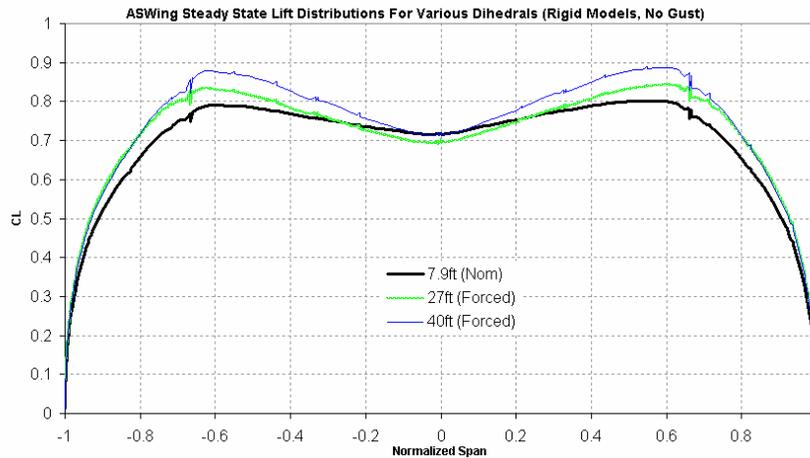
The quantification of the primary effects of dihedral on elevator position and twist is best illustrated by analyzing the spanwise lift distribution. For a given airspeed and motor power setting, the predicted spanwise distribution of lift is provided in Figure 12. The spanwise redistribution of lift from the center of the aircraft to more outboard panels is the primary cause of the unexpectedly slow return to lower dihedral after any perturbation.

Figure 12: Spanwise lift distribution for various wing dihedrals
