**FUEL SYSTEM DURABILITY—
U.S. COAST GUARD**

**INTERIM REPORT
TFLRF No. 393**

**U.S. Army TARDEC Fuels and Lubricants Research Facility
Southwest Research Institute® (SwRI®)
San Antonio, TX**

May 2008

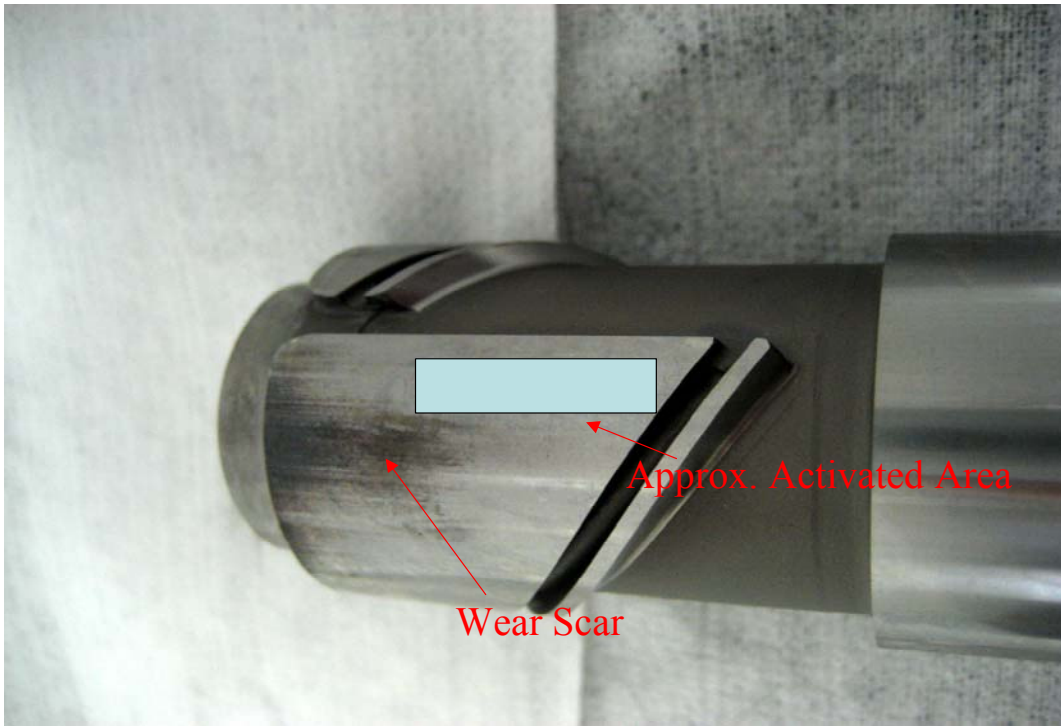
Upon examination of the plunger to check activity it was noted a polished wear scar (Figure 16) was forming on the plunger. However, the wear scar development appears to miss the activated area of the plunger. The wear scar had not been noted prior to the JP-5 operation. However there is not any documentation to specifically indicate the scar was solely due to JP-5 operation. The location of activation was in an area indicated by DUAP as a high wear area. A possible cause for the deviation from that area is the drive system will not steadily hold pump speed above a 3/4-rack position. The wear scar appears to correspond to a position that represents 3/4-rack. Options for testing include running at 3/4-rack as with the other fuels to see if the poor lubricity fuel will affect the plunger wear regardless of the rack position. The other option was to allow greater speed variability and operate as close to full-rack as possible.

Figure 16. Developing Plunger Polished Wear Scar

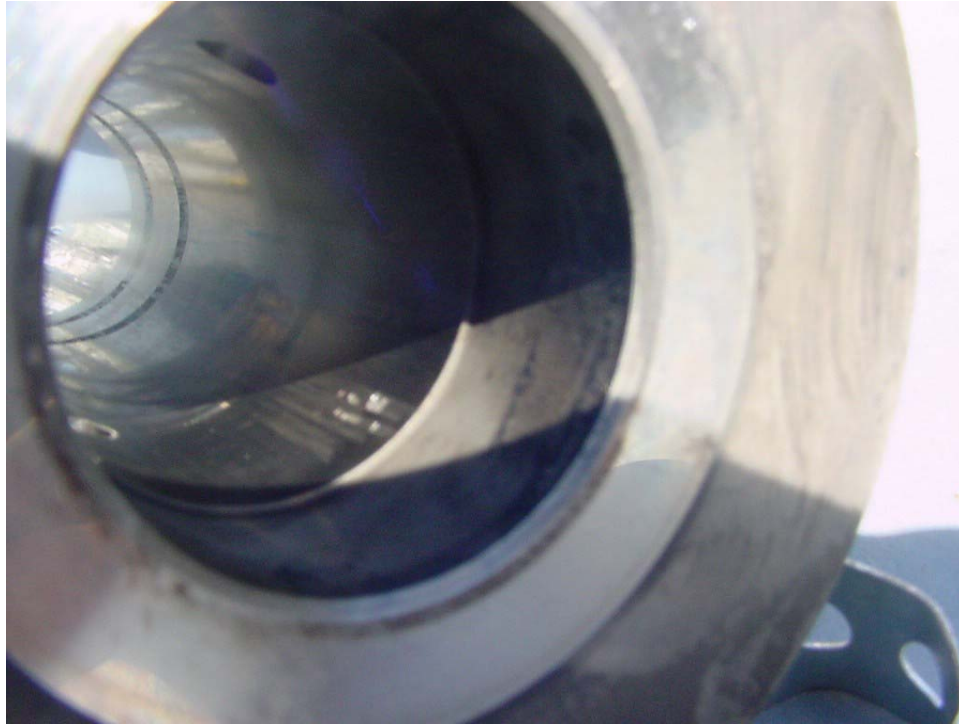
Figure 18. Wear Scars in Injection Pump Barrel

The remaining project efforts attempted to establish whether the damage seen on the barrel and plunger were due to the surrogate JP-5 fuel or due to another factor. The barrel and plunger were sectioned and examined closely to try to ascertain the cause of failure.

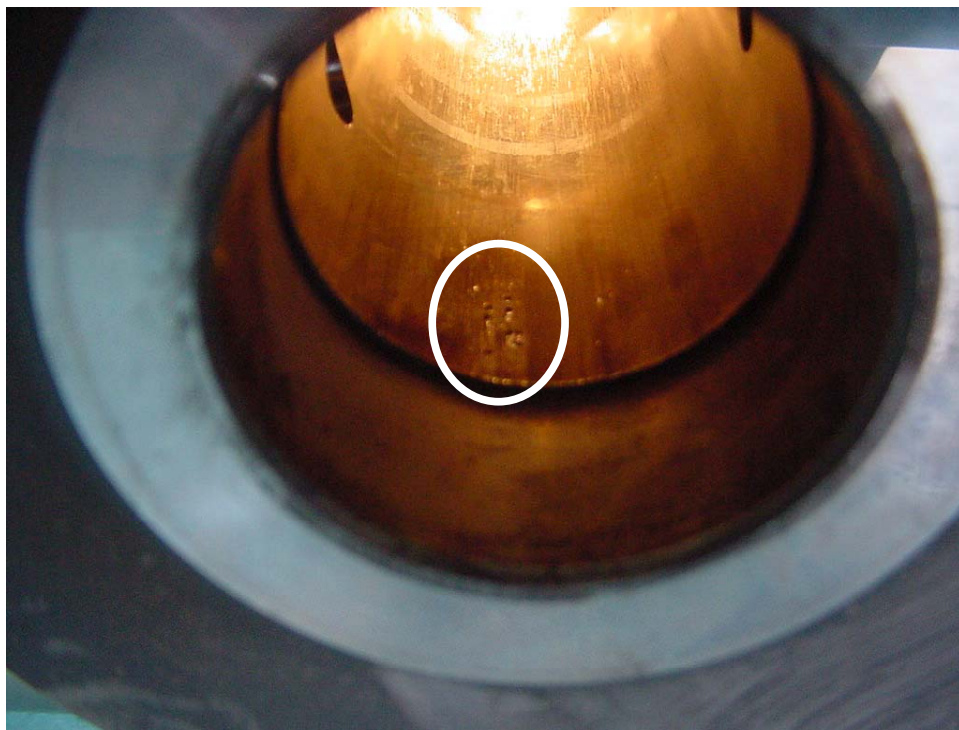
SwRI looked for references that concern the conditions for cavitation in fuel injection barrel and plungers as they relate to the operating conditions, fuel viscosity, and fuel volatility of the surrogate JP-5 test. Cavitation in fuel injection equipment results in pitting due to surface fatigue in a localized area. The backlighted view of the same area in Figure 21 make the pits stand out due to the shadowing. Also seen in the backlighted view are some annular wear patterns that may correspond with machined areas on the plunger.

Figure 21. Sulzer Barrel with Shadows Revealing Pitting

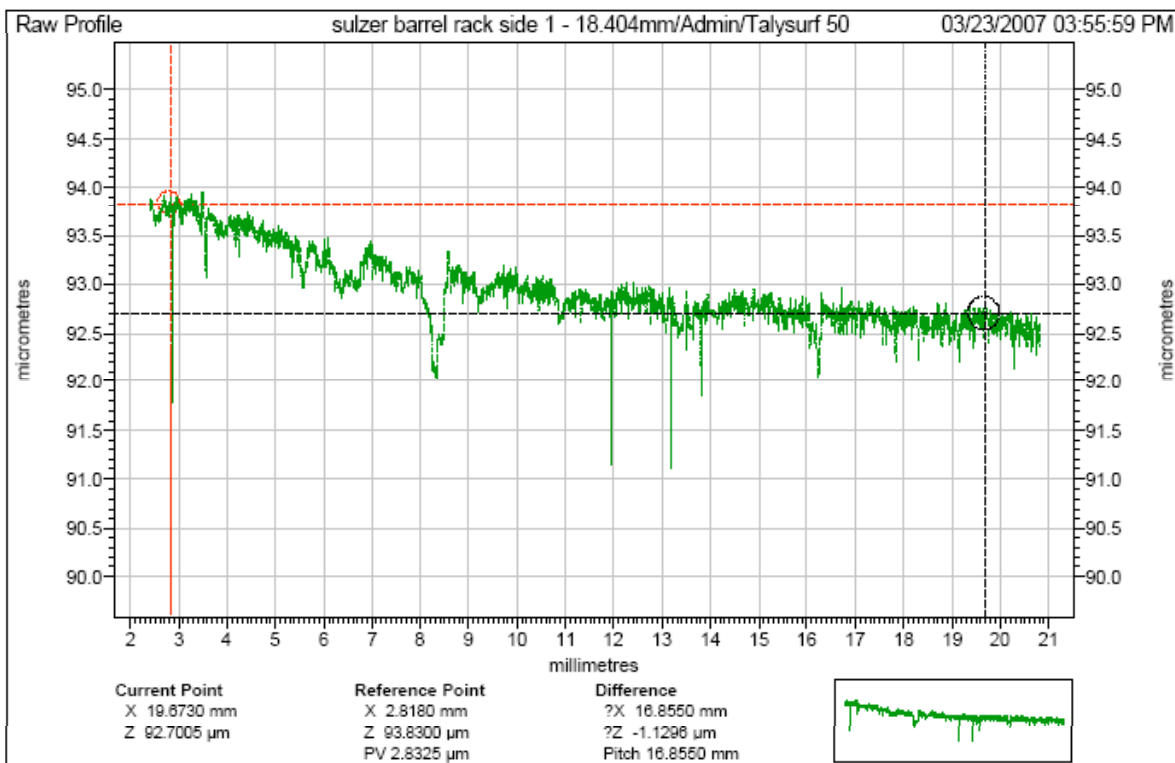
The Talysurf surface profilometer trace shown in Figure 22 suggests there is bell-mouthed wear towards the top of the barrel. The wear is about 1.1-microns for a 18mm stroke from the bottom of the barrel on the left, towards the top of the barrel.

material by the plunger towards the top of the barrel. The ploughed material is likely what caused the severe wear on the plunger.

Figure 22. Surface Profilometer Trace of Barrel after being Leveled Showing Bell Mouth towards Top of Stroke

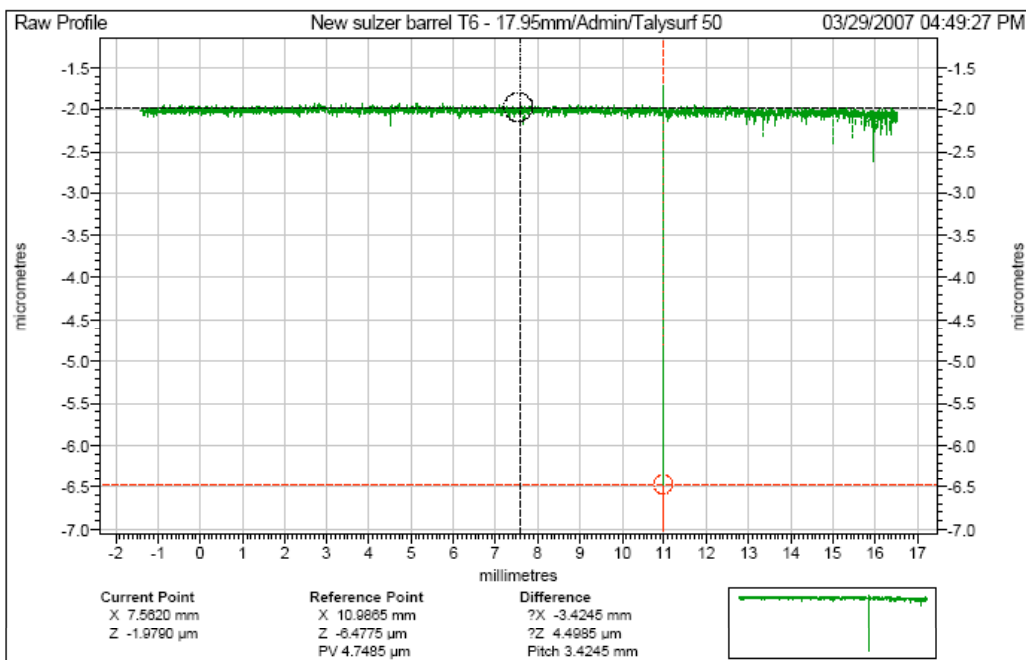
Figure 24 is a profilometer trace for a barrel that had the plunger activated improperly. This barrel only had 20 hours of break in operation on F3000 fuel. It is uncertain what the spike is because it is not visible to the eye. The trace indicates about 0.1-micron wear. At these small values the levelness of the component measured can show up as slight slope, but the trace appears to bell slightly towards the top of the stroke.

Figure 24. Surface Profilometer Measurement on a Low Time Barrel Operated on Diesel Fuel

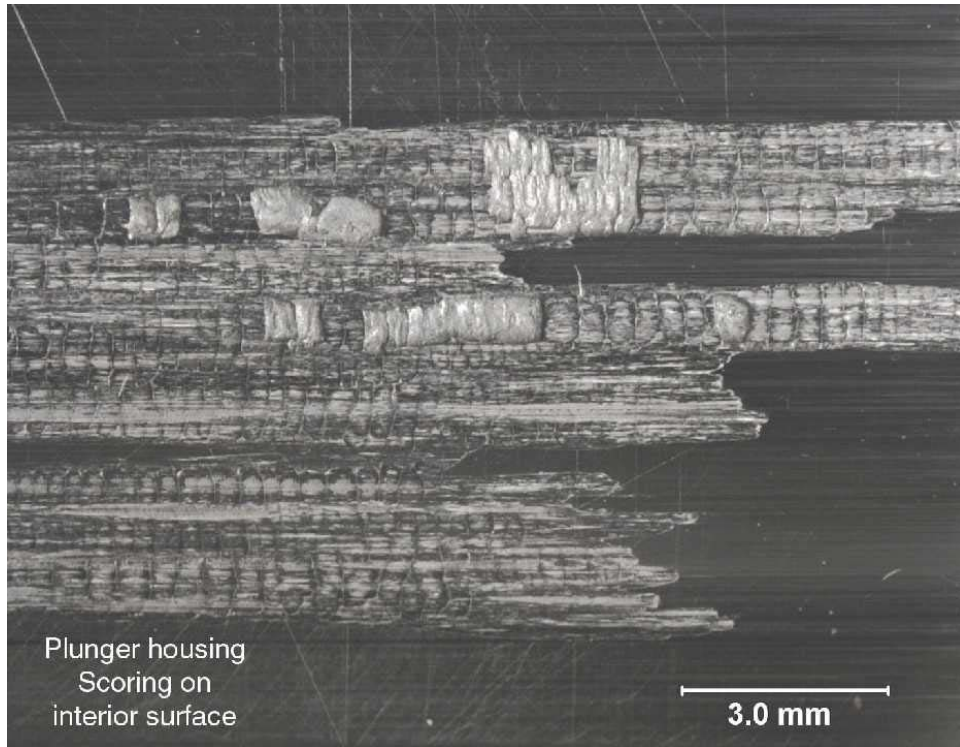
Figure 26 shows a close up of the damaged area of the section barrel. The Secondary Electron Detector (SED) image in Figure 27 is of the wear and scored material seen in the upper -mid section of Figure 26, and was taken with a Scanning Electron Microscope. The image shows how the material appears to be fracturing, as if being ploughed by the plunger. The back-scatter image of Figure 28 highlights the fracture lines in this worn area of the barrel. Another scored area of the barrel is shown in a back-scatter image (Figure 29), which also shows the fracture lines from plowing between the barrel and plunger. These results suggest a third body between the barrel and plunger initiated the wear.

Figure 26. Scuffed and Worn Section of Barrel

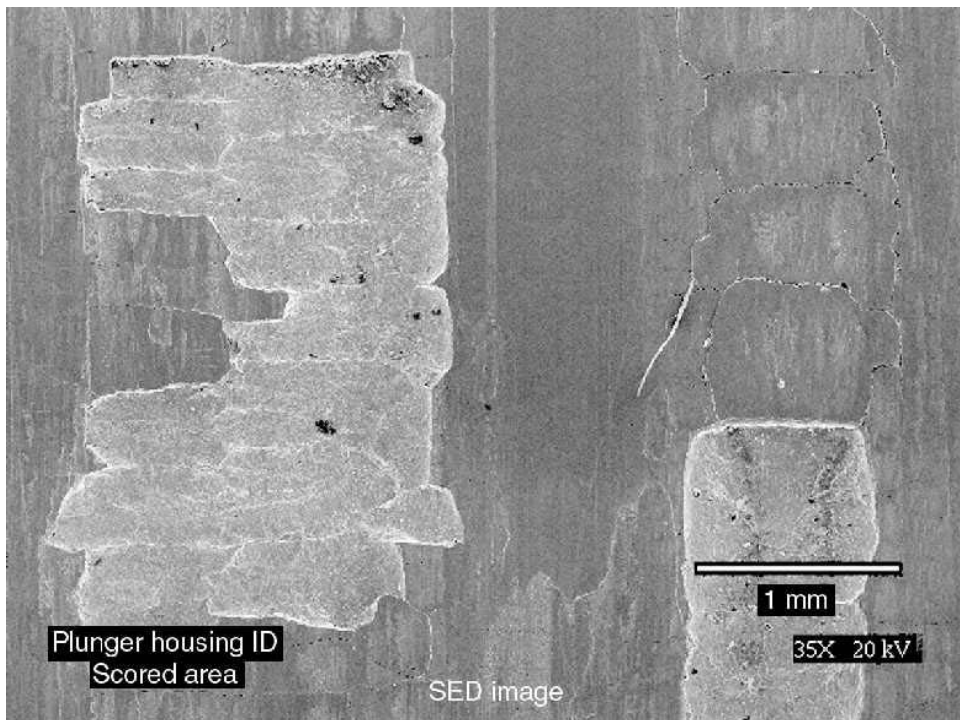
Figure 27. Scanning Electron Microscope Image of Scuffed Area of Barrel

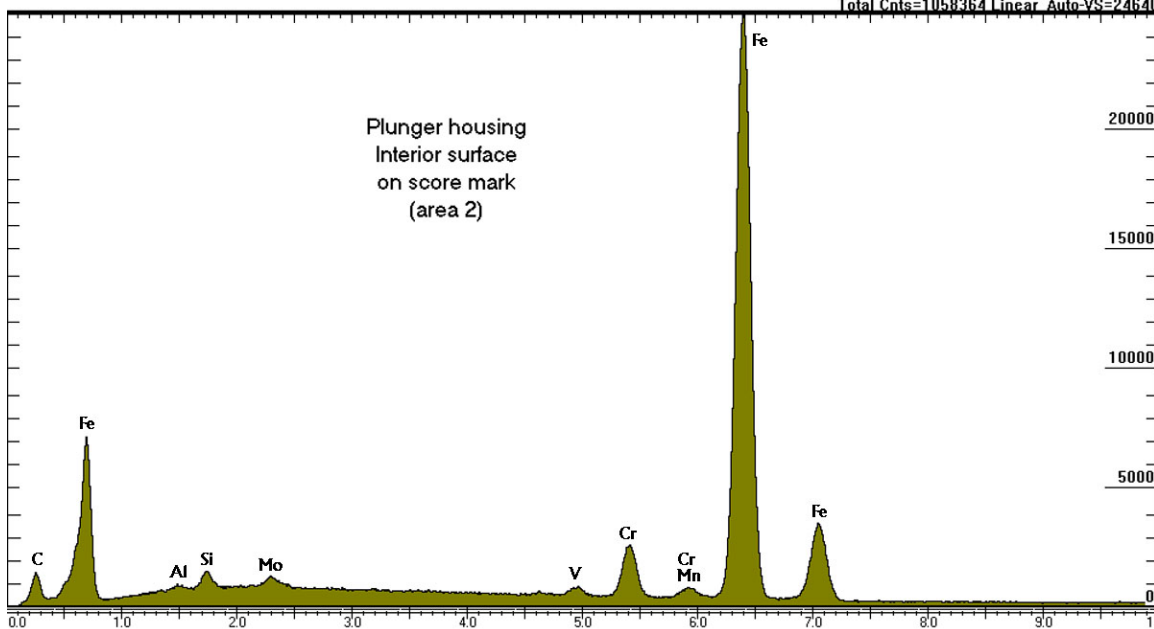
An elemental analysis was performed on an area of the barrel that did not reveal wear and on one of the scored areas. The un-scored area elemental results matched closely with the base metal elemental results. Figure 30 details the elemental analysis of the scored area and Figure 31 details the elements found in a scored area of the barrel. An element that shows up in the scored area is aluminum, which does not show up in the base metal or un-scored area elemental scans. The quantity of aluminum is small, thus alloying elements of are not seen so it is not certain if the aluminum is from an alloy or from an abrasive such as aluminum oxide.

Figure 31. Elemental Scan Results for Scored Area of Barrel

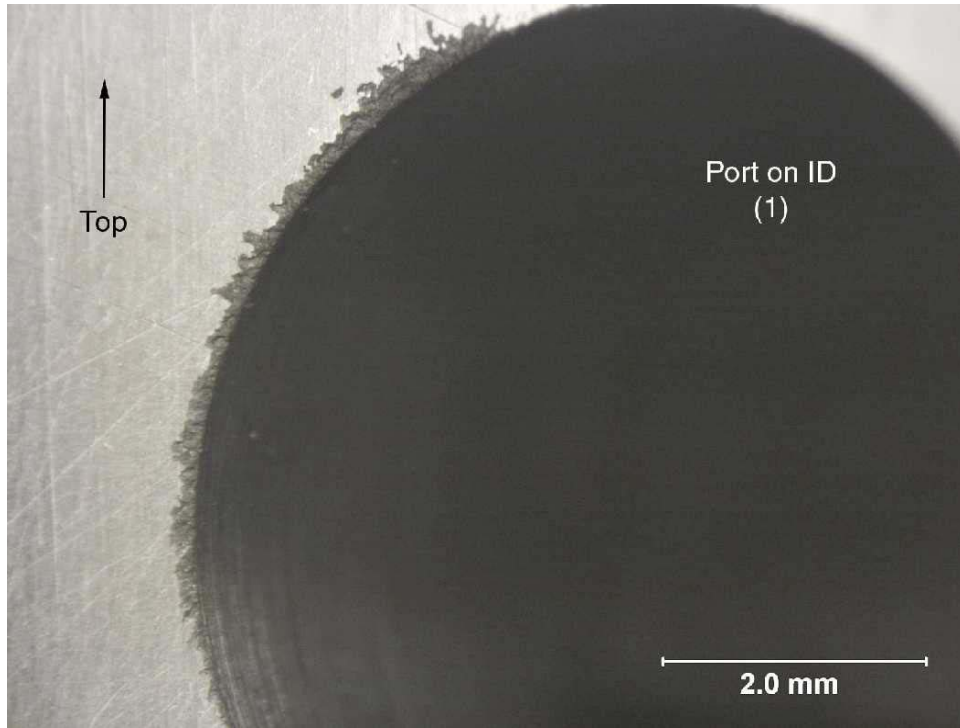
An image of a fuel fill/spill port on the fuel injection barrel is shown in Figure 33, with evidence of chipping on the upper edge of the port. Chipping on the port has been known to occur with debris that is sheared between the plunger and port edge during the injection process. The image suggests some debris may have initiated the chipping of the port edge, than the port edge debris caused the further damage to the barrel and plunger. However the damage around the port may be due to erosion when the high-pressure fuel exits through the port during the spill event. This is further supported by the fact that the barrel is not damaged immediately above and below the ports.

Figure 33. Barrel Fuel Port with Evidence of Chipping on Port Edge

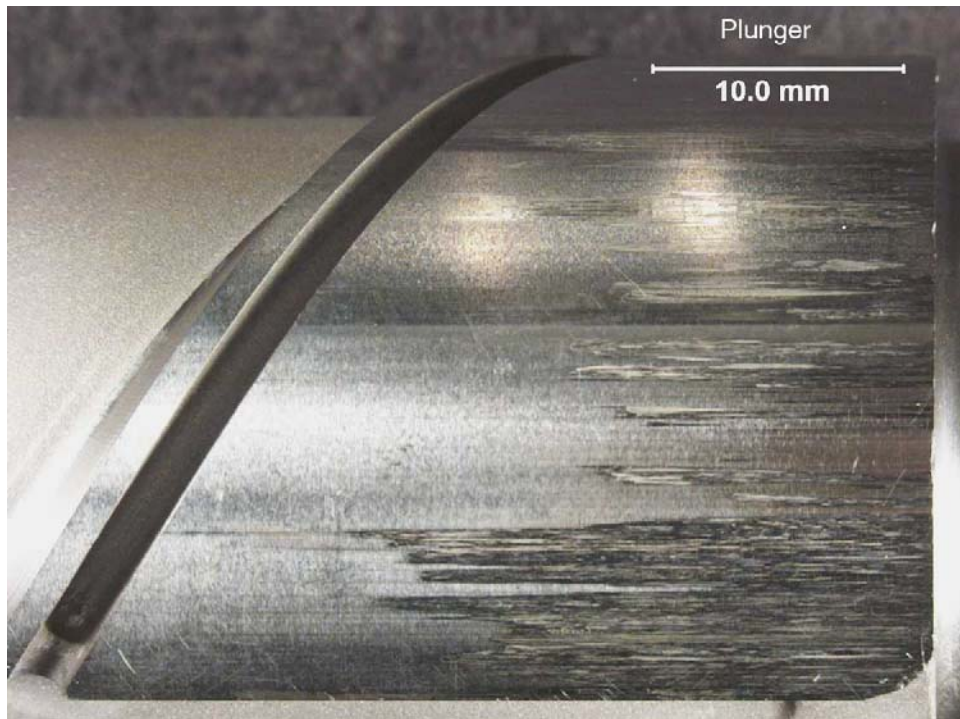
The damaged plunger was also examined. Figure 34 shows a damaged section of the plunger that was examined. The SED image of a worn area of the plunger is shown in Figure 35. Evident in the figure is vertical and circumferential fracture lines. Figure 36 also shows circumferential fracture lines evident on the plunger surface as highlighted by back scatter imaging. A magnified image of the cracking is highlighted by backscatter imaging in Figure 37. On the cracking, plastic deformation of the hardened surface layer appears to be causing cracks that propagate parallel to the surface and cause small pieces to eventually spall off. The depth of the carburized case is around 300 micron as shown in Figure 38. An undamaged area of the plunger is shown in Figure 39. The core and surface hardness of the plunger were found to be Rc 34 for the plunger core hardness and Rc 56 for the surface hardness.

Figure 34. View of Damaged Injection Pump Plunger

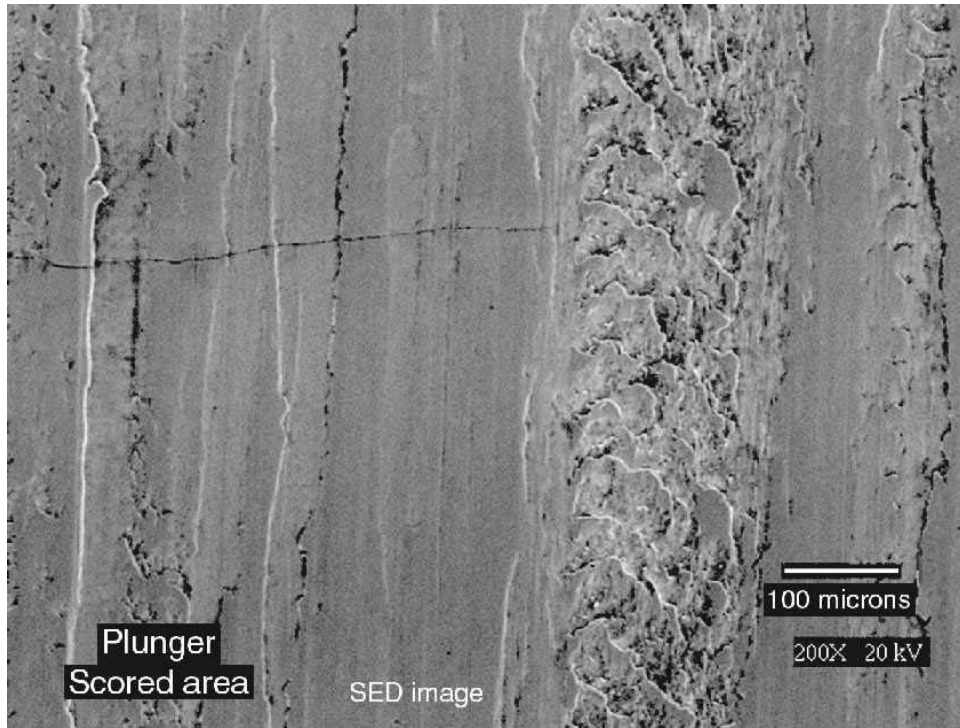
Figure 35. Plunger Scored Area with Evident Fracture Lines

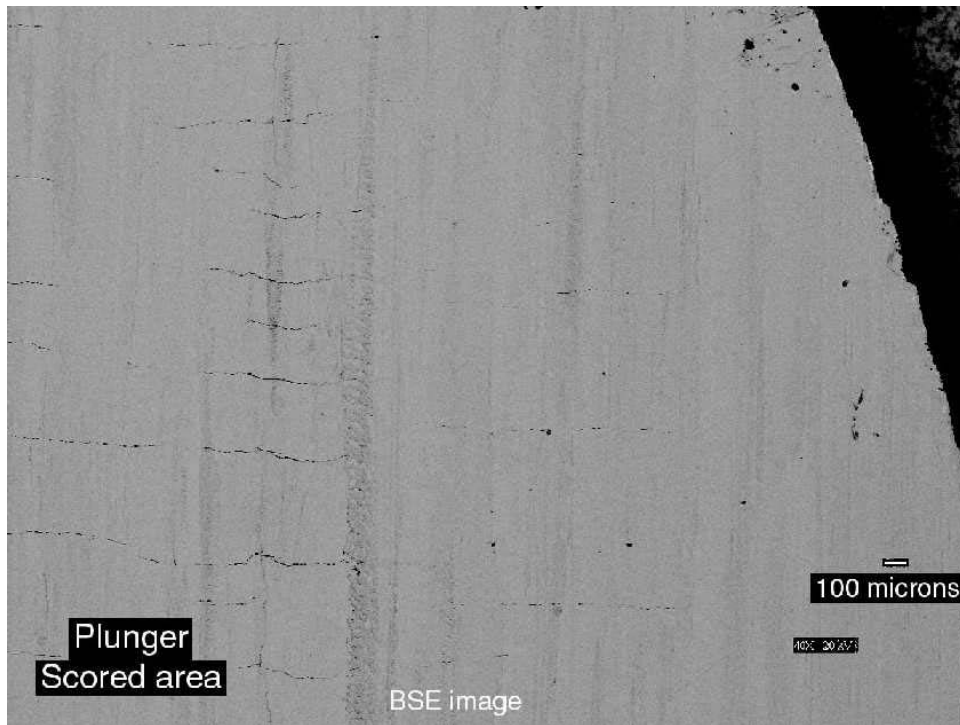
Figure 36. Circumferential Fracture Lines on Plunger Surface

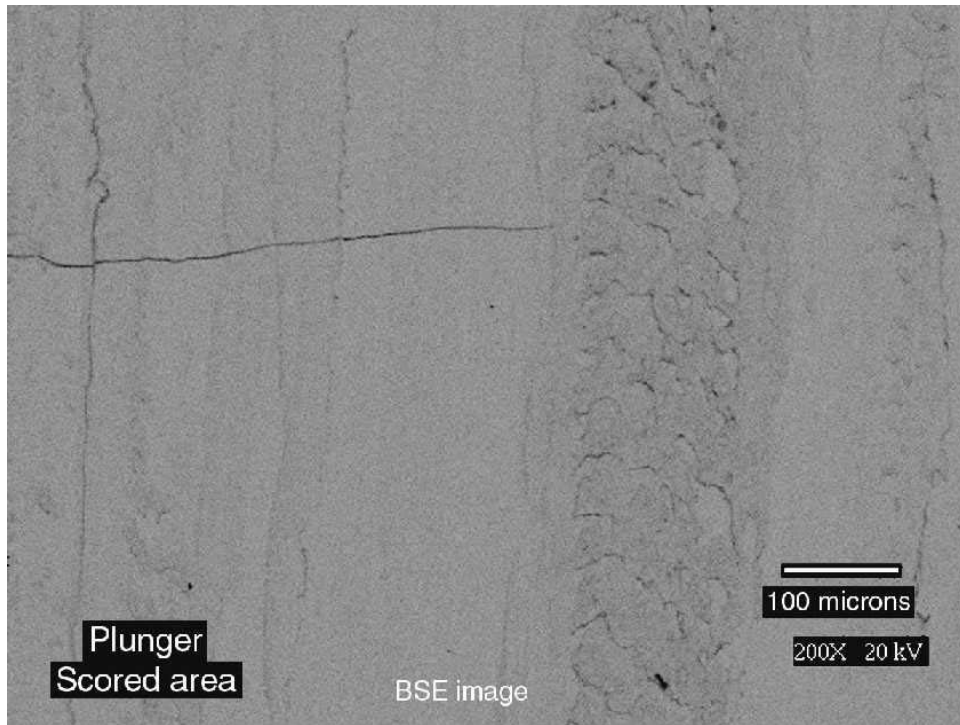
Figure 37. Close up of Cracked Surface of Plunger

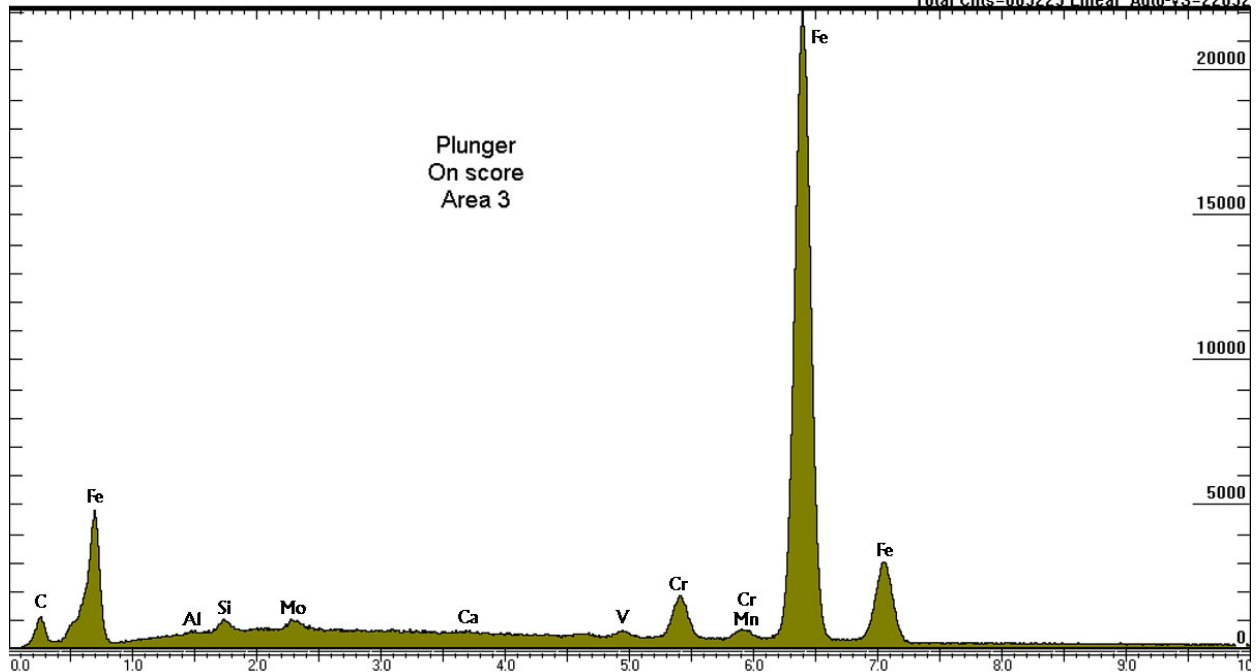
Elemental scans were performed on the base material and on a damaged section of the plunger to determine if foreign materials were present in the wear scars. As seen with the barrel, the plunger revealed a small aluminum peak in the damaged areas as shown in Figure 40. The undamaged area did not show an aluminum peak as seen in Figure 41.

Figure 40. Elemental Scan of Plunger Damaged Surface

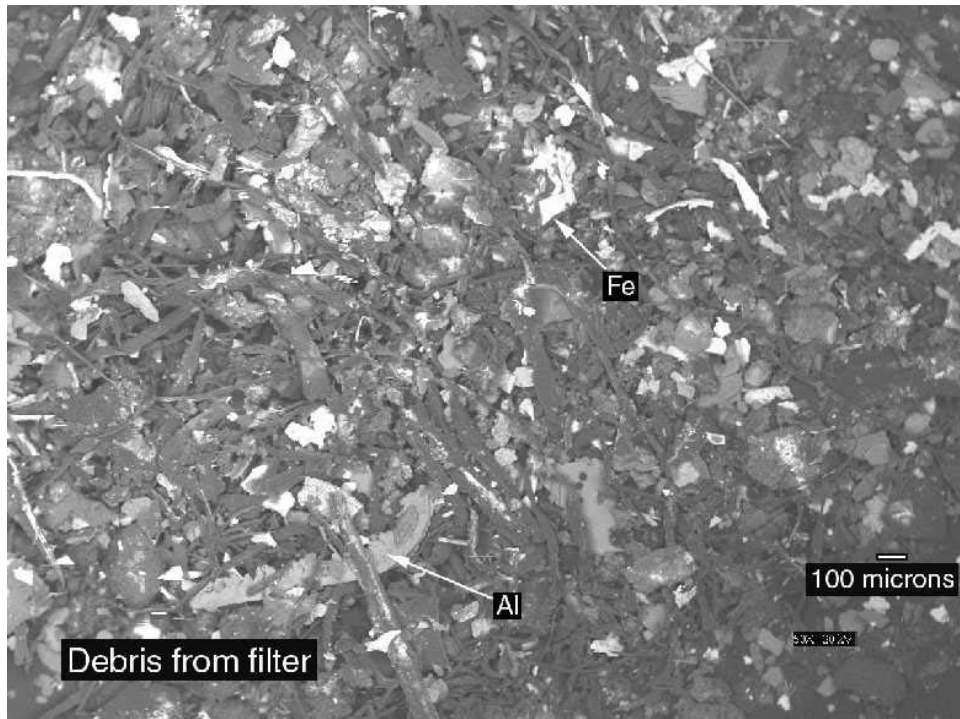
Figure 43. Aluminum and Iron Particles from Fuel Filter Debris

The analysis suggests it is likely a contaminant entered the fuel injection system and caused the rapid wear. It is likely the contaminant may have been introduced during the disassembly/assembly processes that were carried out in order to check plunger activity. Although considerable care was taken when handling the components, it is possible the plunger could have been damaged in the disassembly/assembly processes.

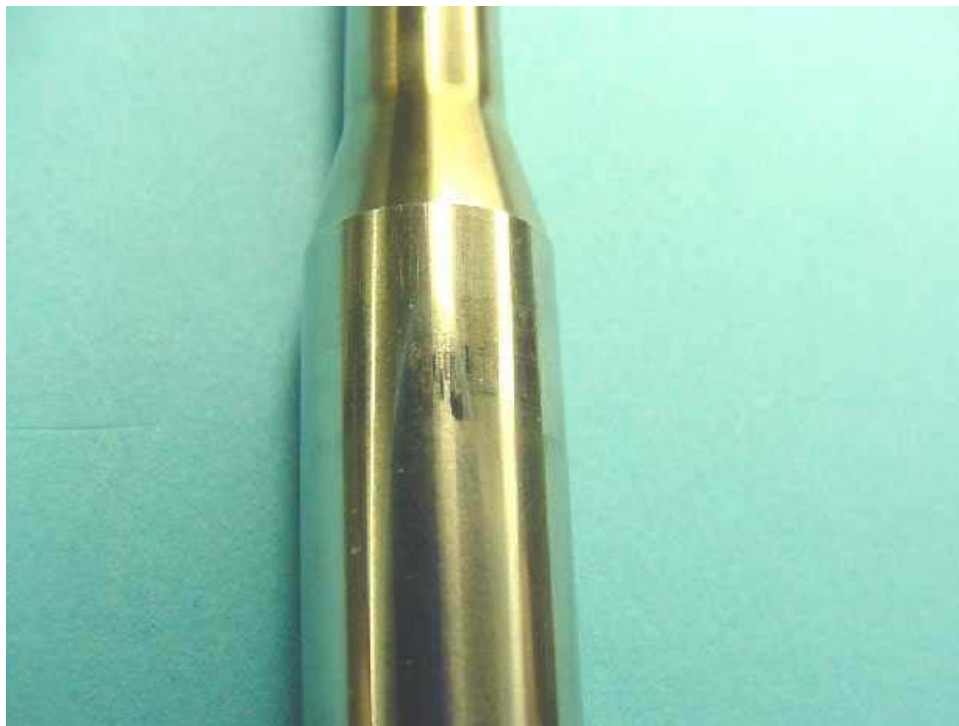
Figure 44. Wear Scar on Fuel Injector Pintle

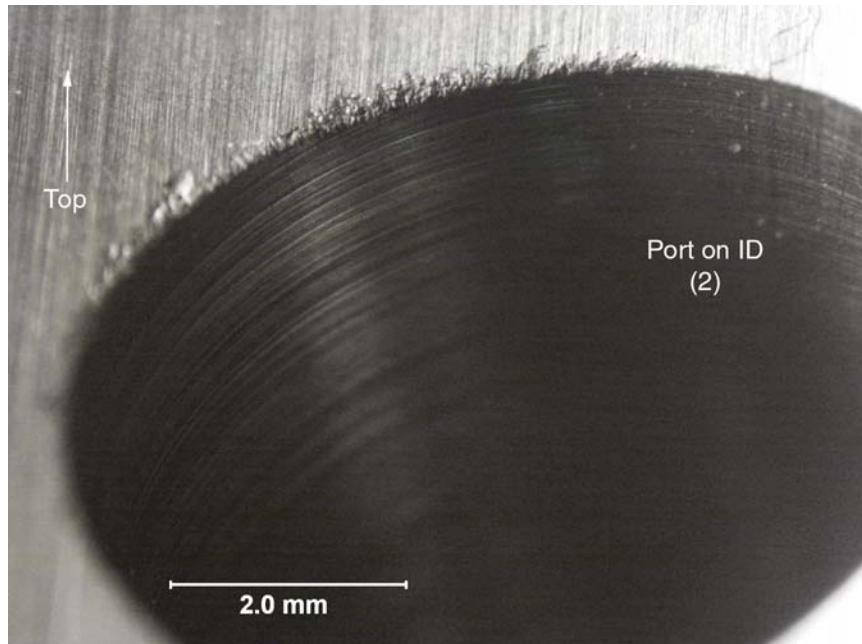
Figure 47. Barrel Port from JP-5 Test Program with Evidence of Cavitation-like Erosion
