Naval Submarine Medical Research Laboratory

NSMRL/TR--2007-1252

March 28, 2007

Results of Inspections of MK-10 Submarine Escape and Immersion Equipment Life Rafts Following Leeway Testing

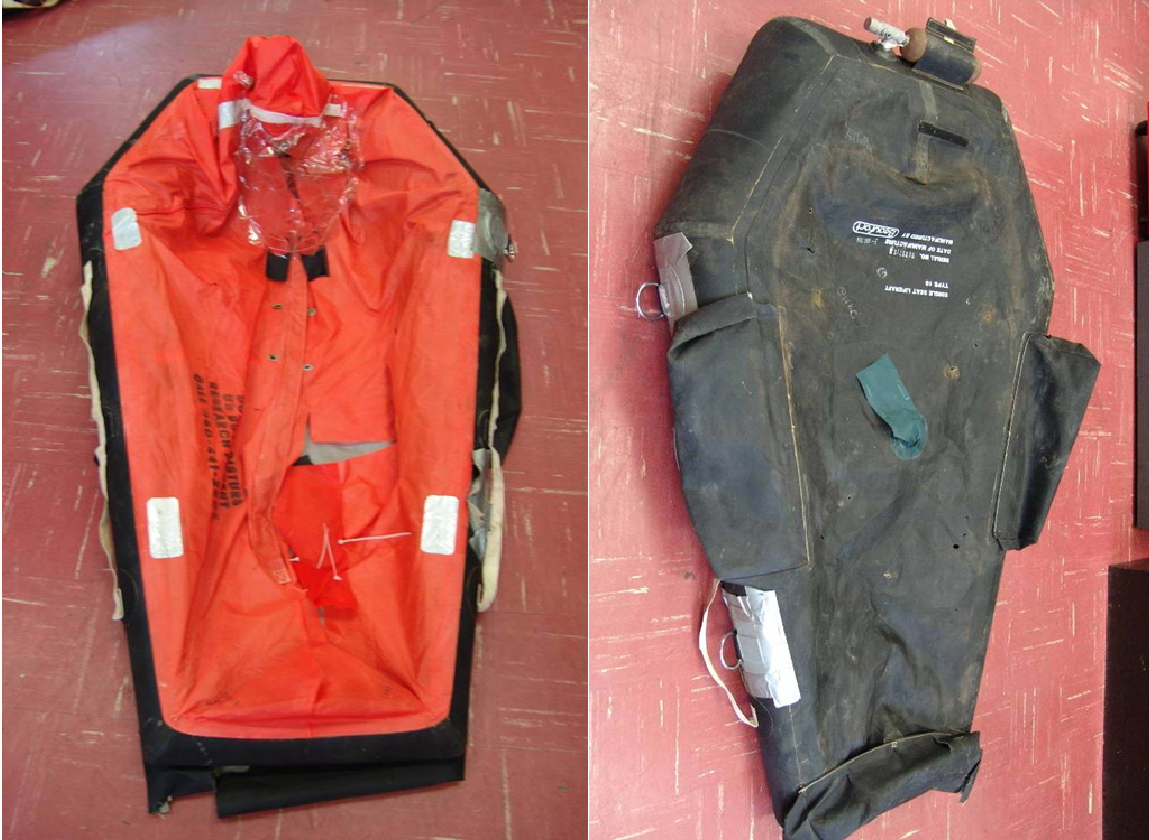
Figure 2: Raft Serial Number 9835715. Top View left, Bottom View right.

- D-rings were added to left side of raft. Grommets were added to the canopy.
- Raft canopy was torn significantly: left side near foot. Plastic face shield torn in center, very jagged tear.
- Electrical tape was placed around the cap on the manual inflation tube to keep it secured in place and possibly to prevent leaking. The manual inflation tube did not exhibit any leaks *without* tape on it.
- No leaks were found on exterior sides of raft.
- The stability pocket at foot of raft had started to tear away from the raft floor at left (as seen from top) end.

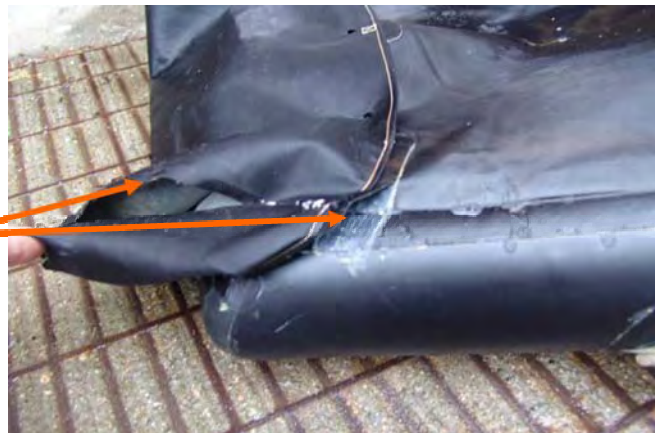
Figure 3: Raft Serial Number 9835715 Forward Stability Pocket Detail (Showing tears)

- Stability pocket at foot end also had an open seam on the left end (as seen from top).
- Two leaks in the buoyancy chamber were located on the inner side of the raft. Both leaks were on right side of the raft in bottom half of buoyancy bladder just above locations where the plywood instrumentation mounting sheet was attached to floor of raft. Both appear to be rub/abrasion locations.

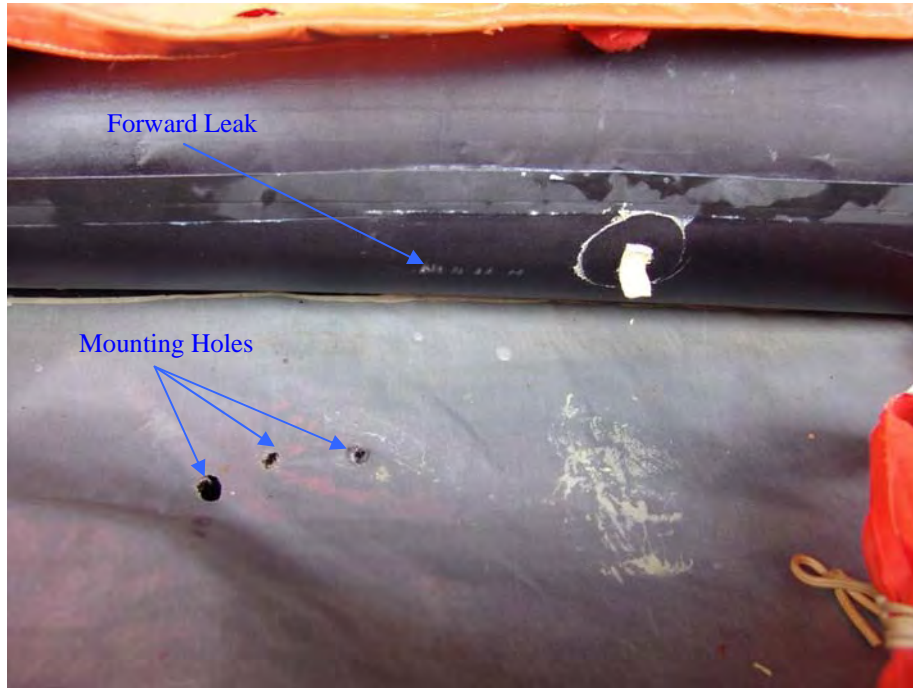
Figure 4: Raft Serial Number 9835715 Detail of Forward Leak

- Raft canopy and face shield were most probably ripped up by the wind during testing.
- The leaks detected appear to have come from abrasions, especially the forward leak. The proximity to the holes in the raft floor where the plywood instrument sheet was mounted seems to imply that the abrasions came from either the plywood sheet itself or the equipment mounted on it.
- The investigators believe that the raft would not have leaked if a human had been the passenger.

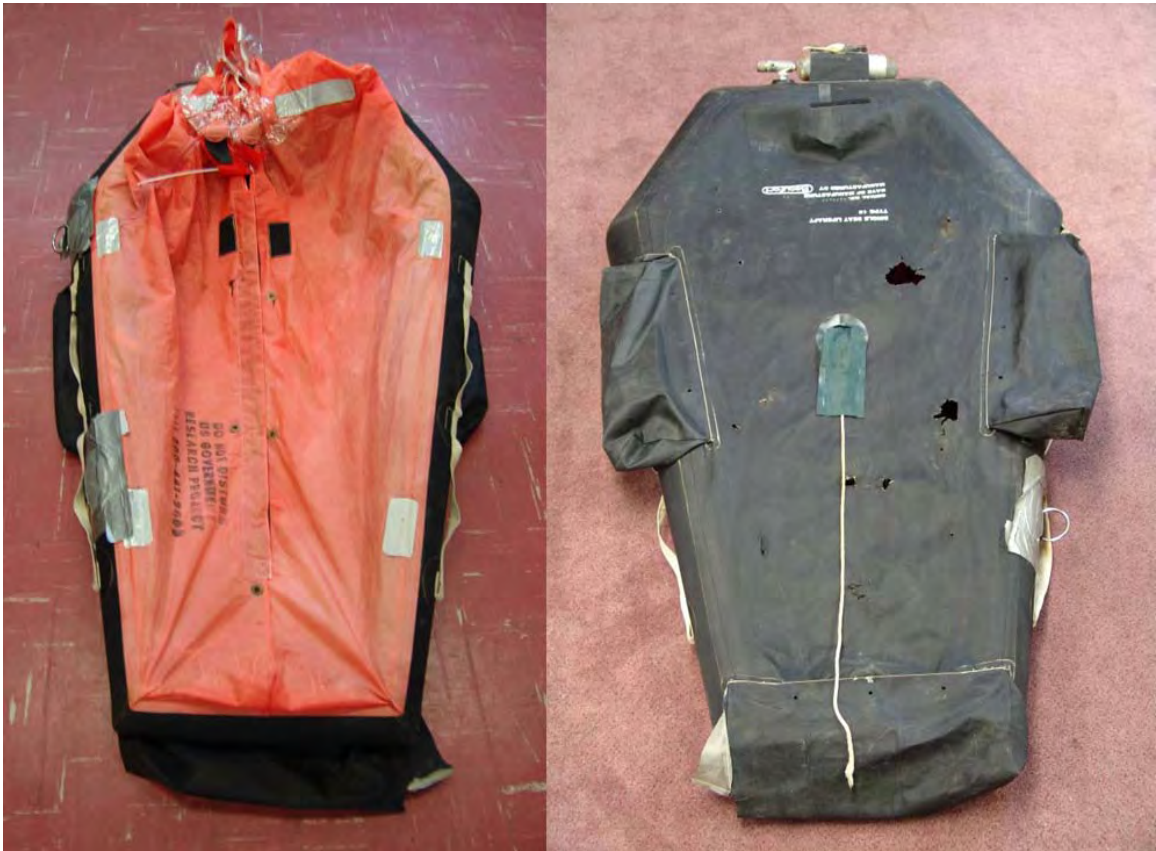
Figure 8: Raft Serial Number 9834882 Top View (Left), Bottom View (Right)

- D-rings were added to the left side of raft. Grommets were added to the canopy.
- Small canopy tears were found around the upper two (aft most) grommets.
- The clear plastic face shield was torn into two pieces. A small part of face shield may be missing. Tear was left/right (horizontal).
- The orange plastic of canopy was significantly sun bleached.
- A significant number of tears and holes were found in the floor of raft associated with points of connection to instrument mounting plate.

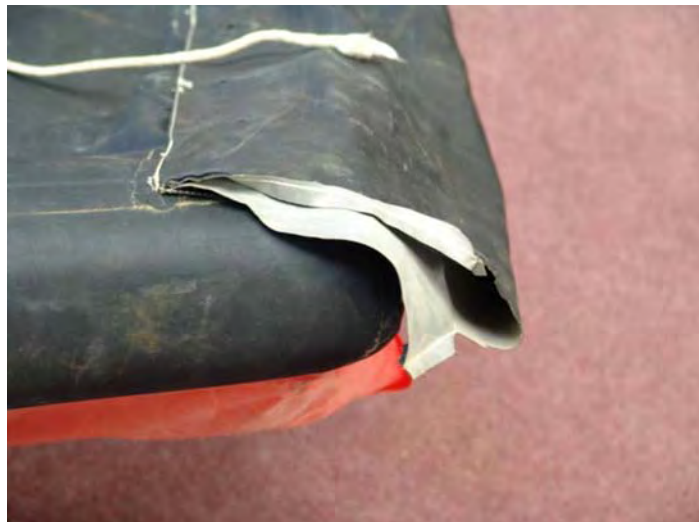
Figure 10: Raft Serial Number 9834882 Forward Stability Pocket Detail

- The forward stability pocket was ripped or cut adjacent to left end seam (as seen from top).

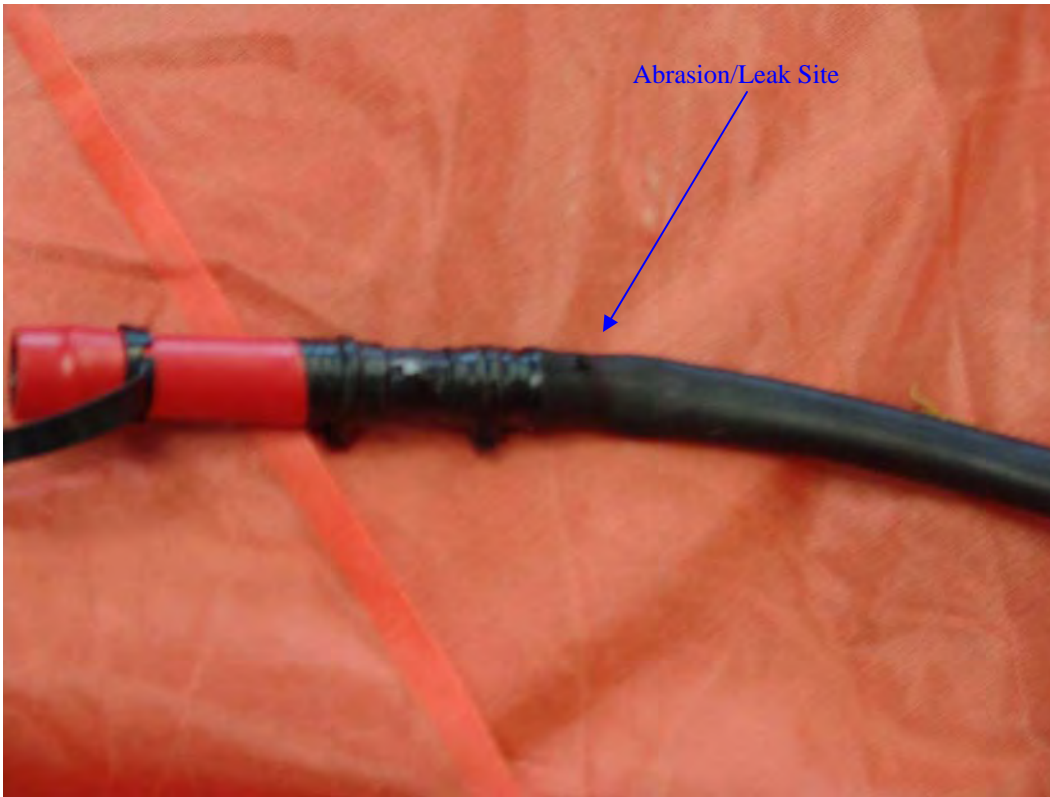
Figure 11: Raft Serial Number 9834882 Manual Inflation Tube Detail

- A significant air leak was found at an abrasion site on the manual inflation tube just below connection to mouth valve. No other leaks found.

- This raft held air longest when inflated. It had a significant amount of air remaining in it after 18 hours. It could easily have been kept afloat by an escaper. Only location of leak that could be found was the manual inflation tube. The abrasion could have come from contact with equipment inside the raft.
- The holes in the floor of this raft were the largest of the group and would have contributed significantly to water entering the raft.
- The investigators believe that the raft would not have leaked if a human had been the passenger.

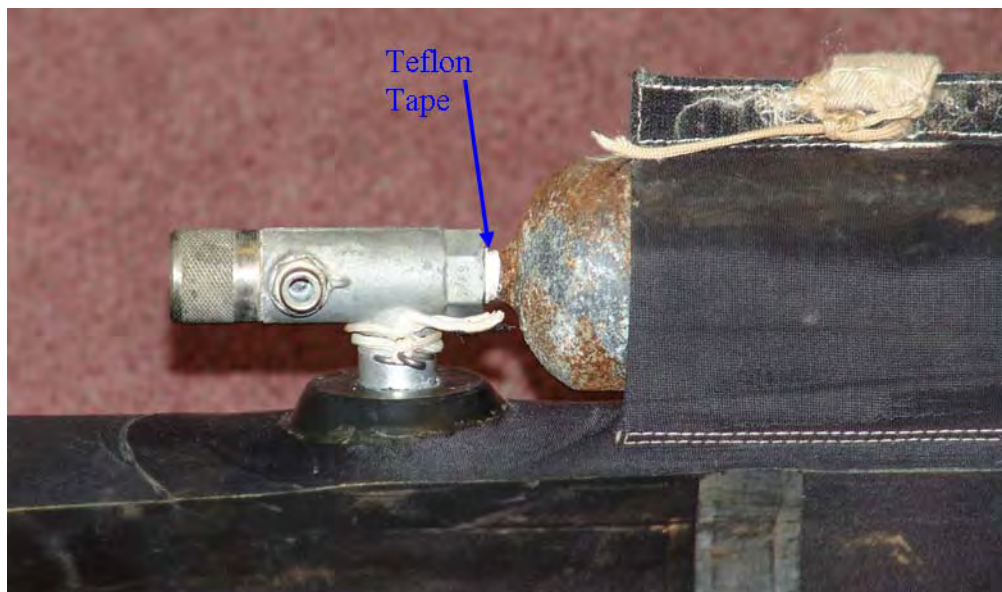
Figure 12: Raft Serial Number 9834882 CO₂ Bottle Detail

- The CO₂ Bottle had Teflon tape added to the threaded connection to the fill valve assembly. No leakage noted during testing.

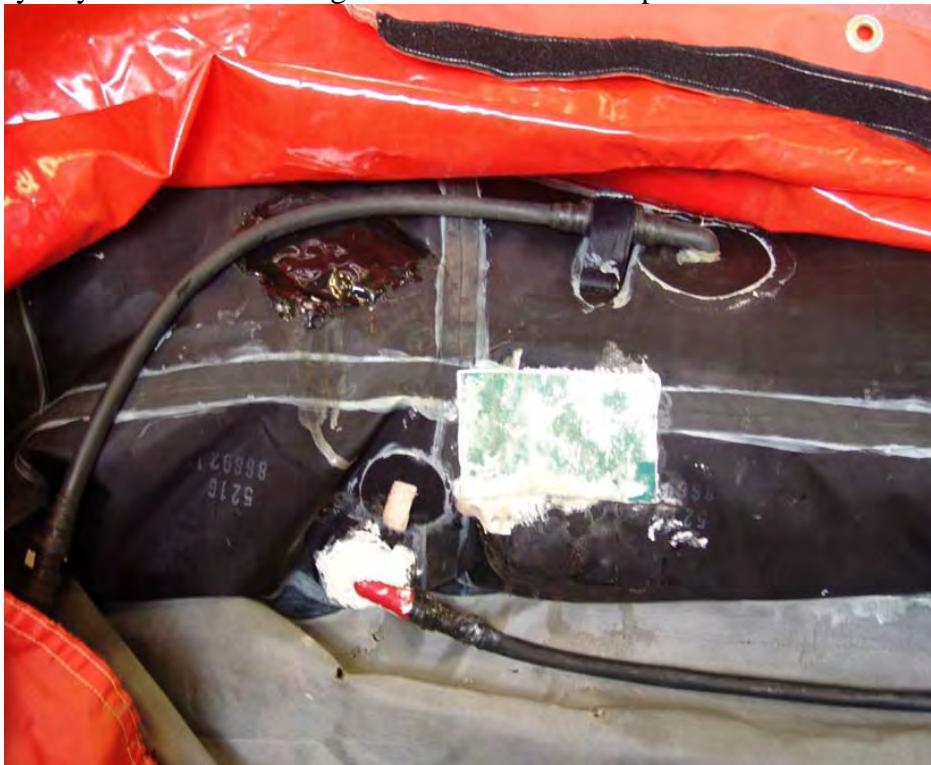
Figure 16: Raft Serial Number 0364837 Manual Inflation Hoses Detail

- This was the only raft in the group with two manual inflation tubes. The lower manual inflation tube had white epoxy coated on attachment point to raft buoyancy chamber indicating that a leak had been repaired.

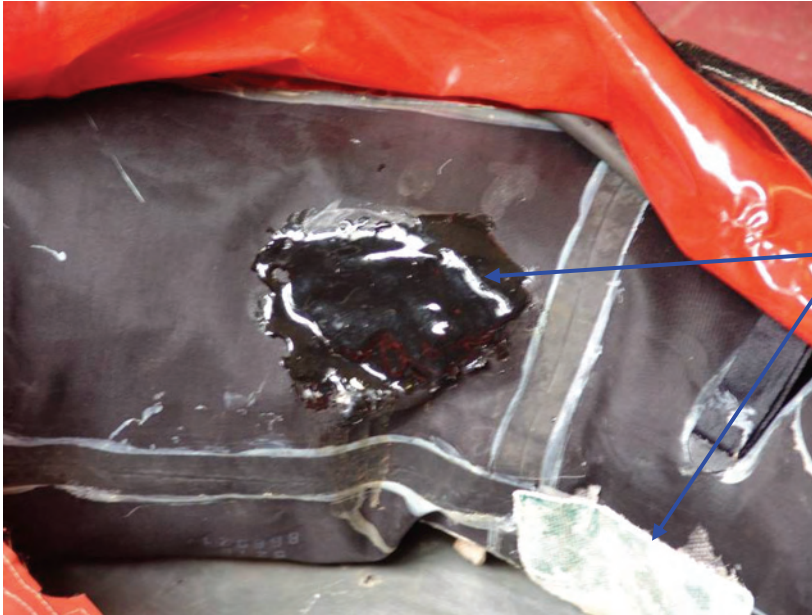
Figure 17: Raft Serial Number 036483 Installed Patches

- SAIC added three patches in the vicinity of the two manual inflation tubes. Only two remained in place. None of the leaks occurred at a seam. The leak that was at one time patched was directly below the forward patch (Green colored rubber) and was very significant. The raft completely deflated in less than 5 minutes due to the size of the leak. The patch that seemed most effective was the one made with hard black resin or epoxy.

Patches that remained in place.

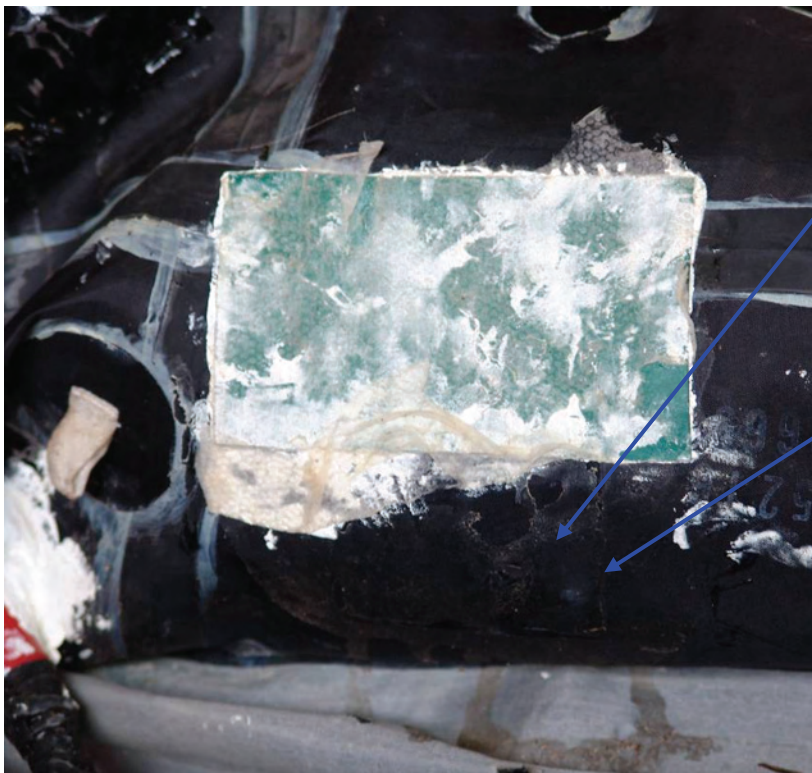
Figure 18: Raft Serial Number 036483 Location of Third Leak

Location of third leak

Ridge of adhesive indicating location of third patch.

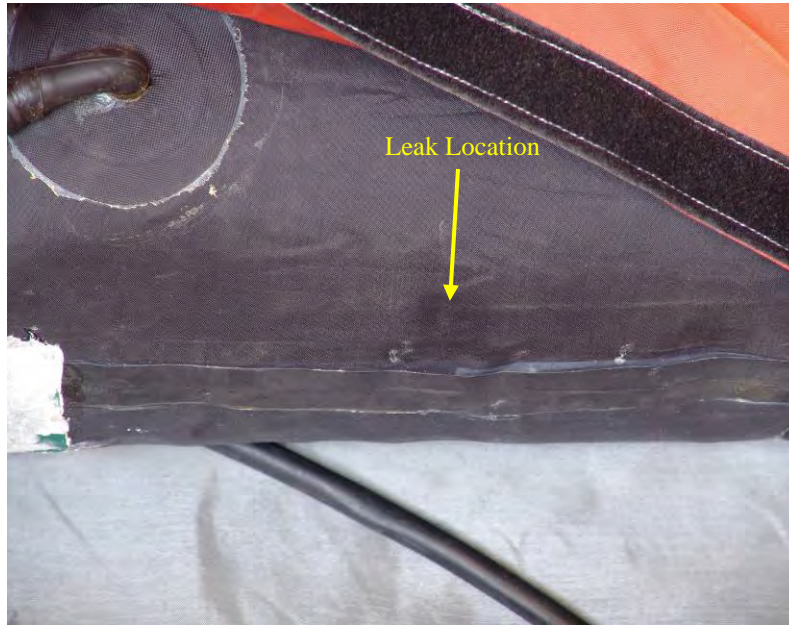
Figure 19: Raft Serial Number 036483 Location of Fourth Leak

- A fourth pin-hole leak was found about 7 inches forward of the manual inflation tubes on upper half of inflation tube. Slight abrasion of bladder material was noted in the area.
- The CO₂ Bottle had Teflon tape added to the threaded connection to the fill valve assembly. No leakage was noted during testing from the connection.

- This raft was clearly in the worst condition with at least four leaks and possibly a fifth leak at the connection of the lower manual inflation tube to the buoyancy chamber of the raft.
- Three leaks were patched; one of the patches failed and fell or was removed from the leak site and was not found. The leak that was “un-patched” appeared to have been caused by an abrasion. The leak was almost 0.5 inches long.
- A fourth small leak developed at a very slight abrasion site forward of the manual inflation tubes. None of the leaks were on seams.
- The investigators believe the leaks were caused by the equipment placed in the raft rubbing against the inside surface of the buoyancy chamber.
- The investigators believe that the raft would not have leaked if a human had been the passenger and if it had been constructed with only one manual inflation tube.

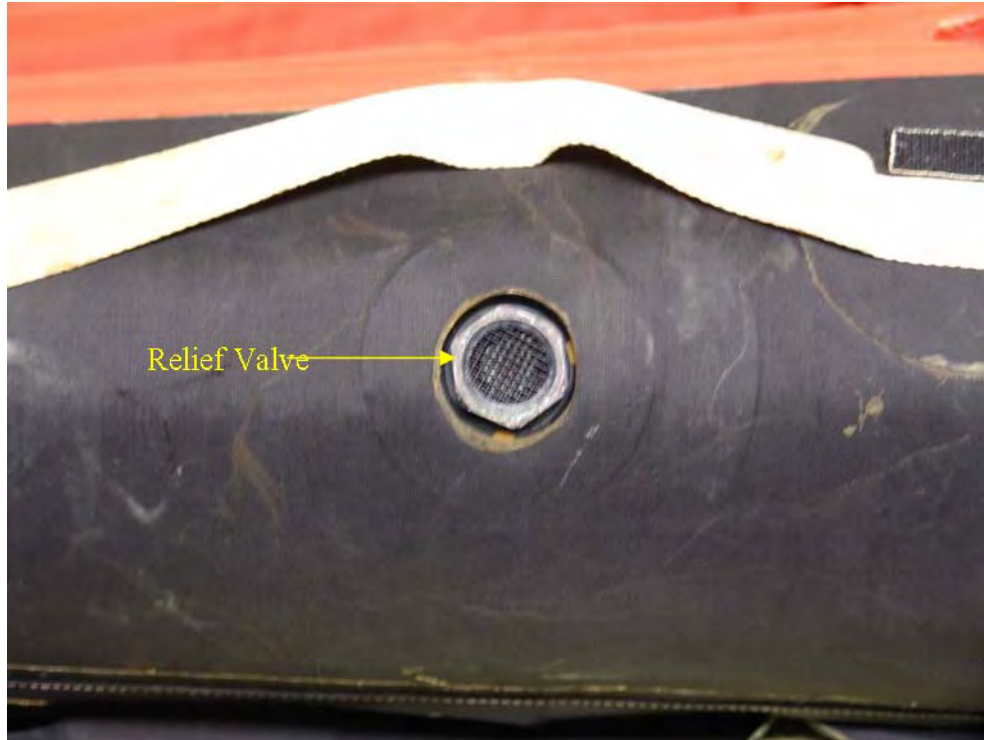
Figure 23: Raft Serial Number 0364812 Over-Inflation Protection Relief Valve

- Two D-rings were added to the left side of the raft. No grommets added to canopy.
- No patches found.
- No leaks in the seams or fabric of the flotation chamber were detected.
- The Over-Inflation Protection relief valve did function (open) as raft reached full inflation and then did not fully reset. Attempts to reseat the valve by directing a stream of water onto the valve were not successful and the valve continued to leak.

- This raft was in the best overall condition of all five rafts with no leaks found in the seams or fabric of the flotation chamber, the smallest mounting holes in the floor of the raft and the least damaged canopy.
- The only leak that could be found was the slow loss of air from the over-inflation protection relief valve failing to reset after opening during inflation.
- This raft held air the second longest of the five tested. The loss could have been kept up with by an escaper using the manual inflation tube.

- The life raft leaks were not a result of poor workmanship by the manufacturer as none occurred at seams.
- The only manufacturing related issues were:
 - Raft Serial Number 0364837 which was constructed with two manual inflation tubes. The lower manual inflation tube apparently leaked at the connection to the buoyancy chamber.
 - Raft Serial Number 0364812 Over-Inflation Protection Relief Valve failure to completely reseal after lifting. The production model MK-10 SEIE life rafts issued to the U.S. Navy Submarine Force does not have an over-inflation protection relief valve thus eliminating that possible leak source.

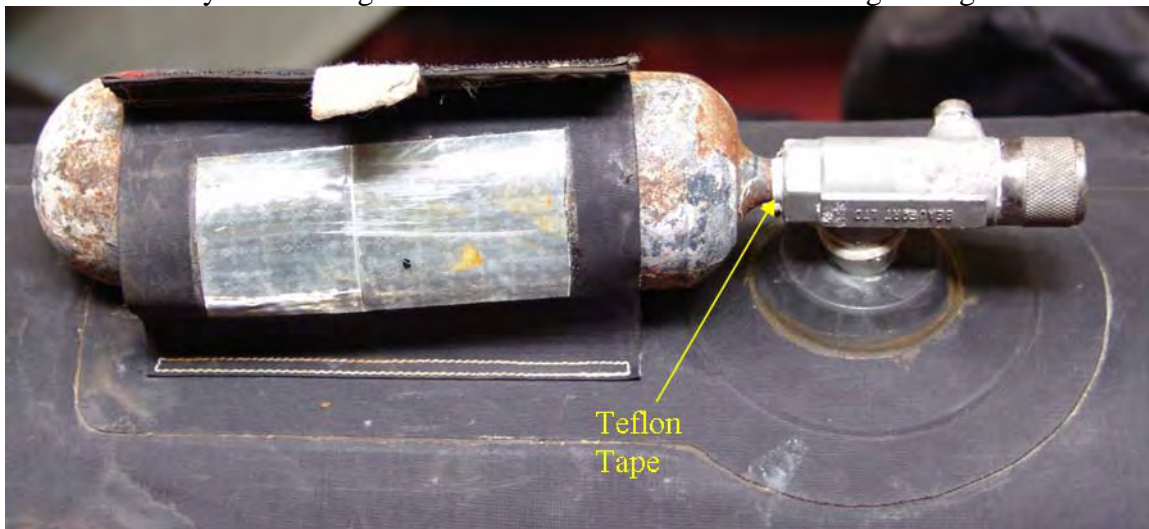
Figure 24: Raft Serial Number 0364812 CO₂ Bottle Detail

- The CO₂ Bottle had Teflon tape added to threaded connection to the fill valve assembly. No leakage from the connection was noted during testing.

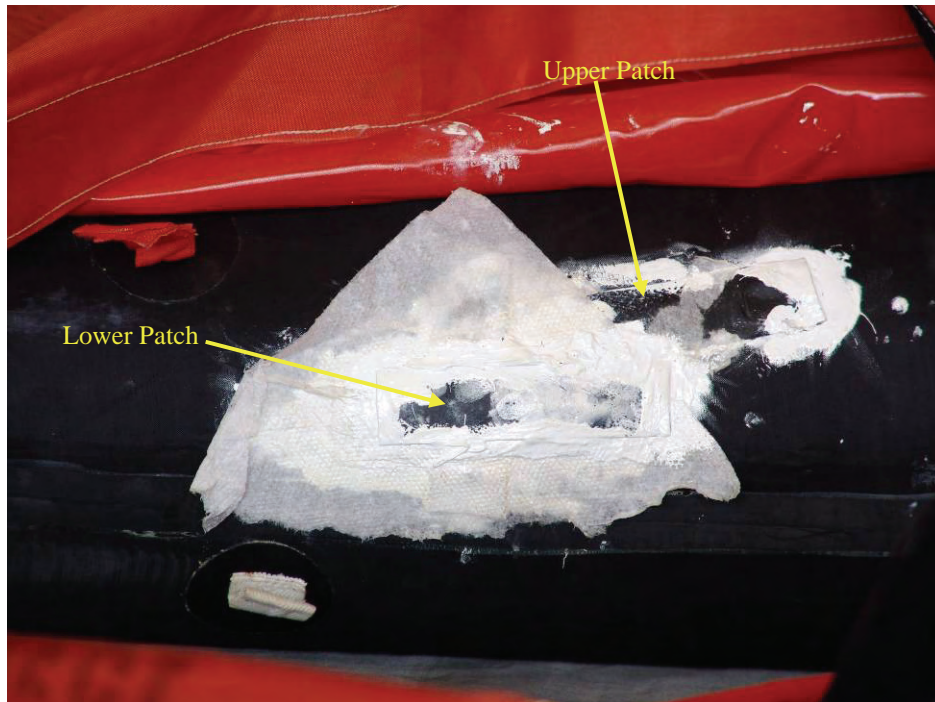
Figure 28: Raft Serial Number 2204171 Patches Detail

- Two patches were added by SAIC on interior right side. The lower patch leaked significantly.

- Raft was in good condition other than the patched leak. If the lower patch had not failed the raft would have held air. The patched leak was roughly in the same position fore and aft as the pin-hole leak found on raft serial number 0364837 (Raft with two manual inflation tubes.) and not on or very near a seam.
