U.S. ARMY ABERDEEN TEST CENTER

ATEC PROJECT NO. 2006-DT-ATC-MK2RB-D2477
TEST RECORD NO. WF-E-83

Jet Propellant (JP)-8 Fuel Evaluation Test

Mk II - Reset (Mk II R) Bridge Erection Boat (BEB)

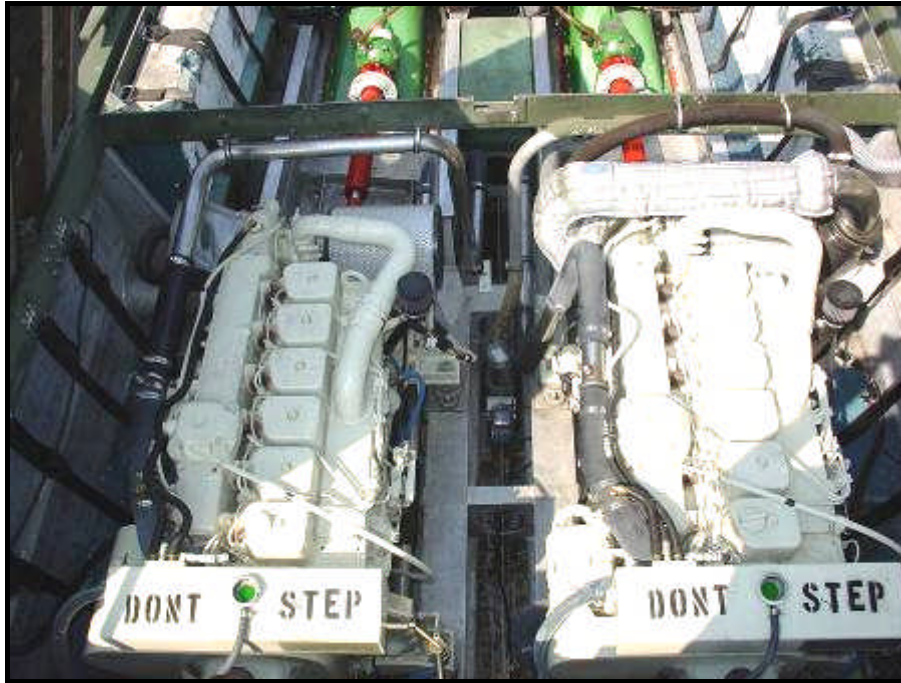
Figure 2. Mk II R, twin Cummins 6BT 5.9-L engines during initial inspection.

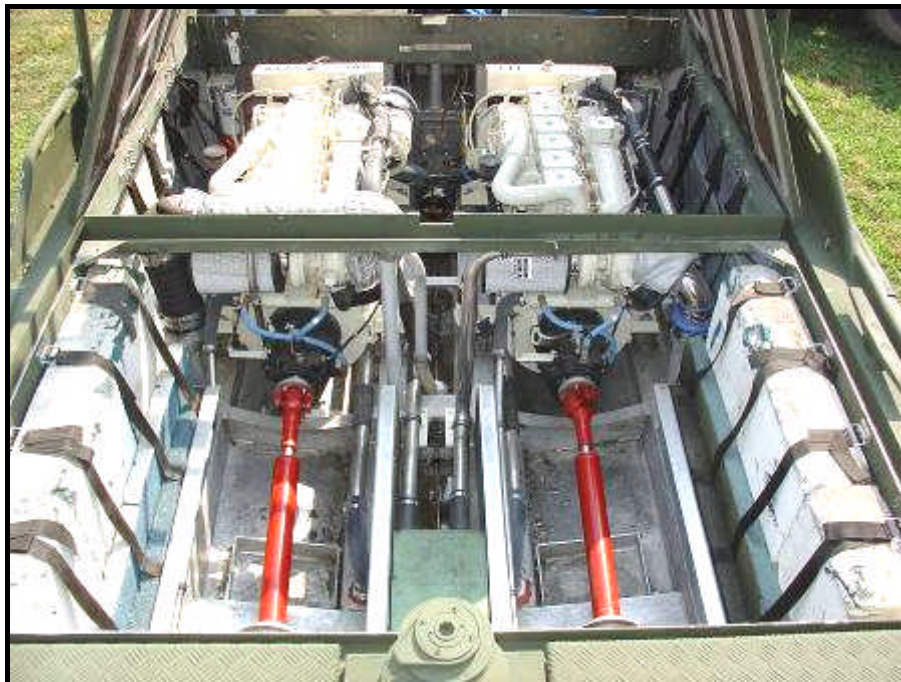
Figure 3. Mk II R, engine compartment, cockpit removed.
