INSPECTION AND ANALYSIS OF FAILED TRANSMISSIONS

**INTERIM REPORT
TFLRF No. 399**

**U.S. Army TARDEC Fuels and Lubricants Research Facility
Southwest Research Institute® (SwRI®)
San Antonio, TX**

June 2009

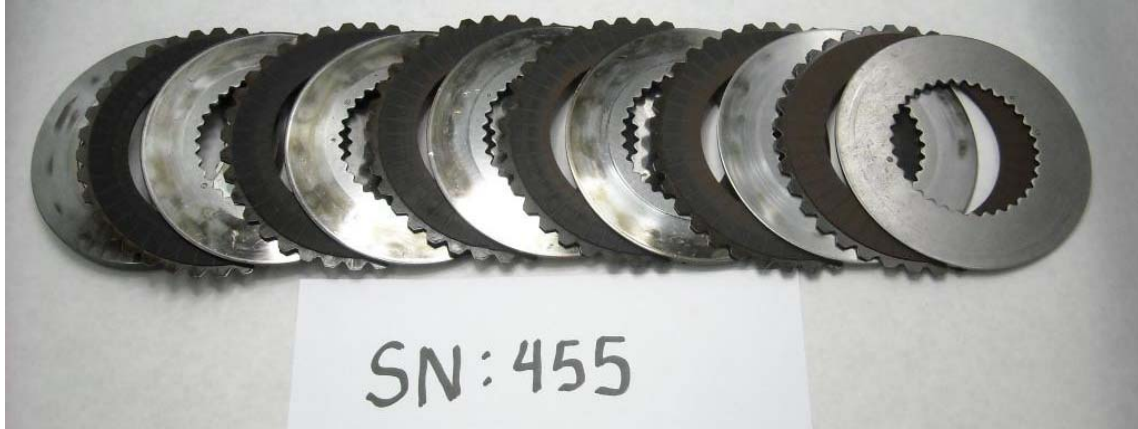
Figure 1 - SN455 C1 Friction Disks and Reaction Plates

- Plastic debris filtering screen in valve body melted and deformed.
- C1 clutch pack had to be forcibly removed from the shaft during disassembly due to warped steel plates. C1 clutch contained darkened and moderately glazed friction disks. C4 friction disks had darkening of the inner radius and slightly polished steel plates. Remaining clutches varied from damage free to some light darkening.

Figure 1 below shows SN455 C1 clutch pack damage. Steel reaction plates were warped and contained hot spots on the reaction surface. Friction disks were burnt and darkened, but remained intact without any chipping or flaking of the friction surface. C1 clutch pack clearance was found to be minimal due to the warped steel plates.

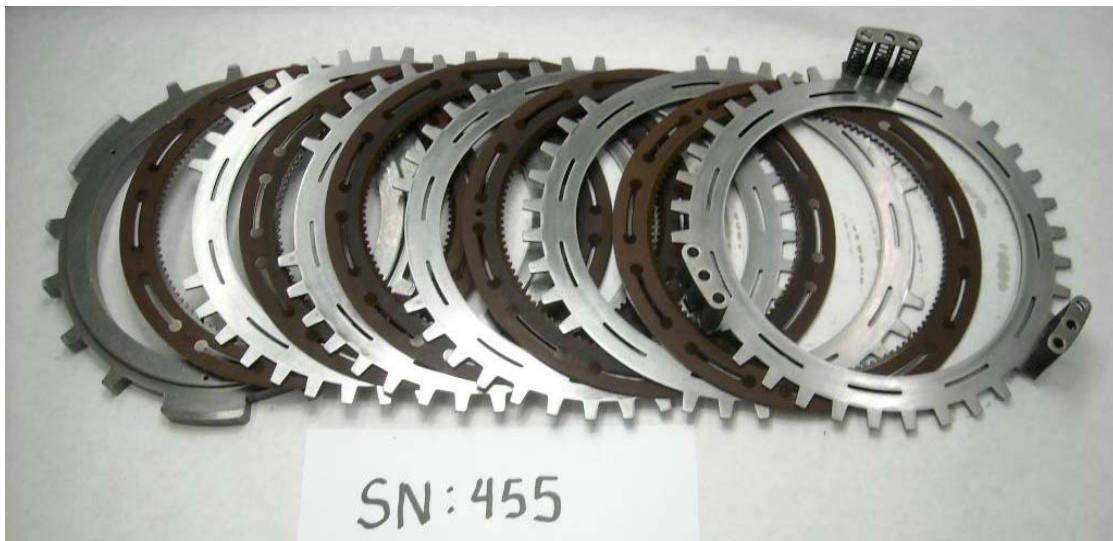
Figure 2 - SN455 C4 Friction Disks and Reaction Plates

Figure 2 below shows SN455 C4 clutch pack damage. Overall condition was good with some mild darkening of the inner radius of the friction disks. Component rating information on clutch packs and planetary gear sets, along with pictures of all clutch packs for SN455 can be found in Appendix A.

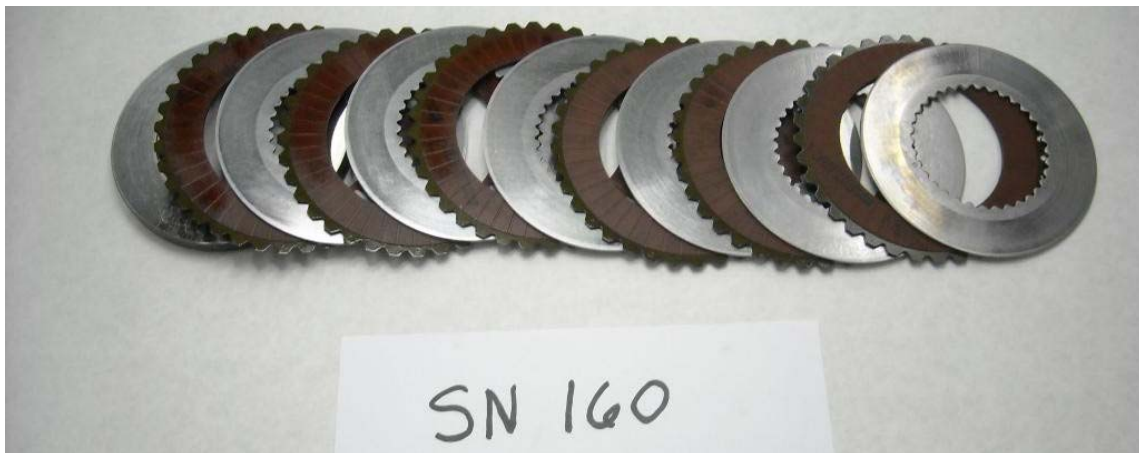
Figure 5 - SN160 C1 Friction Disks and Reaction Plates

Figure 5 below show SN160 C1 clutch pack. Condition of all clutches found to be in excellent condition. Component rating information on clutch packs and planetary gear sets, along with pictures of all clutch packs for SN160 can be found in Appendix C

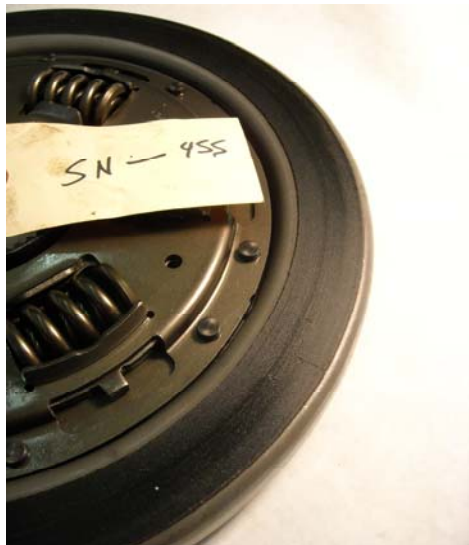
Figure 8 - SN455 Lockup Friction Plate

As to be expected from previous findings, the lockup clutch friction plate and reaction surface both showed signs of exposure to high temperatures. Although darkened, the friction disk showed no signs of chipping or flaking on the friction material as seen below in Figure 8.

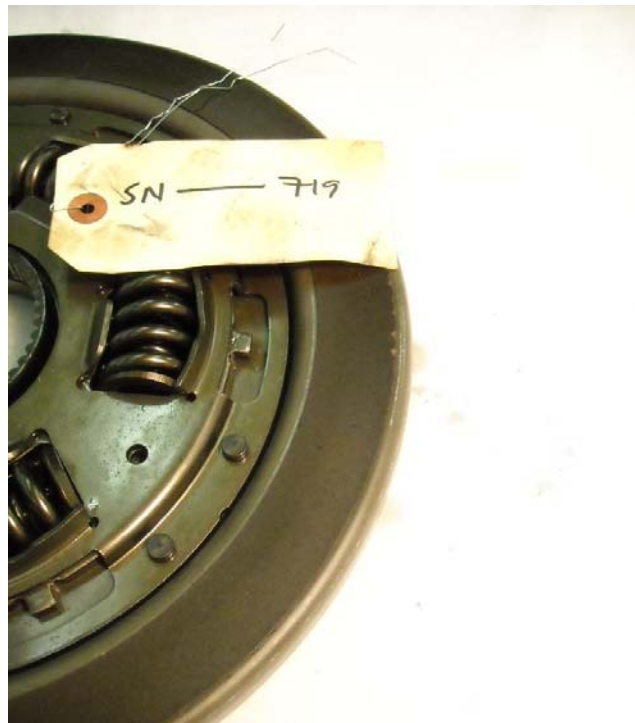
Figure 12 - SN719 Lockup Friction Plate

As seen below in Figure 12, SN719 lockup clutch friction plate was found to be in good condition with only some mild darkening. It was noted that a few small chips in the friction material surface was found along the outer edge, but it is unknown if this occurred from use or during disassembly and handling.

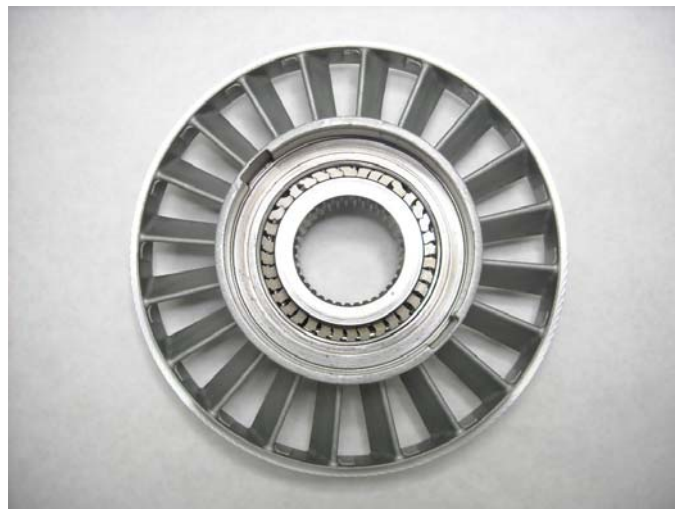
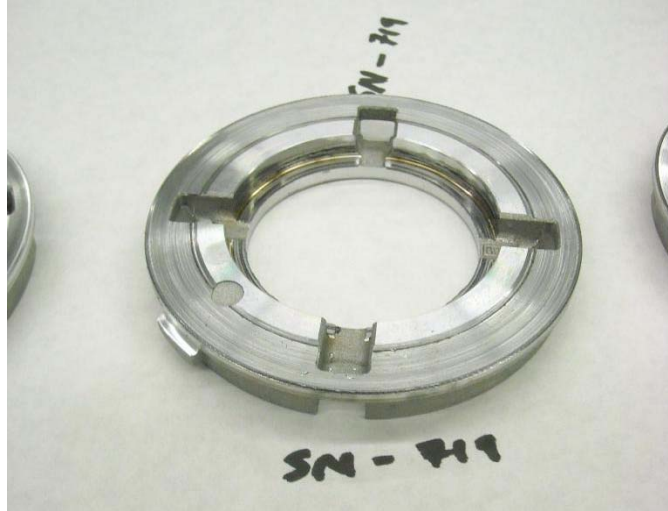
Consistent with SN455, the failure in transmission SN719 was attributable to a damaged or malfunctioning stator assembly. As shown below in Figure 14 and Figure 15, like SN455, the retainer plate and one-way clutch assembly has moved relative to one another causing severe wear on both surfaces. Again, a complete seizure of the one-way clutch was found, likely due to galled doglegs in the assembly.

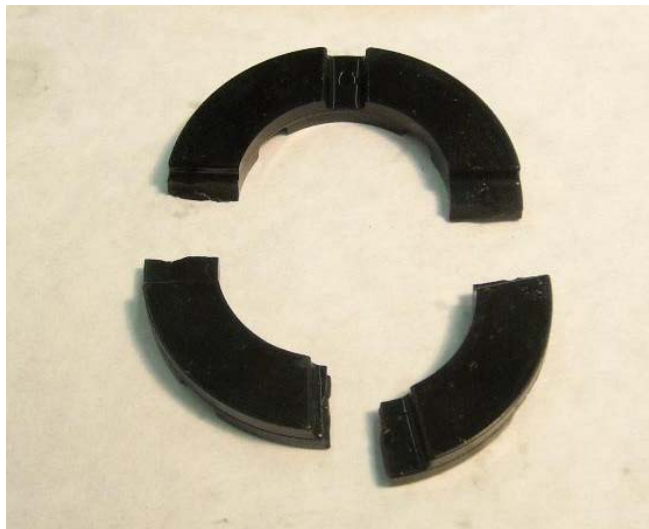
Figure 16 - SN719 Turbine Housing Support Bushing/Thrust Washer

In addition to the failed stator, SN719 was also found to have a broken turbine housing support bushing/thrust washer as shown below in Figure 16. It is likely that this was caused by other problems (i.e. lockup clutch chatter, heat, etc), and is a result of the overall failure and not a cause.

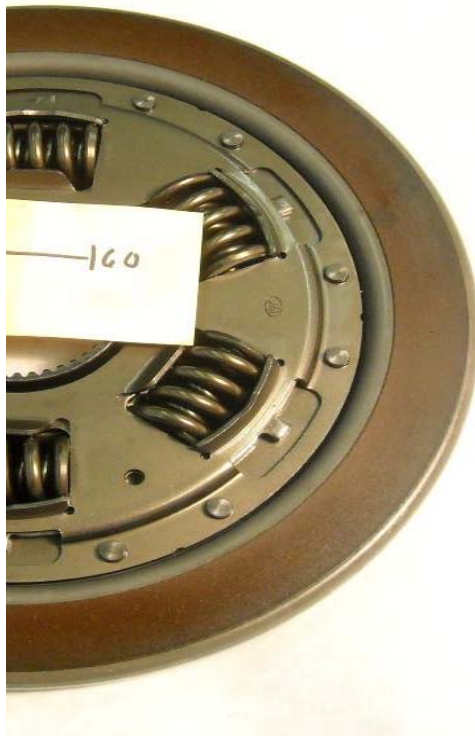
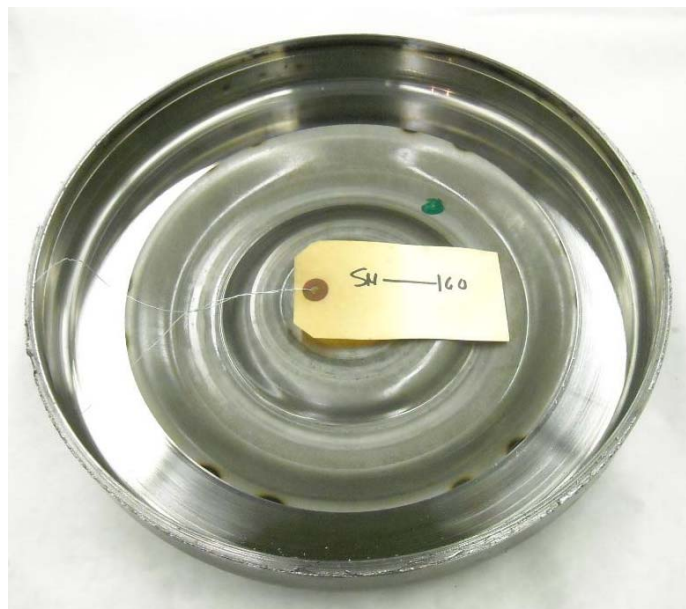
SN160 lockup clutch assembly was found to be in like new condition, with little to no darkening of the friction material, and no polishing or hot spots present on the reaction plate. SN160's lockup friction disk and reaction plate can be seen below in Figure 17 and Figure 18 respectively.

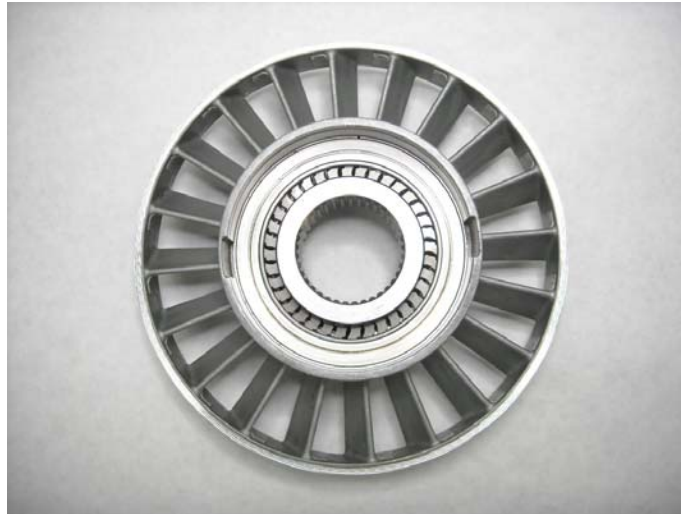
Figure 19 - SN160 Stator Clutch Assembly

Like SN455 and SN719, the failure is attributable to a malfunctioned stator assembly on SN160. However, differences existed between the severity of wear found, and overall condition when compared with the two previous units. Again there was evidence of relative motion between the retainer plate and outer housing of the one-way clutch, but not to the severity of the other units. Like before, it is likely that high temperature caused the expansion of the stator turbine wheel and allowed the one-way clutch assembly to free spin within the stator turbine wheel. From the damage found, it appears as if this unit was removed from service more quickly, as the wear on the retainer plate is minimal. Different from the previous units, the one-way clutch was found to still be operable and did not show signs of premature wear. Figure 19 below shows SN160 stator and one-way clutch assembly.

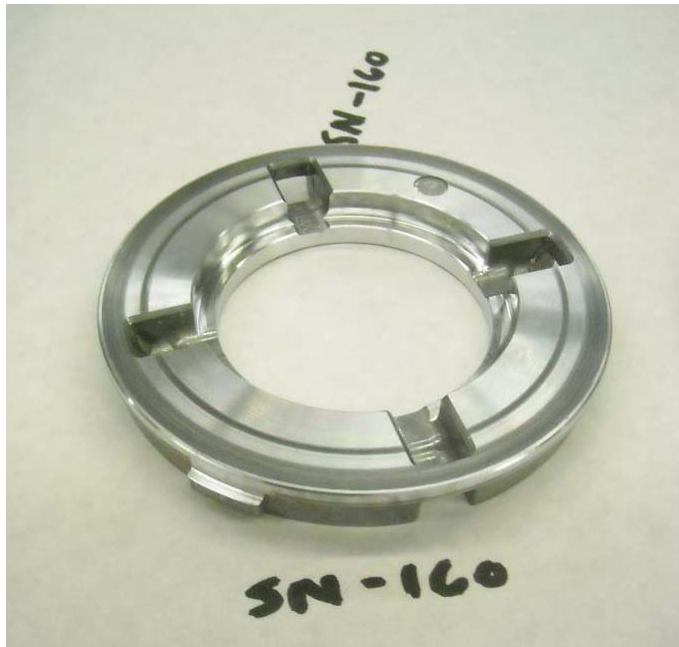
Figure 20 - SN160 Retainer Plate Wear

Similar to the previous retainer plates, the wear patterns on SN160's retainer plate were consistent and showed similar high and low wear areas on its surface. SN160's retainer plate can be seen below in Figure 20.

It is likely that with continued use, SN160's retainer plate would continue to wear against the one-way clutch causing wear metals to enter the one-way clutch assembly resulting in an eventual seizure consistent with SN455 and SN719.

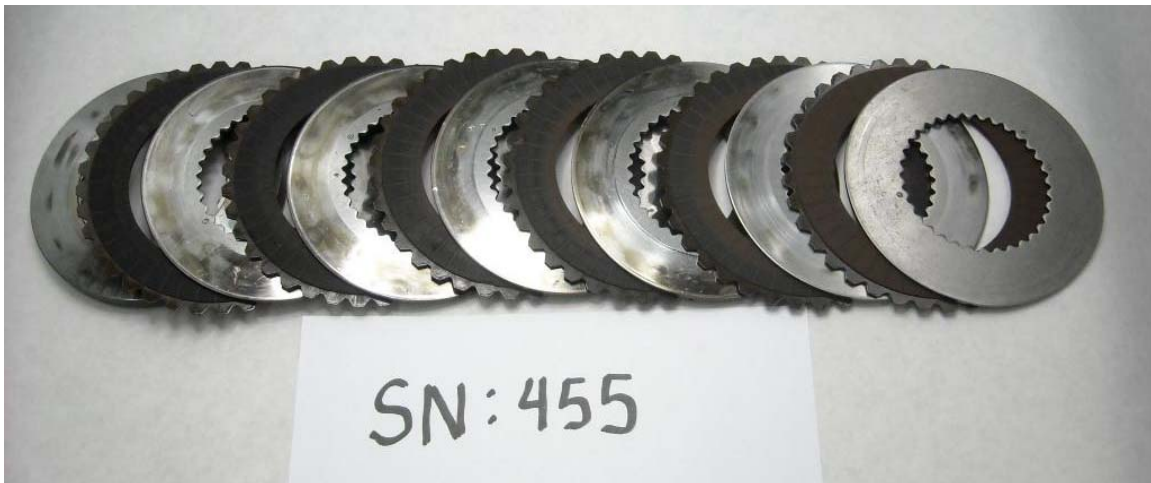
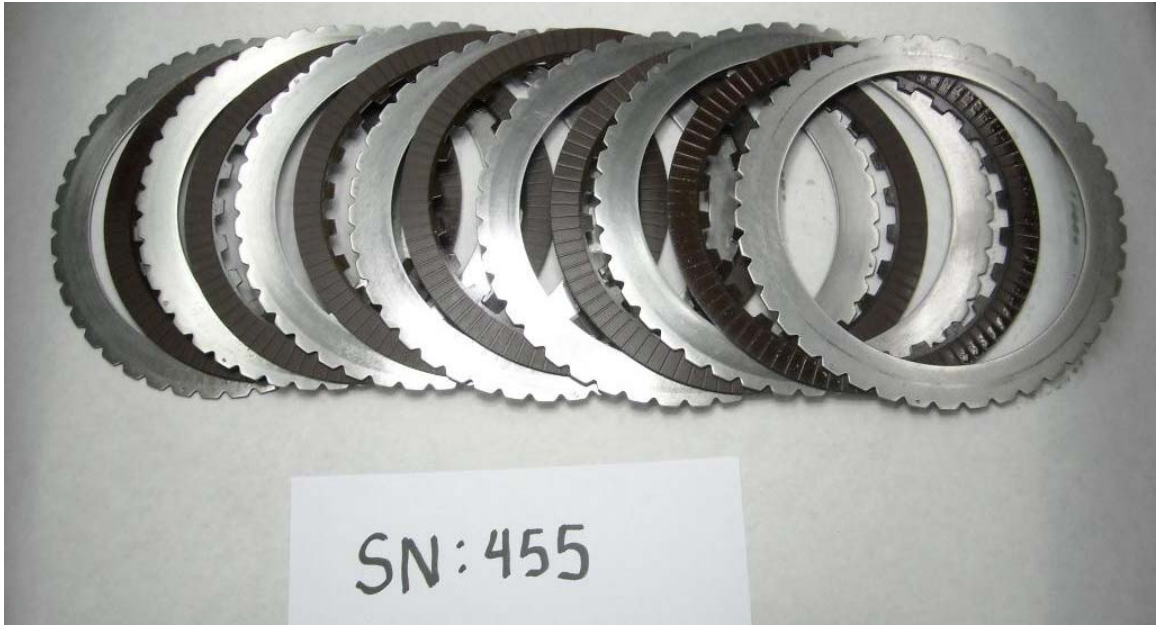
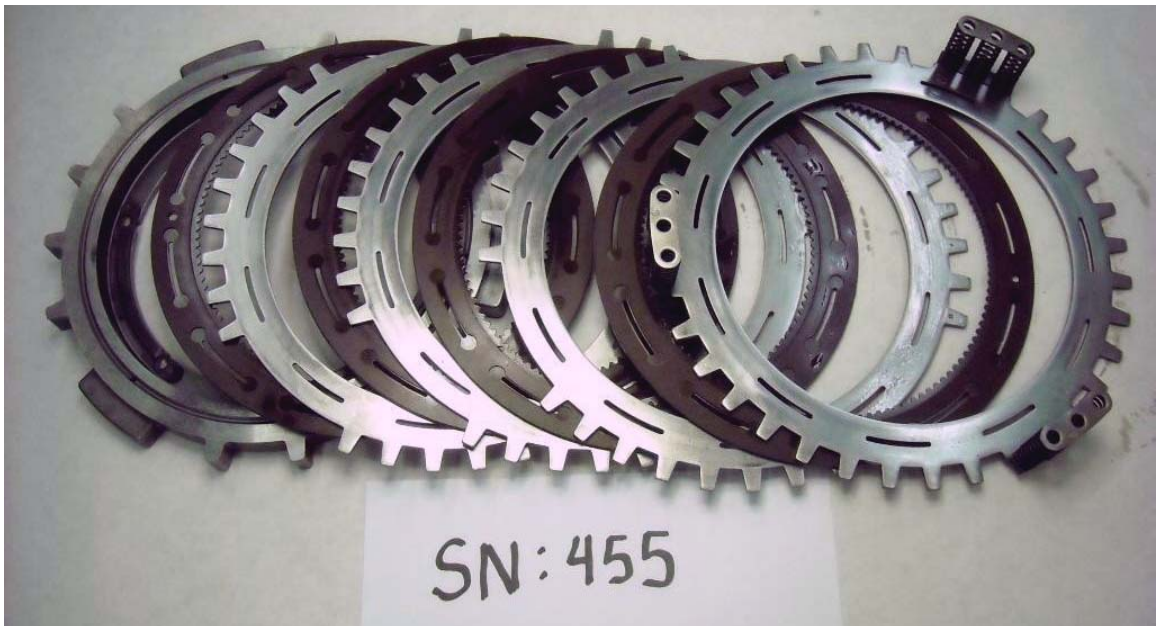
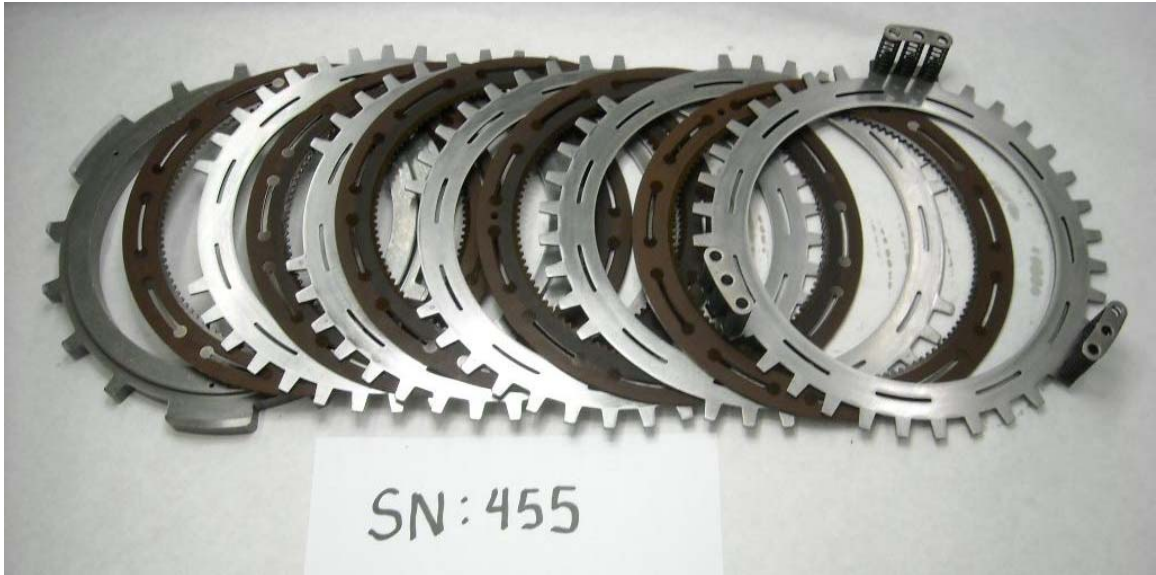
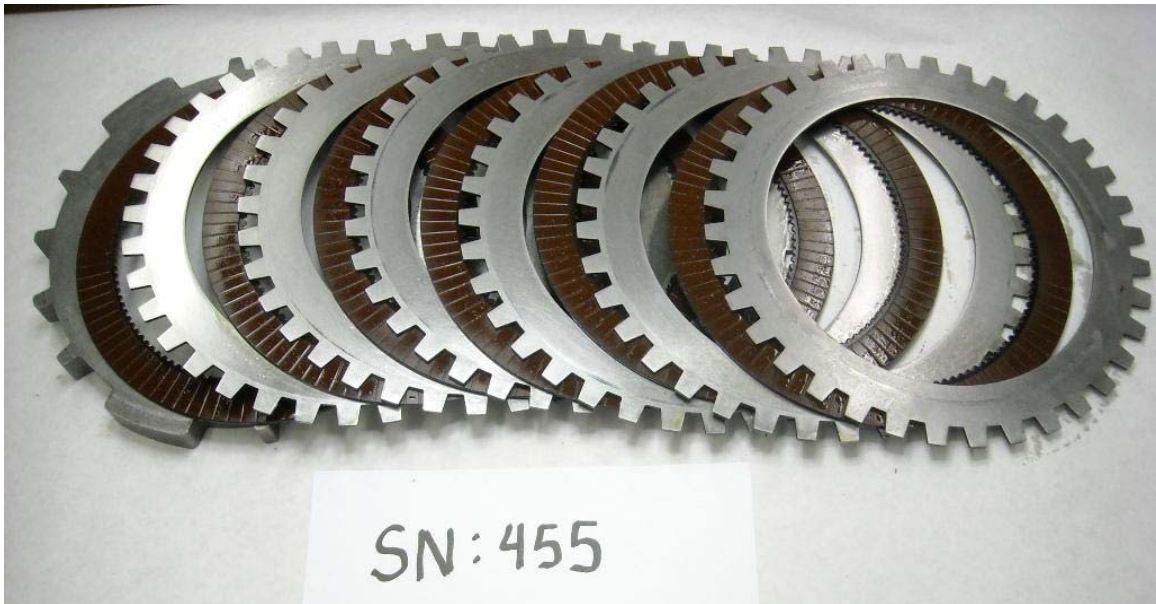
Each clutch pack (friction disk and reaction plates) is shown below in sequential order from C1 to C5. SN455 experienced the most clutch damage due to high fluid temperatures. C1 clutch pack had to be forcibly removed from the transmission due to warped reaction plates.

C1 CLUTCH STEEL PLATES	WARPAGE OF CLUTCH PLATES, HAD TO BE REMOVED BY FORCE
C1 CLUTCH PAPER PLATES	WARPAGE OF CLUTCH PLATES, HAD TO BE REMOVED BY FORCE, PLATES ARE DARKENED WITH SOME GLAZING
C2 CLUTCH STEEL PLATES	SLIGHTLY POLISHED WITH NO ABNORMAL WEAR
C2 CLUTCH PAPER PLATES	SLIGHT BROWN DISCOLORATION
C3 CLUTCH STEEL PLATES	SLIGHT POLISHING WITH SOME HEAT SPOTS
C3 CLUTCH PAPER PLATES	VERY SLIGHT DARKENING
C4 CLUTCH STEEL PLATES	SLIGHTLY POLISHED WITH NO ABNORMAL WEAR
C4 CLUTCH PAPER PLATES	DARKENING IN INNER RADIUS OF THE PLATES WITH PLATE IDENTIFICATION NUMBERS VISBLE
C5 CLUTCH STEEL PLATES	SLIGHTLY POLISHED WITH NO ABNORMAL WEAR
C5 CLUTCH PAPER PLATES	VERY SLIGHT DARKENING WITH PLATE IDENTIFICATION NUMBERS VISBLE
THRUST WASHER	LIGHT WEAR, POLISHED WITH SOME LIGHT DEPOSITS AND CORROSION
BUSHINGS	SLIGHT POLISHING WITH NO ABNORMAL WEAR
FRONT PUMP	NO ABNORMAL DETERIORATION OR WEAR, 60% PHOSPHATE COATING REMAINING ON PUMP GEAR TEETH

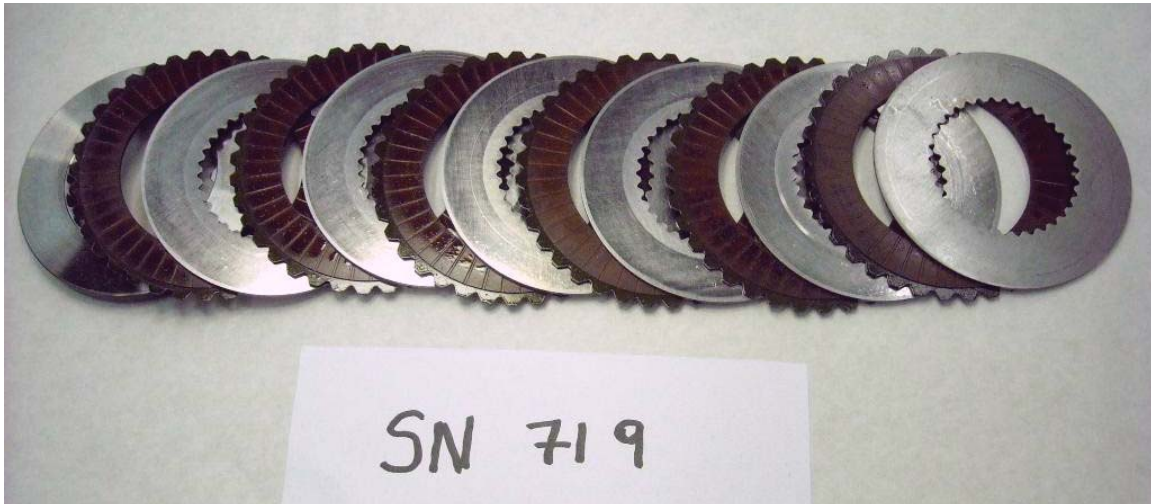
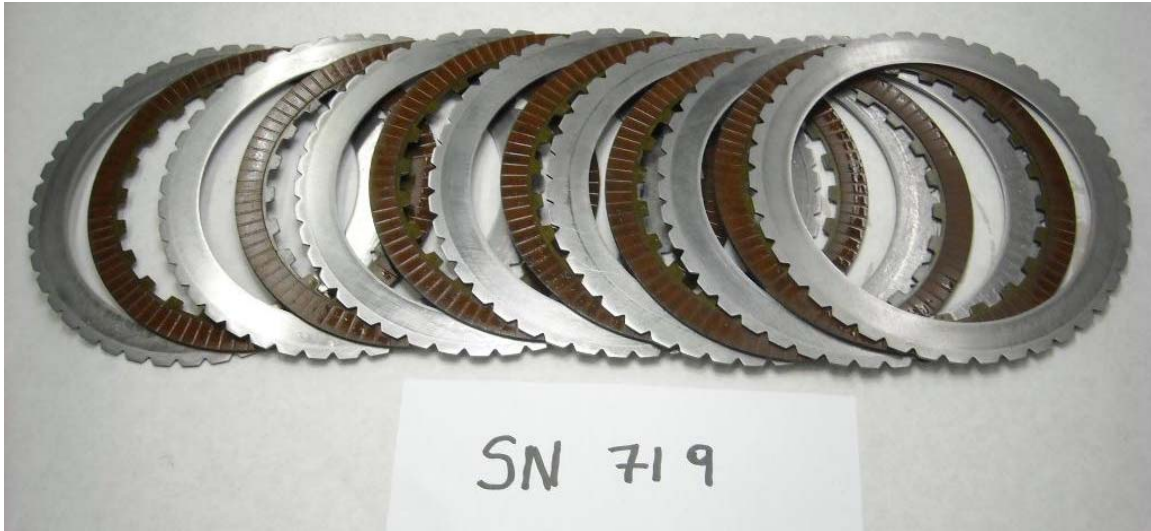
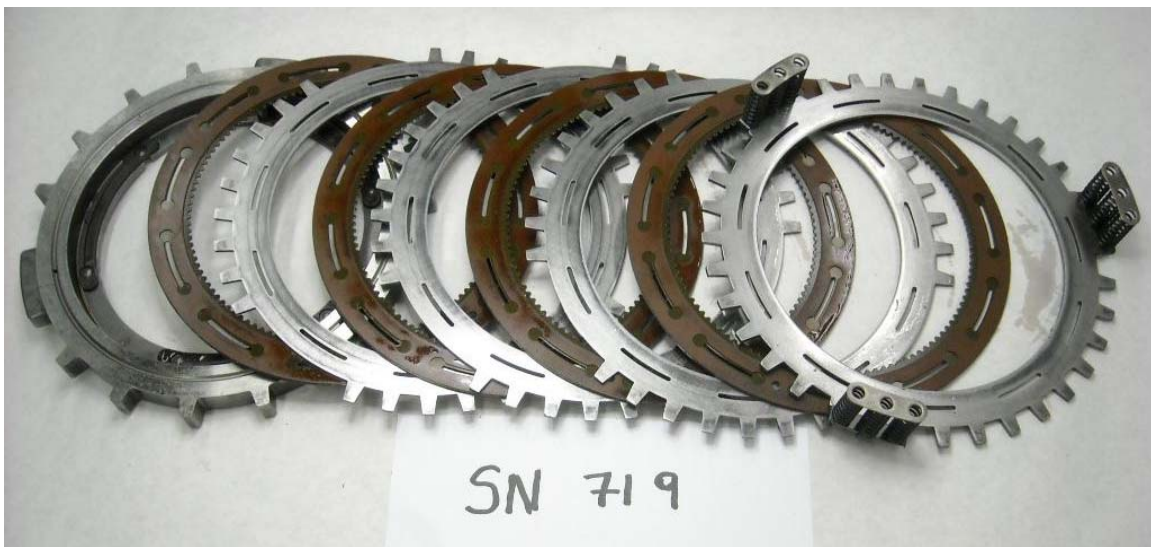
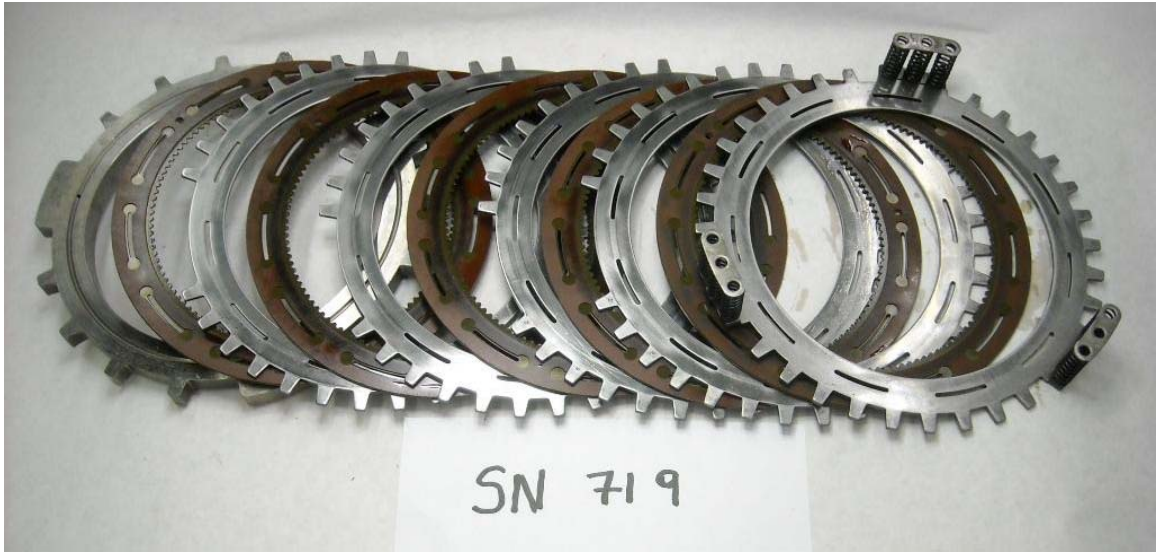
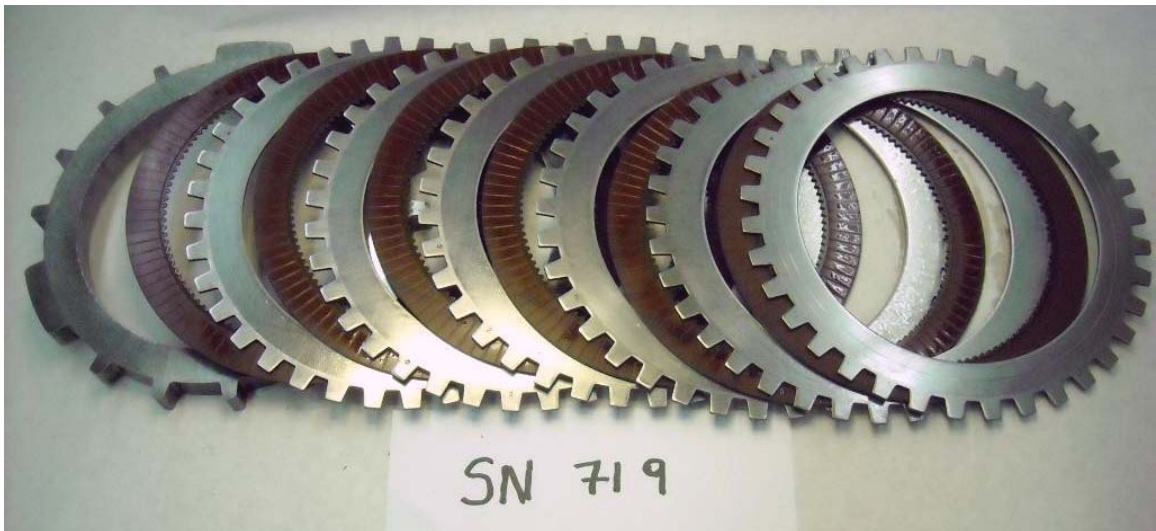
Each clutch pack (friction disk and reaction plates) is shown below in sequential order from C1 to C5. SN719 only experienced minor clutch damage, primarily C1 and C4, but was overall found to still be in operable condition.

C1 CLUTCH STEEL PLATES	SLIGHTLY POLISHED WITH NO ABNORMAL WEAR
C1 CLUTCH PAPER PLATES	VERY SLIGHT DARKENING WITH PLATE IDENTIFICATION NUMBERS VISIBLE
C2 CLUTCH STEEL PLATES	SLIGHTLY POLISHED WITH NO ABNORMAL WEAR
C2 CLUTCH PAPER PLATES	VERY SLIGHT DARKENING WITH PLATE IDENTIFICATION NUMBERS VISIBLE
C3 CLUTCH STEEL PLATES	POLISHED WITH NO ABNORMAL WEAR
C3 CLUTCH PAPER PLATES	VERY SLIGHT DARKENING WITH PLATE IDENTIFICATION NUMBERS VISIBLE
C4 CLUTCH STEEL PLATES	POLISHED WITH NO ABNORMAL WEAR
C4 CLUTCH PAPER PLATES	DARKENING IN INNER RADIUS OF THE PLATES WITH PLATE IDENTIFICATION NUMBERS VISBLE
C5 CLUTCH STEEL PLATES	VERY SLIGHTLY POLISHED WITH NO ABNORMAL WEAR
C5 CLUTCH PAPER PLATES	VERY SLIGHT DARKENING WITH PLATE IDENTIFICATION NUMBERS VISIBLE
THRUST WASHER	LIGHT WEAR, HAS SOME BLACK DEPOSITS
BUSHINGS	SLIGHT POLISHING WITH NO ABNORMAL WEAR
FRONT PUMP	NO ABNORMAL DETERIORATION OR WEAR, 60% PHOSPHATE COATING REMAINING ON PUMP GEAR TEETH

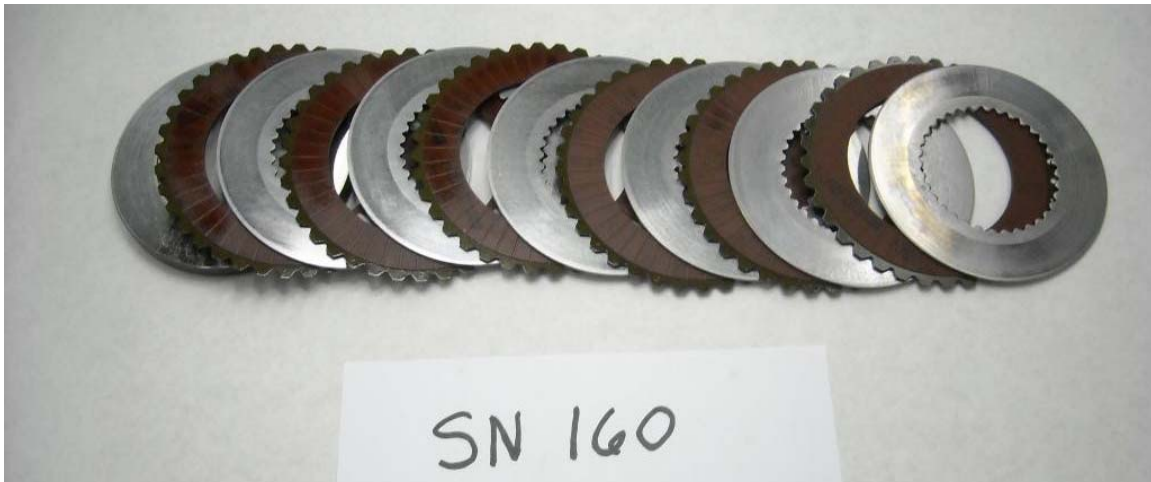
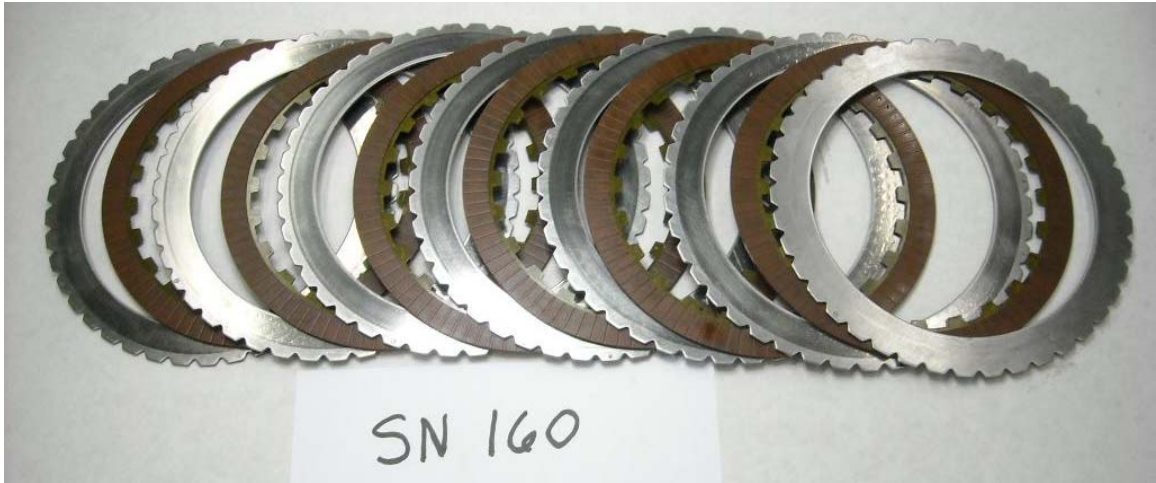
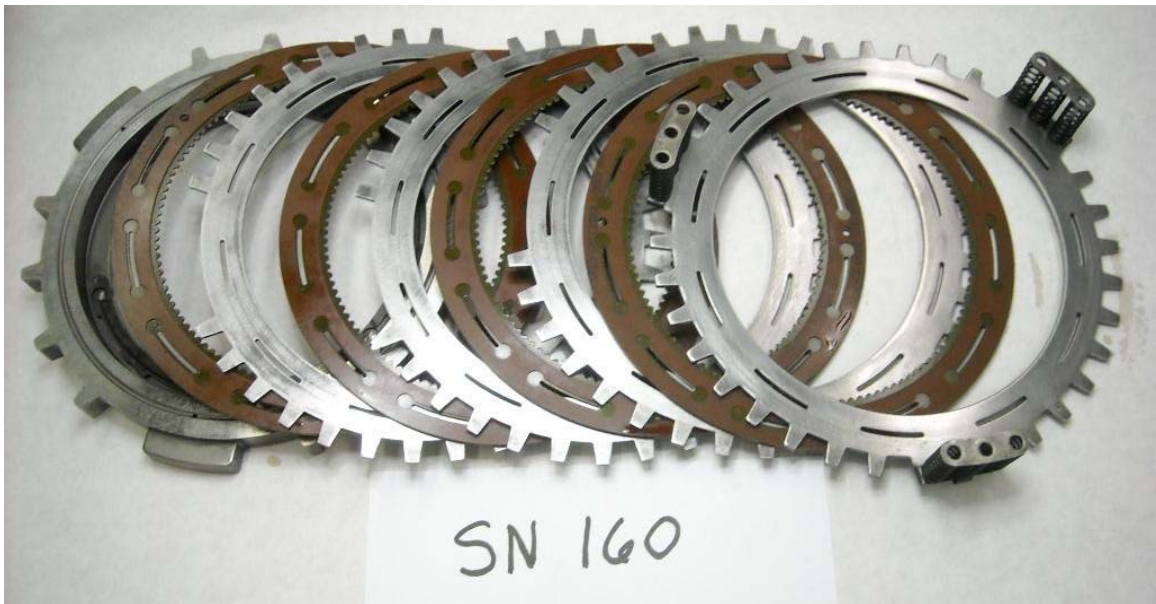
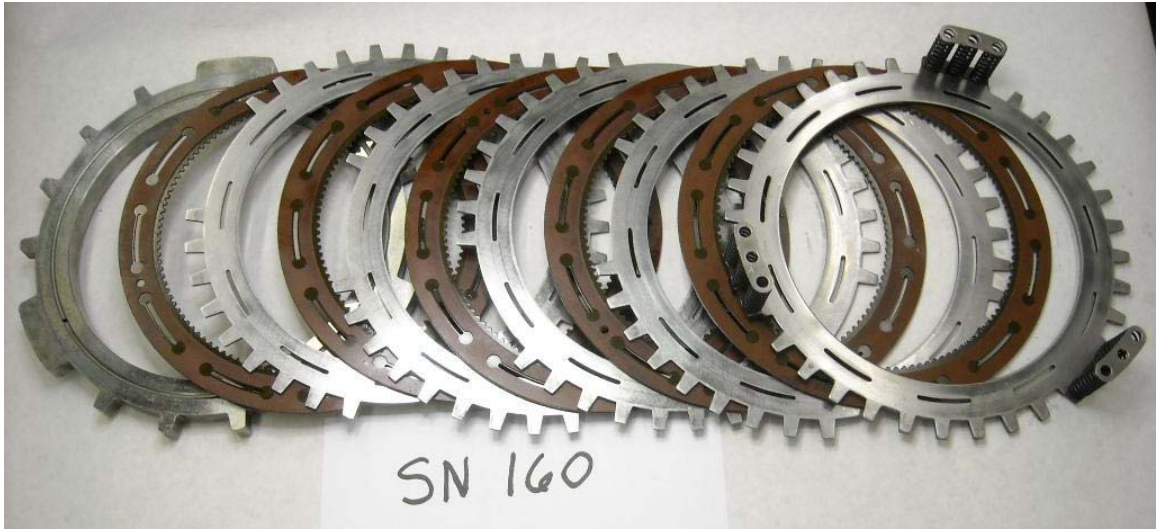
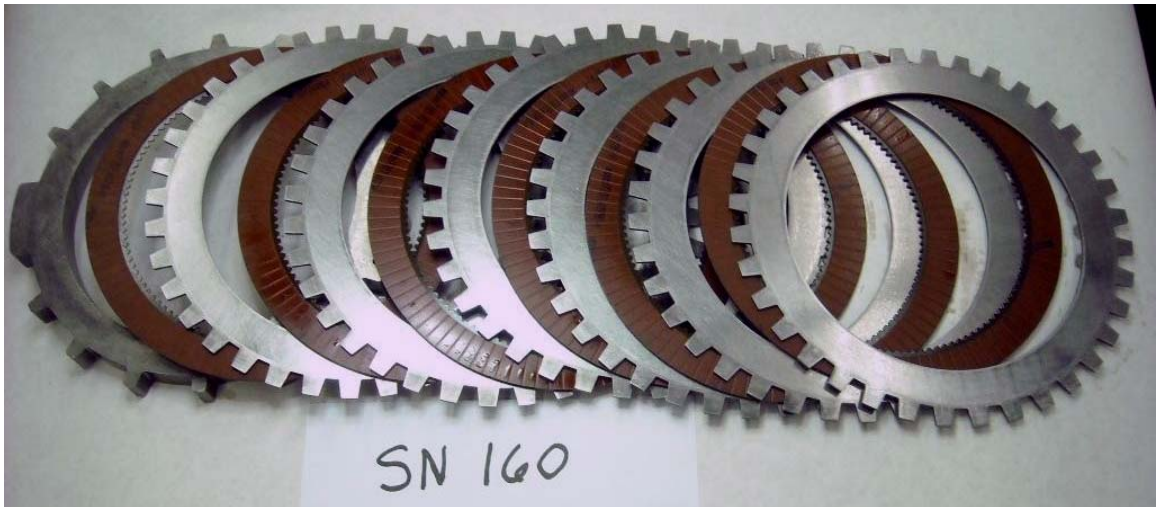
Each clutch pack (friction disk and reaction plates) is shown below in sequential order from C1 to C5. SN160 was found to be in the best overall condition. No clutches showed signs of major damage. Many friction disks retained the factory stampings indicating very minimal use.

C1 CLUTCH STEEL PLATES	POLISHED WITH NO ABNORMAL WEAR
C1 CLUTCH PAPER PLATES	PLATE IDENTIFICATION NUMBERS VISIBLE WITH NO VISUAL WEAR OR DISTRESS
C2 CLUTCH STEEL PLATES	POLISHED WITH NO ABNORMAL WEAR
C2 CLUTCH PAPER PLATES	VERY SLIGHT DARKENING WITH PLATE IDENTIFICATION NUMBERS VISBLE
C3 CLUTCH STEEL PLATES	SLIGHTLY POLISHED WITH NO ABNORMAL WEAR
C3 CLUTCH PAPER PLATES	VERY SLIGHT DARKENING WITH PLATE IDENTIFICATION NUMBERS VISBLE
C4 CLUTCH STEEL PLATES	SLIGHTLY POLISHED WITH NO ABNORMAL WEAR
C4 CLUTCH PAPER PLATES	VERY SLIGHT DARKENING WITH PLATE IDENTIFICATION NUMBERS VISBLE
C5 CLUTCH STEEL PLATES	SLIGHTLY POLISHED WITH NO ABNORMAL WEAR
C5 CLUTCH PAPER PLATES	VERY SLIGHT DARKENING WITH PLATE IDENTIFICATION NUMBERS VISBLE
THRUST WASHER	POLISHED WITH SOME BLACK DEPOSITS
BUSHINGS	SLIGHT POLISHING WITH NO ABNORMAL WEAR
FRONT PUMP	NO ABNORMAL DETERIORATION OR WEAR, ALL PHOSPHATE COATING REMAINING ON PUMP GEAR TEETH
