**4TH BRIGADE, 10TH INFANTRY DIVISION
IRAQI ARMY HEADQUARTERS BARRACKS
MISSAN PROVINCE, IRAQ**

SUSTAINMENT ASSESSMENT

**SIGIR PA-08-164
JULY 20, 2009**

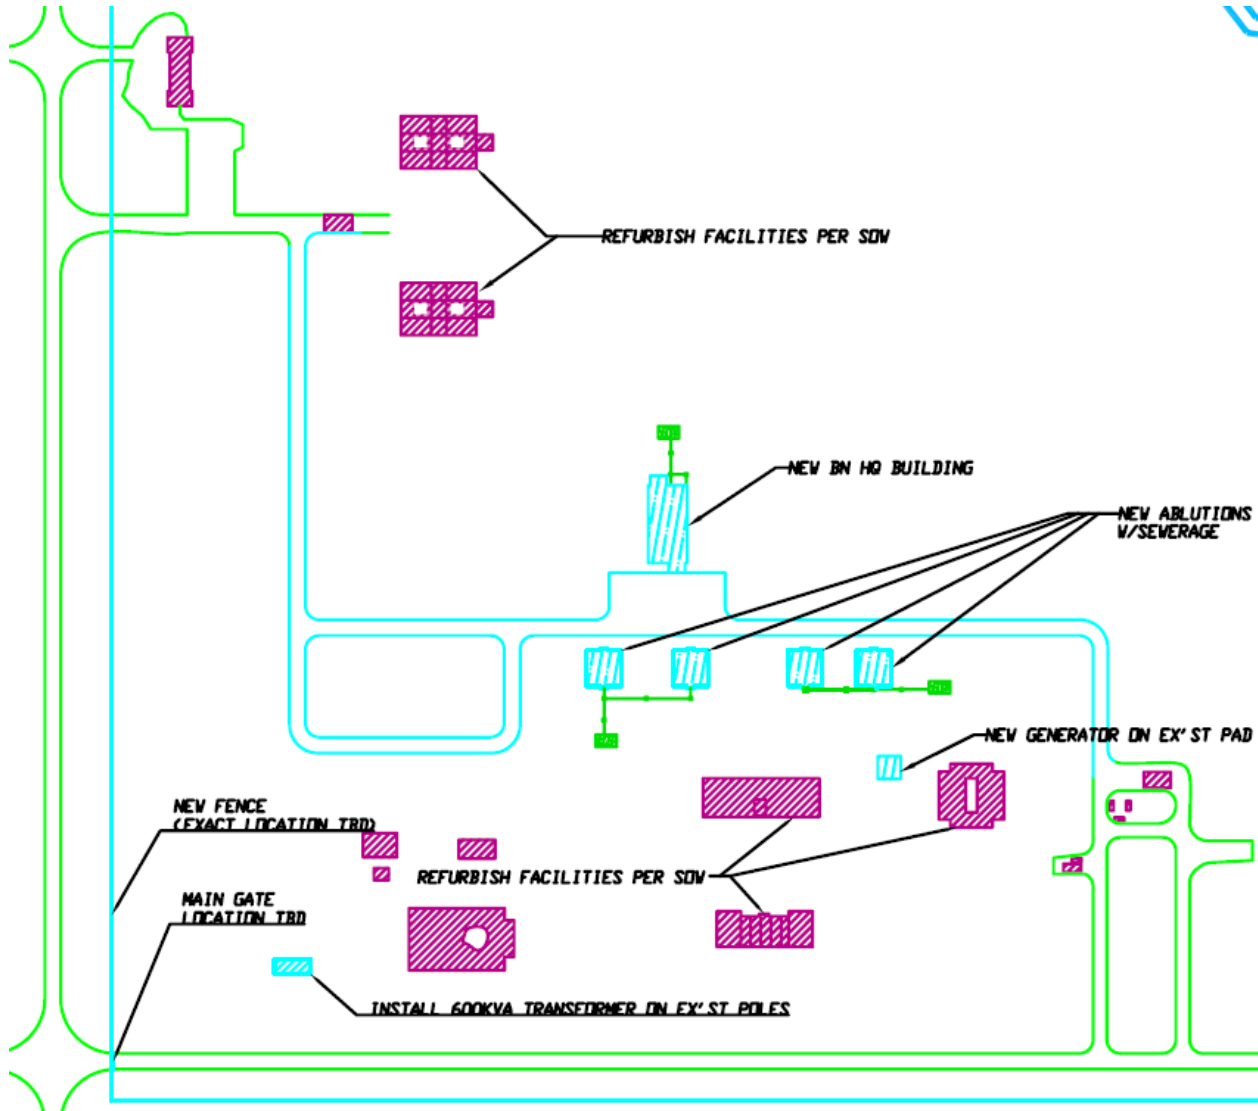
Figure 1. Government Furnished Design C-001 site plan showing the existing and proposed buildings

The project documentation clearly identifies specific drawings that were to be supplied to the contractor for use during construction. The GFDs provided to SIGIR were determined to be adequate to outline the scope of the project for the contractor but were not adequate to construct the project. SIGIR requested additional contractor-furnished drawings from both GRD and GRS, but neither was able to locate the design drawings. The lack of available design drawings limited the ability of SIGIR to determine the adequacy of the project's design. However, the detailed list of specifications provided in the SOW did provide GRS with a limited basis for requiring the contractor to meet some minimum standards during the construction of this project.

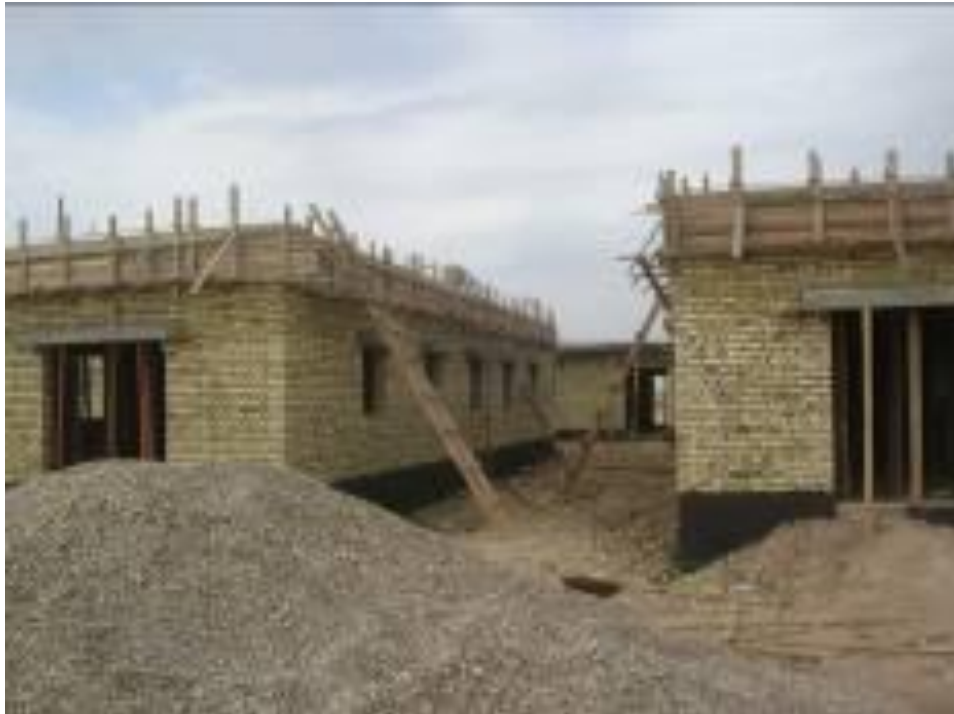
Site Photo 2. Latrine buildings (Courtesy of GRS)

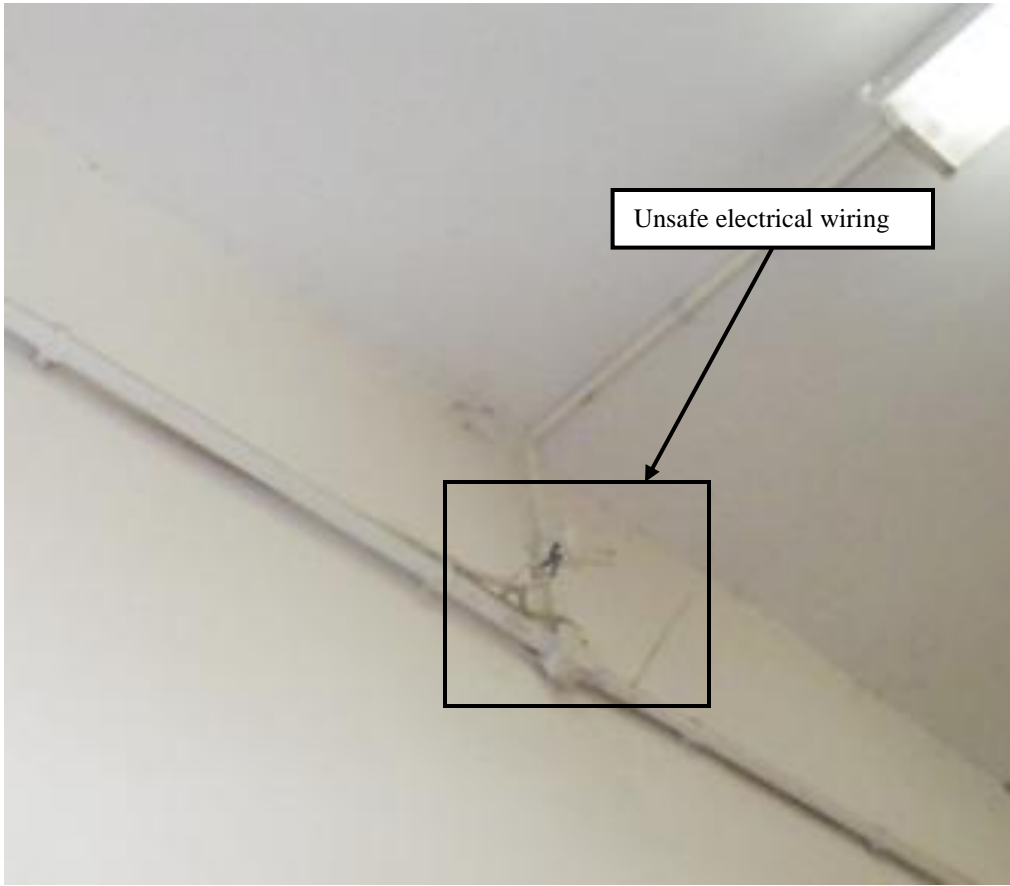
The building construction used typical Iraqi techniques for brick or block walls with a mortar/plaster/paint finish. The building exterior had areas of sandstone cladding (covering of one material with another) and areas of mortar/plaster/paint finish. The flooring was mostly terrazzo tile and a few offices were carpeted. The electrical system appeared to be well constructed, but had poor-quality fixtures. SIGIR noted unsafe electrical connections (Site Photo 3). The heating, ventilation, and air-conditioning system (HVAC) consisted of individual split units, which on-site personnel reported to be working. SIGIR found one room in which the tile flooring had significantly settled. This appeared to be the only major defect in the building. The remainder of the building appeared to be well maintained; however, wall tiles behind the stove and preparation tables in the battalion headquarters kitchen area were missing (Site Photo 4).

Site Photo 3. Unsafe electrical wiring

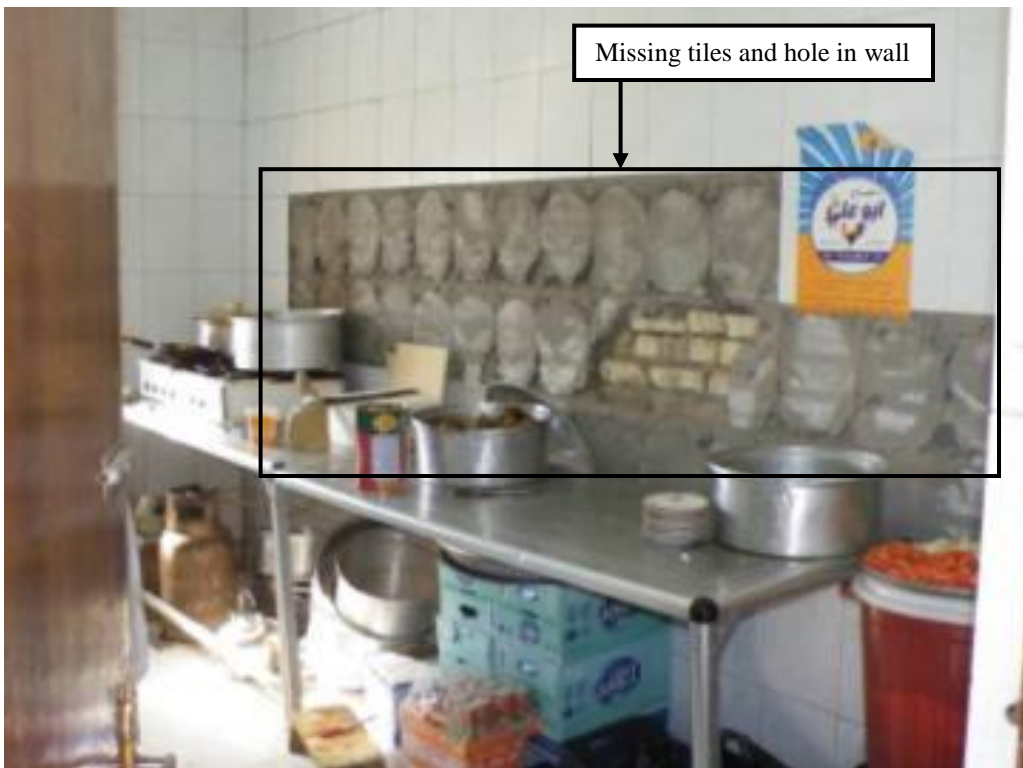
Site Photo 4. Damaged kitchen wall and tiles

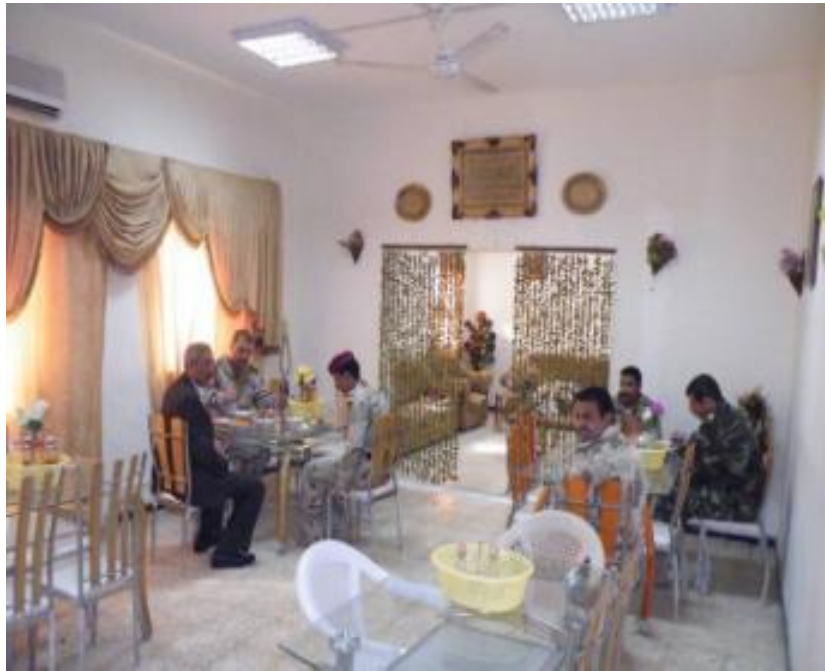
Because the contract did not provide for furnishings, GRS personnel were not sure if the furnishings were transferred from another facility or purchased by the Government of Iraq. The commander's office and the dining area furnishings appeared functional, but not very durable (Site Photo 5).

Site Photo 5. Commander's dining area

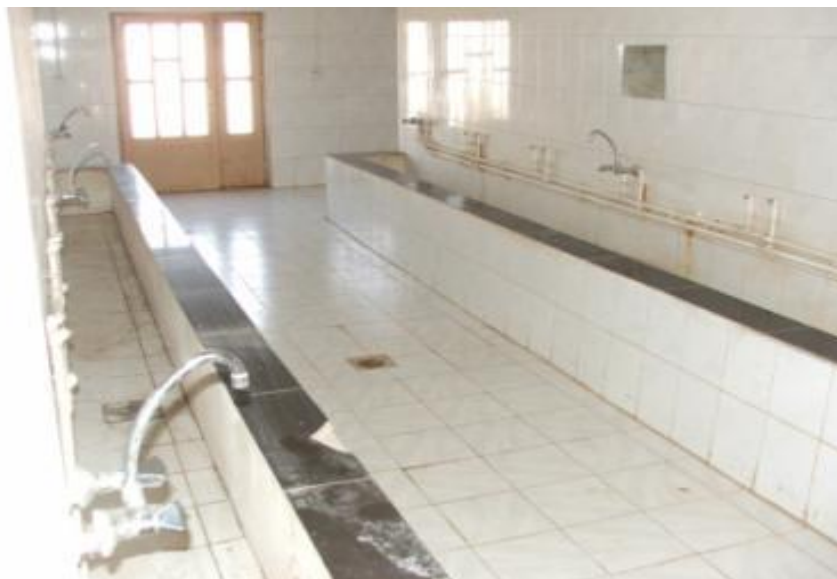
The SOW stated that the contractor was to construct four 12 x 12.4 m latrine buildings. The facilities would contain 20 water closets, 20 showers, and 28 faucets for hand washing. Site Photo 6 shows the hand-washing area. The restrooms were functional; however, SIGIR observed cracks in the tile, missing and broken faucets, and a lack of housekeeping evident by the level of cleanliness observed.

Site Photo 6. Hand-washing station

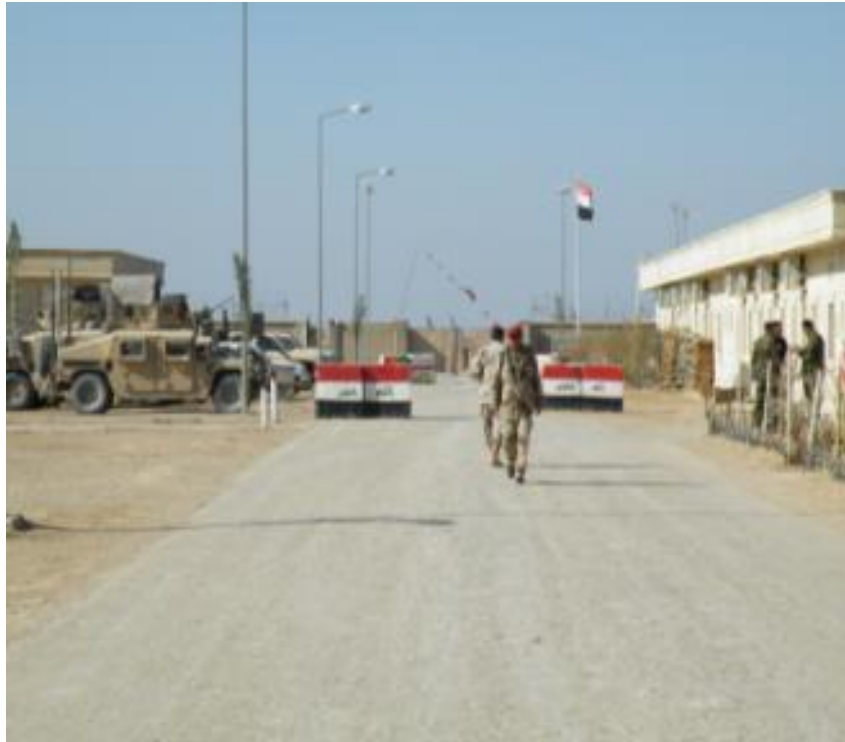
The contractor was required to construct a 7 m-wide aggregate roadway to connect the new construction with the existing roads. SIGIR observed that the project had paved roadways between the buildings connecting to the main entrance (Site Photo 7). Also, the security lights were to be mounted on 4 m-high poles. During the site visit, SIGIR observed mounted security lights around the perimeter wall.

Site Photo 7. Paved road

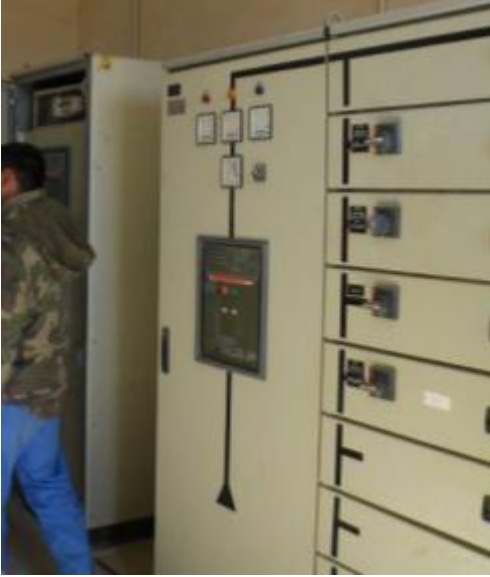
During the site assessment, SIGIR observed the electrical building, which contained several control panels and an automatic transfer switch (Site Photo 8). Two generators were in a separate covered shed that was secured with chain-link fencing (Site Photo 9). On-site personnel stated that the electrical grid was used and the automatic transfer switch was working properly. At the time of the site assessment, the generators were not operating. The generators appeared to have new filters, but the exterior was covered with excessive dust. SIGIR could not verify that any maintenance had been performed on the generators; however, on-site personnel stated that the generators were operational.

Site Photo 8. Electrical control panels

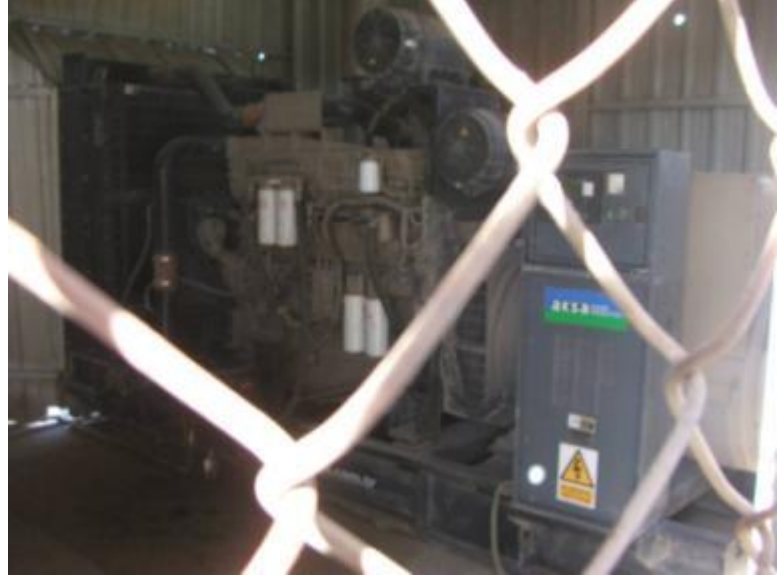
Site Photo 9. Generators

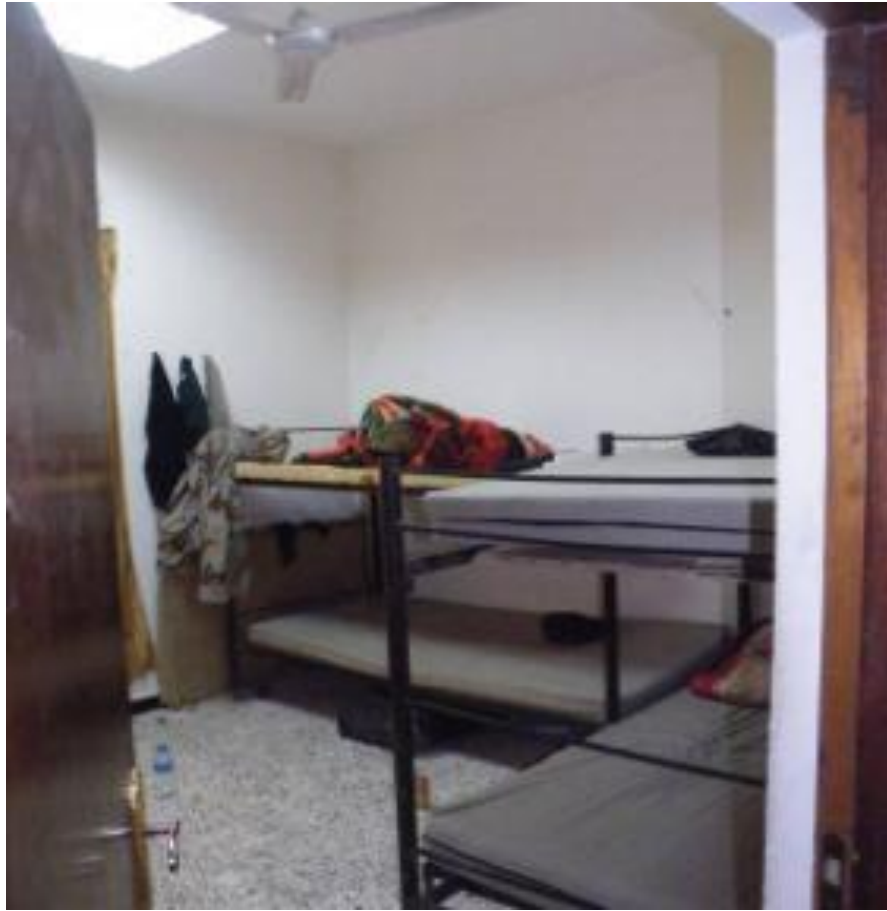
The barracks and office buildings included multiple buildings with sleeping, hand-washing, or storage areas. Barracks building construction used typical Iraqi techniques for brick/block walls with mortar/plaster/paint or tile finish. Also, the exterior consists of areas with sandstone cladding and mortar/plaster/paint finish. The barracks and office buildings had terrazzo tile flooring, and the ceiling was painted concrete with fluorescent lighting. The electrical systems appeared to be well constructed, but poor-quality fixtures were used. The HVAC system consisted of individual split units, which on-site Iraqi personnel stated were working. The sleeping rooms consisted of metal bunks or simple floor mats (Site Photo 10). The faucet fixture quality was poor, and some of the faucets were removed. One of the storage areas was converted into a convenience store to serve the soldiers (Site Photo 11).

Site Photo 10. Sleeping room

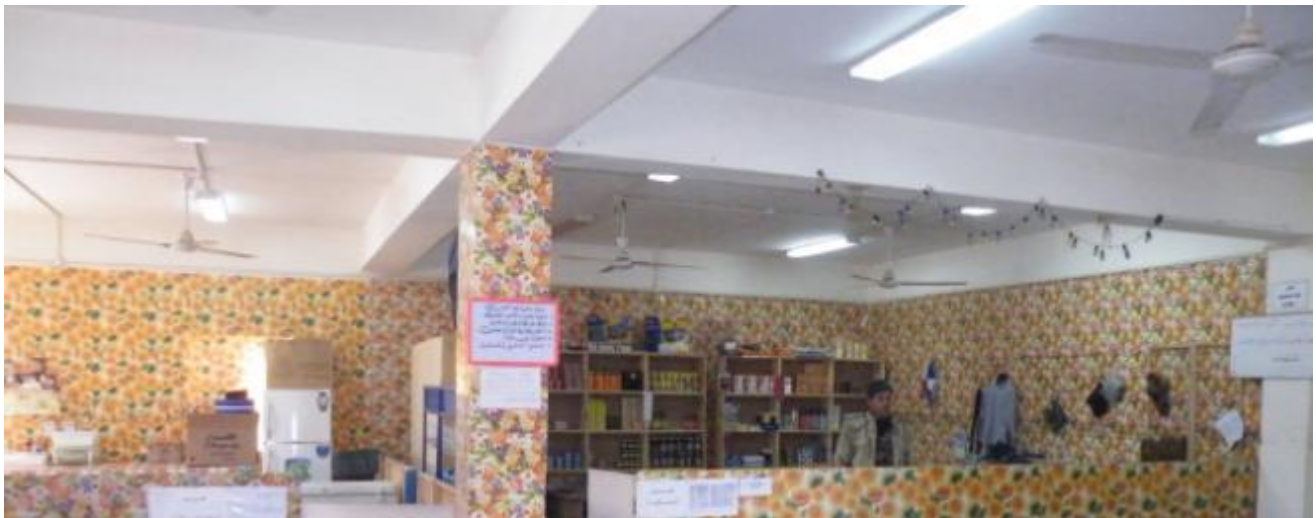
Site Photo 11. Room converted into convenience store

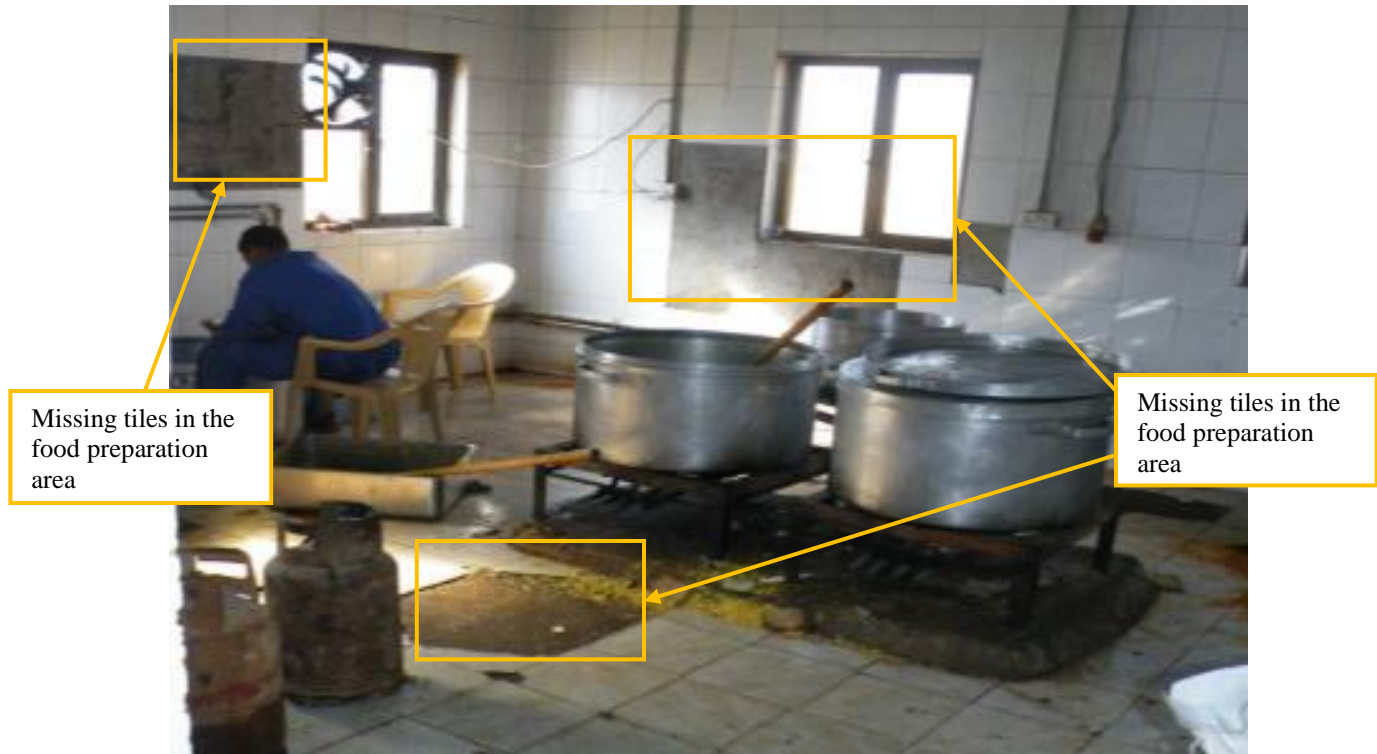
A separate building was used for preparing and cooking the food. This building was similar in construction, but was not well maintained. For example, wall and floor tiles were missing or damaged, and food, dirt, and debris covered the floor and walls (Site Photo 12). Although the food preparation area was designed for electrical food preparation and heating equipment, no electrical equipment was present. Instead, meals were cooked using portable gas cylinders with open-flame grates. The building appeared adequately constructed.

Site Photo 12. Food preparation and cooking area

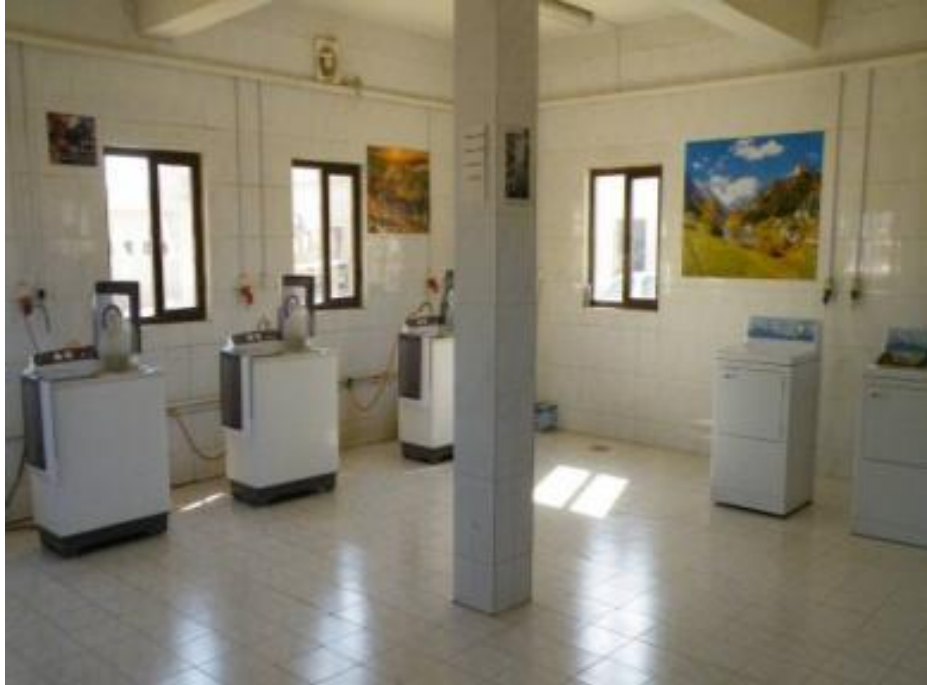
The laundry facility was constructed using the typical brick/block construction with mortar/plaster exterior. The interior was finished with large wall and floor tiles (Site Photo 13). SIGIR found the laundry facility to be well-maintained and in operation at the time of the assessment. The laundry facility was equipped with several washers and dryers, with several electrical and plumbing hookups for additional machines. The electrical and HVAC systems appeared adequately installed and operational.

Site Photo 13. Laundry facility interior

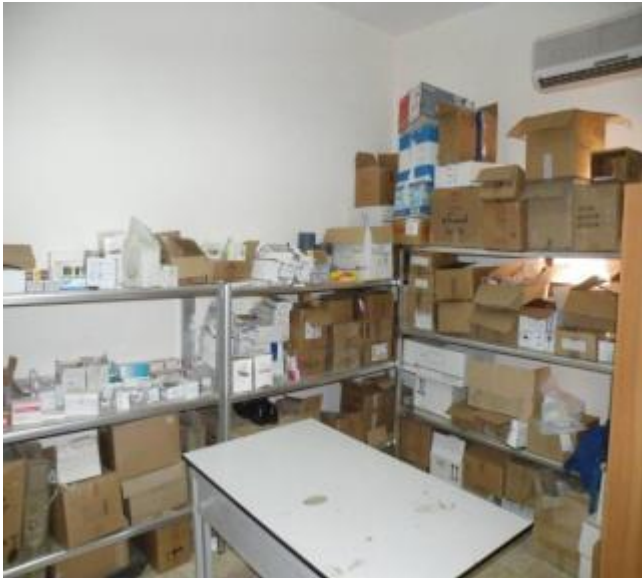
The medical building was constructed using bricks/blocks with mortar/plaster finish. The construction and maintenance of the building was adequate. The interior consisted of a few rooms and was clean but not sterile. At the time of the site visit, no one was being treated; however, medical supplies were readily available (Site Photo 14). SIGIR determined that the medical building was equipped to provide minor medical care to personnel, including dispensing medical supplies, preventing infectious disease, and disbursing pharmaceuticals. SIGIR observed an Iraqi medical technician on site and available.

Site Photo 14. Interior medical room with supplies **Site Photo 15. Equipment maintenance building**

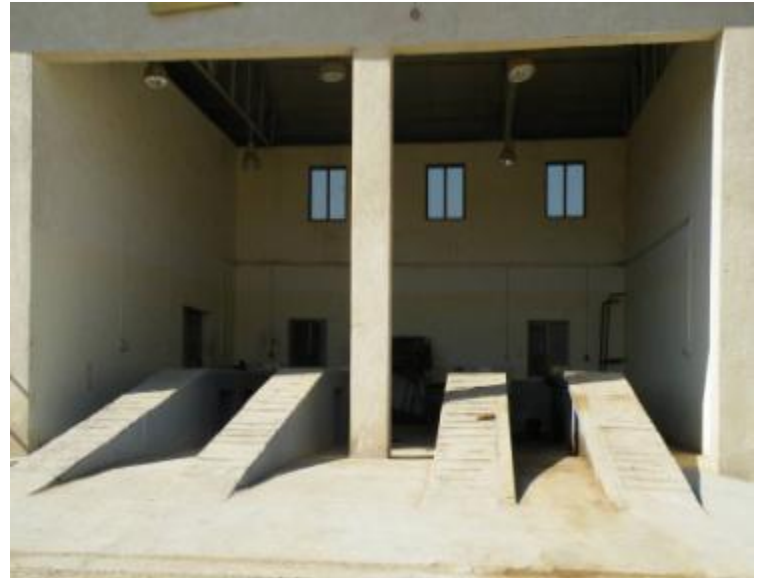
At the time of the assessment, vehicles were not being serviced (Site Photo 15). However, on-site personnel stated that the maintenance building was functioning, and SIGIR observed that the building was adequately maintained.
