October 2009

WARFIGHTER SUPPORT

Independent Expert Assessment of Army Body Armor Test Results and Procedures Needed Before Fielding

Highlights of [GAO-10-119](#), a report to congressional requesters

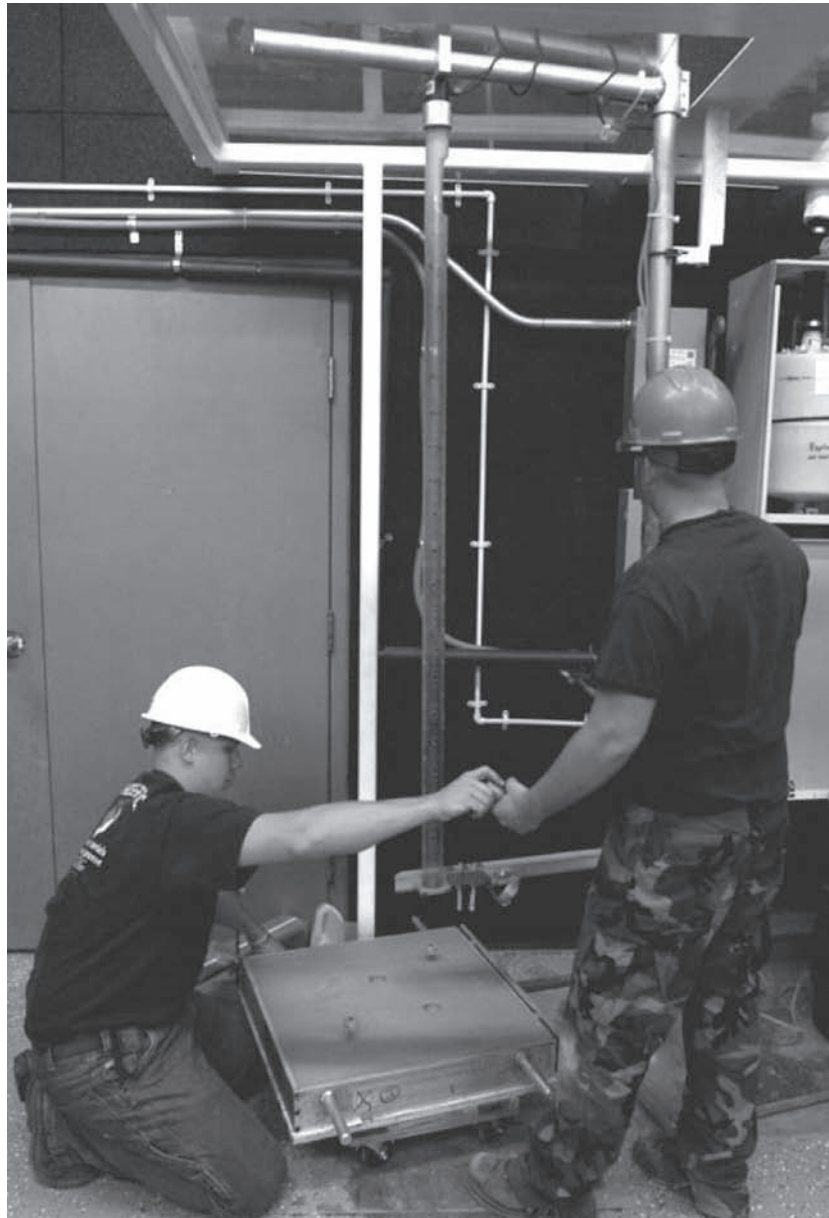
Figure 3: Clay Being Calibrated with Pre-Test Drops

Of potentially greater consequence to the final test results is our observation of deviations from testing protocols regarding the clay calibration tests. According to testing protocols, the calibration of the clay backing material was supposed to be accomplished through a series of pre-test drops.²⁶ The depths of the pre-test drops should have been between 22 and 28 millimeters. Aberdeen Test Center officials told us that during Preliminary Design Model testing they did not follow a consistent system to determine if the clay was conditioned correctly. According to Aberdeen Test Center officials, in cases in which pre-test drops were outside the 22- to 28-millimeter range, testers would sometimes repeat one or all of the drops until the results were within range—thus resulting in the use of clay backing materials that should have been deemed unacceptable for use. These inconsistencies occurred because Army testers in each test lane made their own, sometimes incorrect, interpretation of the testing protocols. Members of the Integrated Product Team expressed concerns about these inconsistencies after they found out how calibrations were being conducted. In our conversations with Army and private body armor testing officials, consistent treatment and testing of clay was identified as critical to ensure consistent, accurate testing. According to those officials if the clay is not conditioned correctly it will impact the test results. Given that clay was used during Preliminary Design Model testing that failed the clay calibration tests, it is possible that some shots may have been taken under test conditions different than those stated in the testing protocols, potentially impacting test results. Figure 3 shows an Army tester calibrating the clay with pre-test drops.

Although Army testers told us that they had orally agreed upon an informal set of procedures to determine when to repeat failed clay calibration tests, those procedures are inconsistent with the established testing protocols. The Army deviated from established testing protocols by using clay that had failed the calibration test as prescribed by the testing protocols. The testing protocols specify that a series of three pre-test drops of a weight on the clay must be within specified tolerances before the clay is used. However, in several instances, the Army repeated the calibration test on the same block of clay after it had initially failed until the results of a subsequent series of three drops were within the required specifications. Army officials told us that the testing protocols do not specify what procedures should be performed when the clay does not pass

On that same day of testing, November 13, 2008, we observed heavy, cold rain falling on the clay blocks that were being transported to test lanes. These clay blocks had been conditioned that day in ovens located outside of the test ranges at temperatures above 100 degrees Fahrenheit to prepare them for testing, and then were transported outside uncovered on a cold November day through heavy rain on the way to the temperature- and humidity-controlled test lane. We observed an abnormally high level of clay blocks failing the clay calibration test and a significantly higher-than-normal level of failure rates for the plates tested on that day. The only significant variation in the test environment we observed that day was constant heavy rain throughout the day. Our analysis of test data³¹ also showed that 44 percent (4 of 9) of the first shots and 89 percent (8 of 9) of the second shots taken on November 13, 2008, resulted in failure

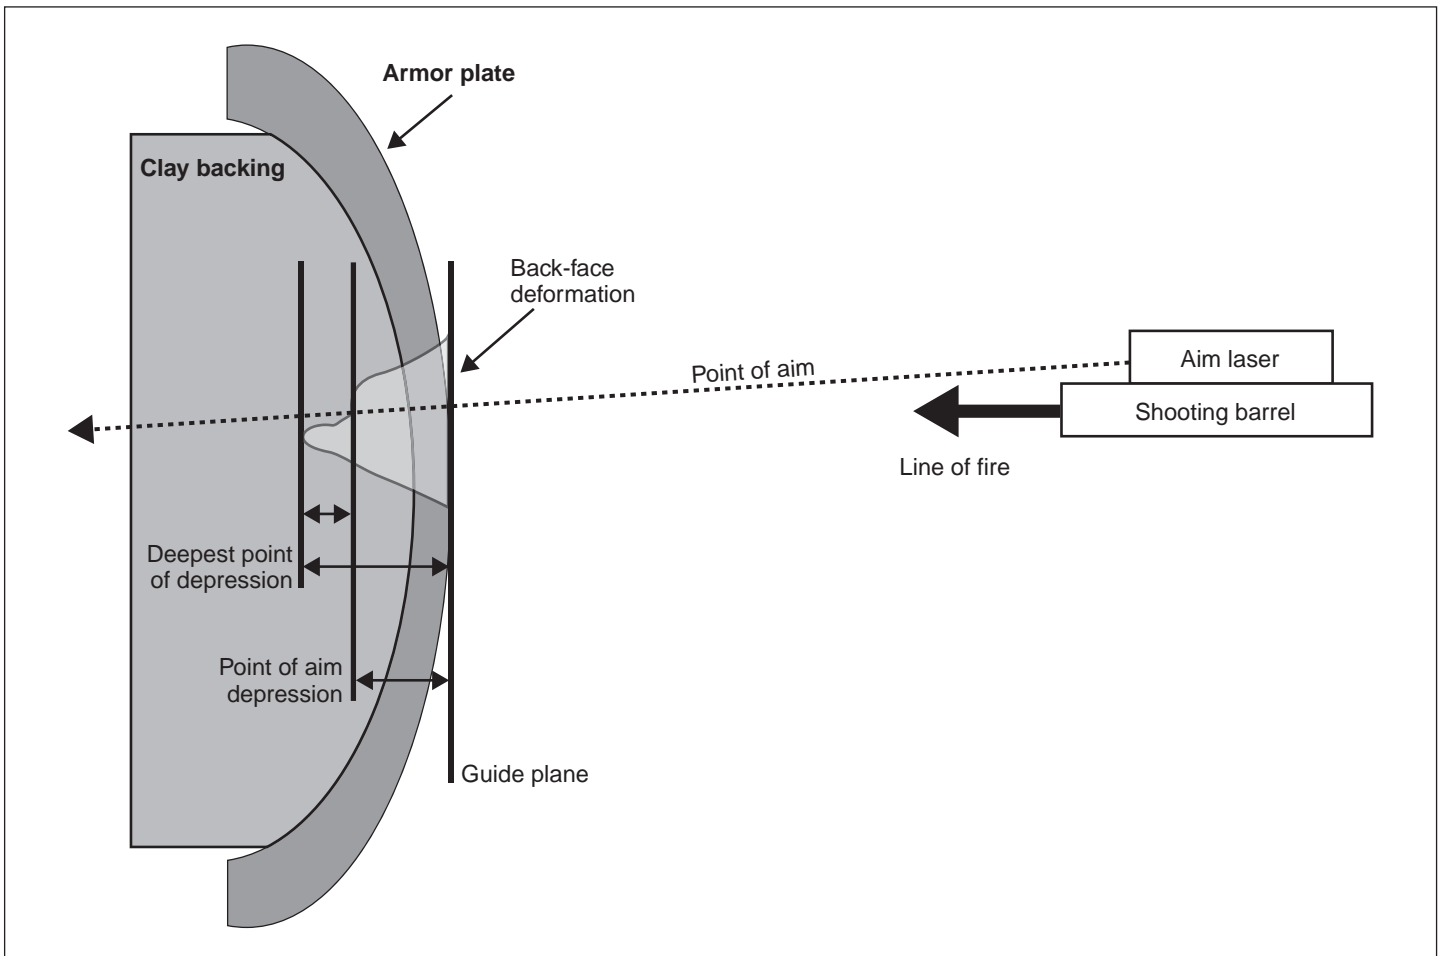
Figure 4: Graphic Representation of the Difference between the Point of Aim and the Deepest Point

During Preliminary Design Model testing the Army took significant steps to run a controlled test and maintain consistency throughout the process but did not always follow established testing protocols and, as a result, did not achieve the intended test objective of determining which designs met performance requirements as a basis for awarding contracts. The Army's significant steps to run a controlled test included, for example, the consistent documentation of testing procedures using audio, video, and other electronic means and extensive efforts to maintain proper temperature and humidity in the test lanes. However, we identified several instances in which the Aberdeen Test Center deviated from testing protocols, including failing to test the ease of insertion of the plates into both pockets of the outer protective vest as required by the testing protocols; shooting several plates at the wrong velocity or location on the plate; and repeating failed clay calibration tests on the same block of clay—the latter having the potential to significantly affect test results. In the most consequential of the deviations from testing protocols, the Army testers incorrectly measured the amount of force absorbed by the designs tested by measuring back-face deformation at the point of aim rather than

at the deepest point of depression.⁷ Army testers recognized the error after completing about a third of the test and then changed the test plan to call for measuring at the point of aim and likewise issued a modification to the contract solicitation. At least two⁸ of the eight designs that passed Preliminary Design Model testing and were awarded contracts would have failed if measurements had been made to the deepest point of depression. The deviations from the testing protocols were the result of Aberdeen Test Center's incorrectly interpreting the testing protocols. Although Aberdeen Test Center officials told us that any deviations from the testing protocols required approval from PEO Soldier, the office of the Director of Operational Test and Evaluation, and other activities, in all these cases the Aberdeen Test Center procedures implemented were not reviewed or approved by officials from PEO Soldier, the Director of Operational Test and Evaluation, and other activities responsible for approving the testing protocols. Furthermore, PEO Soldier representatives were not present at Aberdeen Test Center during most of the testing, an absence that may have contributed to the fact that these deviations were not identified earlier during testing. PEO Soldier officials told us that they were not present at testing in order to ensure the independence of the testing facility, but they later acknowledged that they should have been more involved in that testing and would be more involved in future testing.⁹ After concerns were raised regarding the testing conducted at Aberdeen Test Center under the May 2007 solicitation, the decision was made to not field any of the of the ESAPI and XSAPI plates awarded contracts as a

When members of the Integrated Product Team overseeing the testing were made aware of this error, the Integrated Product Team decided to begin measuring at the deepest point of depression. When senior Army leadership was made aware of this error, testing was halted for 2 weeks while Army leadership considered the situation. Army leadership developed many courses of action, including restarting the entire Preliminary Design Model testing with new armor plate submissions, but ultimately decided to continue measuring and scoring officially at the point of aim, since this would not disadvantage any vendors. The Army then changed the test plans and modified the contract solicitation to call for measuring at the point of aim. The Army also decided to collect deepest point of depression measurements for all shots from that point forward, but only as a government reference. During the second two-thirds of testing, we observed significant differences between the measurements taken at the point of aim and those taken at the deepest point, as much as a 10-millimeter difference between measurements. As a result, at least two of the eight designs that passed Preliminary Design Model testing and were awarded contracts would have failed if the deepest point of depression measurement had been used. Figures 4 and 5 illustrate the difference between the point of aim and the deepest point.

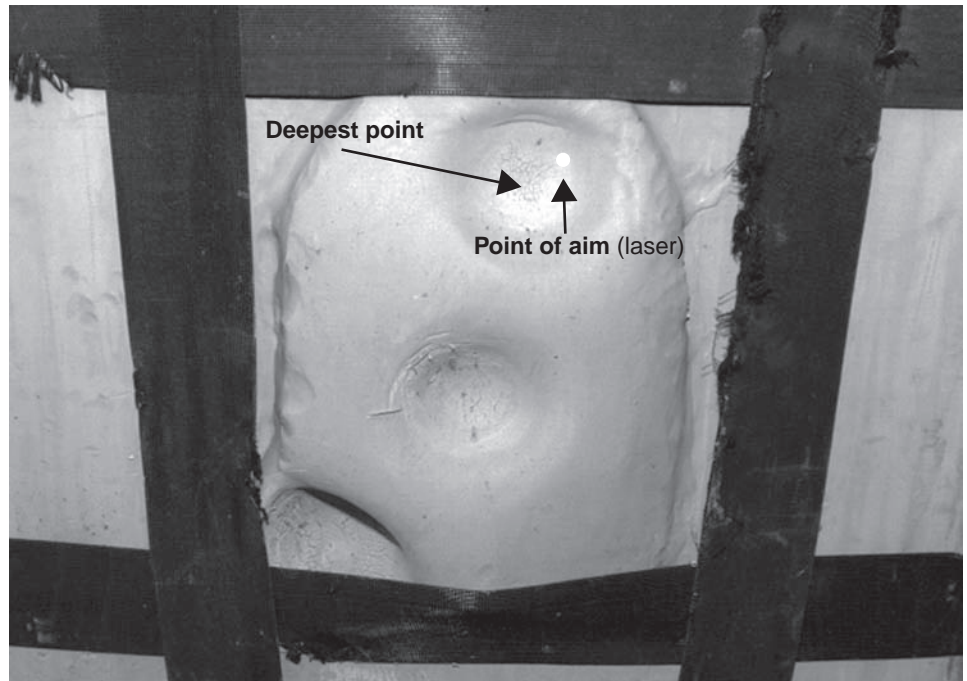
Figure 5: Photographic Representation of the Difference between the Point of Aim and the Deepest Point

⁸ After testers realized they were incorrectly measuring back-face deformation at the point of aim rather than at the deepest point, testers began to measure to both points but used the point-of-aim measure as the official measure, which according to Army officials was necessary to maintain consistency throughout testing and to not disadvantage any vendors. These two designs would have failed if the deepest point measure recorded had been used as the official measure. Because the deepest point was not measured during the first third of testing, additional designs could have improperly passed.

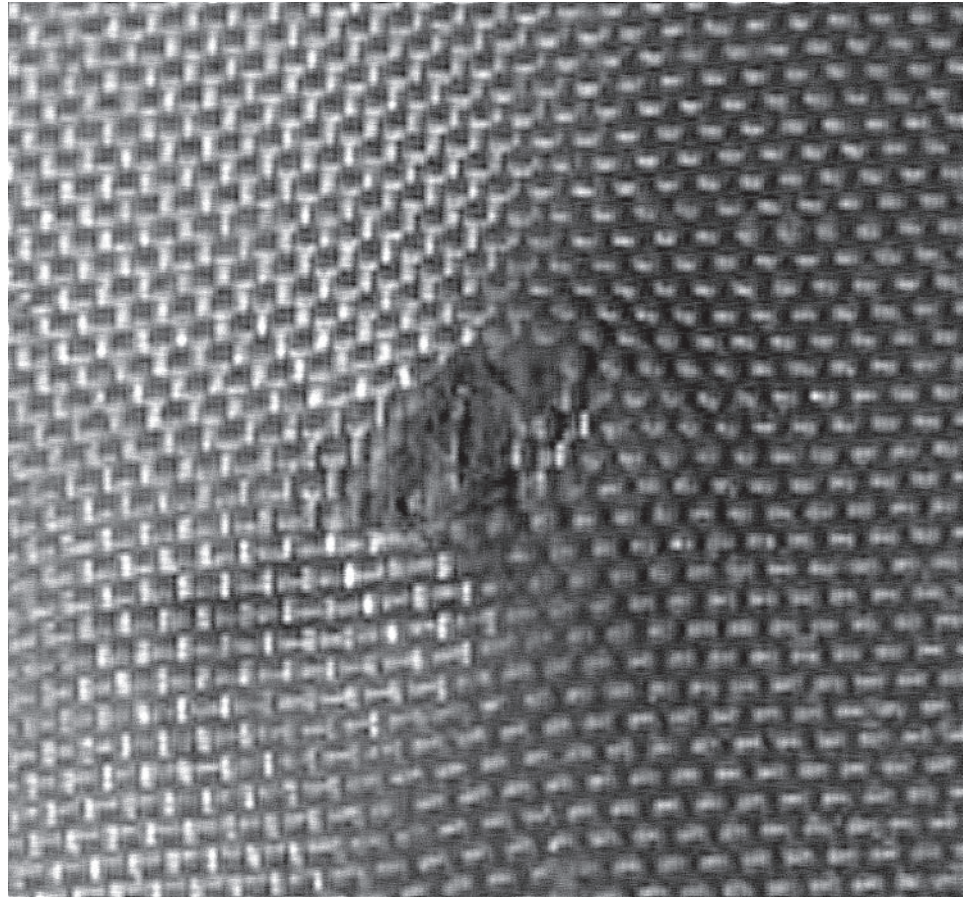
Figure 6: Tears in Kevlar Backing Material after a Penetration of the Plate

During First Article Testing, Army testers deviated from the established testing protocols by improperly scoring a complete penetration as a partial penetration. Army testers said they used a method to evaluate the penetration results that was discussed internally before First Article Testing but that was not described in the testing protocols or otherwise documented. As a result of this incident, one design passed First Article Testing that would have otherwise failed.¹¹ With respect to internal control issues, the Army did not consistently maintain adequate internal controls to ensure the integrity and reliability of test data. In one example, during ballistic testing, data were lost and testing had to be repeated because an

⁴¹ We observed Kevlar fibers that were frayed and tattered.

the testing protocols or otherwise documented but said that Army testers discussed this before First Article Testing began. Figure 6 shows the tear in the fibers of the rear of the plate in question.

Response: This information appends that provided in the earlier discussion of this issue. While Figure 6 of the GAO report appears to show evidence of a perforation on the rear of the test plate in question, by the definition in the Purchase Description, a complete perforation is scored based upon the damage to the soft armor shoot pack directly behind the ballistic test plate. The front (face immediately behind the plate under test) of the shoot pack in question is shown in Figure 6 of this response, located below. Though deformed, the damage does not constitute a complete perforation of the plate according to the definition in the Purchase Description.

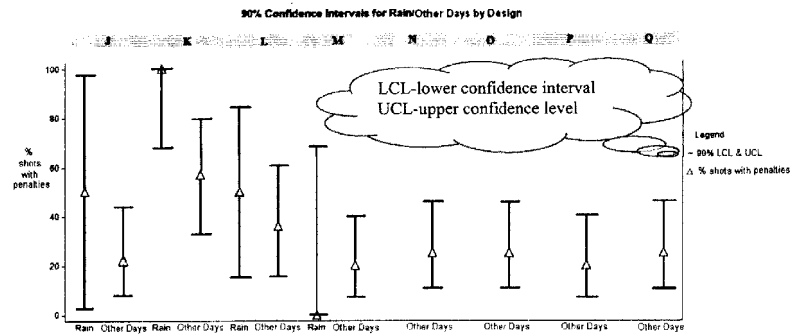
Figure 5. Results of ATC analysis of test results for all vendor designs against the most formidable threat.

ATC analysis also shows that the poor performance of the vendor's design in question was attributed to its marginal performance against the most formidable threat round under test, not to a brief time (seconds) of exposure to a “constant heavy, cold rain and low temperatures” or the effects of rain on the clay surface. Statistical analyses were performed on the test results for all designs including those tested on November 13, 2008. The result of that analysis, as shown in Figure 5, indicate Design K was the weakest

design on days with no rain as well as days with rain. Design K had a 70 percent failure rate during all testing against the most formidable threat. Even when excluding the rain day data, which was when that design was subjected to the most stressing tests, the design still had a 57 percent failure rate.
