Monitoring of Streambank Stabilization and River Restoration Structures on Ice-Affected Rivers in Northern Vermont

Andrew M. Tuthill

July 2009

Final report

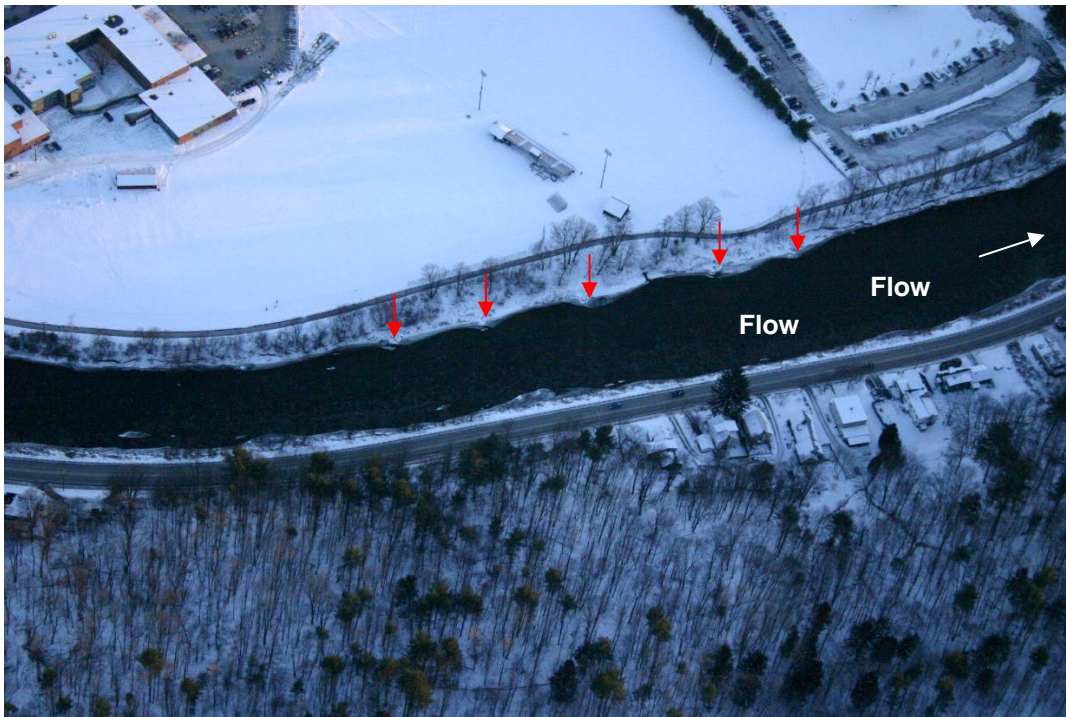
A series of five rock vanes were constructed in the Cemetery Bend reach of the Winooski River to stabilize the banks along the Montpelier High School playing fields (Figure 10). The vanes, which are spaced about one channel width apart, form about a 25° angle with the upstream bank and protrude into the river about 25 ft.

Figure 10. Rock vanes on the Winooski River at Montpelier, VT 12/21/05.

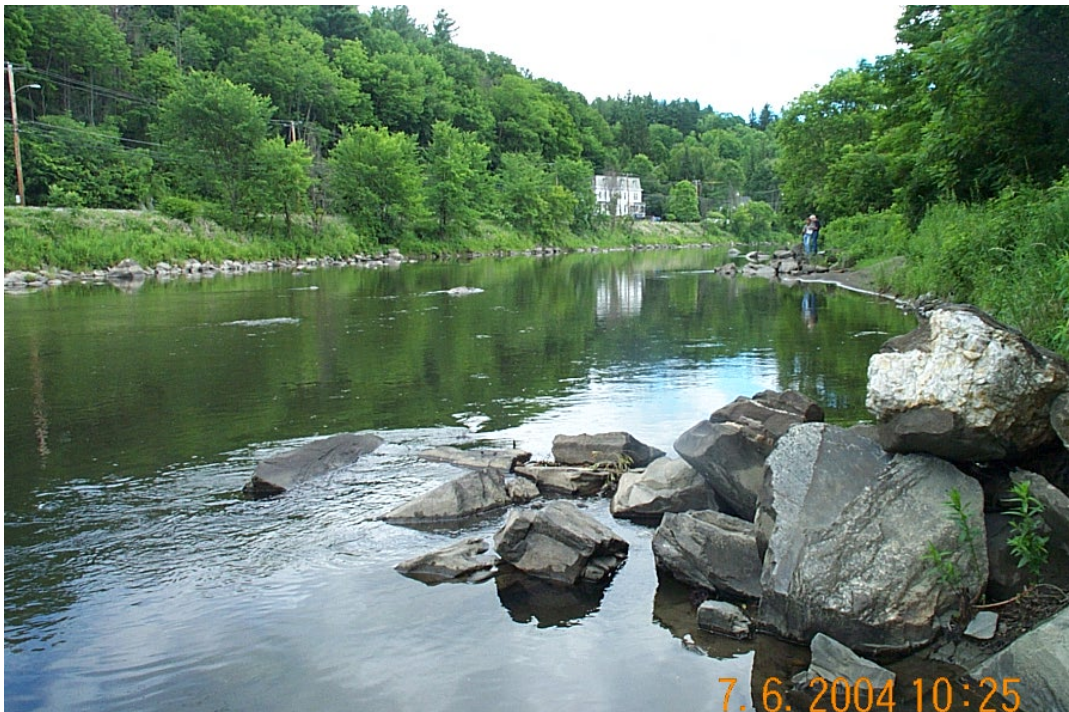
The randomly-placed rocks have an average diameter of about 1.5 ft. and a maximum diameter of about 2 ft. (Figure 11). The vanes tie into a narrow terrace at about half of the total bank height. Although the vane profiles represent only a small portion of the total cross sectional flow area, they effectively deflect flow away from the banks at normal flows and create zones of slower water in between, promoting sedimentation and the formation of stable sheet ice in winter (Figure 12).

Figure 11. Rock vanes on the Winooski River at Montpelier, VT viewed from downstream on 7/6/04.

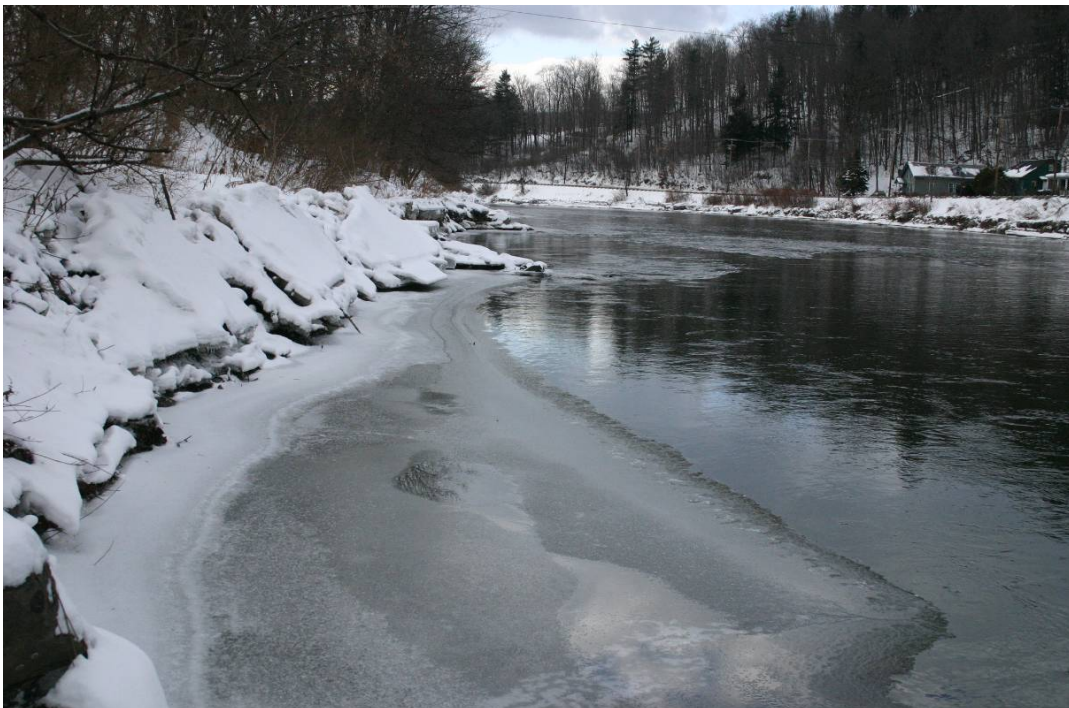
Figure 12. Rock vanes on the Winooski River at Montpelier, VT. viewed from upstream on 1/10/06.

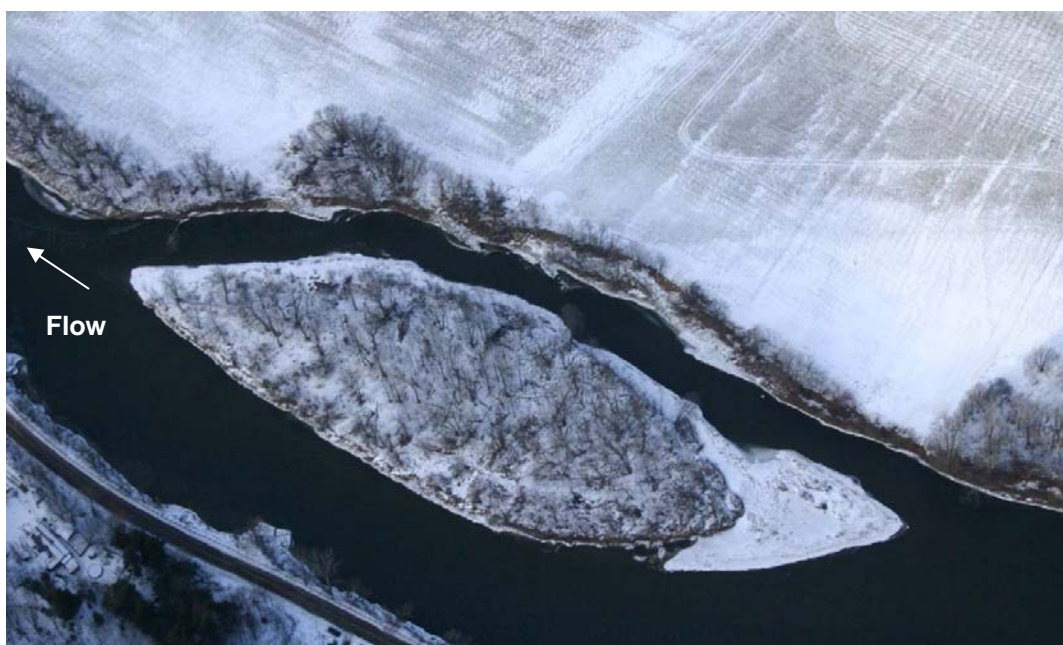
A photo taken during the freezeup period in January 2006 shows border ice forming around the vanes in patterns similar to the observed sedimentation (Figure 15). No dynamic ice breakups have occurred in this section of the Winooski since 2002, when the project was built. From the plan configuration of the channel, it appears that the breakup ice run would probably follow the main channel to the left of the island and not impact the structures directly. Another mitigating factor is the project location, about 3.5 miles downstream of the Bolton Falls Dam, which likely impedes the breakup ice run and lessens potential ice impacts to the structures.

Figure 15. Ice forming around rock vanes on the Winooski River, Fuller Farm, Bolton, VT 1/4/06.

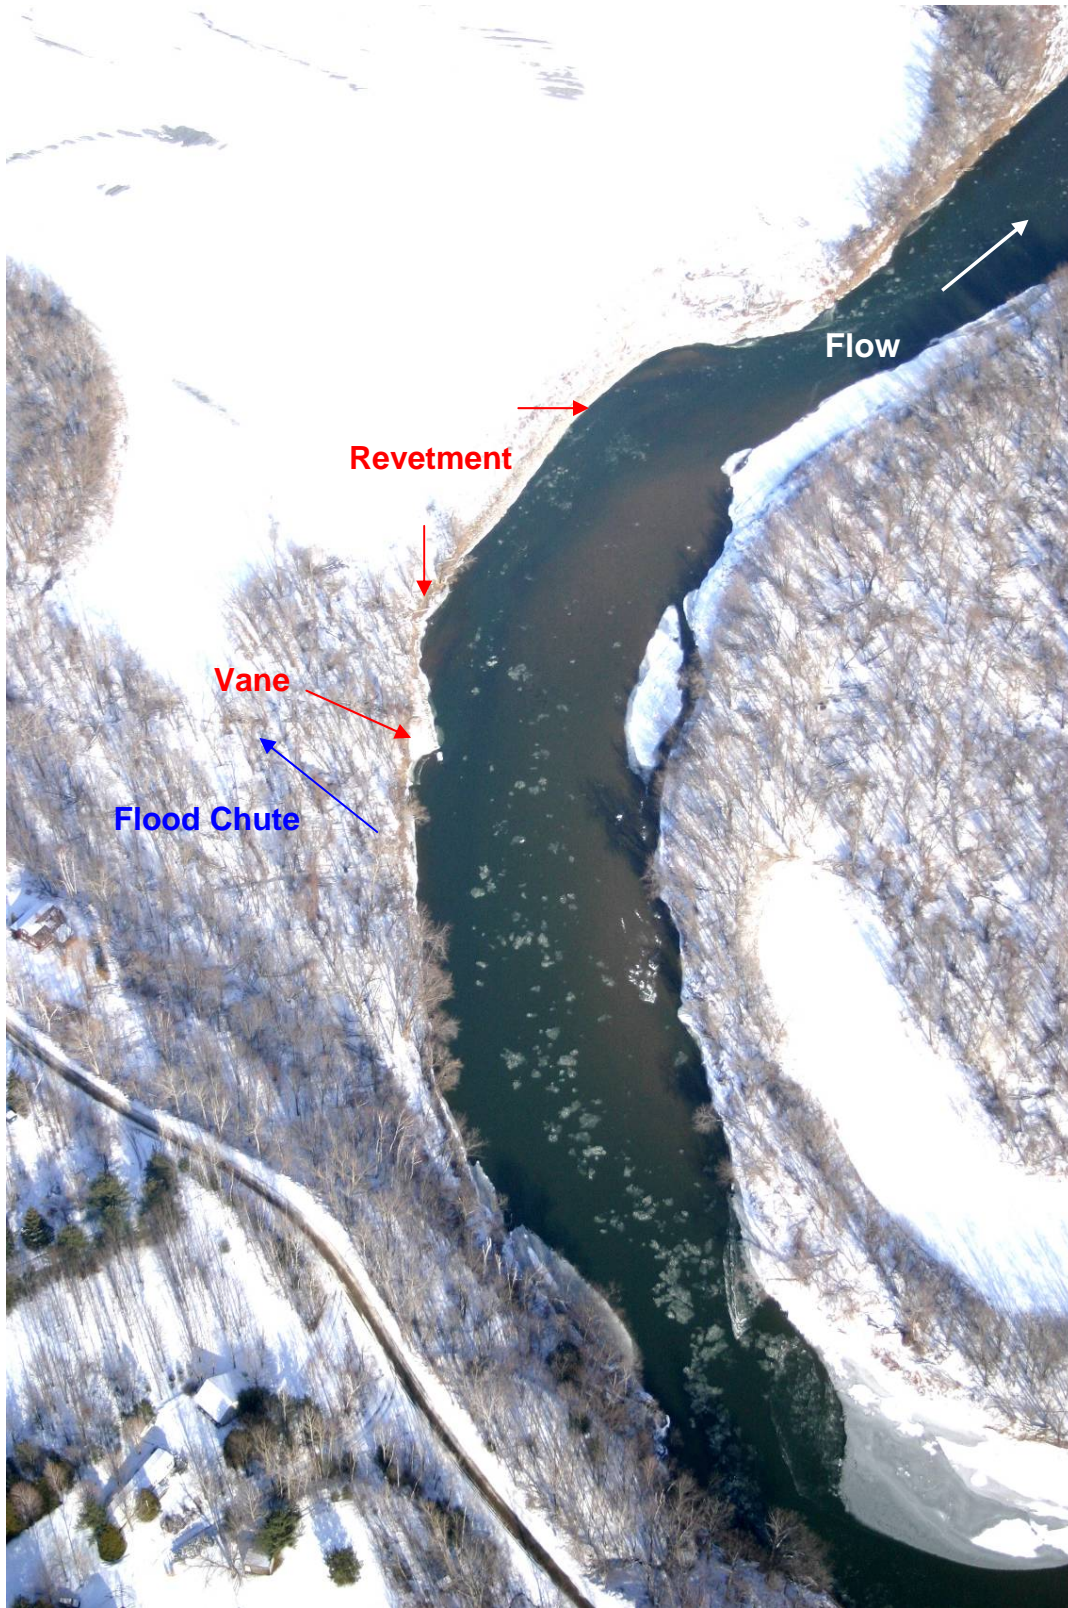
Figure 16. Frazil pans drifting past vane and revetment at the Snowflake Farm property downstream of Richmond, VT, 1/31/08.

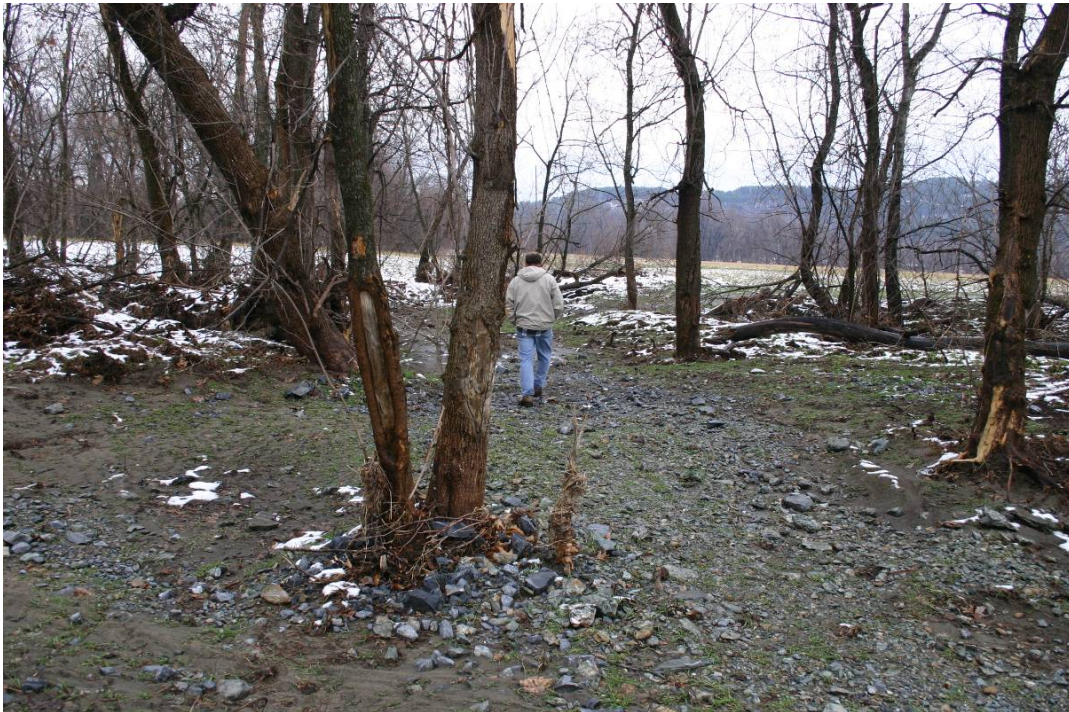
The trees in this area have been heavily scarred by ice to heights 5 ft. above the floodplain elevation (Figure 18) indicating heavy ice action in the past. This is not surprising since the 10 mile section of river from the Bolton Dam to Richmond Village is relatively straight with few features to impede the movement of breakup ice. Just downstream, the Snowflake Farm property lies in a transition zone into a wider valley with increased sinuosity and reduced slope. In light of these factors, one would expect heavy ice impacts at the Snowflake Farm site. As a result of the relatively mild environmental conditions of the recent series of winters, the project has not been tested by a severe ice event since its construction in 2003.

Figure 18. Entrance to flood chute at Snowflake Farm 11/28/05. Note tree scars due to ice.

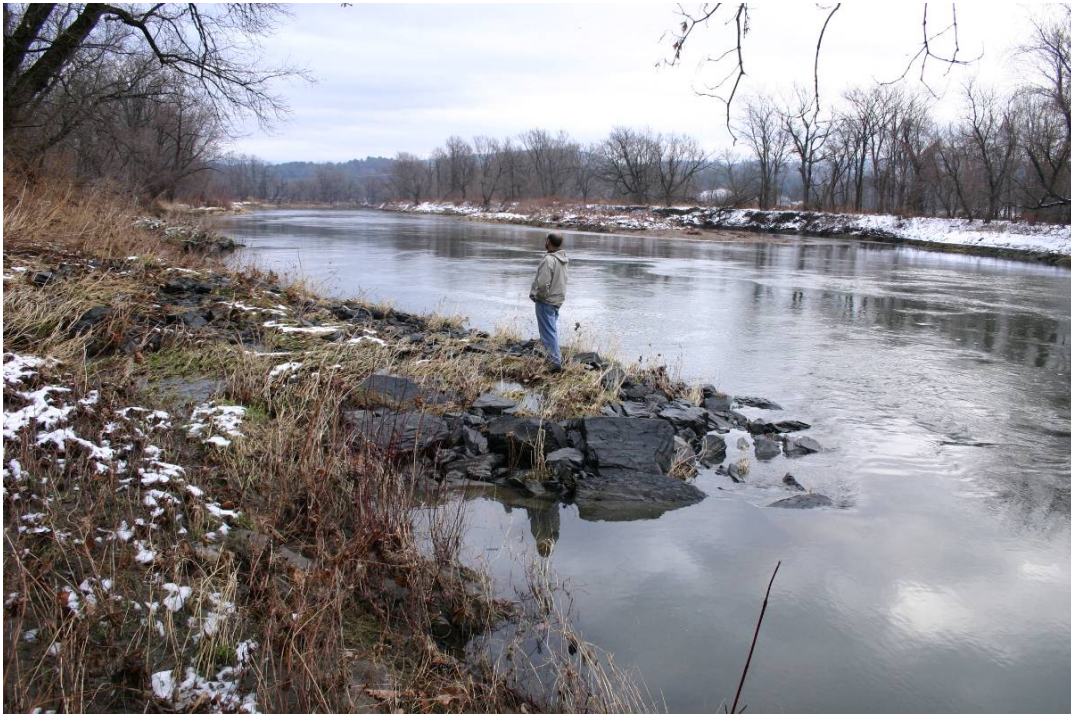
At the time of the 2 November 2005 visit, the Winooski discharge was up and the vanes were visibly diverting flow away from the banks, towards the channel center. On a 28 November 2005 visit, the water was lower, exposing randomly-placed riprap with an average diameter of about 12 inches (Figure 19).

Figure 19. Cross vanes on the Winooski River along Gov. Chittenden Rd. viewed from upstream on 11/28/05

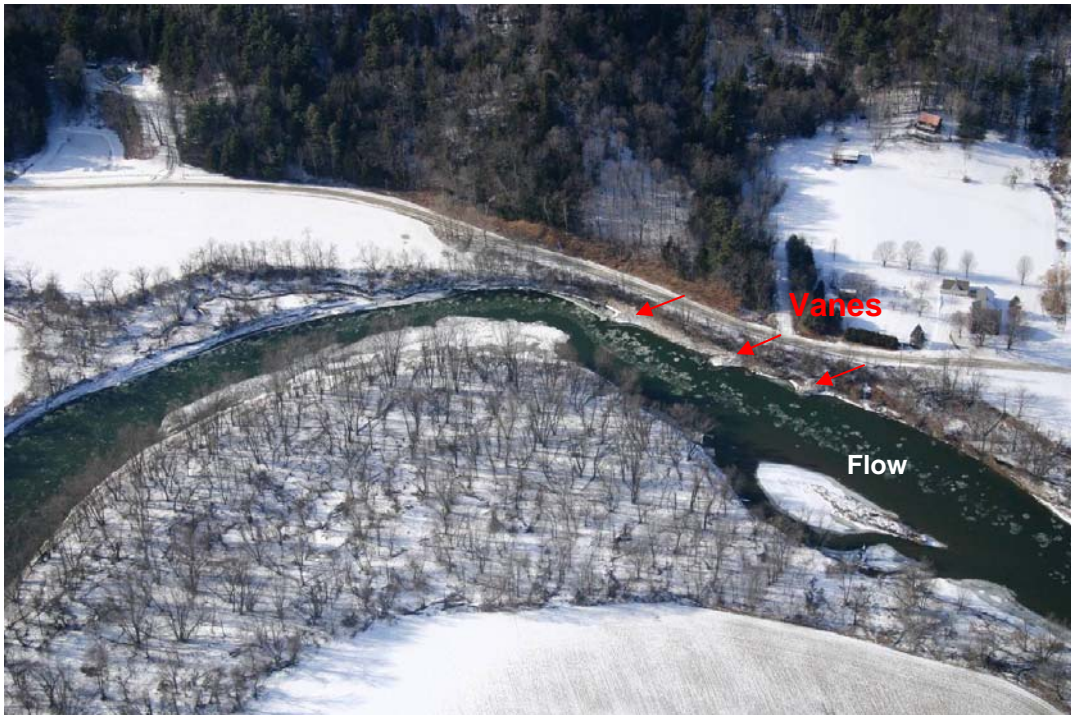
Figure 20. Drifting frazil ice and shore ice forming around vanes and on the Winooski, R. at Gov. Chittenden Rd. vanes, 1/31/08.

flyover show the vanes effectively deflecting drifting frazil pans towards the channel center (Figure 20). Judging from the upstream channel configuration, abundant tree scarring, and anecdotal accounts, the Gov. Chittenden site can experience significant ice action during the breakup period (Figure 21). No major ice events have occurred on this section of the Winooski in the eight years since the vanes were built however.

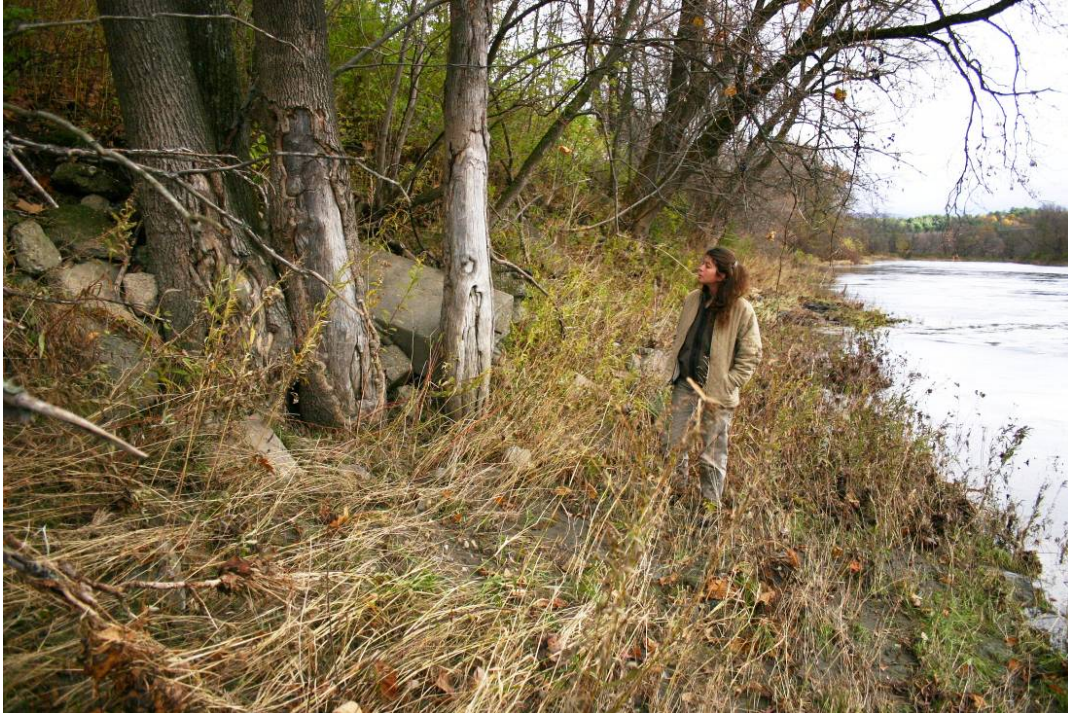
Figure 21. Heavy tree scarring by ice along Winooski, R. at Gov. Chittenden Rd. vanes, 11/2/05.

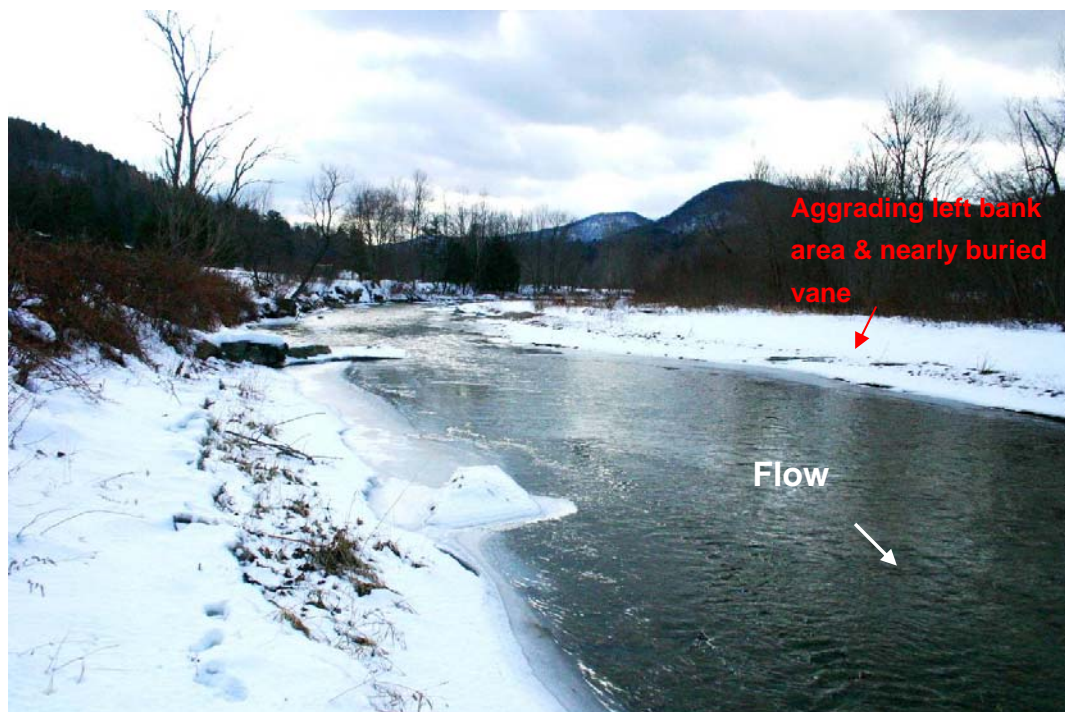
An aerial view on 10 January 2006 shows a continuous open lead along the path of fastest current. The lead narrows at the structures where border ice has formed around the vanes (Figure 23). It appears that the river is still aggrading in the vicinity of the upstream cross vane, as the rocks forming the left hand vane (facing downstream) are now nearly buried in gravel (Figure 24).

Figure 24. Mad River near Warren, upper cross vane viewed from downstream on 1/10/06. Note aggradation on the left bank (looking downstream) has nearly buried the vane.

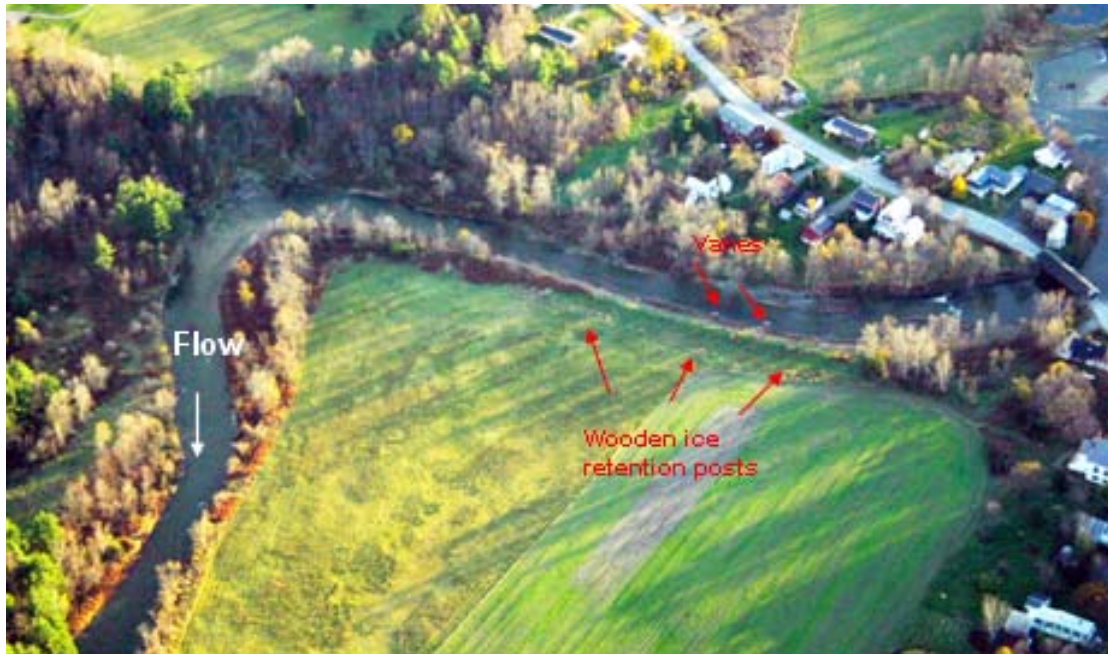
Several small rock vanes were constructed at least ten years ago stabilize the left bank of the Mad River immediately below Waitsfield Village (Figure 25). The vanes tie into the bank well below the bankfull elevation and do not extend very far into the channel.

Figure 25. Mad River at Waitsfield: Site of two small rock vanes and ice retention posts. 11/2/05.

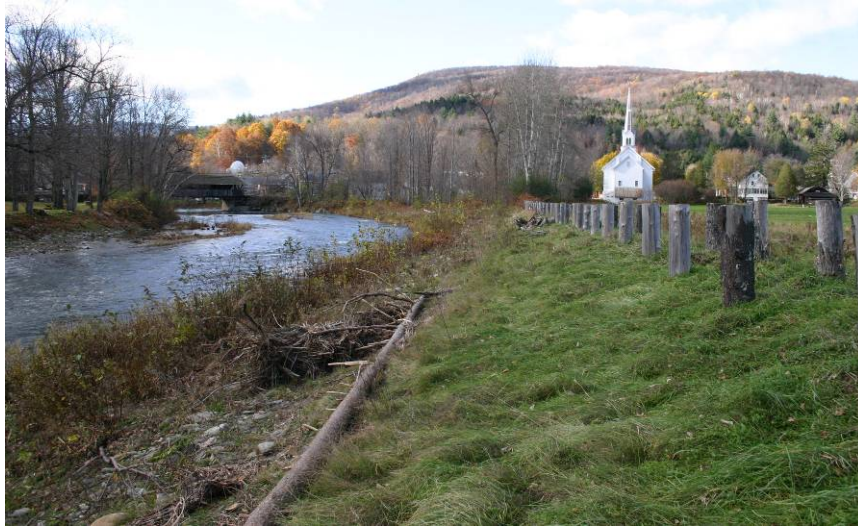
A double row of wooden posts lines the top of the bank to prevent debris and breakup ice from escaping into the adjacent field (Figure 26). At this point, the posts have started to rot and would probably not withstand an extreme ice event. On a 2 January 2005 visit, the rock vanes did not appear to be having much effect in terms of deflecting flow away from the shore. Several hundred yards downstream in a tight bend to the left, the river channel cuts into a clay bank, a large portion of which has slid into the river. This sharp bend is a possible breakup ice jam location. It could be that erosion and ice action since construction have diminished the original size of the rock vanes and decreased their effectiveness.

Figure 26. Mad River at Waitsfield: Ice retention posts 11/2/05.

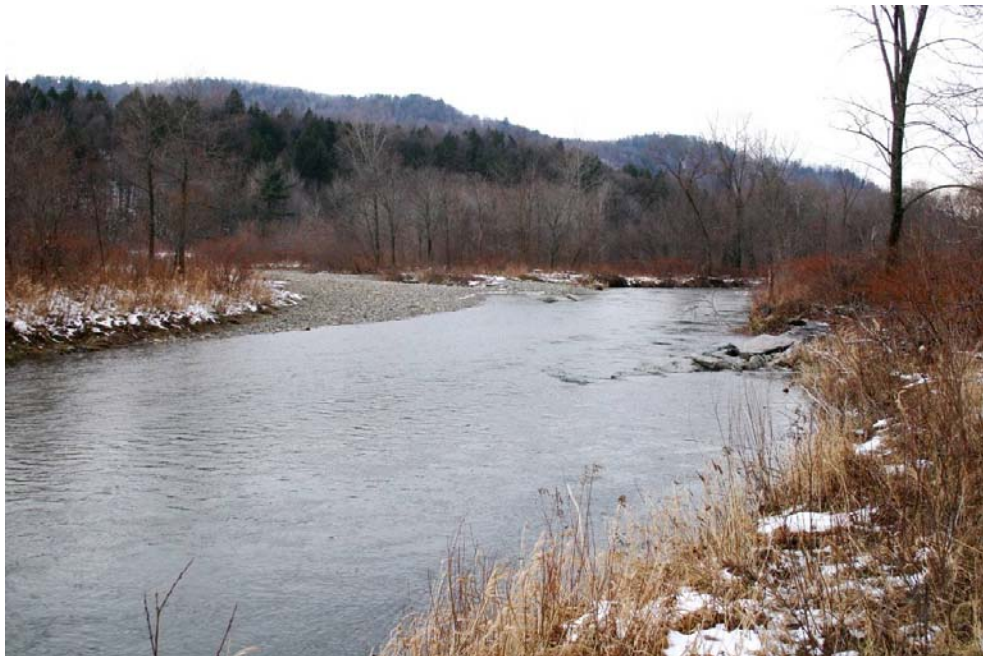
The project performed successfully for its first five years until an extreme flow event, on 17 October 2005, deposited a large volume of coarse bed material in the meander, causing a major avulsion into the blocked-off former channels to the right (Figures 30-34).

Figure 31. Gravel deposits in meander during October 2005 flood caused major avulsion to the right into former channel area. Photo taken 11/28/05.

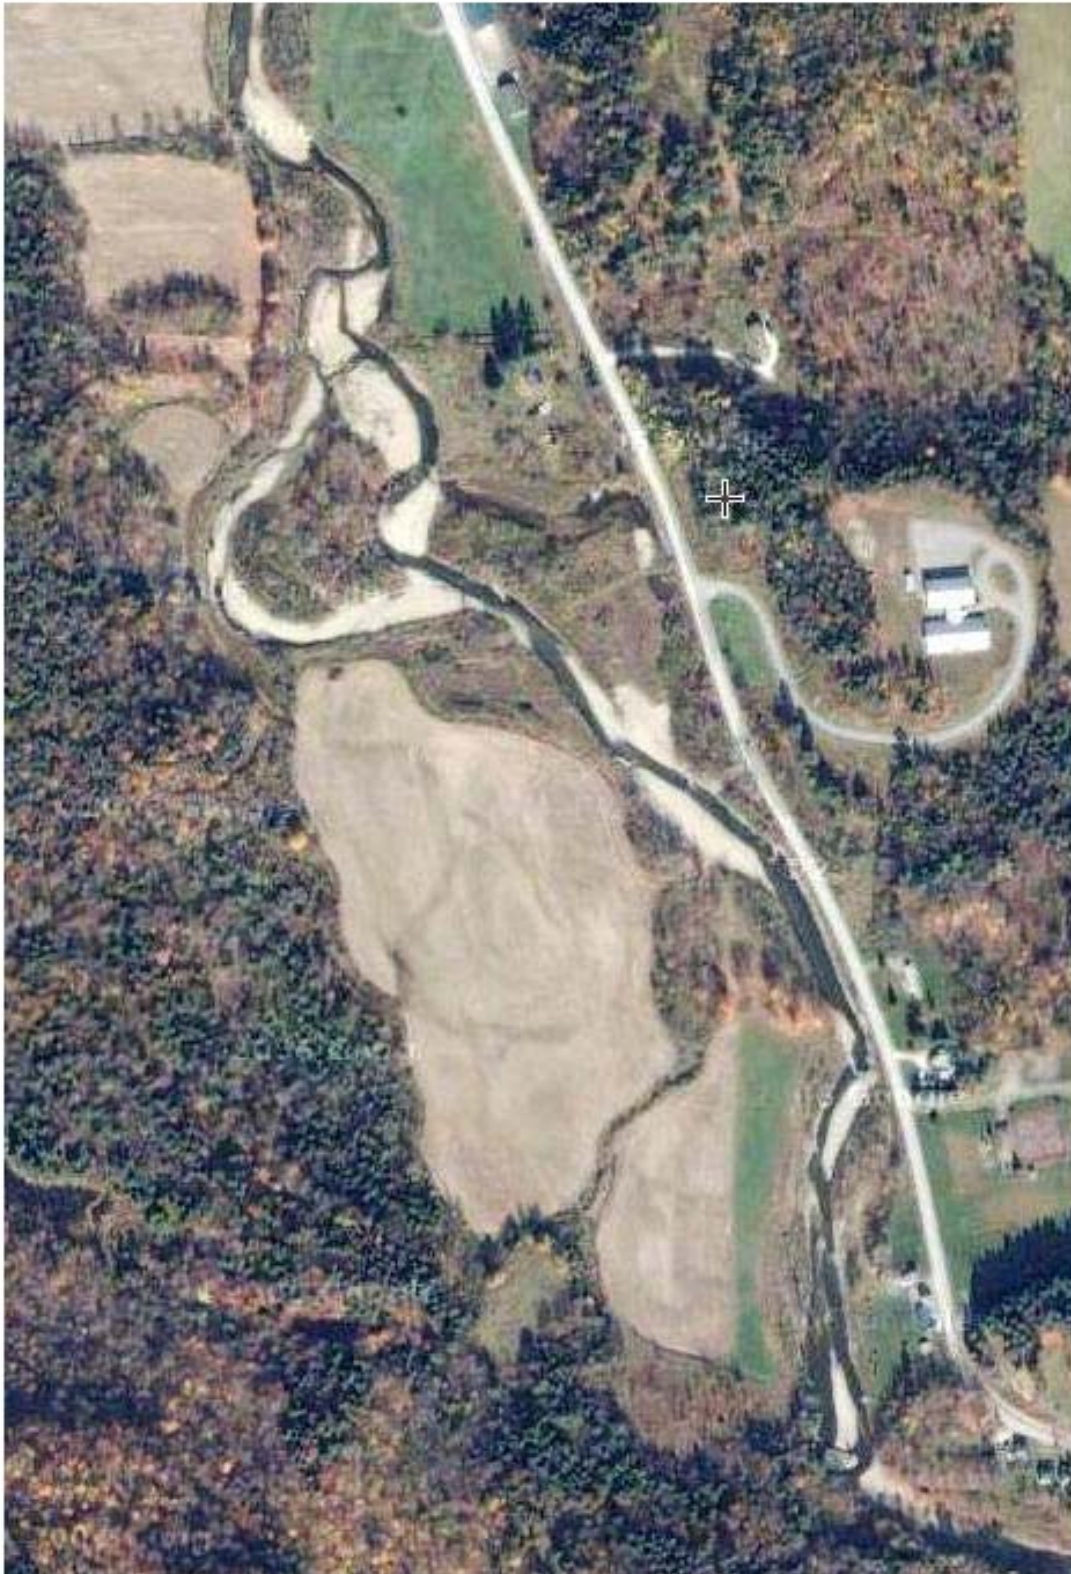
Figure 32. Recent air photo of Trout River restoration project below Montgomery Center. Deposition of coarse material in large meander during October 2005 flood caused a channel avulsion into the former channel area to the right.

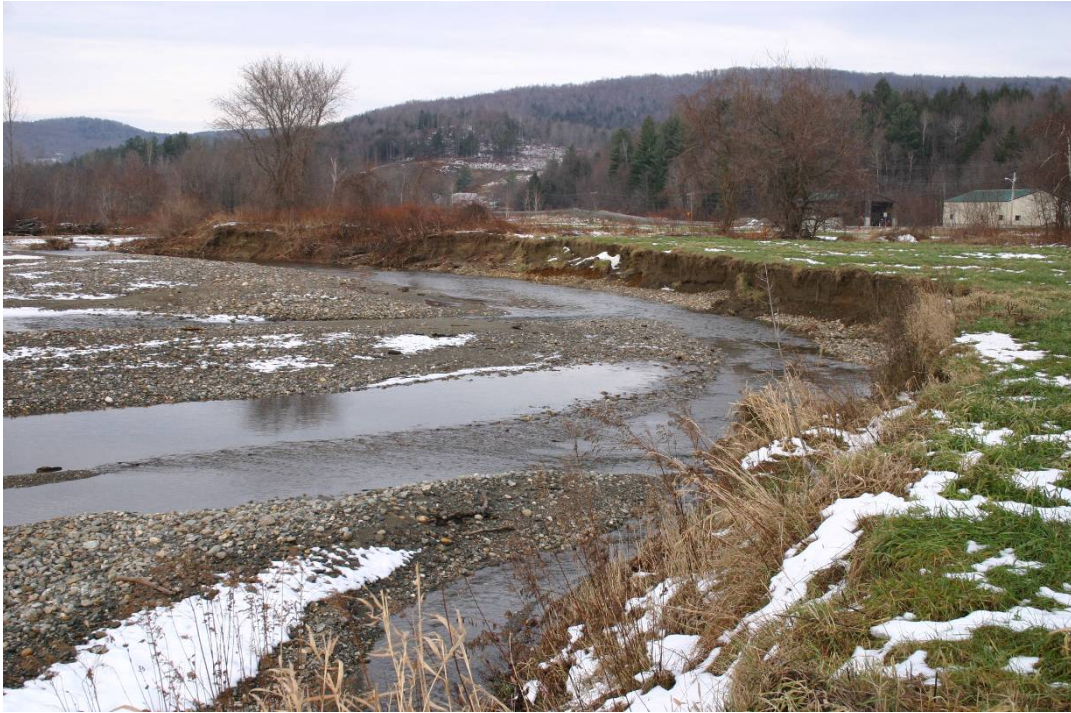
Figure 33. Trout River looking downstream at eroding bank on 11/28/09.

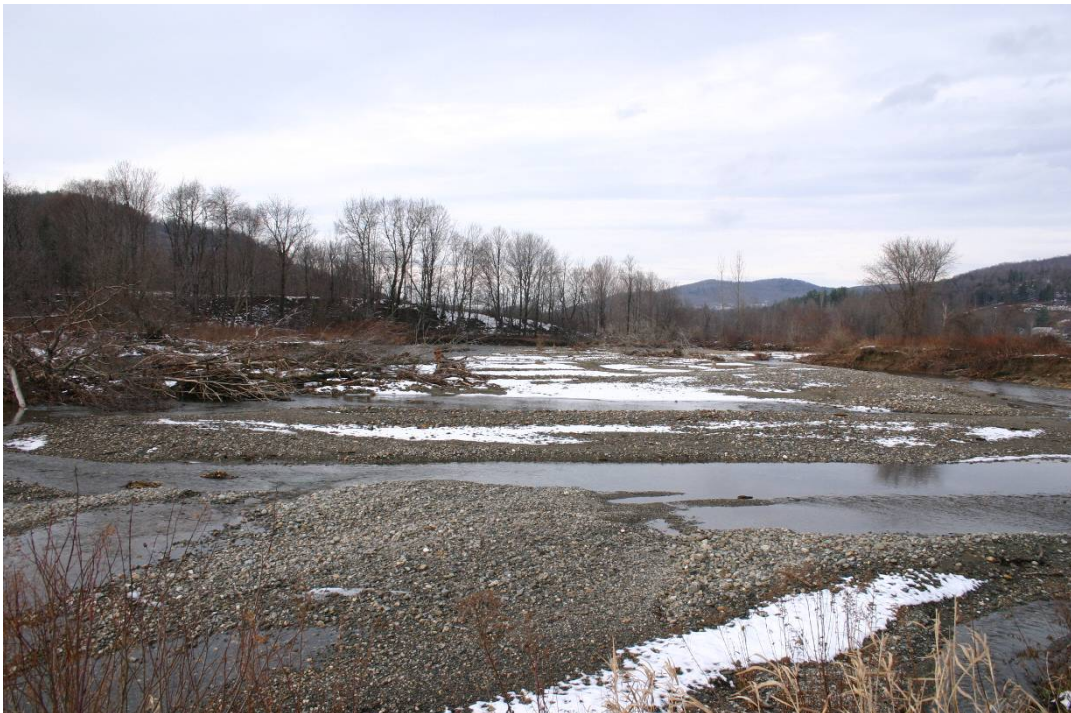
Figure 34. Trout River looking downstream at braided channels on 11/28/09.

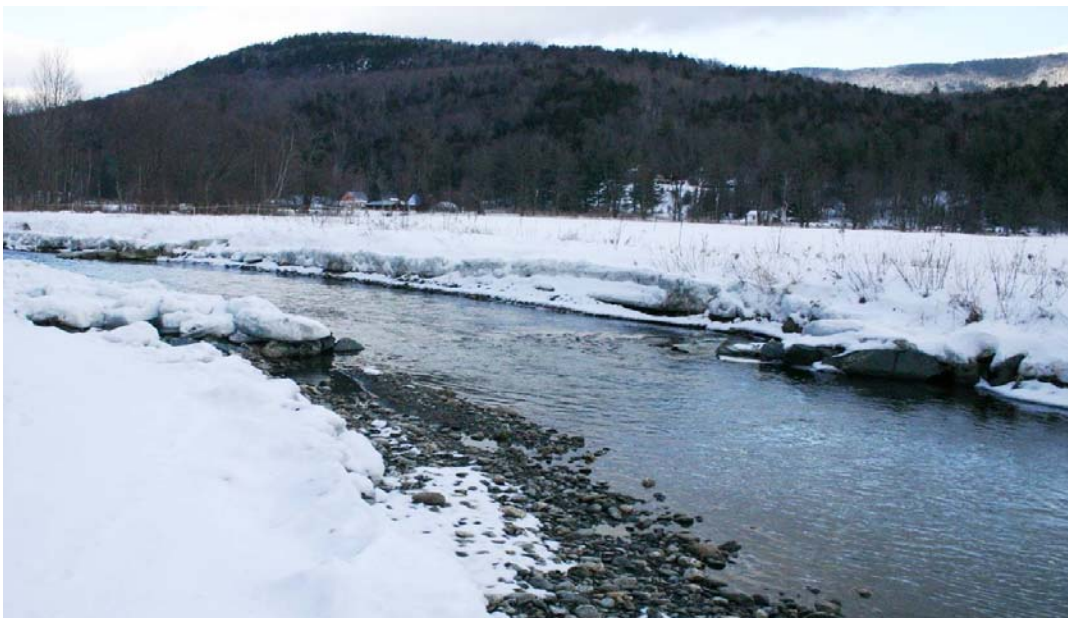
These two small streambank stabilization projects are located in the upper White River watershed. At the upstream project, near the village of Granville, the river banks have been stabilized by a series of small vanes and four cross vanes made of quarried rock. The project appears to be performing as designed in terms of bank stabilization and deposition. The structures had withstood a mild mid-winter breakup ice run just prior to a 10 January 2006 field visit (Figure 40).

Figure 40. Cross vane stabilizing banks of the White River below Granville, VT following mid-winter breakup 1/10/06.
