## **Evaluation of Ultra High Molecular Weight (UHMW) Polyethylene Panels for Aircraft Arresting Systems**

E. Ray Brown

August 2009

Final report

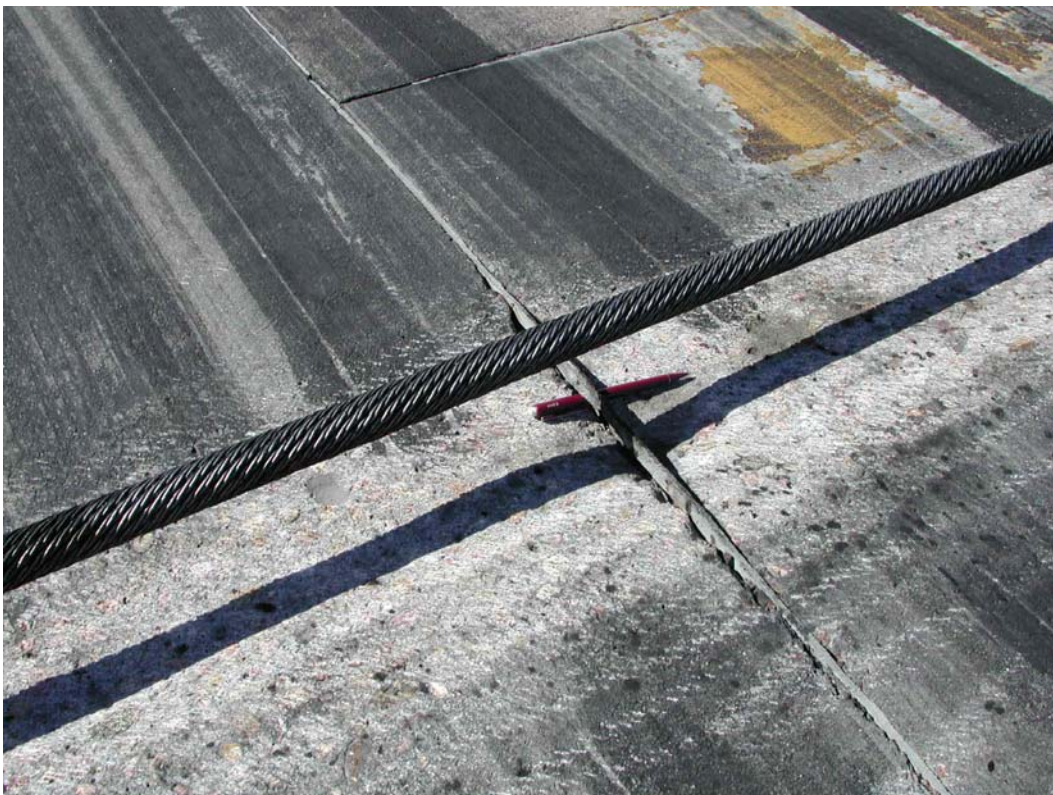
Figure 1. Early cable damage to concrete pavement.

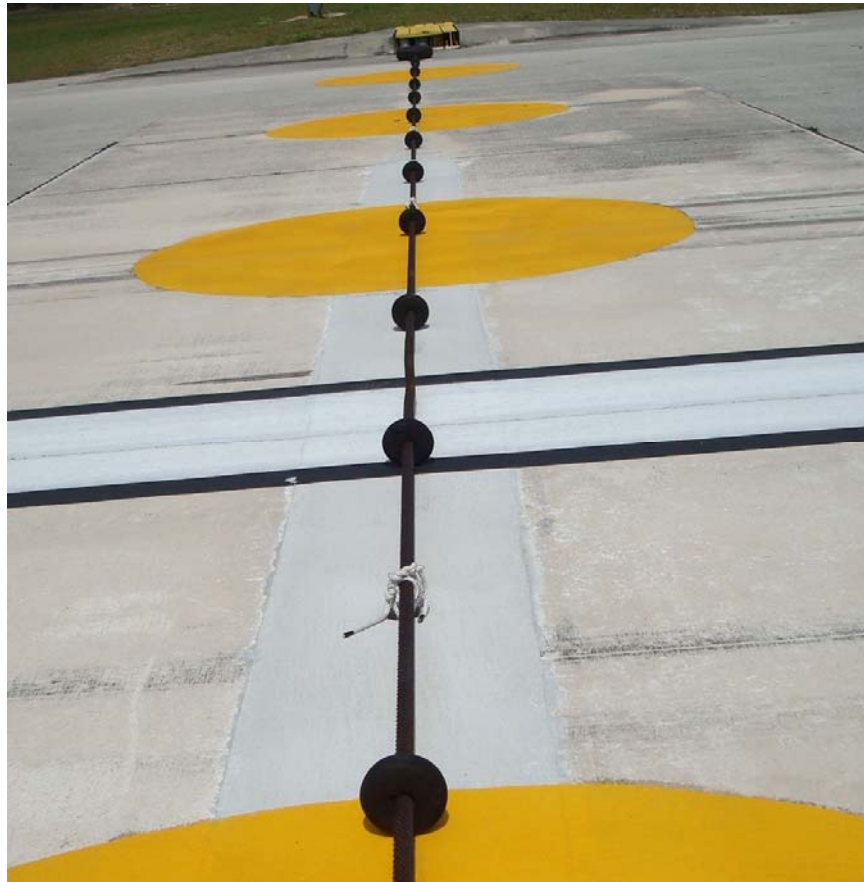
Figure 2. Typical patch area underneath cable in concrete pavement.

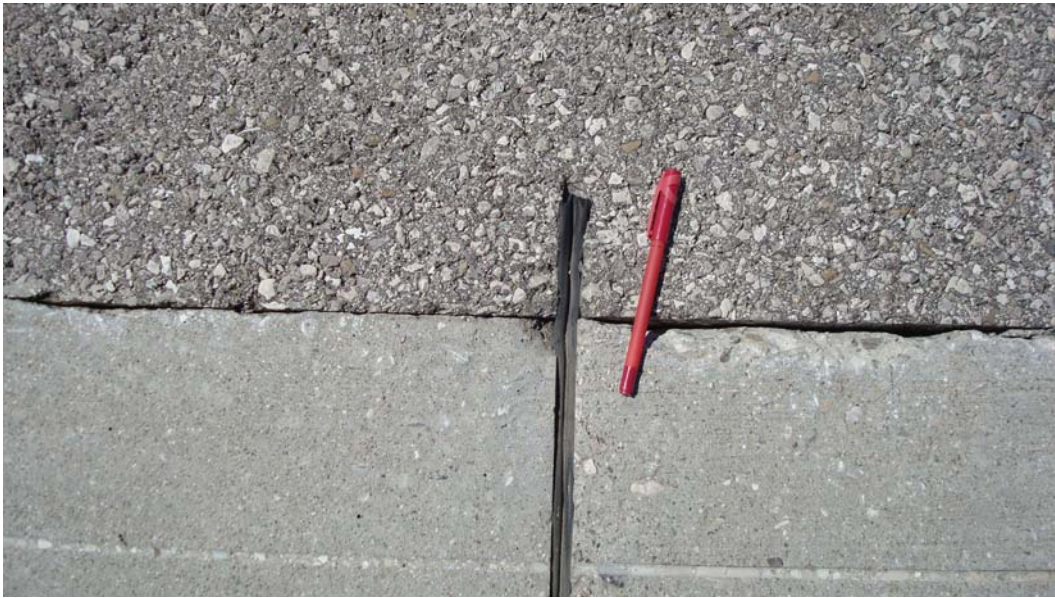
Figure 6. No damage of the SMA and slight spalling of the concrete slab at Aviano AB.

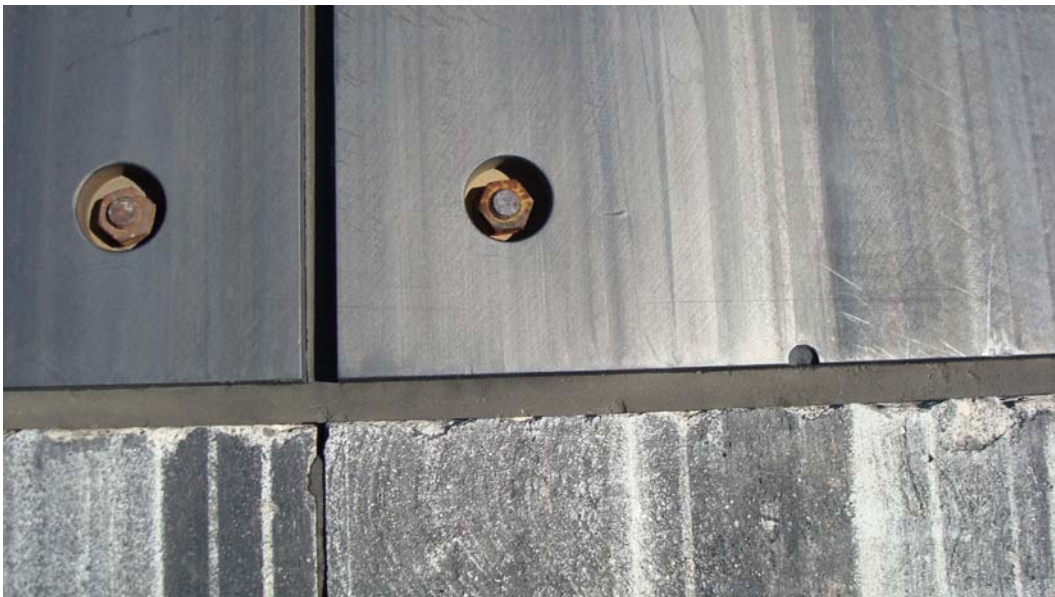
Figure 7. Sealant in good shape adjacent to panels at Aviano AB.  
Note lack of sealant in anchor bolt recess.

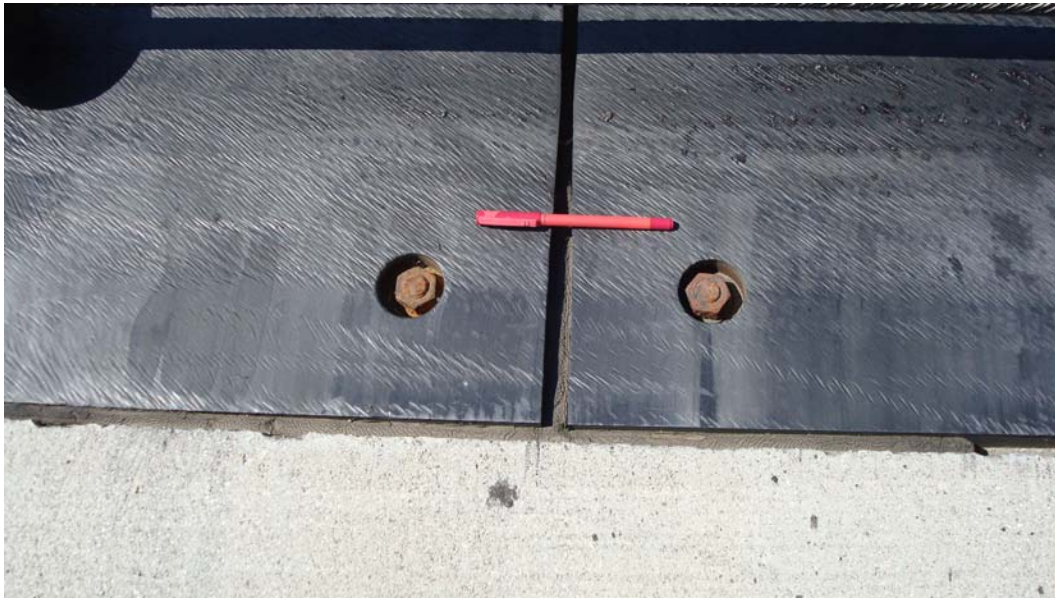
repeated beating of the cable over the panels eventually led to this scarring, which appears to be very minor. This damage was typical of that seen on a number of projects. However, the panels still appeared to be in good overall shape (Figure 8).

Figure 8. Sealant in poor shape adjacent to panels at Aviano AB.

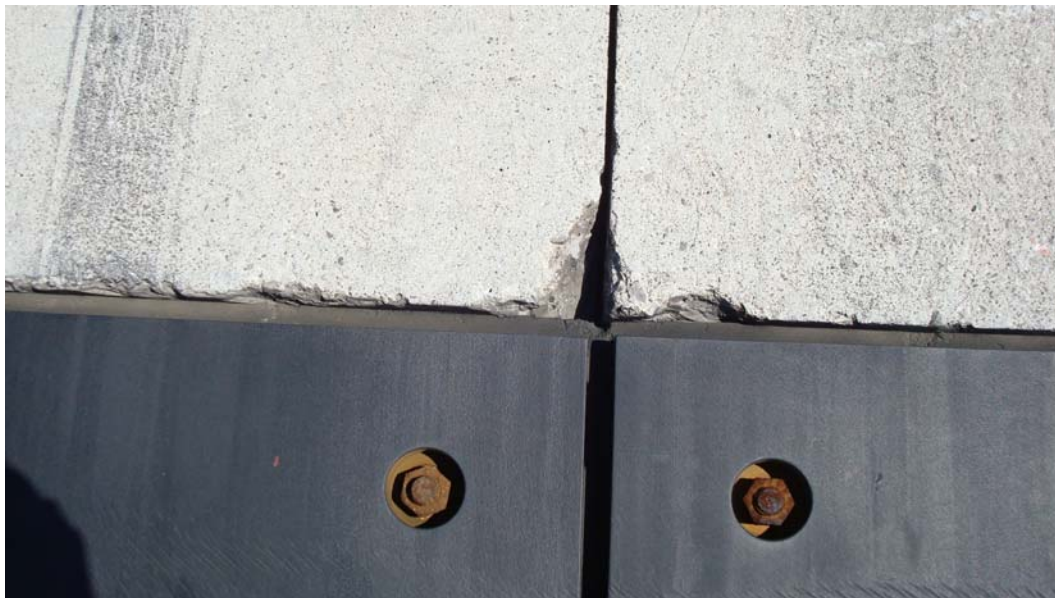
Figure 9. Some spalling of concrete adjacent to panels and at contraction joint at Aviano AB.

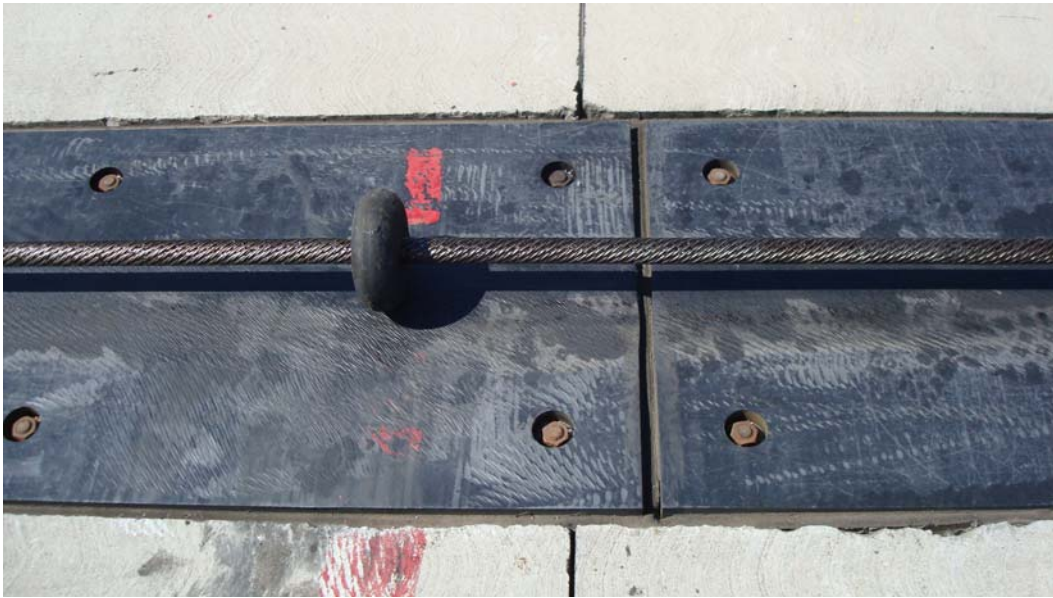
Guidance for installing the panels states that they should be placed such that the gap between the panels lines up with the contraction or construction joints in the concrete. It is even more important to ensure that the joints do not line up with the anchors. This could result in failure of the anchor. In at least one case, the contraction joint was lined up within 1 in. of the anchors (Figure 10), but there was no noticeable performance problem.

Figure 10. Anchors for panels placed very close to contraction joint in concrete at Aviano AB.

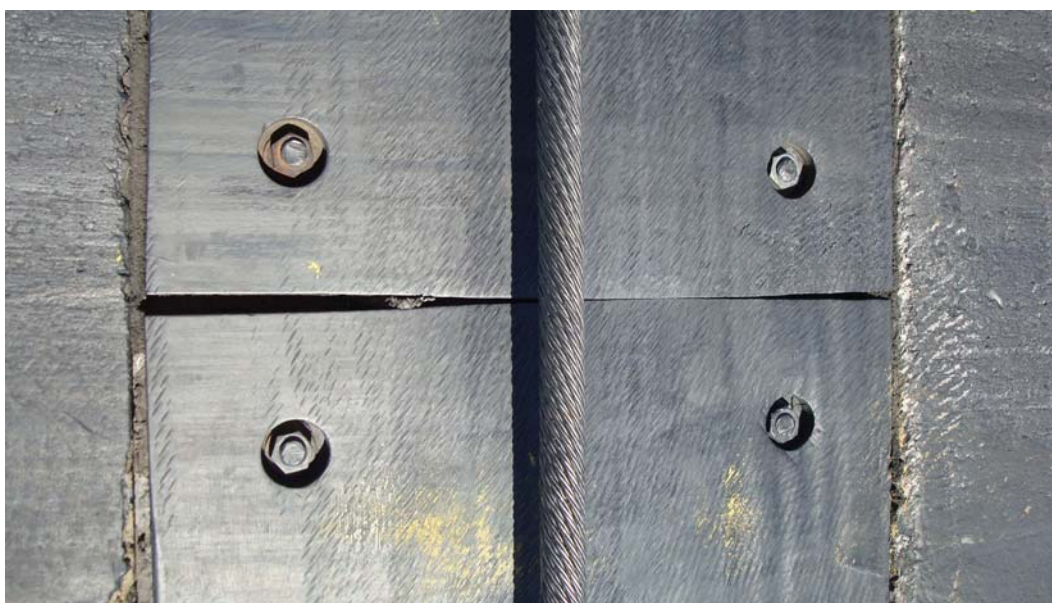
Some of the joints in the polyethylene panels had uneven widths (Figure 15). It is likely that this was caused by temperature and warping effects as well as the beating of the cable on the surface of the panel. It is also possible that the anchors held the panel in place, not allowing it to move immediately adjacent to the anchors, thus resulting in the partial closing of the joint during hot weather in between the anchors but not at

Figure 15. Variable width of joints in polyethylene panels at Davis-Monthan AFB.

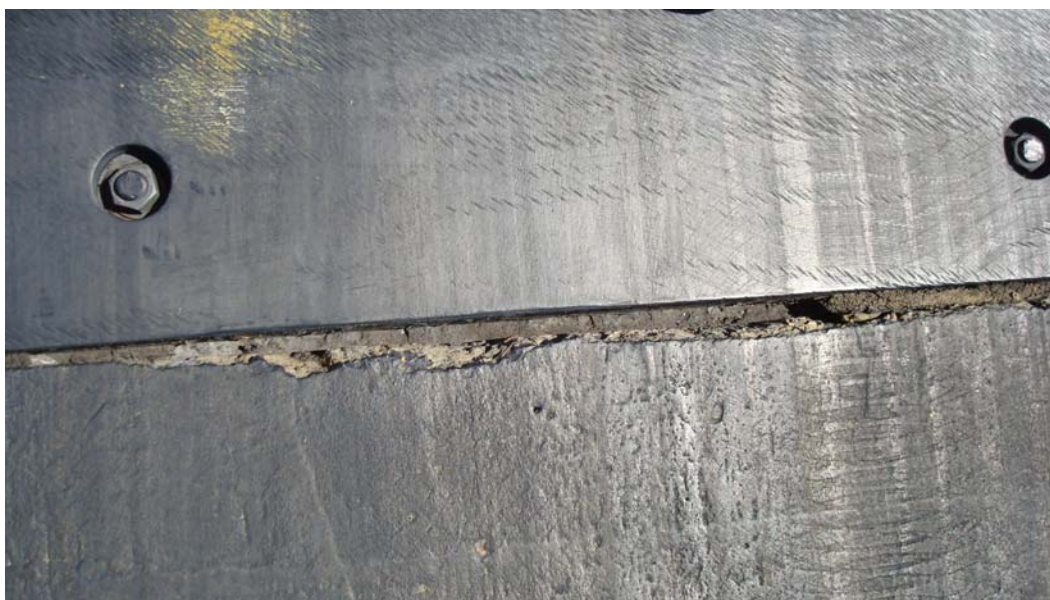
The sealant in the joint between the concrete and the polyethylene panel was in poor shape. In some cases, the sealant had been lost, and in others it had pulled away from the panels and adjacent pavement (Figures 15 and 16). There was some spalling in the concrete adjacent to the panels. The damage is likely caused by the high amount of expansion of the panels during temperature increases and the possibility that incompressibles were able to get into the joints and result in high pressure being exerted on the concrete pavement during hot weather.

Figure 16. Condition of joint between concrete and polyethylene panel at Davis-Monthan AFB.

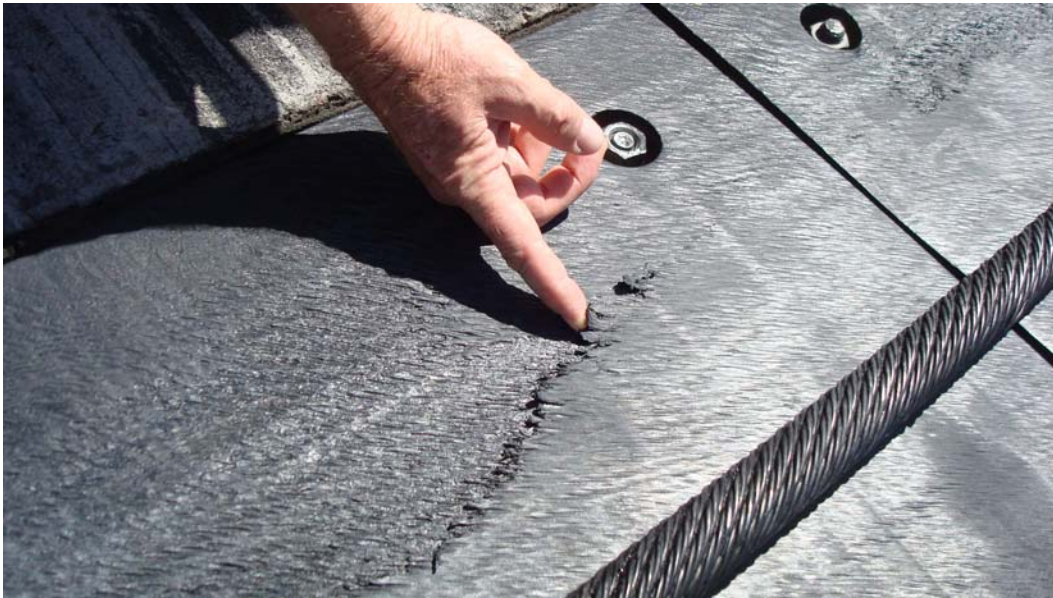
There was some damage to the top of the panels due to the beating of the cable on the panels (Figure 17). Of all of the panels surveyed, this appears to be the only occurrence of this problem, indicating that this may be a material defect or the result of some other problem, such as some type of spill. The panels were still performing reasonably well even though this damage had occurred.

Figure 17. Damage to polyethylene panel likely caused by cable beating on surface of panel at Davis-Monthan AFB.

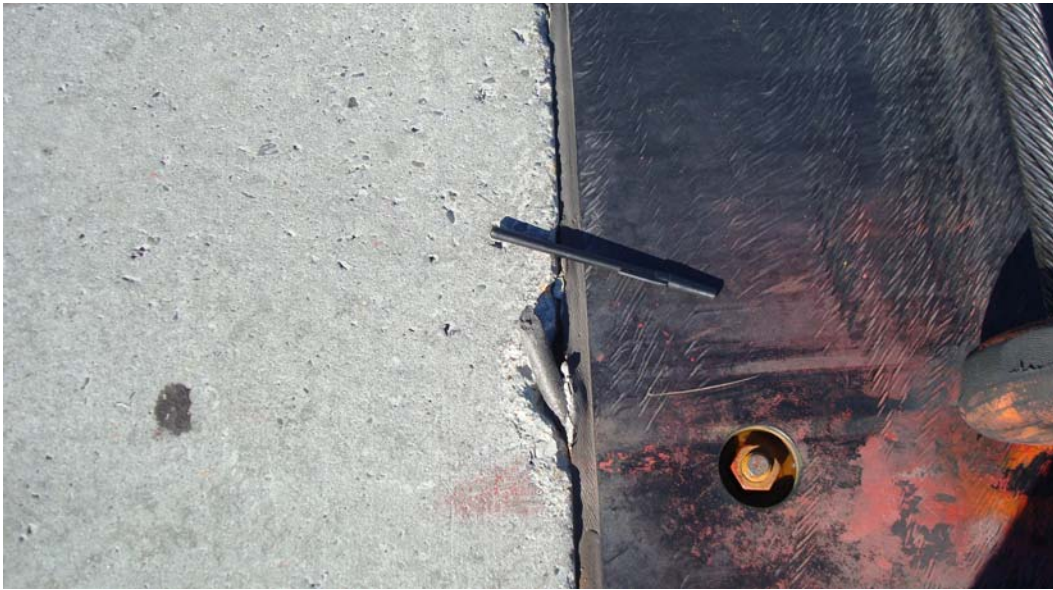
the sealant was in reasonably good shape, but in many locations it did not perform well. In at least one location the backer rod that was underneath the sealant was damaged and exposed (Figure 21). It is not clear if the backer rod was damaged during construction or if something happened after construction to cause the damage and exposure of the backer rod. It is interesting that the concrete is spalled slightly in the same area. This damage may be the result of the cable beating against the concrete, snow removal equipment, or some other occurrence.

Figure 21. Exposure of backer rod between panels and concrete pavement (south end of runway) at Eielson AFB.

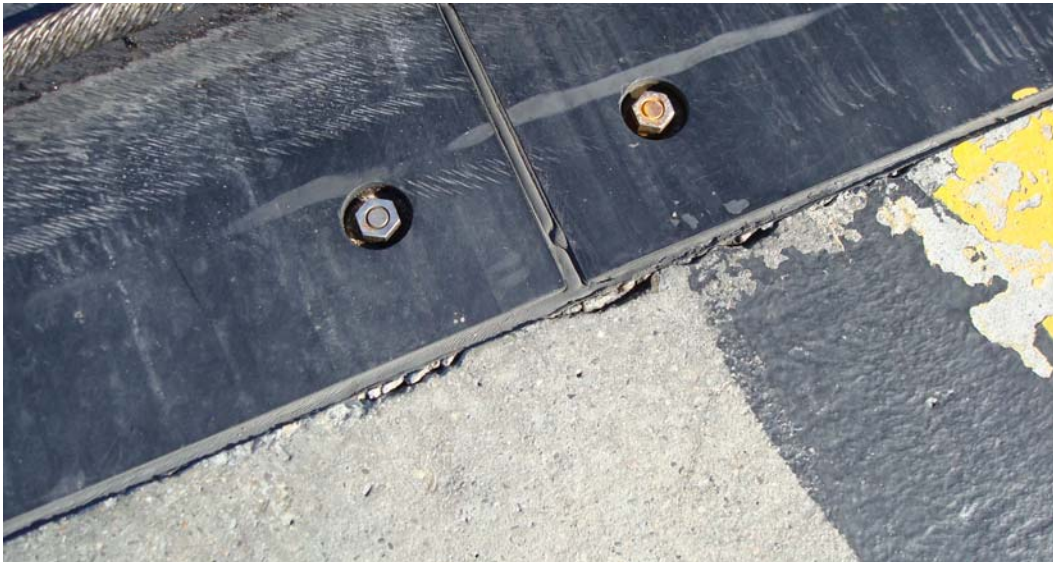
An overview of the panels on the north end of the runway is provided in Figure 22. Typical spalling of the concrete is shown in Figure 23.

Figure 23. Typical spalling in concrete adjacent to panels at north end of runway at Eielson AFB.

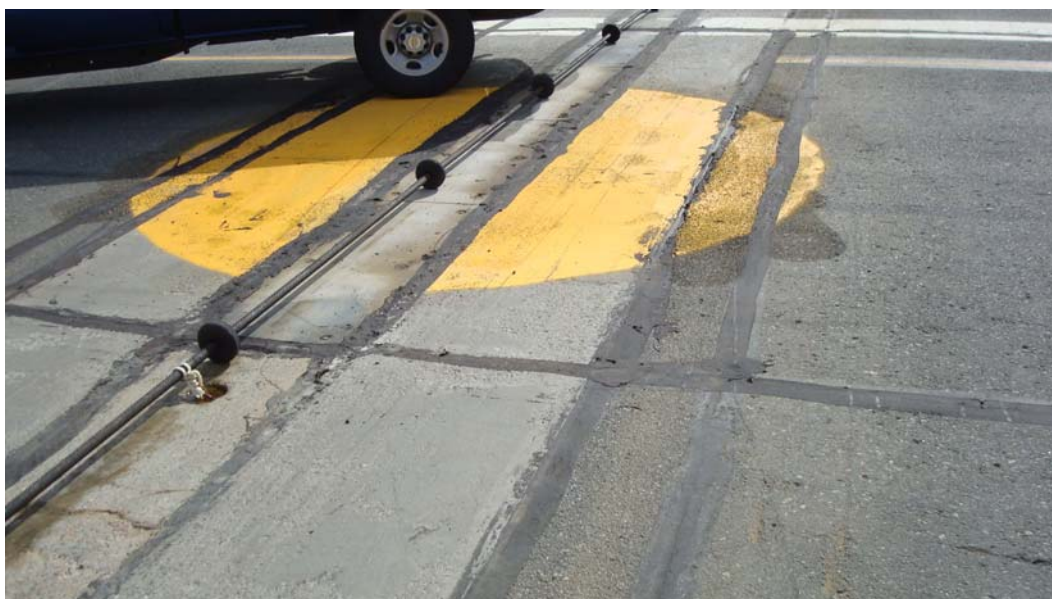
concrete, approximately 4 ft wide, on the surface on both sides of the panels. There was some deterioration (Figure 25) in the asphalt mix adjacent to the concrete next to the panels. The deterioration primarily consisted of loss of material from the asphalt mixture immediately adjacent to the concrete strips. This damage was likely the result of snow plow damage and/or some construction deficiency immediately adjacent to the concrete strips. It appeared that the asphalt mixture had been patched for a width of approximately 1 ft on both sides of the concrete slabs. The arresting system on Runway 34 violated the recommendations of the AFI by changing from asphalt to concrete within 200 ft of the arresting cable.

Figure 25. Some damage to the asphalt mixture adjacent to the concrete strip on Runway 34 at Elmendorf AFB.

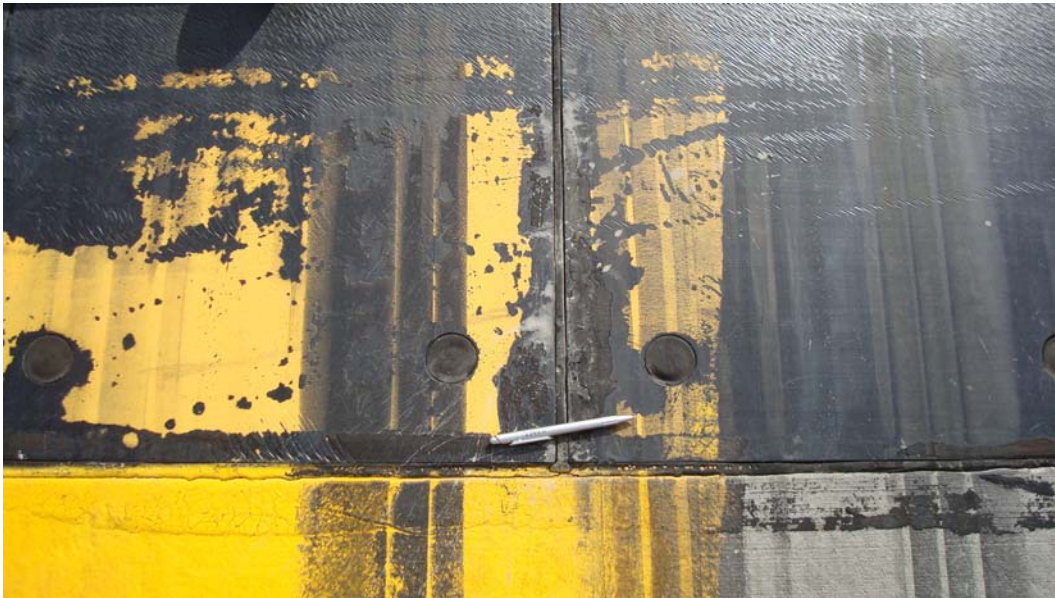
The sealant in the joints between the panels and the concrete and between adjacent panels was in poor shape (Figure 26). It appeared that the joints were initially sealed with some type of sealer, and the performance was poor. The joints were then sealed with another sealer (Figure 27), which looked like a rubberized asphalt sealant, to help hold the old sealant in place and to waterproof the joints. This rubberized sealant was actually applied to the surface of the panels and the adjacent pavement and was not placed directly in the joints. It appeared that this rubberized sealant adhered to the surface of the panels as well as the adjacent pavement. It is doubtful, however, if this sealant would perform satisfactorily when placed in the joints where the amount of movement is very high.

Figure 26. Condition of joint sealant on Runway 34 at Elmendorf AFB.

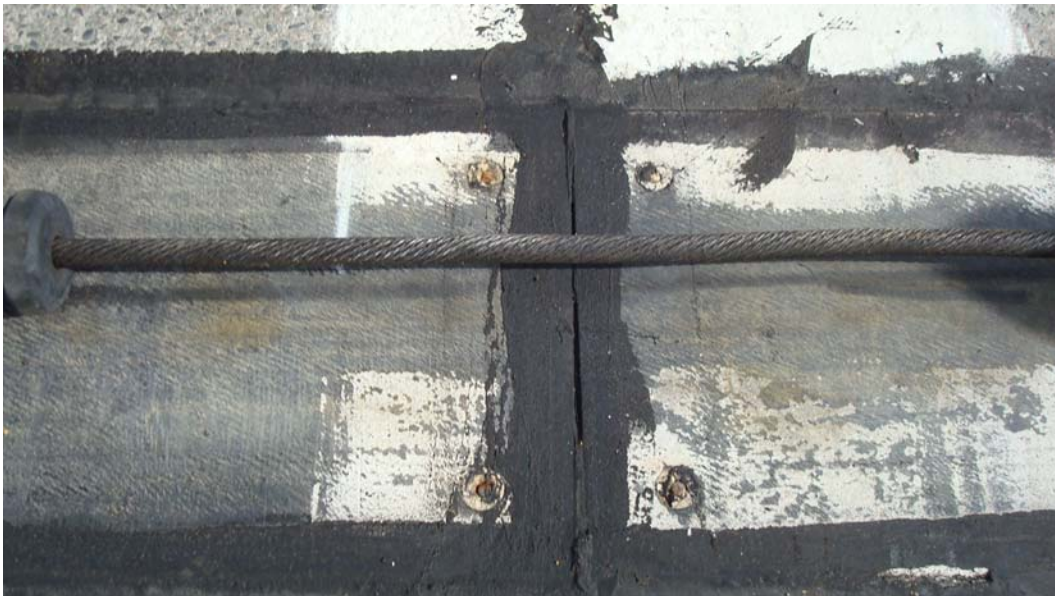
Figure 27. Excessive sealant on the pavement surface on Runway 34 at Elmendorf AFB.

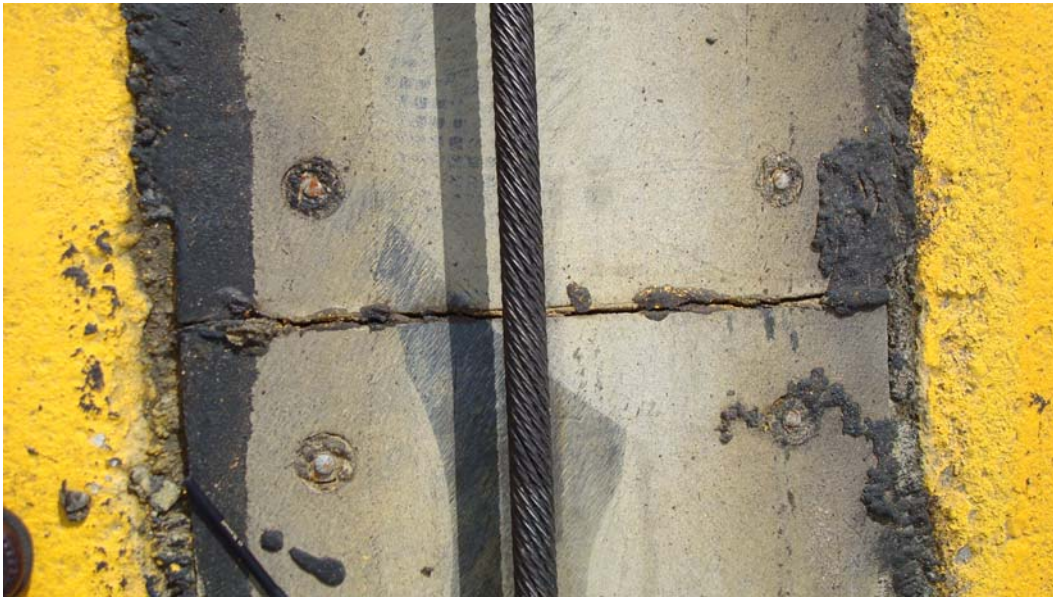
The panels appeared to be in satisfactory shape. The recesses at the top of the anchors appeared to have been sealed, but some of this sealant had worn off, exposing the ends of some of the anchors. There was no noticeable problem with the anchors; however, for the most part, they were covered with sealant (Figure 28) and could not be inspected.

Figure 28. Partially sealed anchors on Runway 34 at Elmendorf AFB.

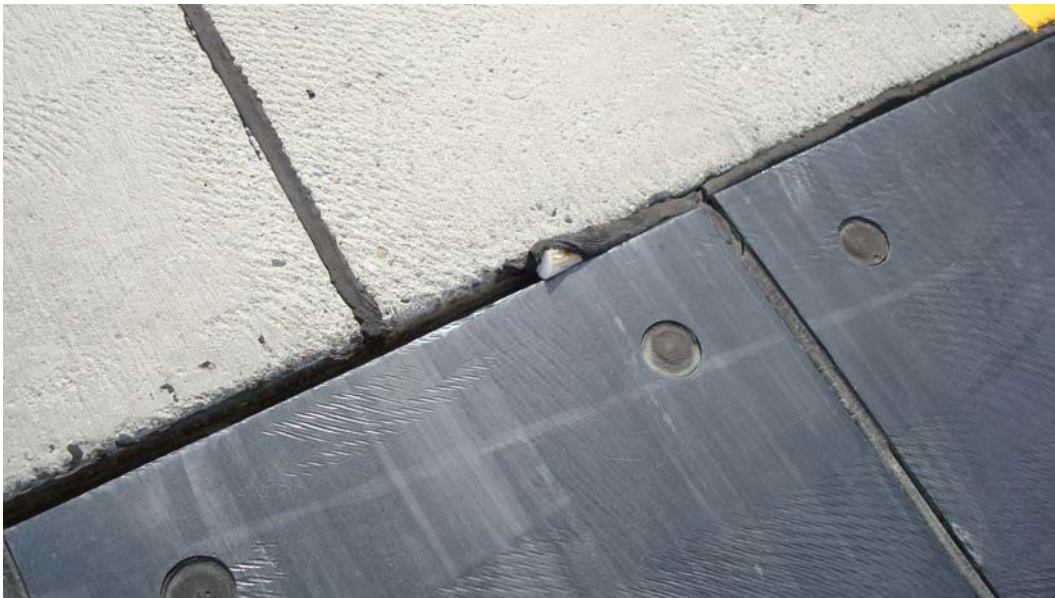
The condition of the adjacent pavement was very good, with only very minor spalling and some minor scarring of the surface due to action of the cable under traffic (Figure 30). The condition of the panels was good, with no particular problems. The sealant appeared to be intact for most of the joints (Figure 31), but there was some loss in bond between the sealant and the panels (Figure 32).

Figure 30. Minor surface wear of the pavement surface and rounding of the edges on Runway 06 at Elmendorf AFB.

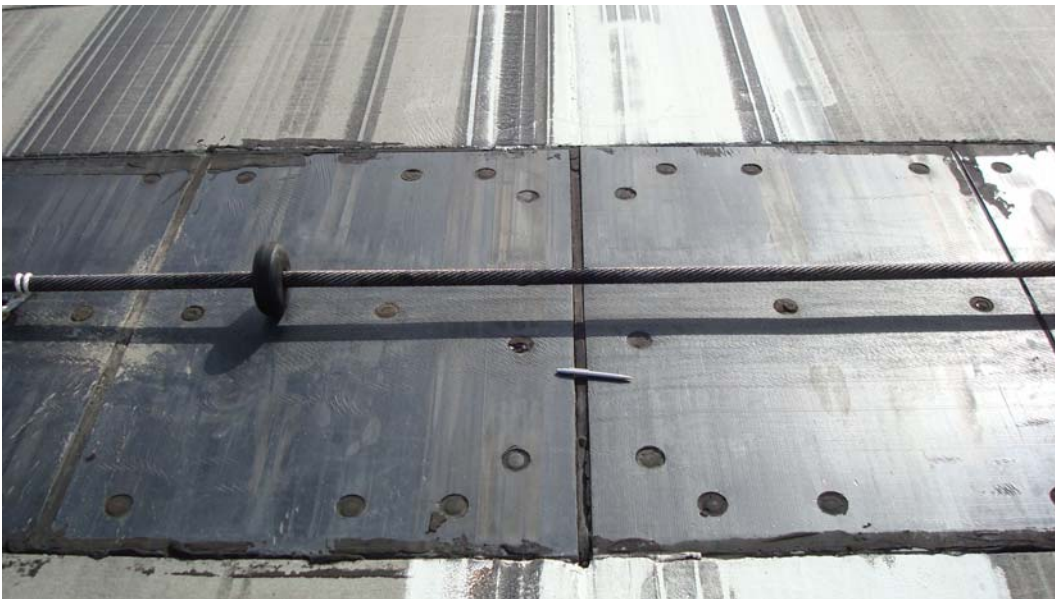
Figure 32. Sealant in poor condition on Runway 06 at Elmendorf AFB.

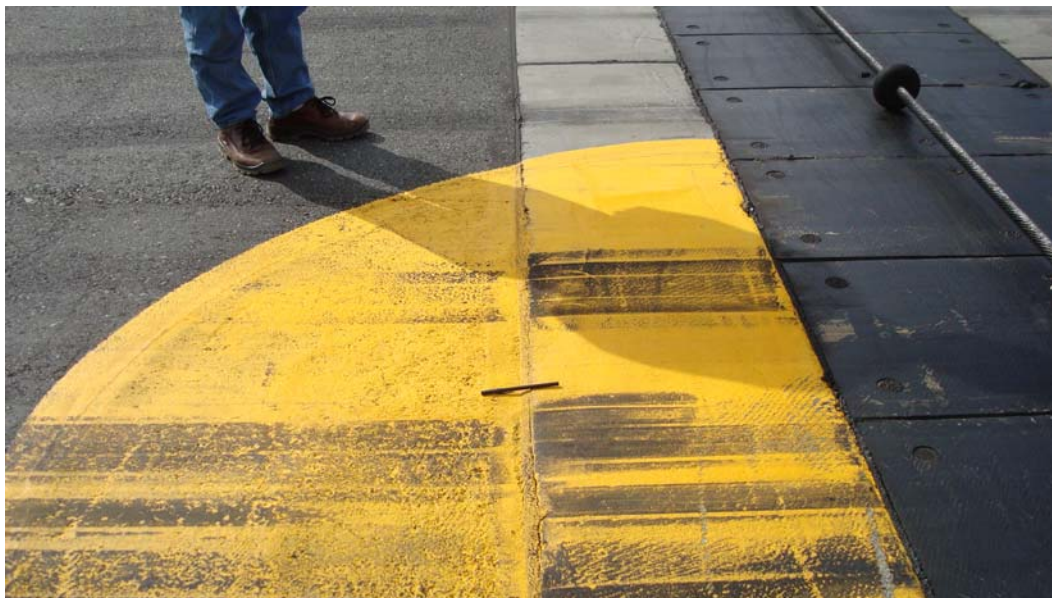
There was also a bump between the asphalt pavement and the concrete strip caused by the concrete protruding above the asphalt mixture (Figure 34). Grinding is a good method to make this smooth at this location, as well as any other location having a similar problem. One concern is that this bump will cause the hook to skip and not engage the cable.

Figure 34. Bump between asphalt pavement and concrete strip on Runway 24 at Elmendorf AFB.

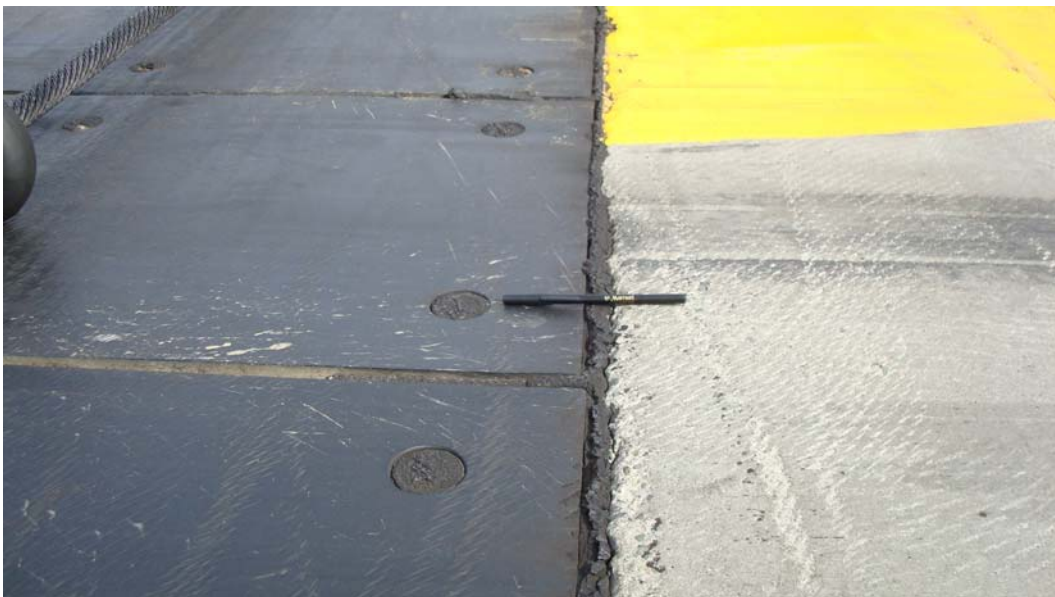
Figure 36. Poor performance of sealer between two adjacent panels and between the panels and the adjacent concrete on Runway 24 at Elmendorf AFB.

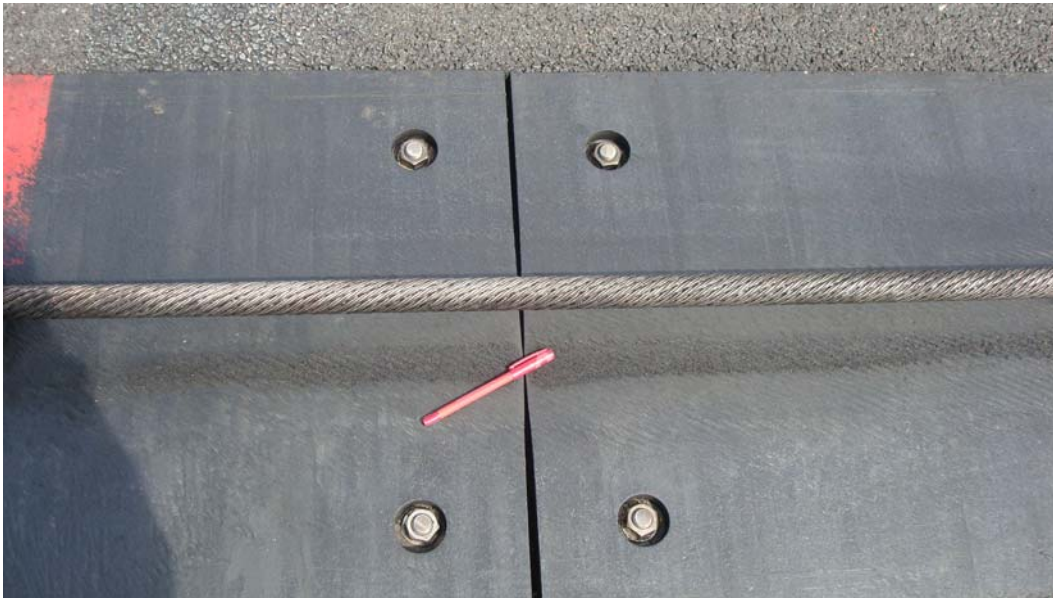
Figure 53. Panels were in good shape but some unevenness at joint underneath cable likely due to beating of the cable (RAF Lakenheath).

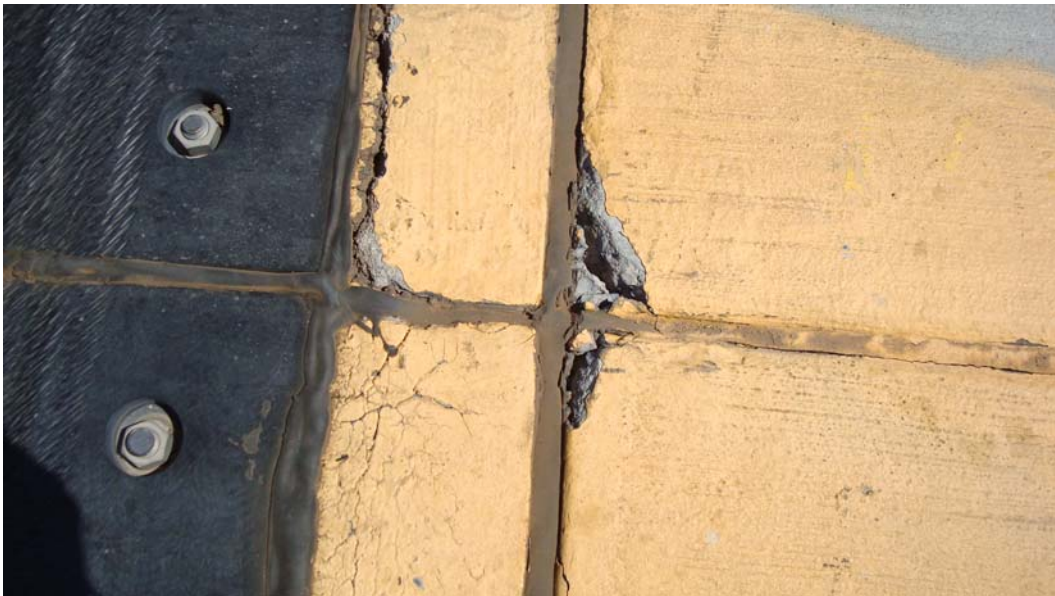
Figure 55. Some localized spalling of concrete at Luke AFB.

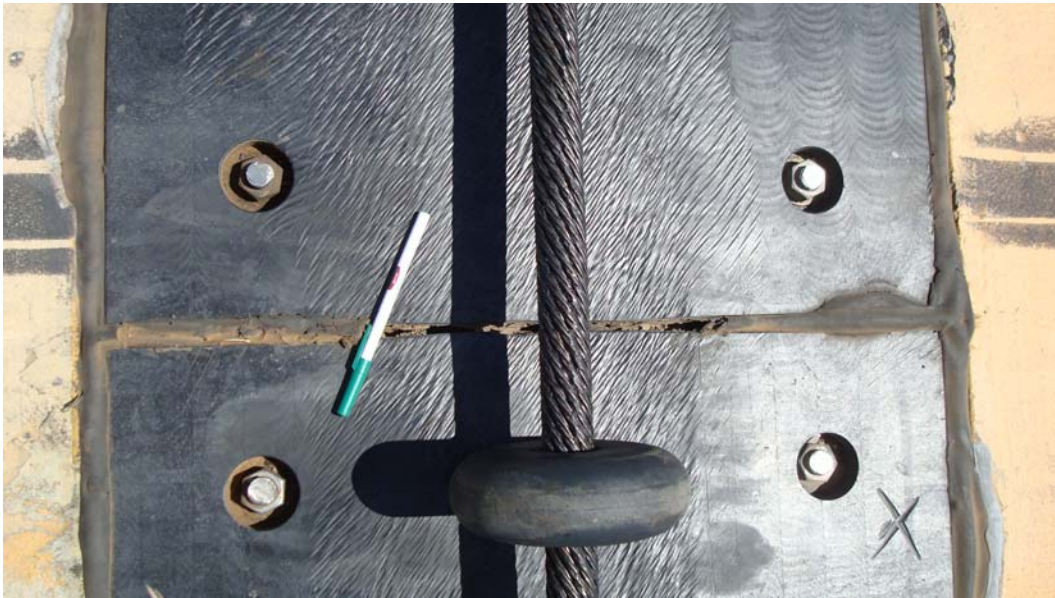
The original sealant was placed when the panels were installed 5 years prior to inspection, and only some small amount of additional sealer was applied to localized areas.

Figure 56. Condition of sealer satisfactory in spots and damaged in other areas at Luke AFB.

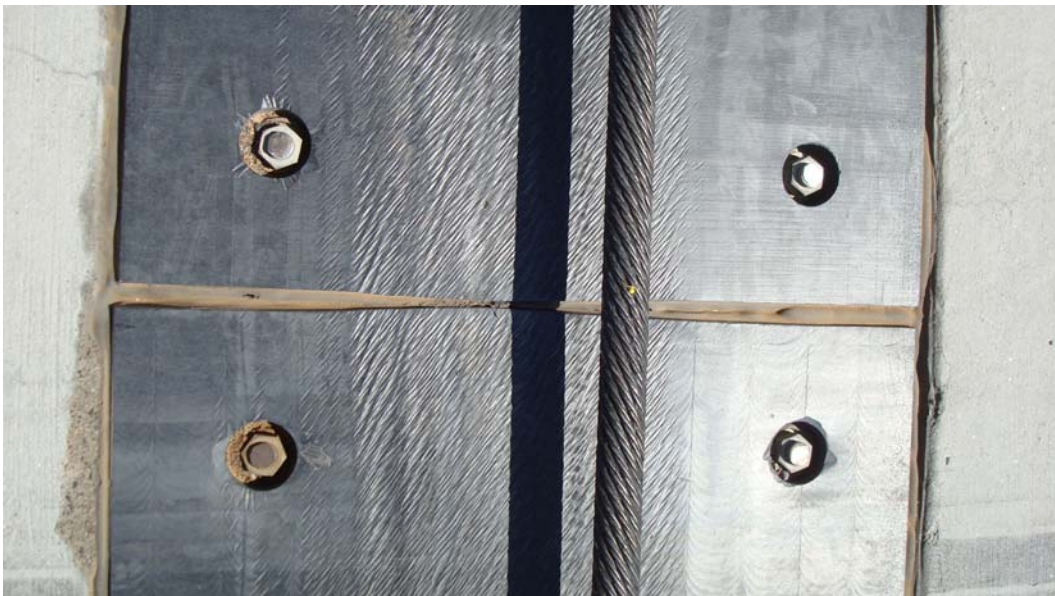
Figure 57. Some deformation in the panels and some wear from beating of the cable at Luke AFB.

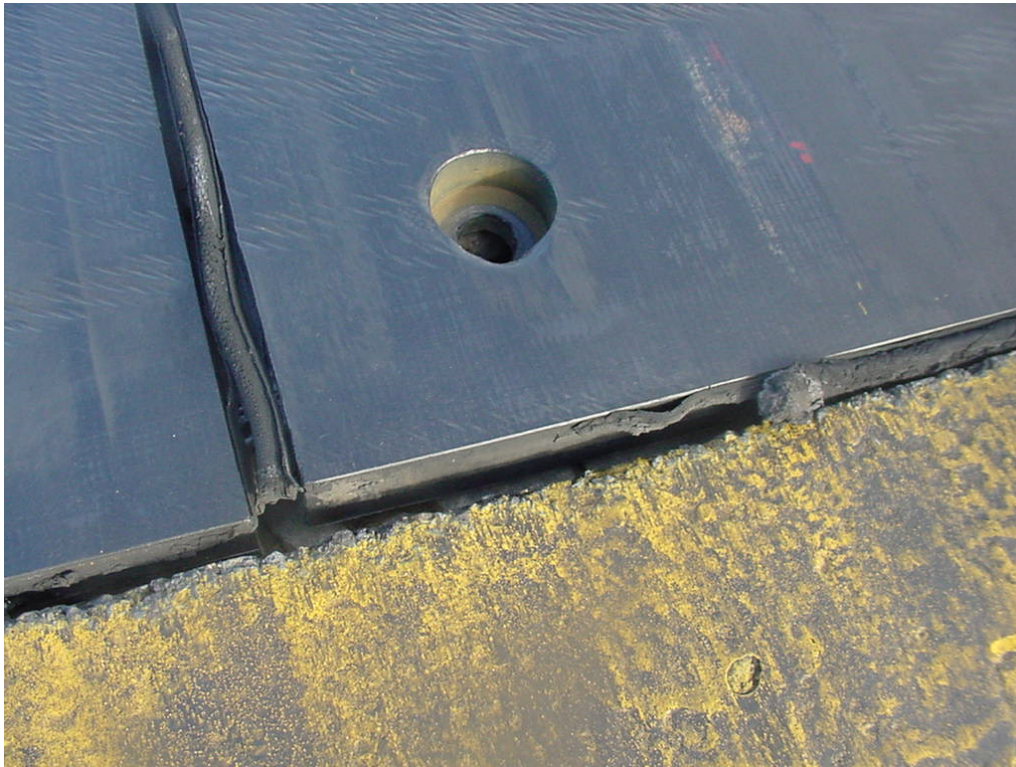
Figure 61. Loss of anchor bolt and nut at McChord AFB.

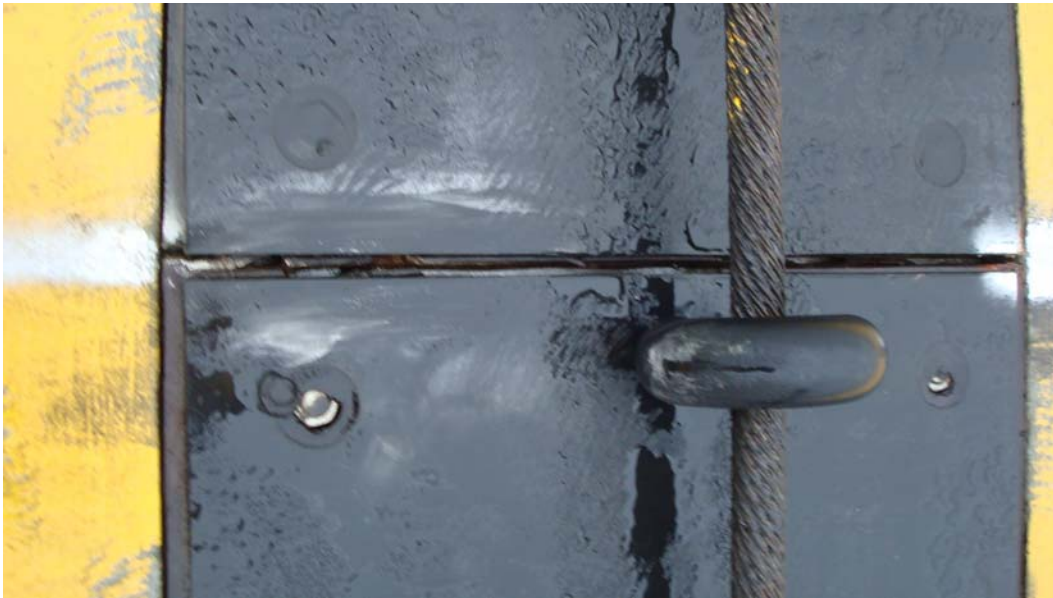
Figure 68. Loss of sealant in recess for anchor at Runway 22 R at Shaw AFB.

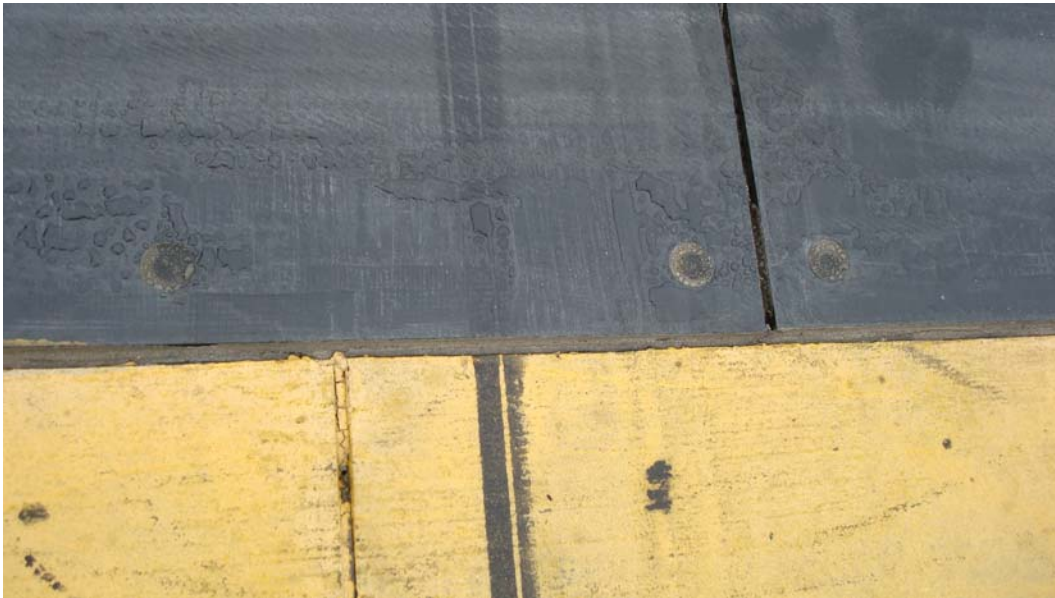
Figure 73. Performance of sealant and offset of joints in panels and concrete on Runway 22 L at Shaw AFB.

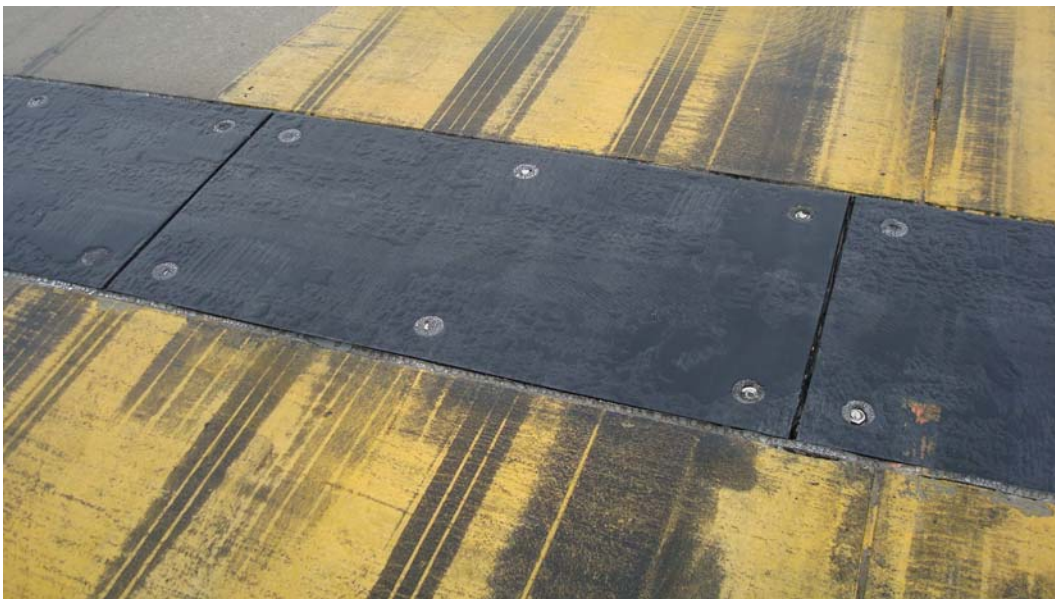
Figure 74. Offset of joint between panels and joint in concrete at Runway 22 L at Shaw AFB.

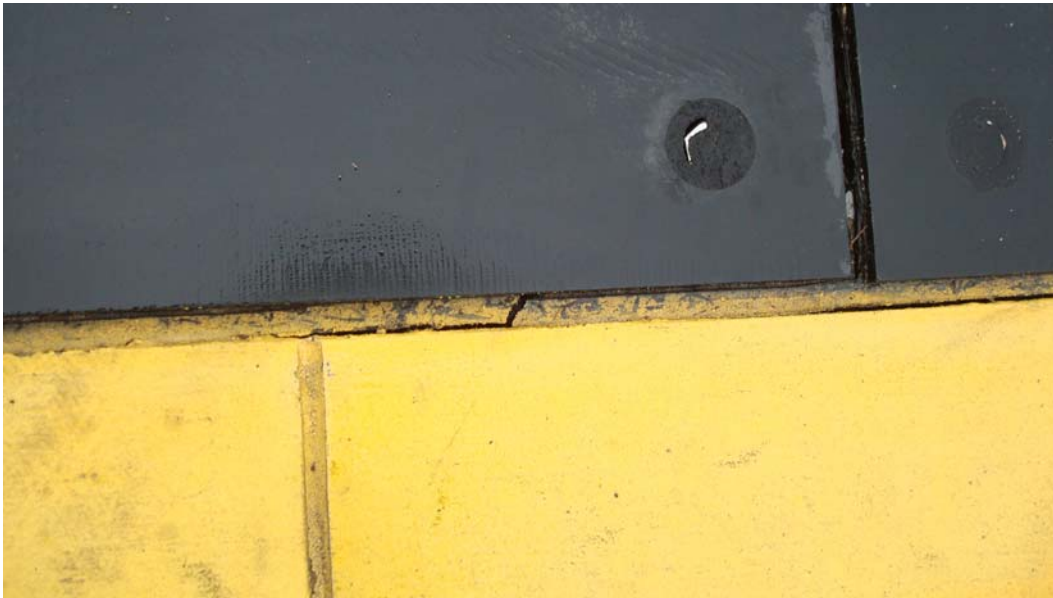
Figure 77. Joints in concrete do not match joints between panels at Runway 4 L at Shaw AFB.

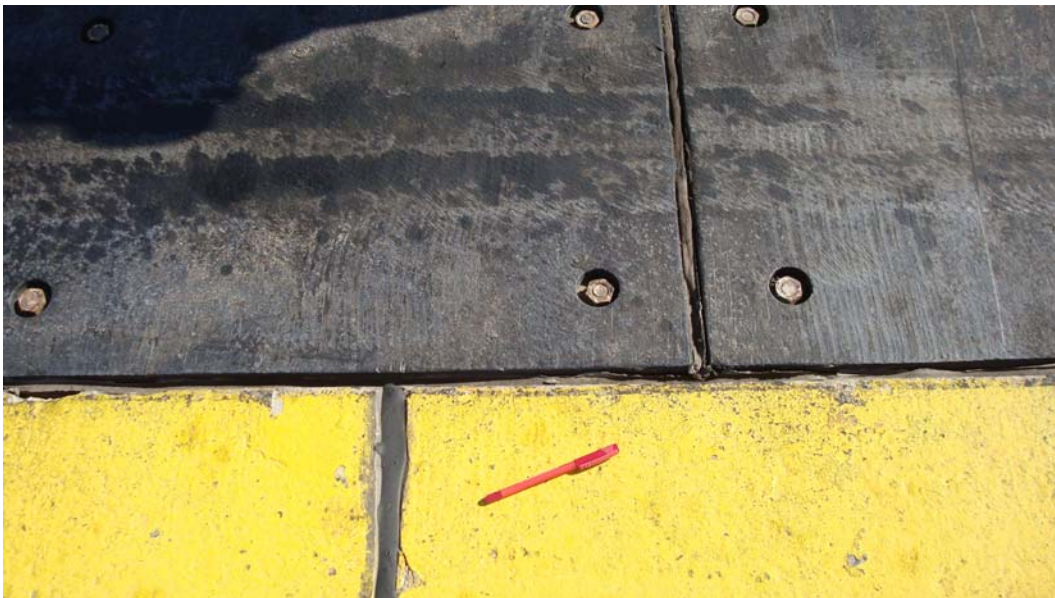
Figure 82. Joints between panels did not match joints in adjacent concrete at Spangdahlem AFB.

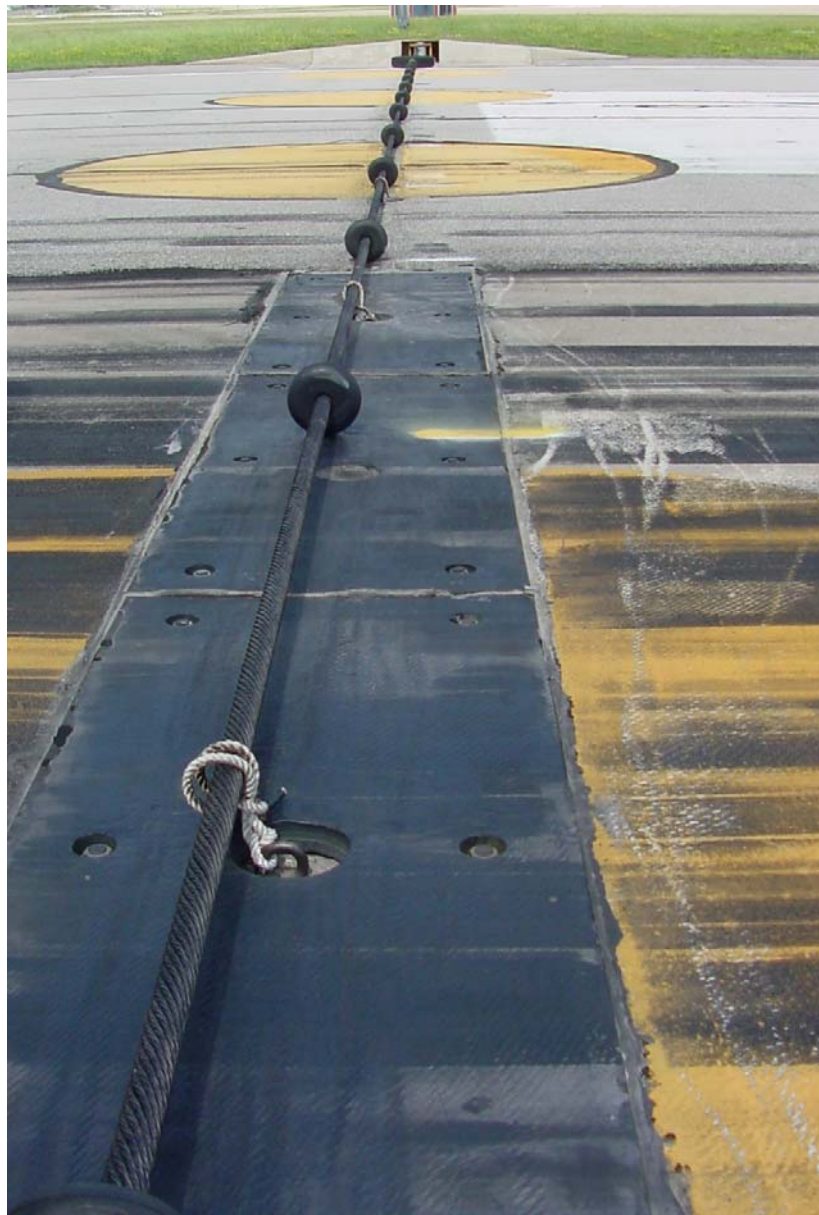
Figure 84. Lack of sealant in recess at end of anchor at Tinker AFB.
