## **Evaluation of Ultra High Molecular Weight (UHMW) Polyethylene Panels for Aircraft Arresting Systems**

E. Ray Brown

August 2009

Final report

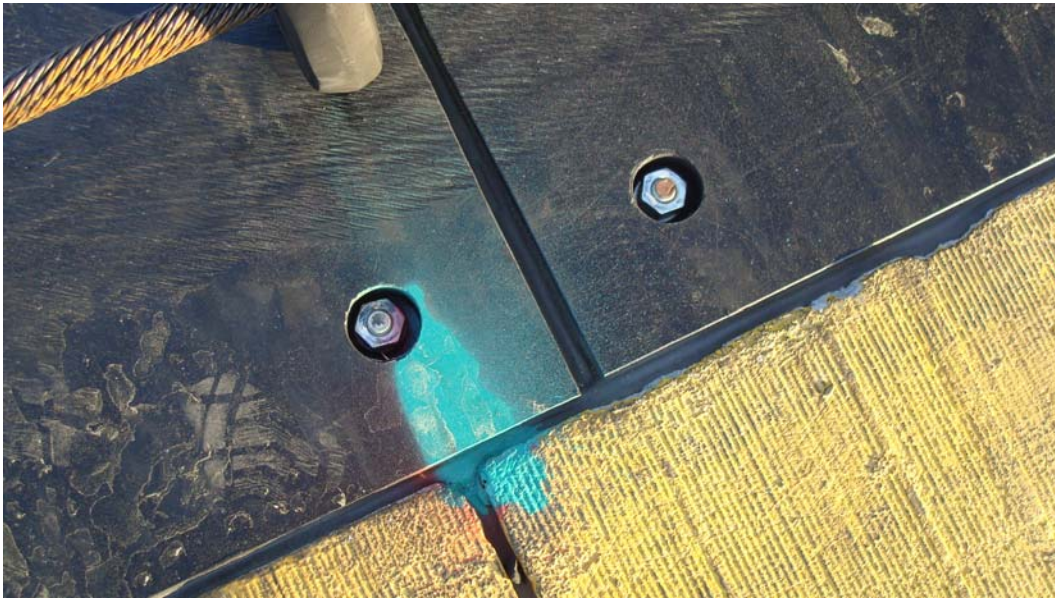
Figure 87. Barrier Cable at Runway 13 L at Tyndall AFB showing joints in concrete not matching joints between panels.

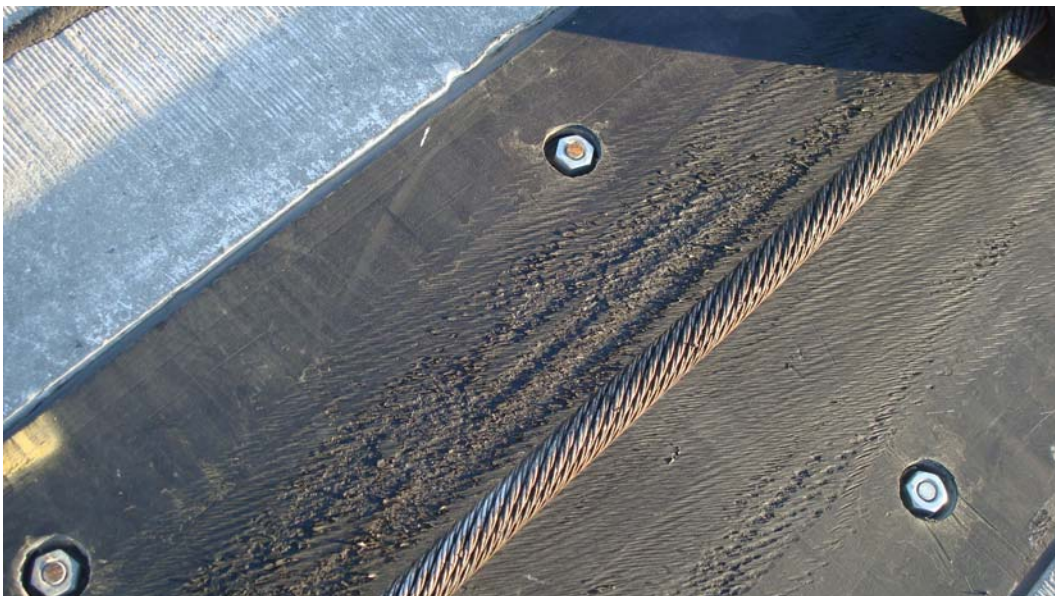
Figure 88. Barrier Cable at Tyndall Runway 13 L showing minor damage to panel from beating of the cable.

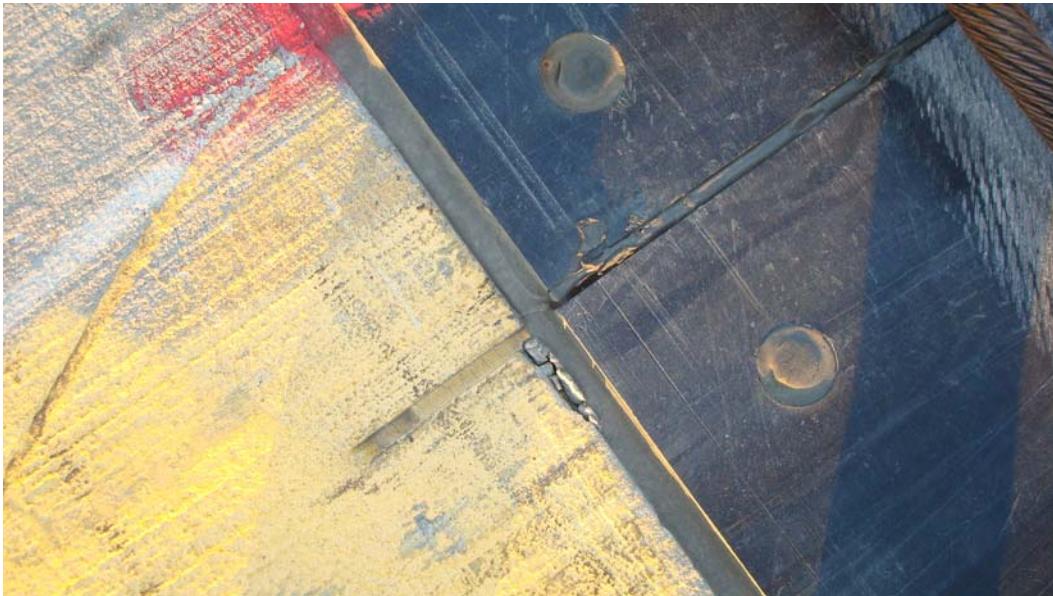
Figure 94. Some sealant damage at BAK-12 and some minor spalling in the adjacent concrete at Runway 31 L at Tyndall AFB.

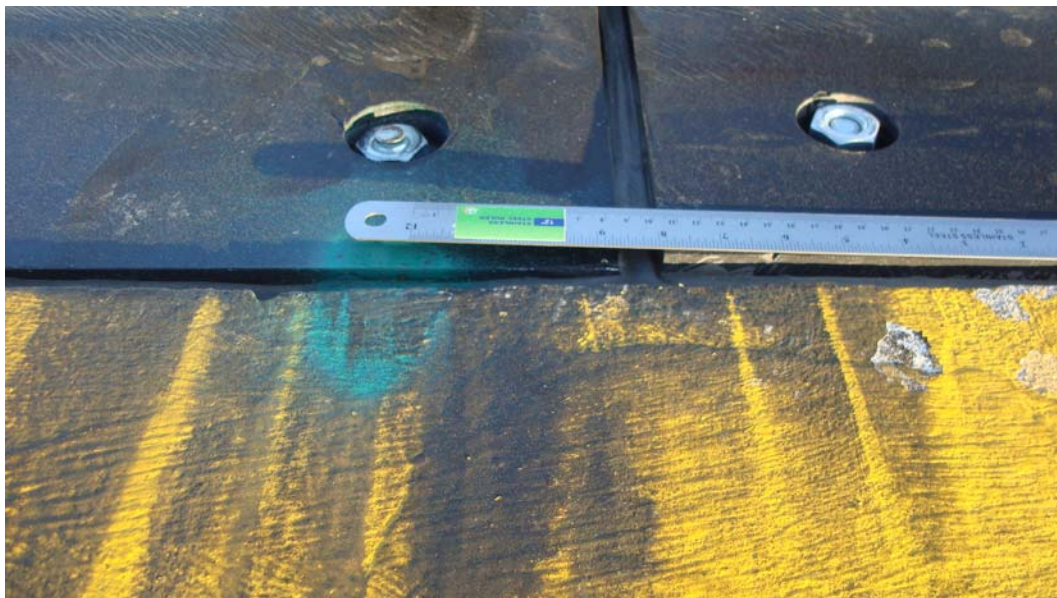
Figure 98. Some deviation in elevation of panels at Runway 13 R at Tyndall AFB.
