Hurricane Ike along the upper Texas coast: An introduction

Nicholas C. Kraus, Ph.D., and Lihwa Lin, Ph.D.

U.S. Army Engineer Research and Development Center, Coastal and Hydraulics Laboratory, 3909 Halls Ferry Rd., Vicksburg, MS 39180 Nicholas.C.Kraus@usace.army.mil

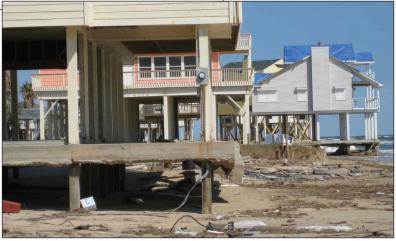
Figure 6 (above). Undermining of concrete slabs was progressively less with distance landward (to right of picture).

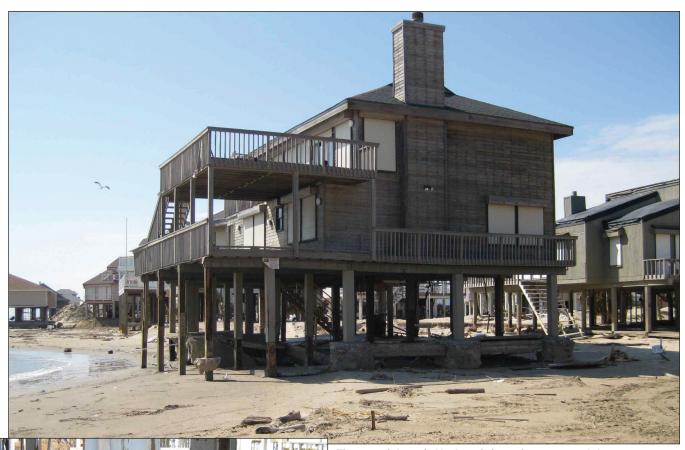
Figure 7 (left). Up and down movement of heavy concrete slab by the surge current and waves scraped this large piling, rounding and weakening it from its orginal square shape.

Buildings near the beach are inferred to have been damaged primarily by erosion induced by surge and waves, which undermined the massive concrete slabs under them. Some slabs were moved energetically by waves and the flooding current from the sea to bay, as seen in Figure 7. This photograph indicates that the slab was repeatedly moved up and down by hydrodynamic forces. Such movement stressed the pilings, tilted the structure, and caused damage that otherwise might not have occurred. Concrete slabs are constructed primarily for parking beneath the main dwelling and to serve as a foundation for large appliances and water heaters. A conclusion is that concrete slabs should not be placed under structures built on pilings that may be exposed to surge and waves. A gravel layer on top of filter cloth might be an appropriate and low-cost alternative.

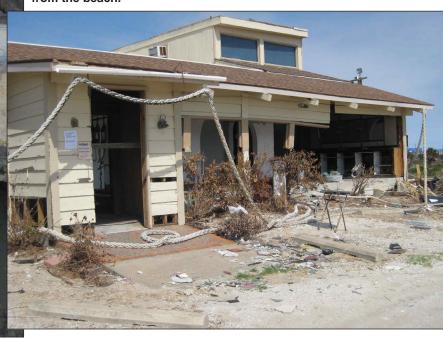
Figure 8 (below). Flood damage by surge on structure facing the Gulf of Mexico, but more than 1,500 ft (450 m) from the beach.

Older structures not on pilings were heavily damaged by the surge. The picture in Figure 8 shows such a structure, a restaurant located on the bay (north) side of FM 3005, some 1,500 ft (450 m) from the beach. Debris was driven into the building by the surge from the Gulf of Mexico and its functionality as a restaurant was destroyed.
