HADITHA GENERAL HOSPITAL
UNDER THE ECONOMIC SUPPORT FUND PROGRAM
HADITHA, IRAQ

SIGIR PA-08-132
JANUARY 23, 2009

SUBJECT: Report on Project Assessment of the Haditha General Hospital, Haditha, Iraq
(SIGIR Report Number PA-08-132)

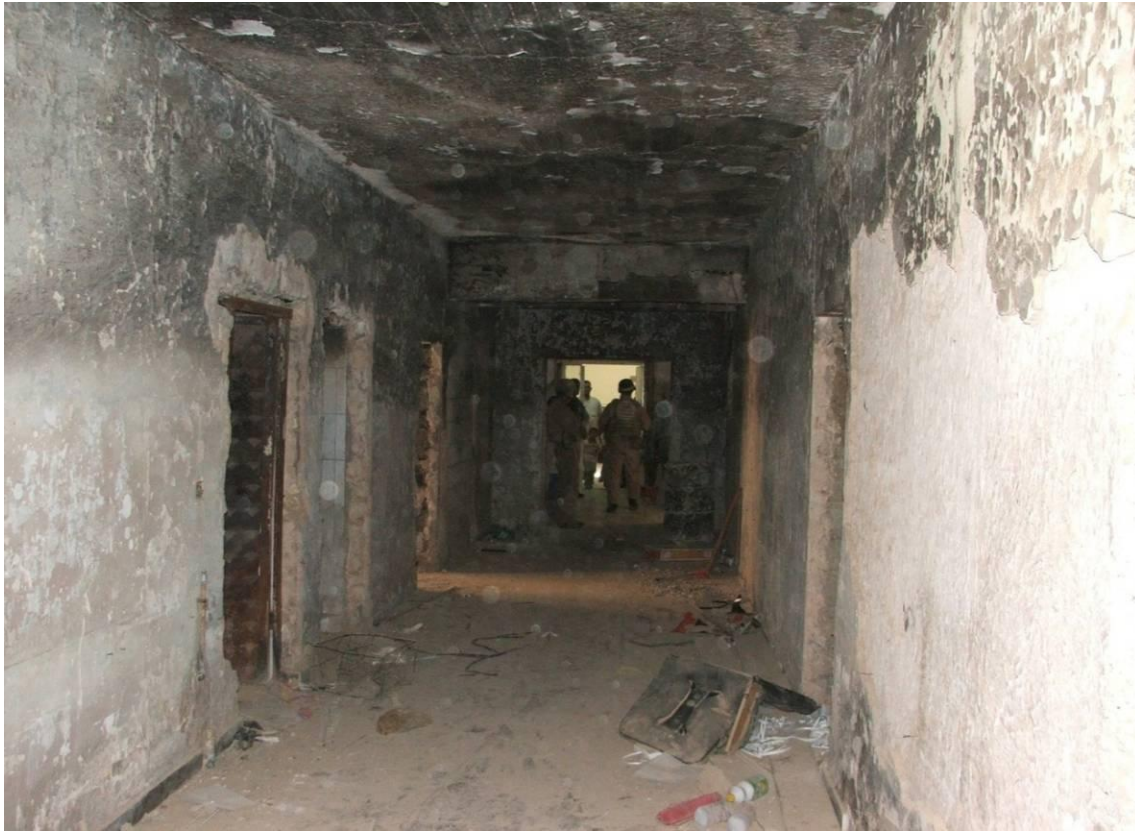
Site Photo 1. VBIED damage to Haditha General Hospital (Courtesy of USACE)

At the time of the inspection, no work had been performed in the ward previously damaged by the VBIED. It appeared that the ward had sustained heavy damage due to the explosion and resulting fire (Site Photo 1). Most of the interior plaster was scorched or covered with heavy soot. Due to time limitations on site, SIGIR could not perform a structural assessment of the building; however, previous GRC documentation stated that it is not feasible to repair the existing structure. SIGIR found no evidence during the inspection to contradict this finding.

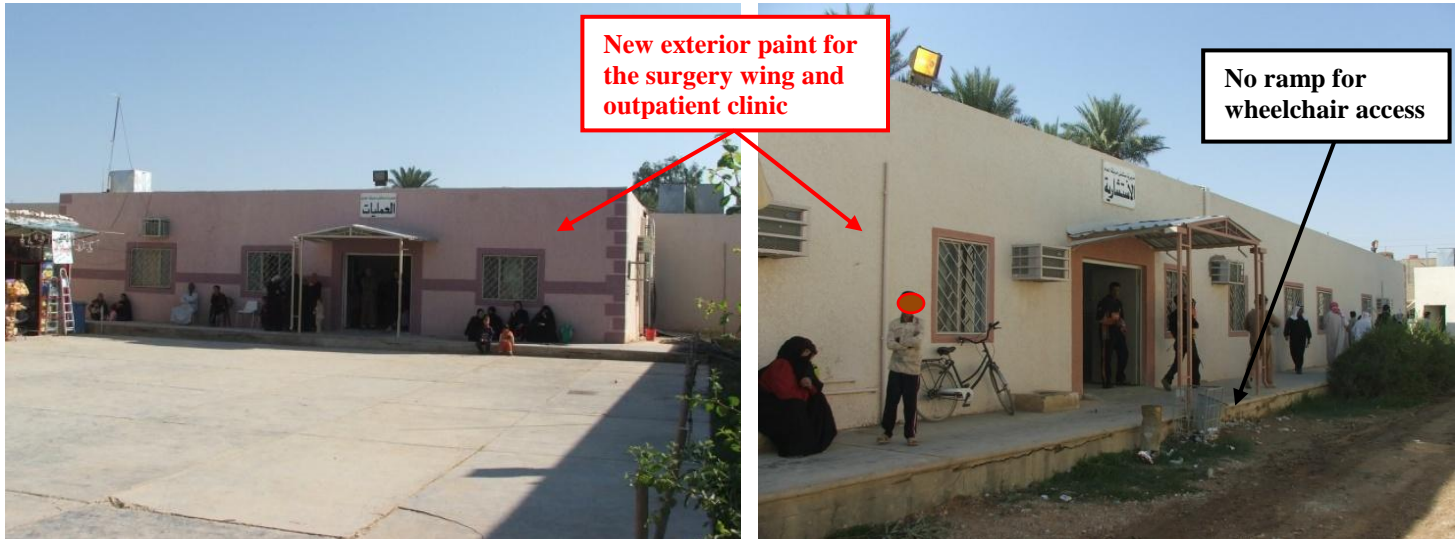
SIGIR inspected the exterior of the surgery wing and the outpatient clinic. Due to security concerns, other areas of the hospital exterior were not accessible. Several of the building exteriors appeared to have been painted (Site Photos 3 and 4), but there did not appear to be other significant renovations to the exterior of the hospital. The hardscape and other site elements had not been renovated. SIGIR noted that the revised SOW did not address the issue of how patients in wheelchairs or with limited-ambulatory capabilities can access the outpatient clinic (Site Photo 4).

Photos 3 and 4. Exterior of the surgery wing and outpatient clinic buildings

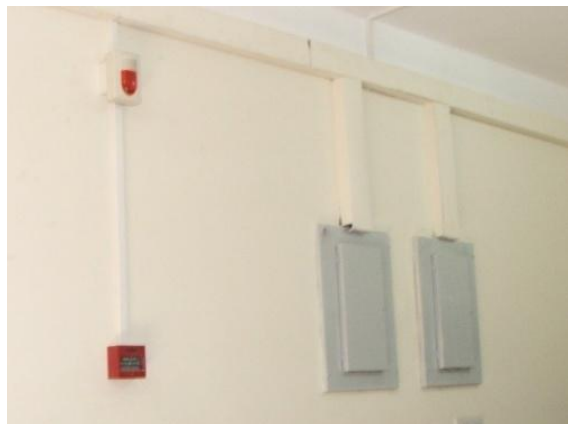
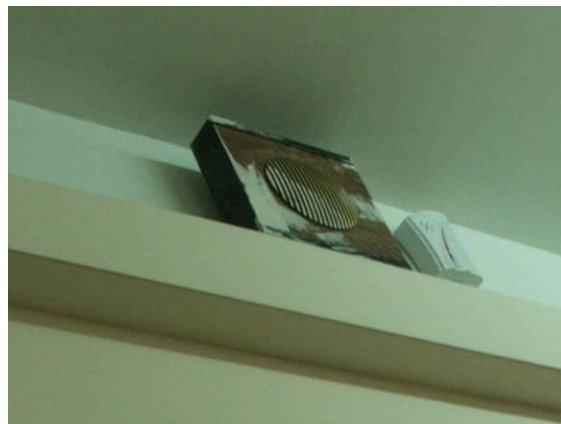
The renovation of the administration wing included an upgrade to the electrical system. SIGIR noted the installation of what appeared to be new wire molding, outlets, light fixtures, and new main distribution panels (MDPs) (Site Photo 7). The MDPs were situated at a reasonable location and were reasonably secure. An intercom system was installed in some areas of the hospital. According to the contractor representative, the system was new; however, due to the careless over-painting of the components, the inspection team could not determine if the equipment was in fact new (Site Photo 8).

Site Photos 7 and 8. Installation of new wire molding, outlets, light fixtures and new main distribution panels (left) and careless over-painting of intercom system (right).

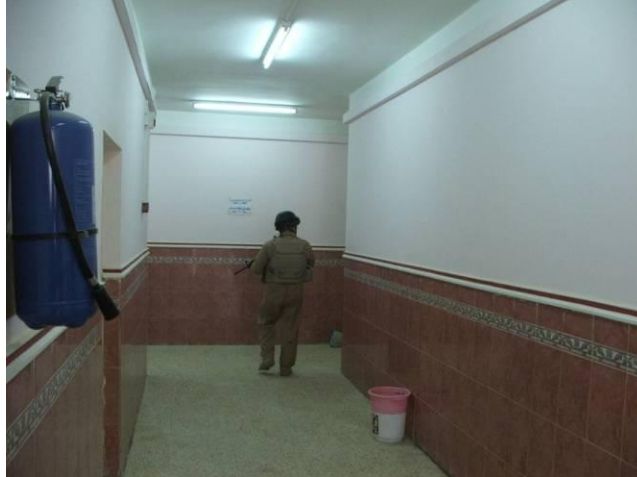
The men's and women's wards appeared to consist of the same type of concrete frame and concrete block infill construction. The main hallways of both wards were renovated with new finishes on the ceiling and walls. The ceiling and walls were painted and ceramic tile installed in the main corridors and most rooms to a height of approximately one meter (Site Photo 9). According to the USACE GRC representative, the flooring was in good condition and was not replaced.

Site Photo 9. Typical ceiling and wall painting and ceramic tile installation.

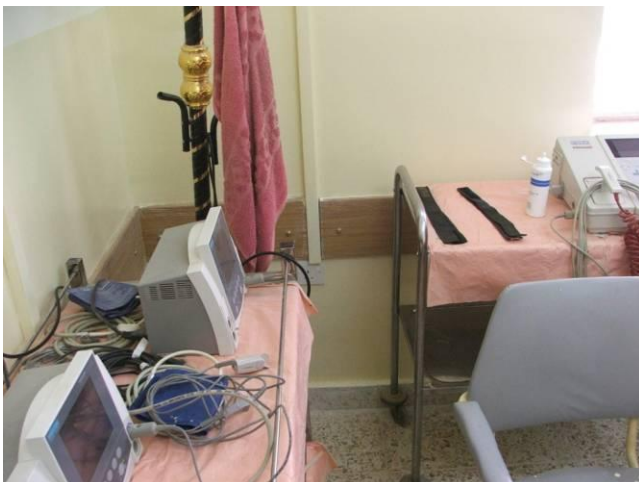
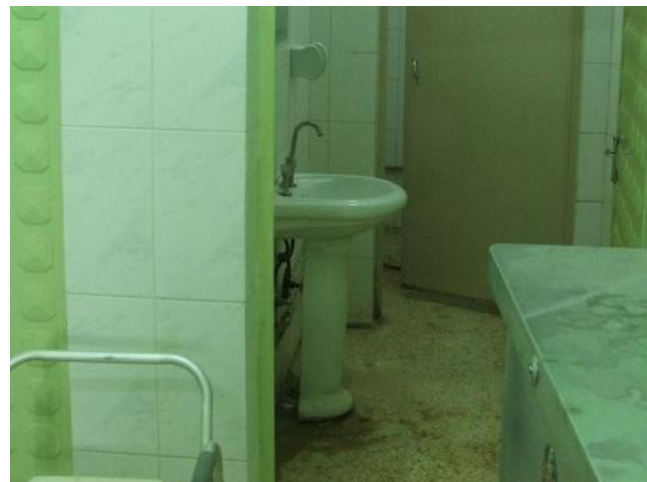
SIGIR noticed a moderate amount of modern medical equipment requiring electricity; specifically, several heart monitors and defibrillator machines (Site Photo 10). This equipment appeared to be supplied with power from the renovated electrical system.

Several of the common restrooms were kept in an unsanitary manner. At least one lavatory in the common restroom between the wards appeared to be leaking and there was standing water on the floor (Site Photo 11). Due to time limitations, SIGIR could not determine if the leak was in a previously renovated area or if the contractor was required to perform additional work, including repair of the lavatory, under the re-scoped portion of the contract. However, there is a significant potential for germs and the spread of disease from the use of the restrooms.

Photos 10 and 11. Heart monitors and defibrillator machines (left) and standing water on the restroom floor (right).

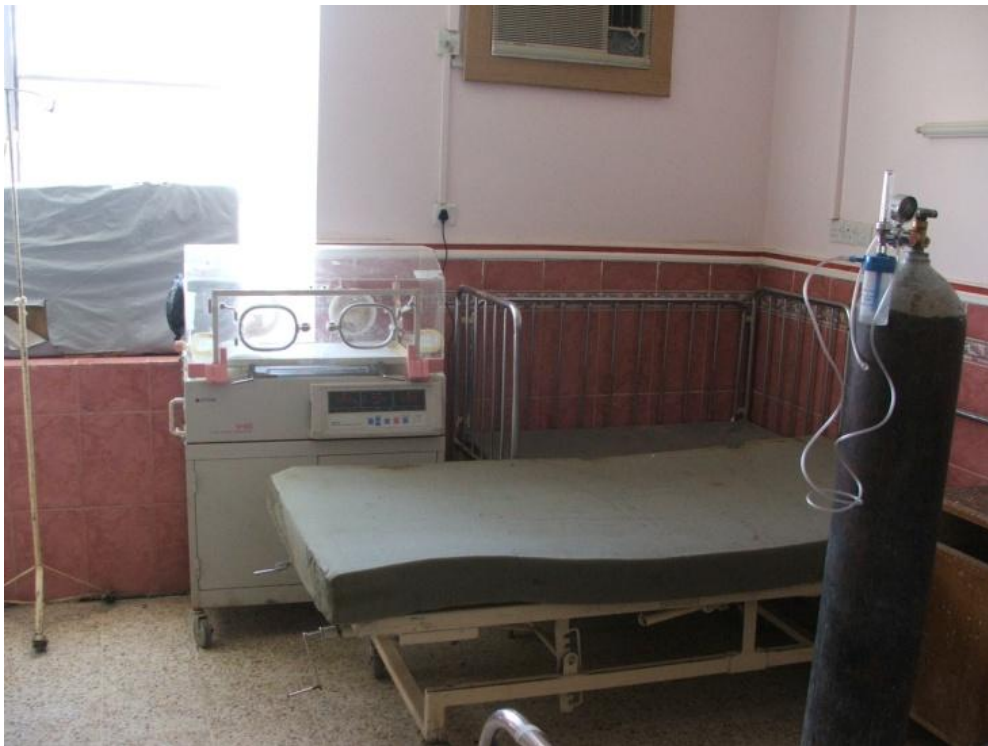
The maternity wing was in operation at the time of the inspection, with several rooms in use and the remainder appearing operational. During the site visit, SIGIR noticed an unsecured oxygen tank in one of the rooms, which represents a significant concern both from potential toppling and rupture, and as a serious fire hazard (Site Photo 12).

Site Photo 12. Unsecured oxygen tank in maternity wing

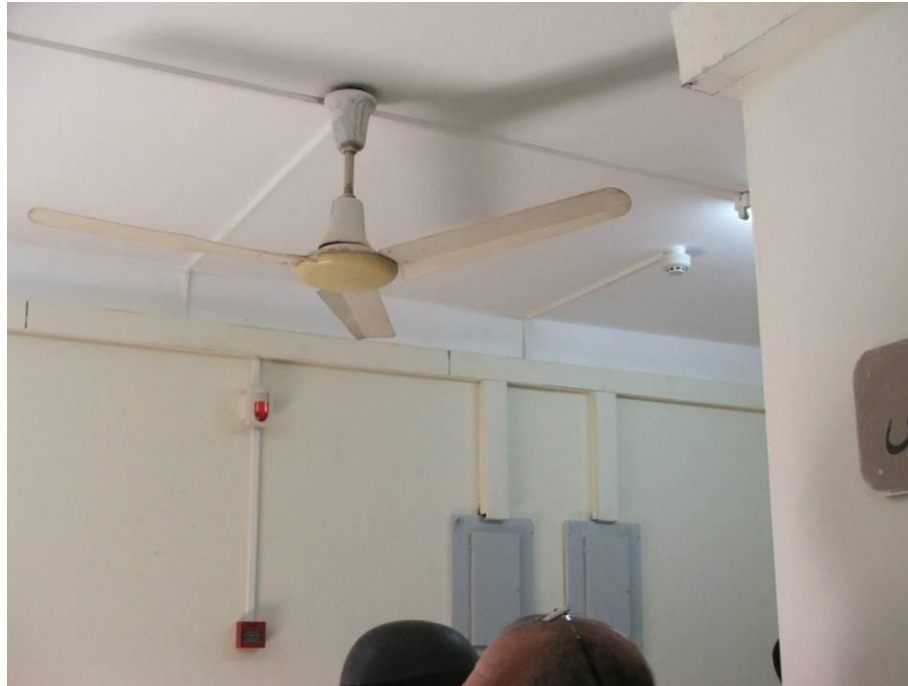
Measures to improve fire safety were included throughout the facility, including in the men's and women's wards and the maternity wing. The contractor installed fire extinguishers, which appeared to be new and fully charged (Site Photo 9). The contractor representative stated a fire alarm system was installed and functioning properly (Site Photo 13).

Site Photo 13. Installation of fire alarm system.

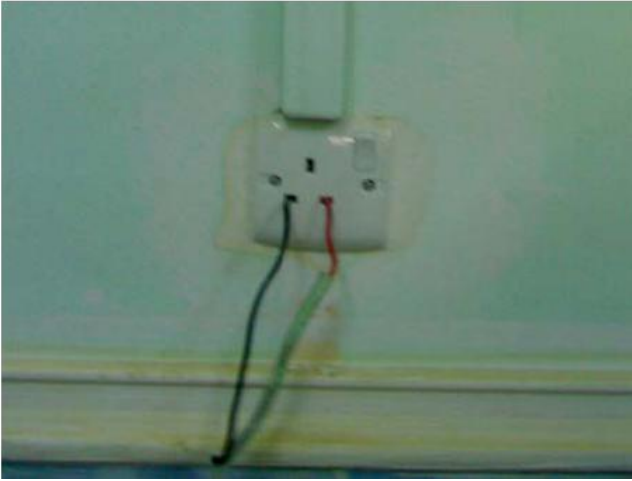
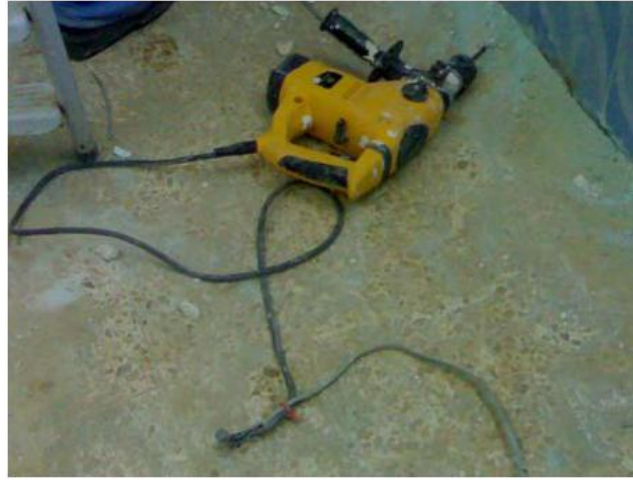
The USACE provided SIGIR with 14 daily QA Representative (QAR) reports from the months of September and October 2008. The reports provided detailed information regarding the progress of renovation and the quality of construction. The QAR provided written reports, including photographs, which documented activities being performed and deficiencies in construction quality or materials. The daily QA reports identified the safety concerns, inferior workmanship, and the progress of construction. For example, the QAR identified potentially dangerous safety concerns with the contractor's use of electrical connections and the corrective actions taken (Site Photos 14-17).

Site Photos 14 and 15. Unsafe electrical practices used by the contractor and captured in daily QA reports (Courtesy of USACE)
