**SECURE DOCUMENT STORAGE FACILITY
BAGHDAD, IRAQ**

SUSTAINMENT ASSESSMENT

**SIGIR PA-08-166
OCTOBER 20, 2009**

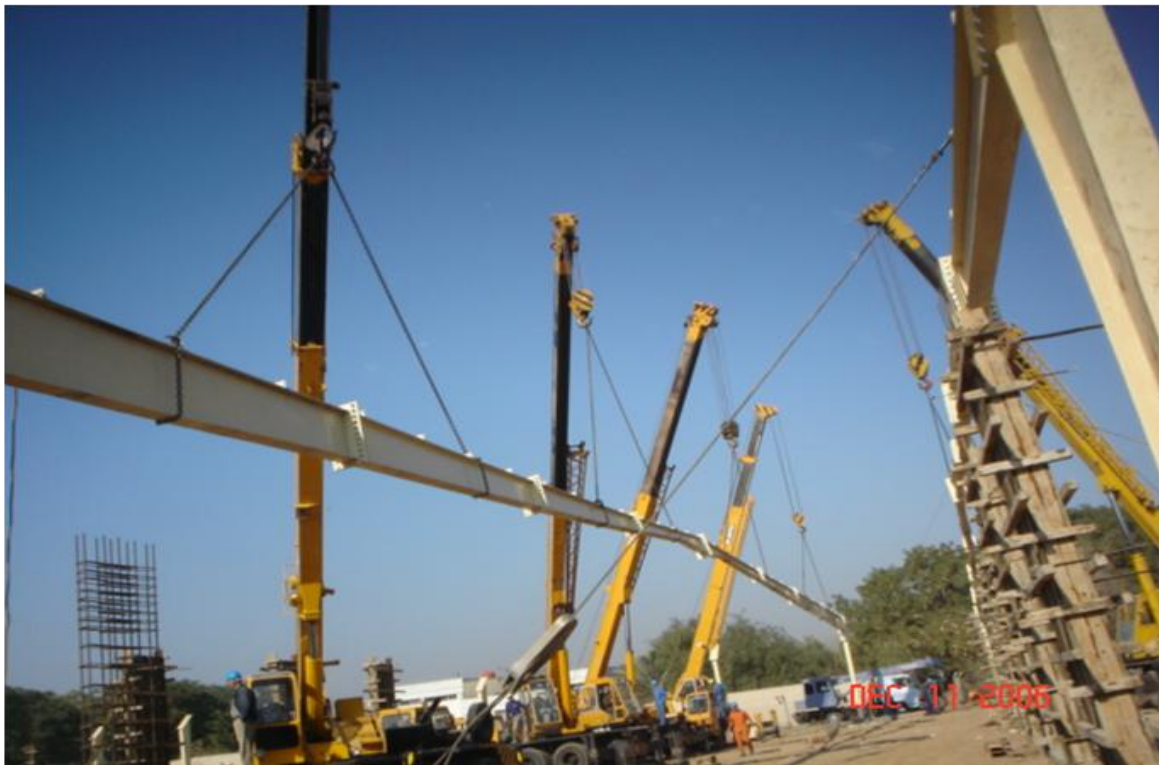
Site Photo 1. Initial construction of the steel columns prior to the structural failure (Courtesy of GRC)

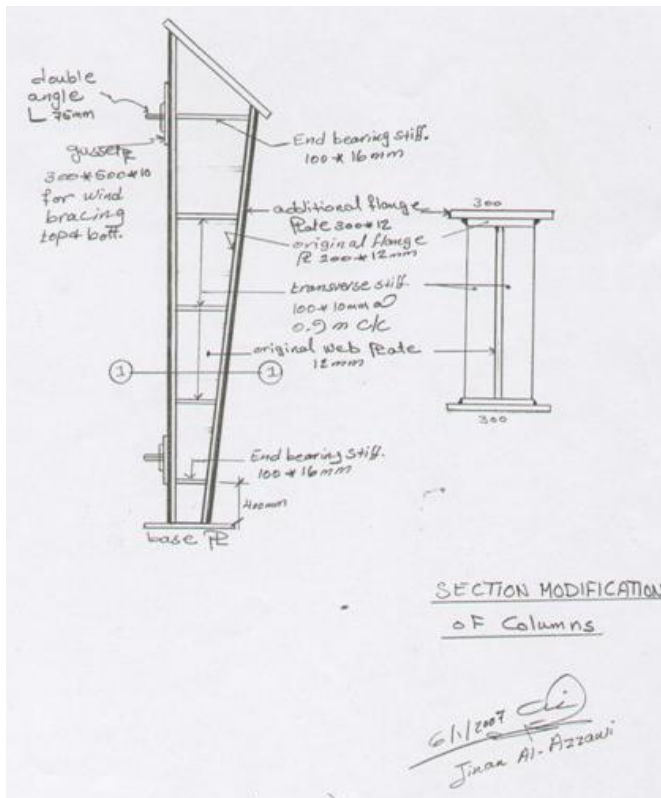
Figure 1. Strengthening columns

After the December 2006 structural failure, the contractor performed an evaluation and proposed a revised design in January 2007. Specifically, the contractor proposed reinforcing the structure to accommodate the design deficiencies. The proposed solution consisted of the following:

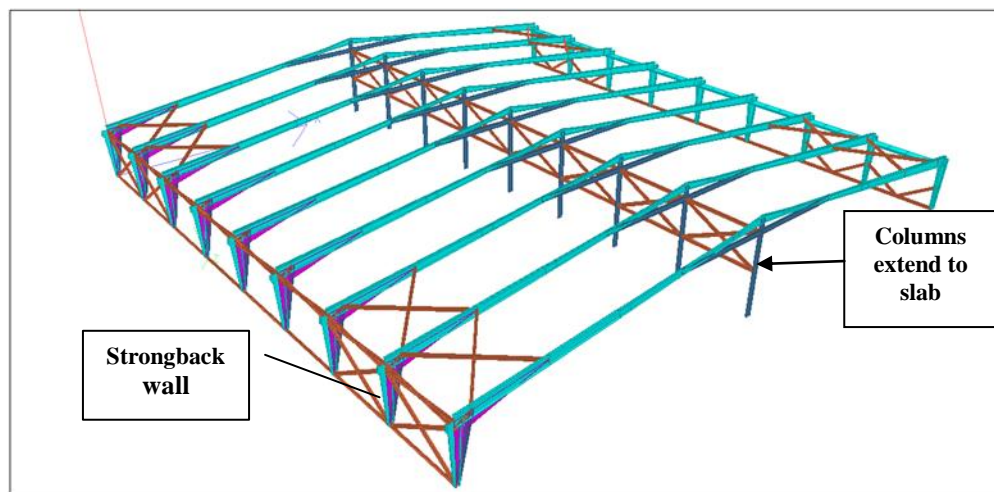
Figure 3. Three-dimensional model of contractor-proposed improvements (Courtesy of GRC)

Figure 3 illustrates the proposed new steel columns along the centerline, extending to the floor. However, by this time, the interior vault rooms had already been constructed, including a reinforced-concrete beam and partition wall running the length of the building, beneath the centerline of the steel frames. Based upon review of the October 2007 QA reports, it appeared that the contractor performed a modified approach to placing the columns. A base plate was placed on the top of the reinforced-concrete beam, and the columns were welded to the base plate (Site Photo 3). Consequently, this model and corresponding structural analysis do not account for the additional load to the reinforced-concrete beam, supporting columns, and foundation.

The contractor provided a revised design submittal in January 2007 to correct the design deficiencies that led to the structural failure. In July 2007, the GRC quality assurance (QA) representative documented examples of the building not being constructed in accordance with the planned structural improvements of January 2007. On 26 July 2007, a GRC structural engineer performed an inspection of the construction to date. The GRC structural engineer issued an observation report, which identified several construction deficiencies; all structural work again stopped while the contractor performed another structural evaluation. In September 2007, the contractor presented GRC with structural improvements, including a structural analysis indicating that the proposed improvements would provide a stable structure under eight different loading conditions. The proposal included a row of columns to be constructed along the centerline of the facility, as well as other strengthening improvements, such as corner bracing, cross bracing, and a strongback¹³ wall (Figure 3).

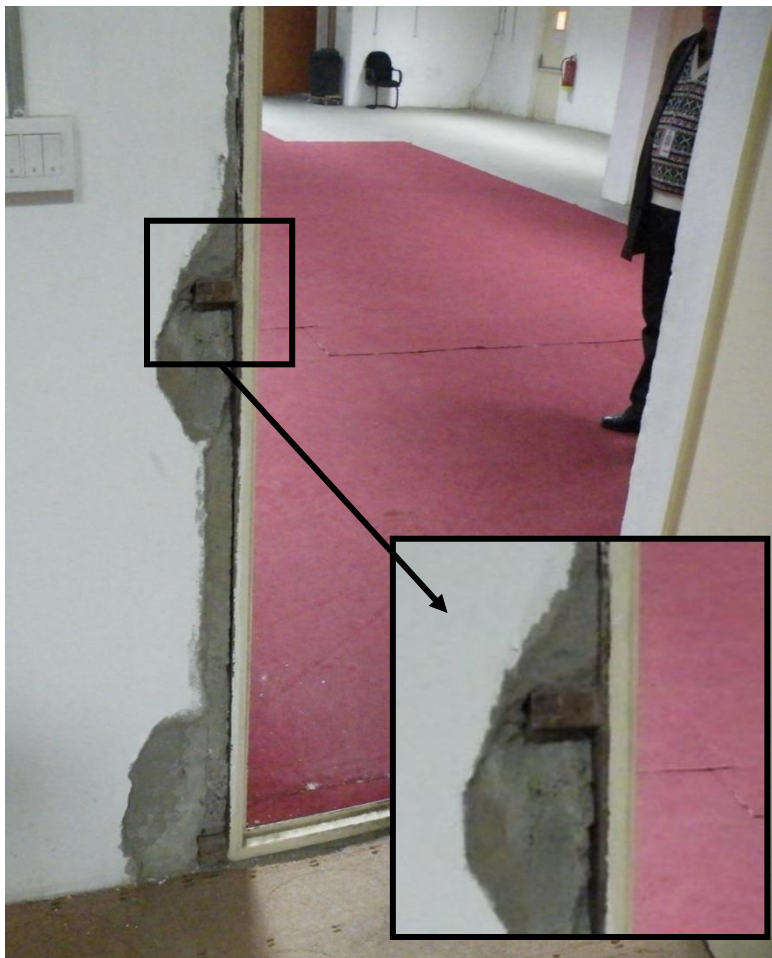
Throughout the SDSF, SIGIR observed significant damage to the interior and exterior door frames (Site Photo 9). According to the SDSF facility manager, the original doors used were too heavy and the door assembly fell out of the wall, which caused damage to the surrounding walls. The SDSF facility manager stated that IHT maintenance personnel were able to reattach the door, but at the time of the site visit, the surrounding walls had not been repaired.

SIGIR did observe damage to both interior and exterior door frames. Site Photo 9 shows a poorly installed door frame. The frame anchor is not embedded into the concrete block wall securely; instead, it is outside the block wall, which left the door frame being secured by the plaster covering the block wall. The door frame is too heavy for the plaster and eventually cracked the plaster and fell off. The SDSF facility manager stated that IHT maintenance personnel had reattached several door frames throughout the facility; therefore, SIGIR could not assess the quality of the contractor’s door frame installation. (The door frames that did not fall off were still covered with plaster; the door frames that did fall off had been reattached by IHT maintenance personnel.)

Site Photo 9. Interior door damage

GRC representatives later visited the SDSF to evaluate the door frame issue. According to GRC, the IHT stated that it had replaced the original metal door frames. The IHT stated that the original door frames could not handle to the load of the doors and that was the justification for replacing the original door frames. According to GRC: “new frames were not completely patched in at the time of the inspection but are handling the weight

of the original doors.” Therefore, GRC considered this a user modification and not a warranty item.

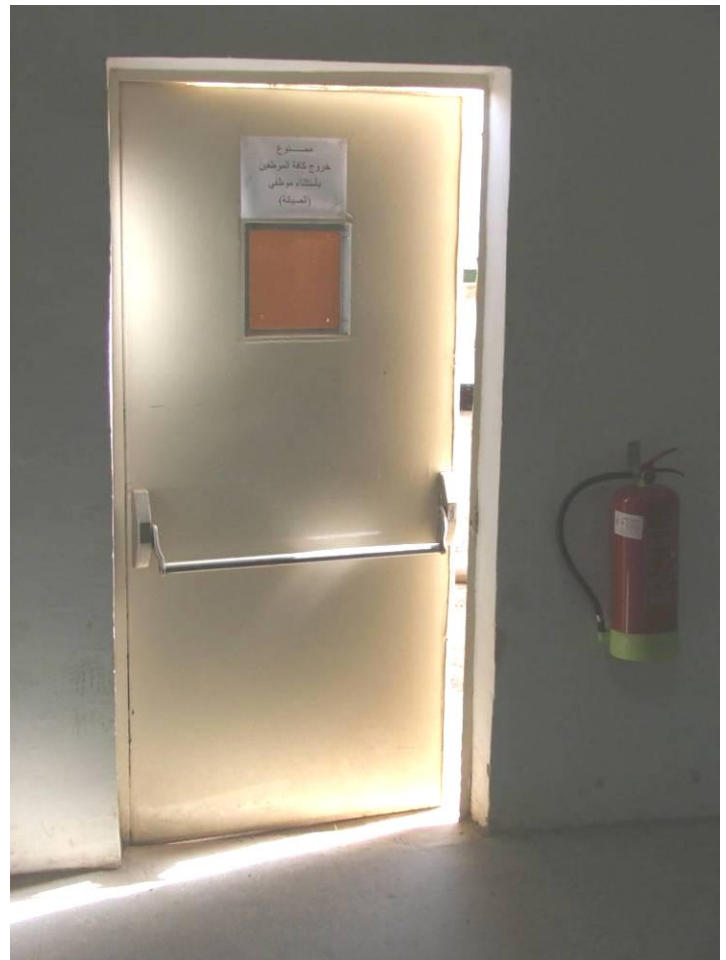
Site Photo 10. Door unable to fully swing open

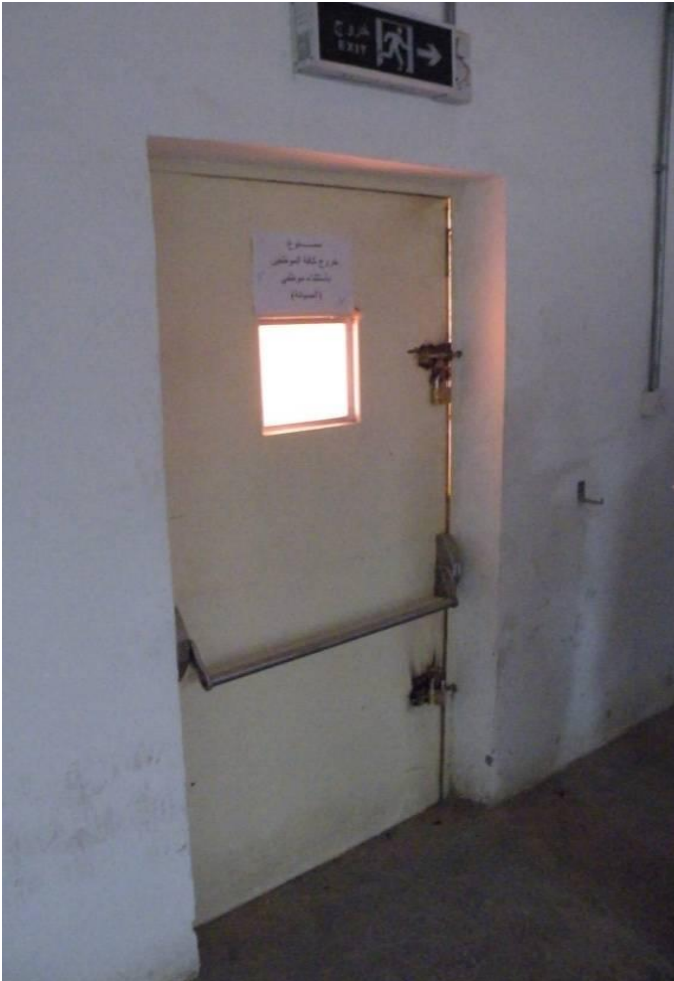
Site Photo 16. Newly installed security door funded by the IHT

In addition, the IHT used its own funding to correct some of the other issues not covered by the warranty, such as the HVAC units and interior/exterior doors. The IHT purchased several condensers, which remedied the HVAC unit problems; purchased a small air-conditioning unit for the room without air vents; and purchased and installed quality security doors and frames (Site Photo 16). SIGIR noted several wall cracks; however, the SDSF facility manager stated that the IHT maintenance personnel will continue to patch the wall cracks as they appear (Site Photo 17).
