**MUJARRAH CANAL BRIDGE
RAMADI, IRAQ**

**SIGIR PA-09-170
JULY 14, 2009**

Mujarrah Canal Bridge

Summary of Report: PA-09-170

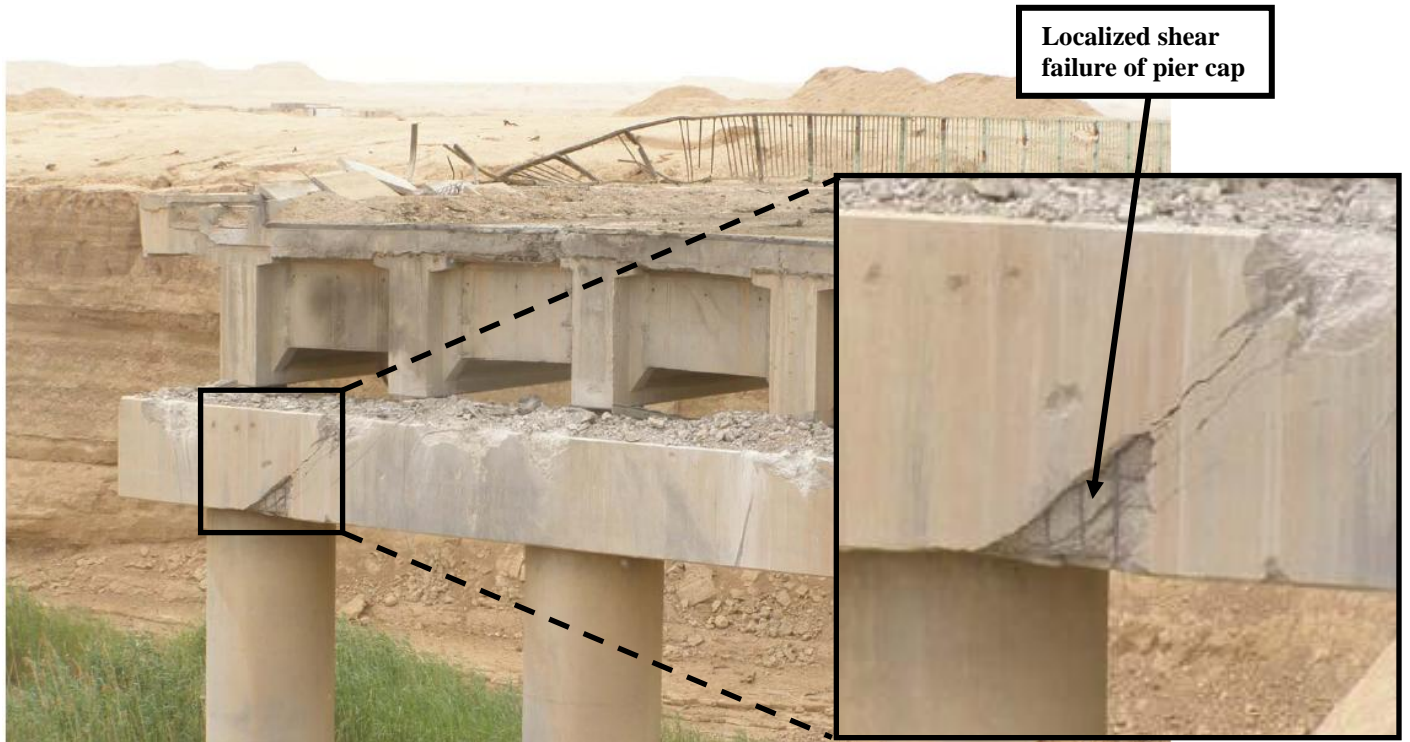
According to project file documentation, in May 2007, a VBIED was detonated on the eastern span (Span No. 1) of the structure. The detonation caused damage to the pier cap (the beam across the column top) of Bent No. 1 and post-tensioned concrete girders, resulting in the collapse of Span No. 1 (Site Photos 3 and 4).

Site Photo 3. VBIED damage to the Mugarrah Canal Bridge's pier cap at Bent No. 1 (Courtesy of GRC)

Damage from the VBIED resulted in a shear failure³ of the reinforced-concrete pier cap at Bent No. 1 and a collapse of Span No. 1. Abutment No. 1 was also damaged, most likely as secondary damage caused by the collapse of Span No. 1. The project file documentation also identified other damage:

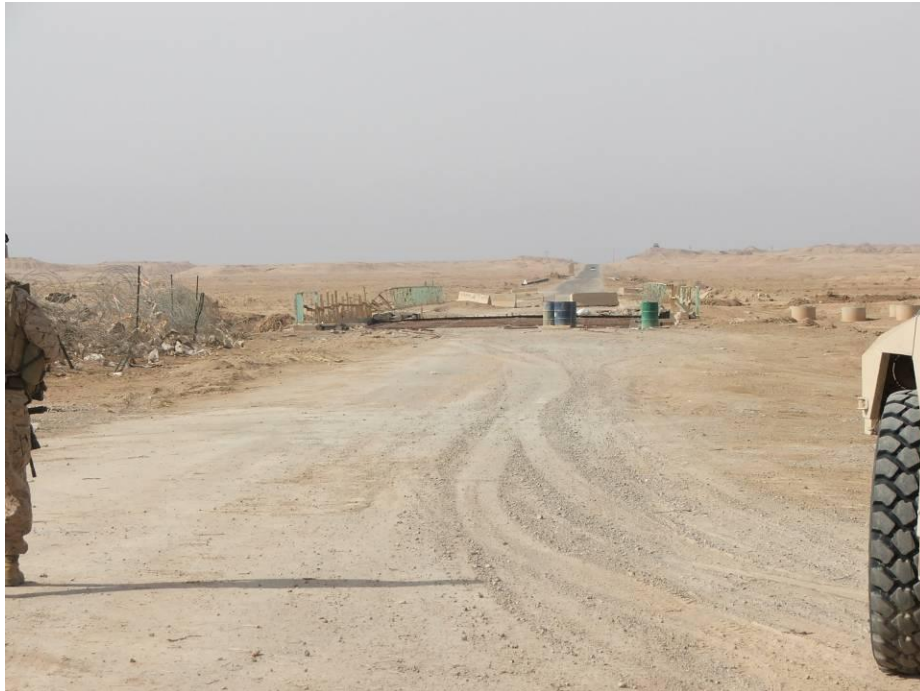
SIGIR observed that roadway visibility at the bridge is very good due to the approach roadway geometry; however, due to the low profile of the bridge and the vertical walls of the canal, SIGIR is concerned that approaching traffic may have difficulty seeing the bridge itself. No permanent advance-warning signs for the bridge were posted, and there is no guiderail to prevent vehicles from leaving the cart way and entering the canal. The structure-mounted rail appeared to be intended to protect pedestrians only and did not appear to be strong enough to resist even a minor vehicle impact.

Site Photo 5. Northern approach roadway looking south across the bridge

Due to the long, straight approach, SIGIR is concerned that traffic could attain significant speeds along this section of roadway, increasing the distance required for traffic to be warned of the construction project. Under the SOW, the contractor is:

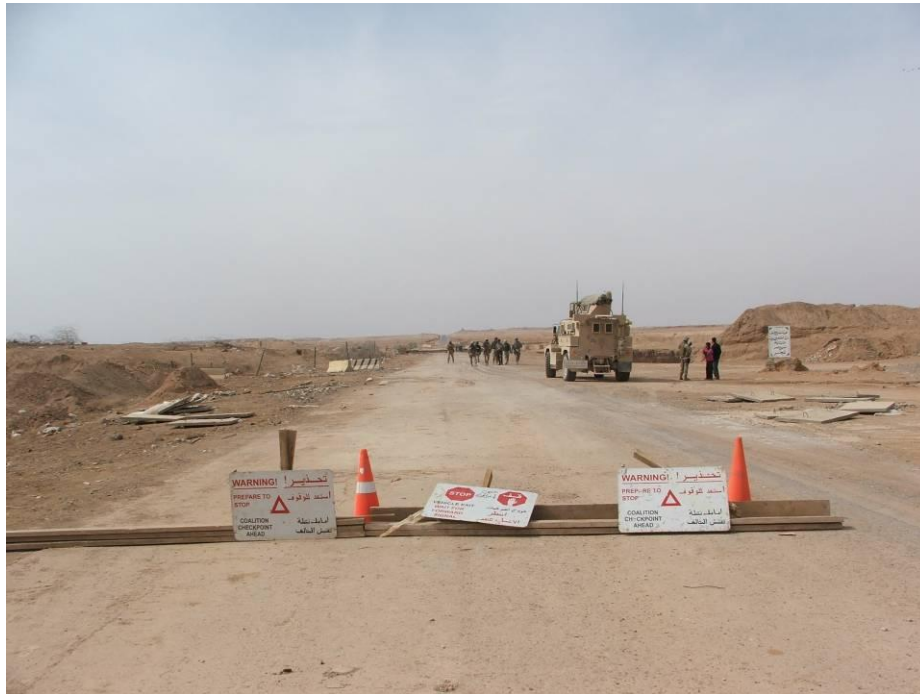
SIGIR observed warning signs near the project with concrete or timber barricades across the roadway at either end of the project site (Site Photo 6); however, it is questionable

whether the distance from the signage to the structure is adequate for vehicles to perform a controlled stop.

The methods employed at the site to protect traffic and pedestrians do not meet the contract specifications, and they expose the traveling public to danger. Also, any collision with the structure will damage the work in progress, resulting in a serious setback to the contractor's completion schedule, which has already been significantly delayed.

Site Photo 6. Traffic control signs looking south across the bridge

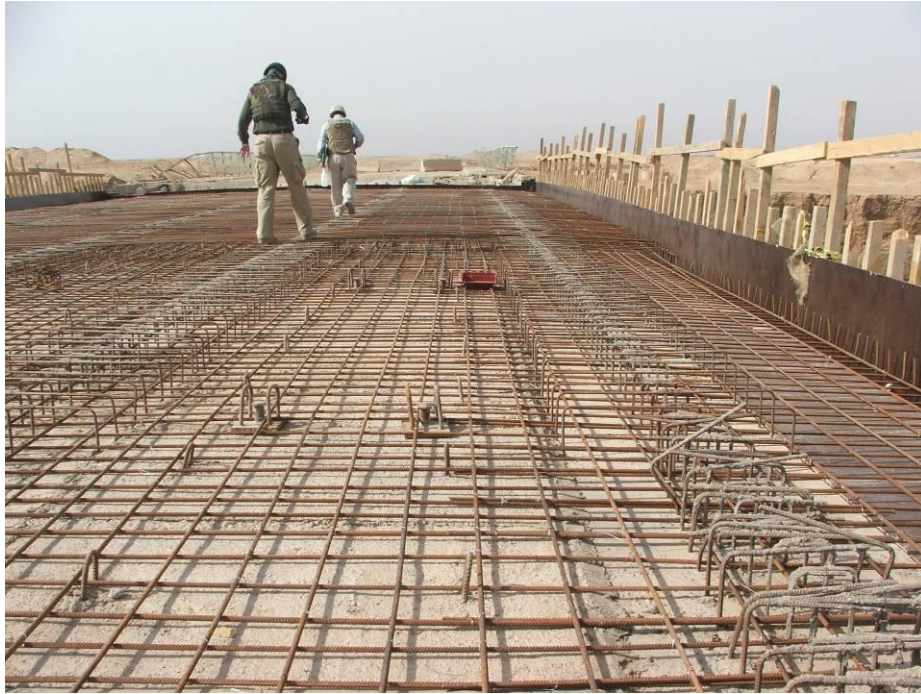
Site Photo 7. Concrete deck reinforcing (prior to placing top mat, foreground)

SIGIR also noted that the bottom mat of reinforcing steel was placed directly on the precast-concrete deck pans. To provide composite action between the reinforcing and the concrete deck, adequate cover needs to be obtained around the reinforcing to permit stress transfer. Inadequate cover may result in the reduced capacity of the deck. SIGIR understands that it is a common practice for contractors to place chairs under reinforcing steel immediately before concrete placement. This helps avoid bending the chairs or rebar when walking on the matting as shown in Site Photo 7. If the contractor placed adequate chairs under the reinforcing steel prior to concrete placement, this is not an issue.

In addition, any moisture penetrating the concrete deck will most likely gather between the poured concrete deck and the precast-concrete deck pans. Without adequate concrete cover, the reinforcing steel will be vulnerable to corrosion and deterioration, which would result in decreased load-carrying capacity and/or accelerated deterioration of the deck.

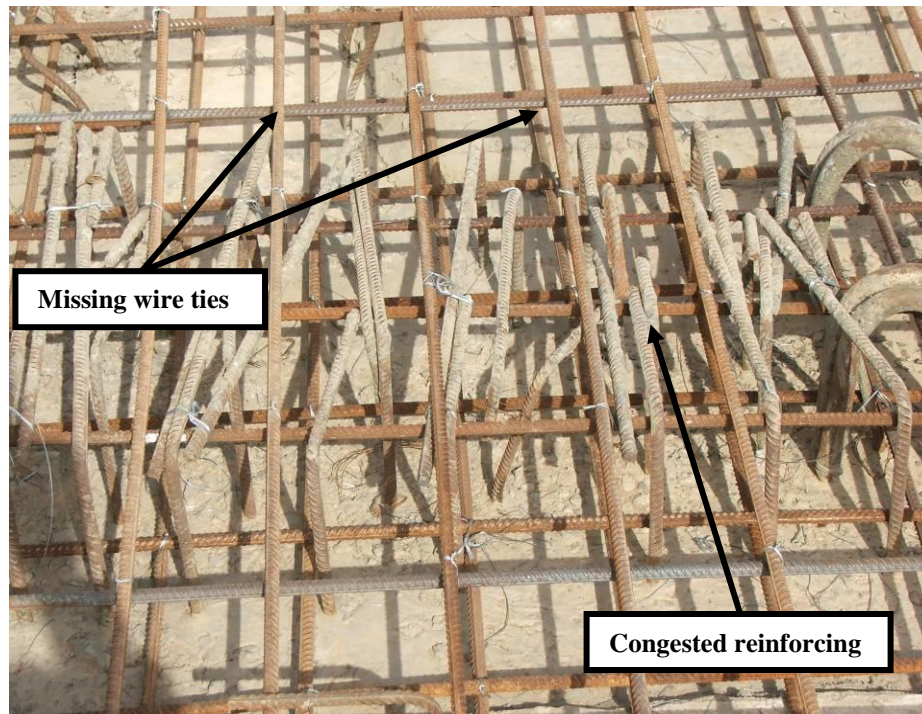
SIGIR noted several issues with the placement of the reinforcing for the concrete deck. For example, near the ends of the girders, SIGIR found areas of severe reinforcing steel congestion (Site Photo 9.) SIGIR is concerned that this configuration of reinforcing steel may prevent homogeneous concrete placement, which would result in voids in the deck. Since the purpose of the reinforcing steel in this area is to create composite action

between the deck and the girders, voids beneath the reinforcing could reduce the capacity of the structure.

Site Photo 9. Reinforcing congestion and missing wire ties at girder ends

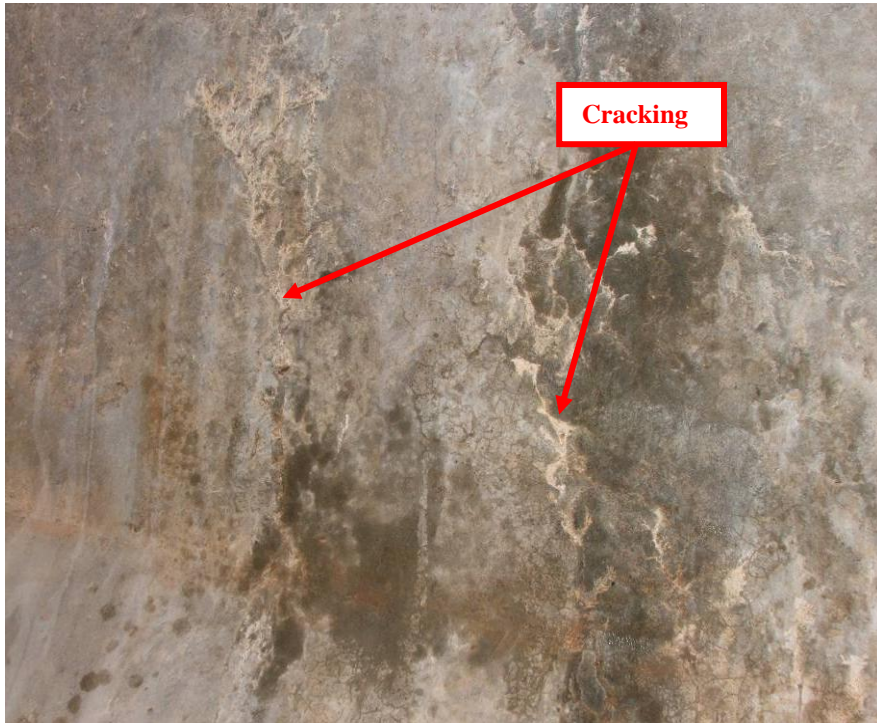
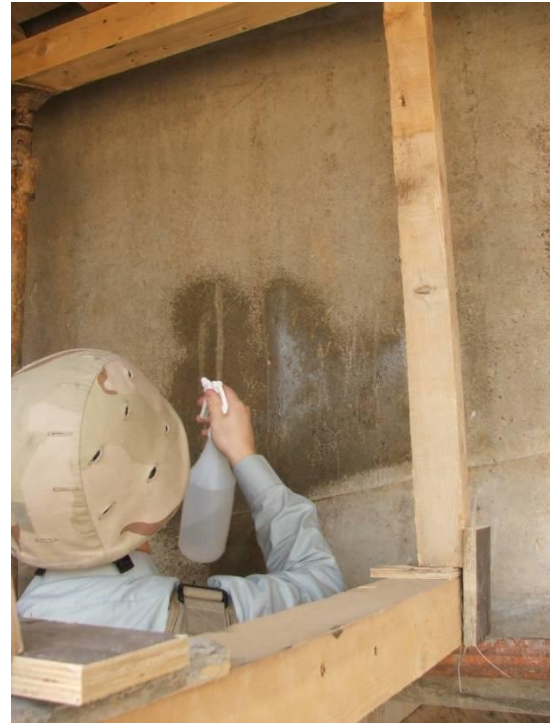
SIGIR observed no exposed honeycombing⁸ but did identify hairline cracking on the girders. Using squirt bottles, SIGIR sprayed water onto the concrete girders to wash away dirt and make any existing cracks more visible (Photo 11 and 12). Due to time limitations, SIGIR could not map the cracking or determine if the quantity and depth of the cracks are indicators of significant issues with the beams. Any visible cracking, specifically vertical and diagonal, are indicators of potentially serious issues with either post-tensioning or shear reinforcement.⁹ In a draft of this report, SIGIR recommended that the GRC Fallujah Resident Office further investigate and determine the seriousness

of the cracks. A Fallujah Resident Office team conducted an on-site inspection on 20 May 2009. Their inspection revealed no structural cracking, only minor surface shrinkage cracks and cracks caused by form irregularities.

Site Photos 11 and 12. Cracking at girder ends

SIGIR recommended that the Commanding General, Gulf Region Division of the U.S. Army Corps of Engineers investigate the hairline cracks on the girders and determine if the quantity and depth of the cracks are indicators of significant issues with the beams and take necessary corrective actions.

SIGIR received comments on the draft of this report from the Commanding General, GRD concurring with the recommendation and providing the results of an investigation by the Fallujah Resident Office team conducted on site on 20 May 2009. Their investigation revealed no structural cracking—only minor surface shrinkage cracks and cracks caused by form irregularities.

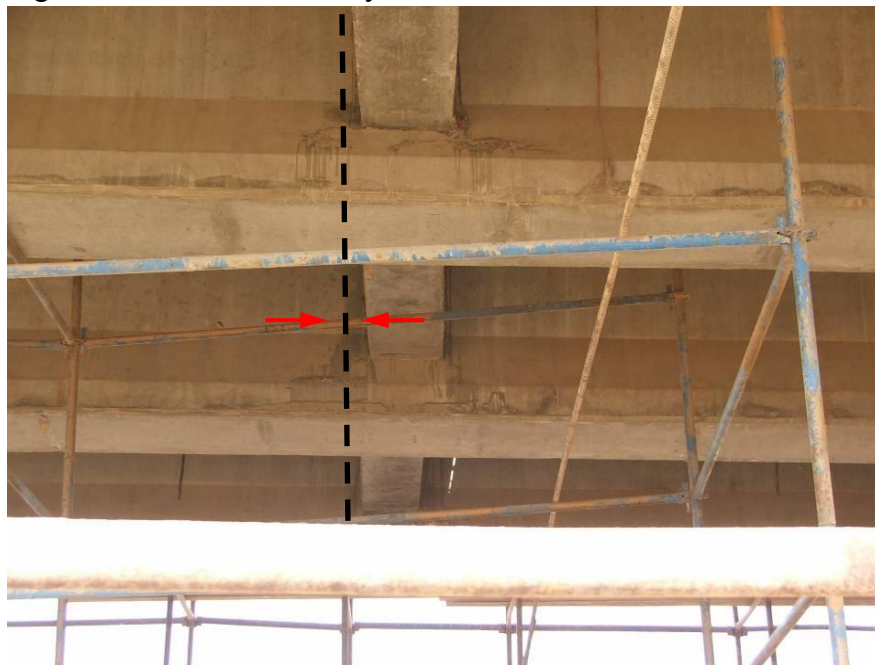
While reviewing the underside of the superstructure, SIGIR noted several misaligned interior diaphragms (Site Photo 13). Due to the secondary load-carrying nature of the diaphragms, this did not appear to be a serious issue; however, it is an indicator of quality issues relating to the contractor's ability to construct accurate formwork.

Site Photo 13. Misaligned diaphragms

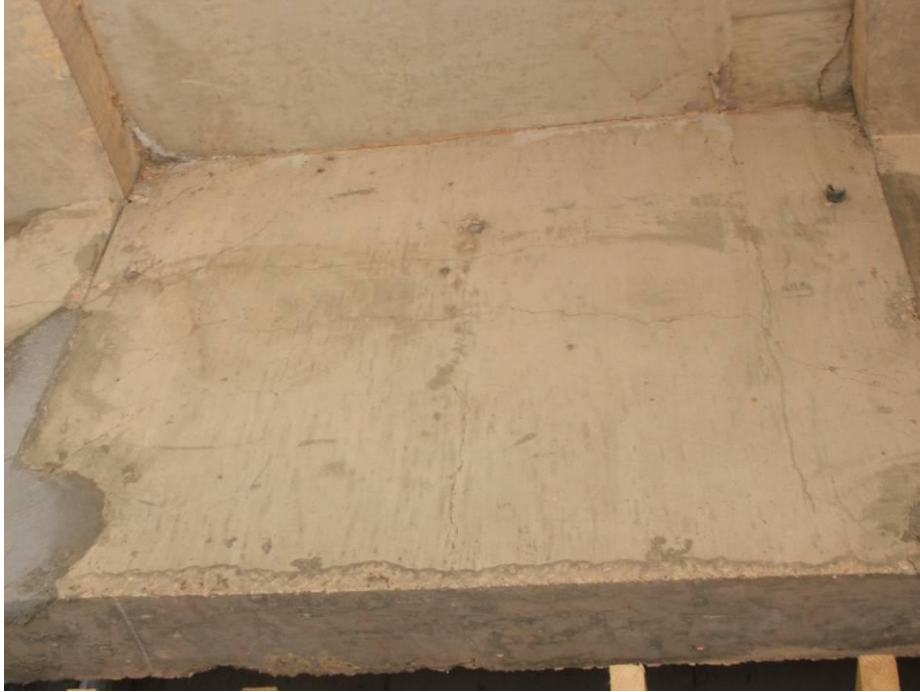
SIGIR examined some of the existing bridge structure near Pier Cap No. 1. Several of the end diaphragms for Span No. 2 had been damaged in the VBIED detonation, and the panels show varying degrees of attempted repair.

The existing end-diaphragm panel near the center of the pier appeared to have been shattered (Site Photo 14). The horizontal and vertical cracking through the center of the panel indicated that the panel has completely failed and offered limited resistance as a diaphragm. An attempt appeared to have been made to patch some of the damaged areas of the panel; however, due to its complete failure, a more comprehensive repair or complete replacement of this panel should have been considered.

Site Photo 14. Existing damaged diaphragm at Bent No. 1

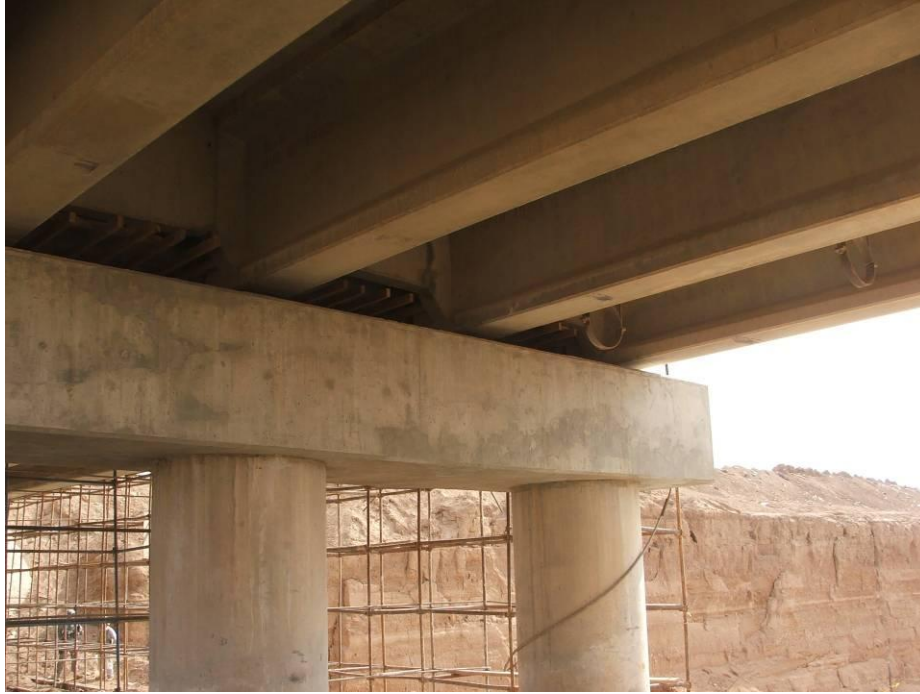
SIGIR noted that the new reinforced-concrete cap appeared to be well constructed. SIGIR did not observe any significant cracking or defects in the cap. The surface of the cap appeared smooth and properly formed (Site Photo 15), and the jointing of the cap to the columns was uniform with clean, consistent joints.

Site Photo 15. Bent cap at Pier No. 1
