**ROLL-ON/ROLL-OFF BERTH
PORT OF UMM QASR, IRAQ**

SUSTAINMENT ASSESSMENT

**SIGIR PA-08-162
JULY 8, 2009**

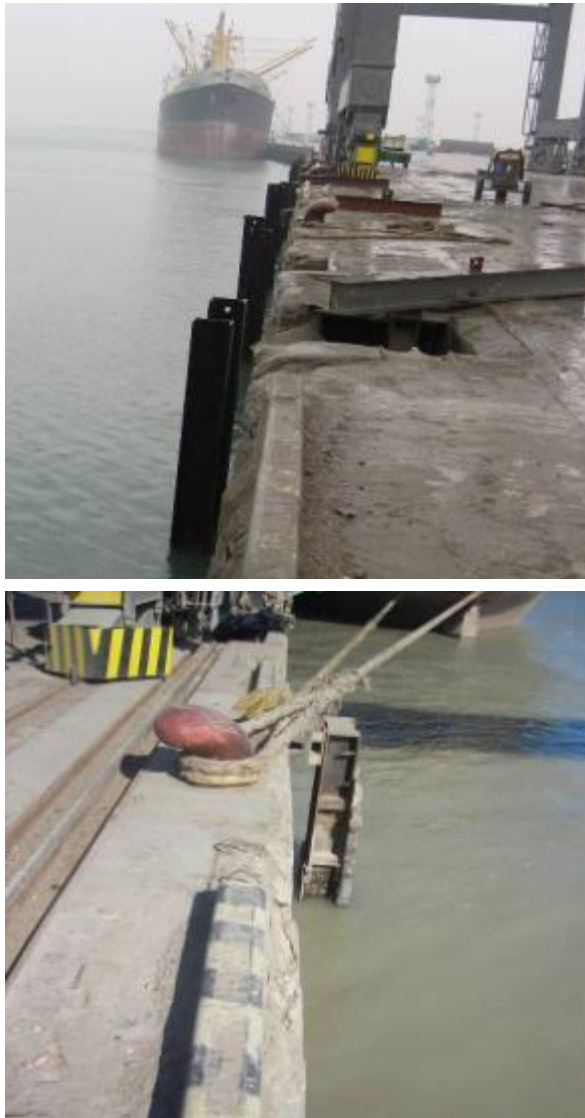
Site Photos 5 and 6. Berth 5 jetty fenders in disrepair (Courtesy of GRS)

In addition, the SOW required design documents for Berth 5's jetty fender repairs; approximately 20 jetty fenders were missing or in poor condition and needed to be replaced. The contractor was required to coordinate with the Iraqi Port Authority on the operational requirements for the jetty fenders to determine the appropriate design live loads and impact loads, based on the anticipated size and types of ships using the jetty fenders.

The contractor replaced the jetty fenders with new Seibu Polymer Corporation Trapezoid Type V 800HX1220L model rubber fenders. The new fenders include 400 millimeter (mm) H-piling⁹, section stiffeners between the piles, and anchor bolts to affix the fenders to the existing concrete pier. Site Photo 8 shows the contractor painting with a coal tar epoxy to prevent corrosion, and Site Photo 9 documents the construction of the new jetty fenders at Berth 5.

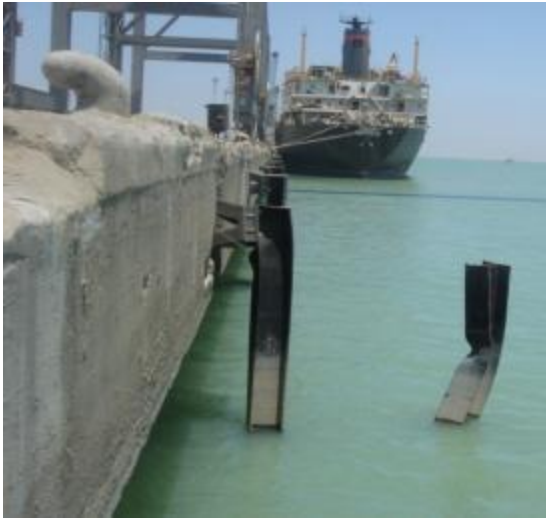
Site Photo 7. Damaged jetty fenders
(Courtesy of GRS)

Also, the contract required the construction and repair of jetty fenders at Berth 5. The contract stated that the installed jetty fenders should be able to withstand live loads and impact loads from ships. The contractor removed the existing jetty fenders that were in disrepair and the partially constructed damaged fenders (Site Photos 5, 6, and 7). The local port authority continued using Berth 5, and the partially constructed fenders were damaged by a storm.

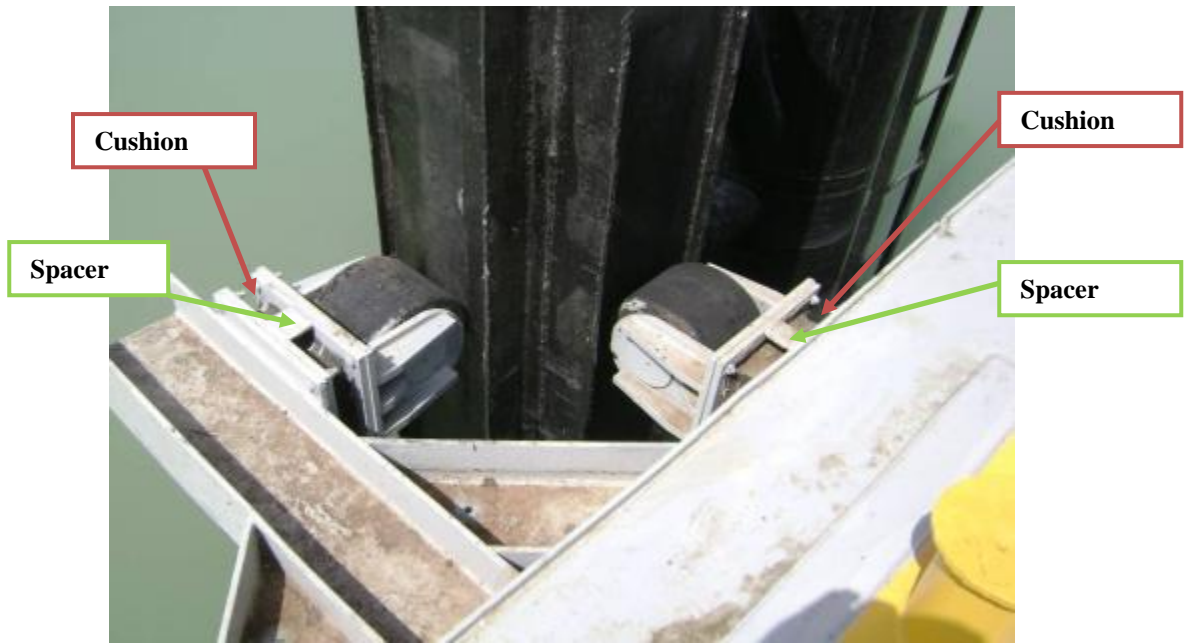
Site Photo 11. Cushion rollers with steel spacer plates (Courtesy of GRS)

Originally, the contractor designed the cushion roller assemblies with flexible elastomeric mounts (cushions) (Figure 3). The mounts permit relative movement of the rollers and prevent binding on the vertical tracks caused by irregularities in the roller system geometry.

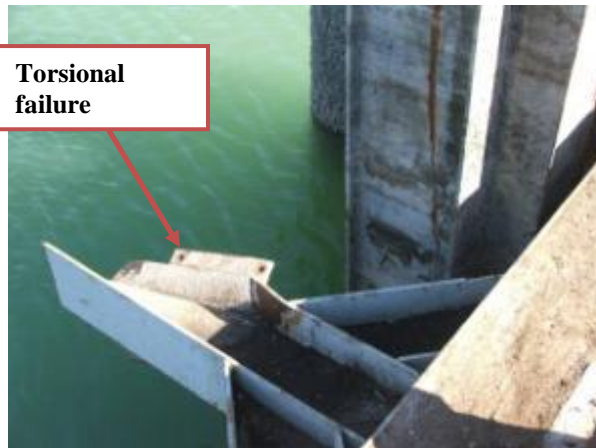
Site Photo 12. Torsional failure of rail/roller

occurred: the damaged steel cantilevers exhibit textbook torsion failure of a steel wide flange section with transverse tearing of the flange (Site Photo 12).

1. Pontoon guide rail and roller assemblies
2. Hinges that connect the steel structure decking and the pontoon decking
3. Two rubber fenders on the berthing dolphins

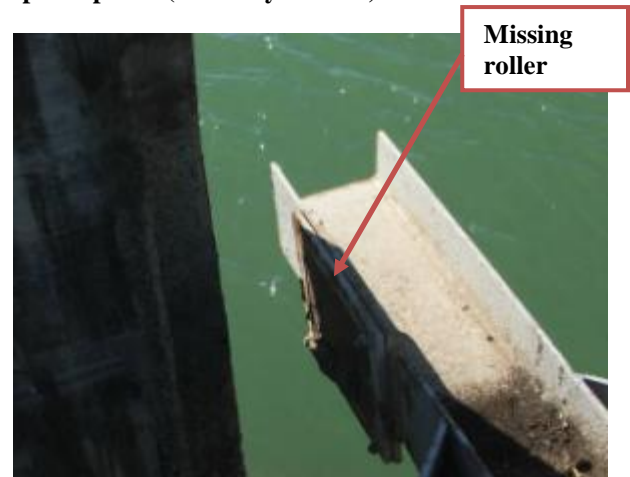
Site Photo 13. Missing rail/roller

At the time of the site assessment, all four of the rail/roller assemblies had been severely damaged, including missing rollers and bent support beams. The specific cause of the damage could not be determined; however, GRS personnel stated that the damage was caused by careless/rough operations by port personnel. Based on information obtained from the site assessment and SIGIR's review of the project information, the cause of the damage was inconclusive, but SIGIR noted several factors as likely contributors.

Once a cushion roller assembly is damaged, the change in load path for the remaining roller assemblies could result in overload and additional assembly failures. This appears to have occurred; the roller assemblies are damaged or missing at all four pontoon-supporting pile locations (Site Photo 13).

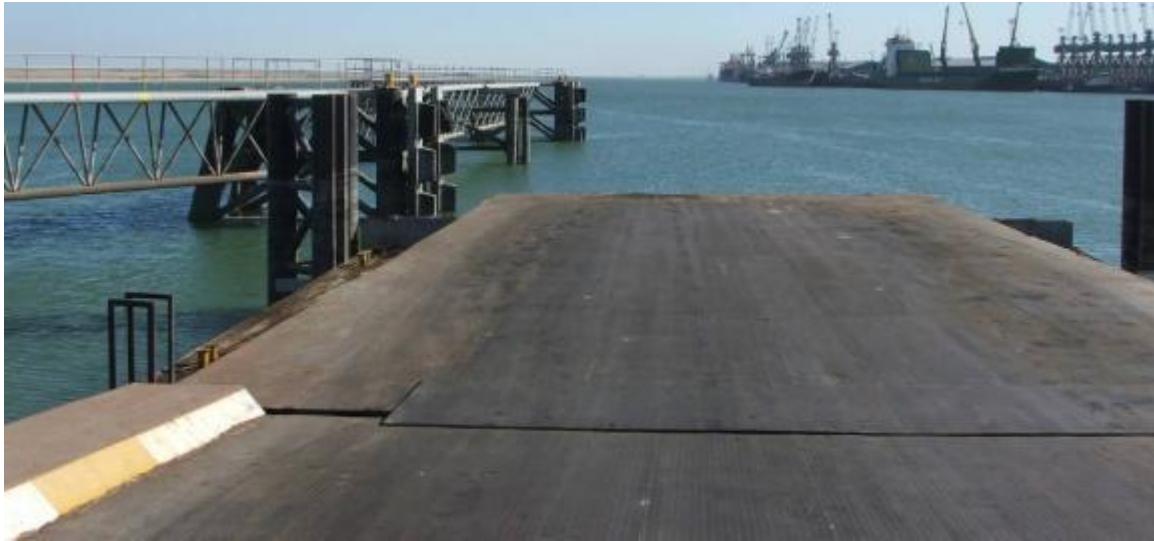
Site Photo 14. Empty RORO Berth 22

During the site assessment, no ships were docked at the RORO Berth, and no loading or unloading was taking place (Site Photo 14). Unfortunately, as SIGIR departed, a ship was entering the port to dock at RORO Berth 22. Reviewing the docking methods and unloading and/or loading process would have been the best indicator of how the project was functioning, if the current damage is limiting the use of the facility, and if rough docking procedures are damaging the facility.

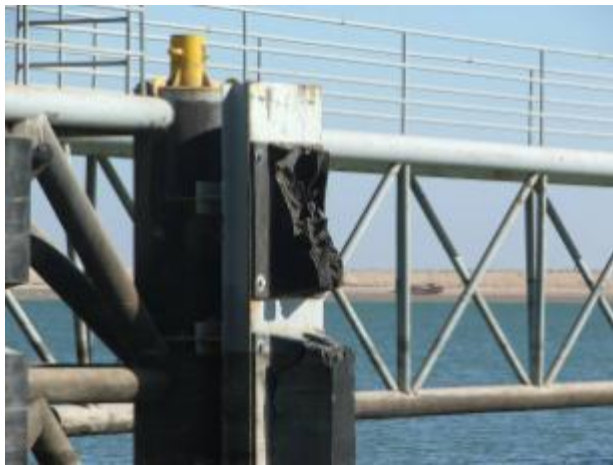
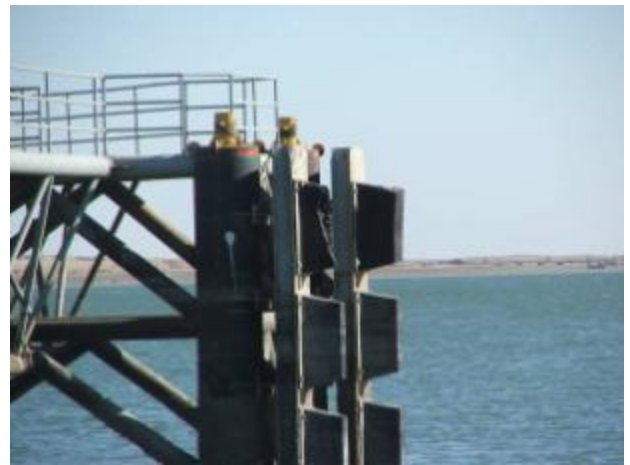
Site Photos 15 and 16. RORO Berth 22 sheared rubber fenders

The design showed that RORO Berth 22 fenders were 600 mm high and 1150 mm long. At the time of the inspection, one of the rubber fenders on the first berthing dolphin had been severely damaged. The rubber fender appeared to be sheared off (Site Photos 15 and 16). The specific cause of the damage could not be determined; however, GRS personnel stated that the damage was caused by careless/rough operations by port personnel. In SIGIR's opinion, the damage was probably caused by ships approaching the dolphin too fast or poor mooring during storms. The damage will not have a significant impact on the operations of the facility; SIGIR considers this a minor maintenance issue.

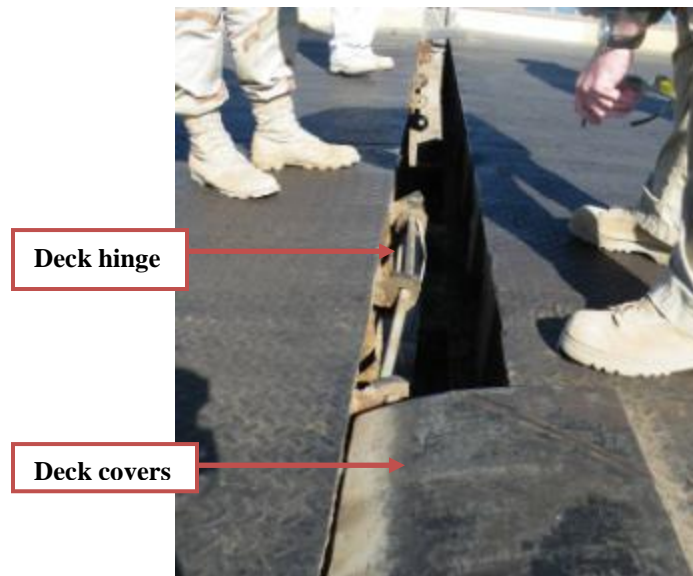
Site Photo 17. RORO Berth 22 deck hinges

The contractor installed steel deck hinges to connect the fixed steel decking to the ramp decking. At the time of the site assessment, the steel deck hinges were damaged (Site Photo 17). The damage included missing hinges and steel deck covers. The specific cause of the damage could not be determined; however, the damage appears to be caused

by careless operation of vehicles and rolling stock¹¹ or traveling at excessive speeds over the hinge. In addition, SIGIR concludes that the damage of the cushion roller assemblies and resulting movement of the pontoon and attached ramp misaligned the ramp and exposed the plate to impact from vehicles and rolling stock.
