**HAI TISEEN PRIMARY HEALTHCARE CENTER
TAMEEM PROVINCE, IRAQ**

SUSTAINMENT ASSESSMENT

**SIGIR PA-08-158
APRIL 16, 2009**

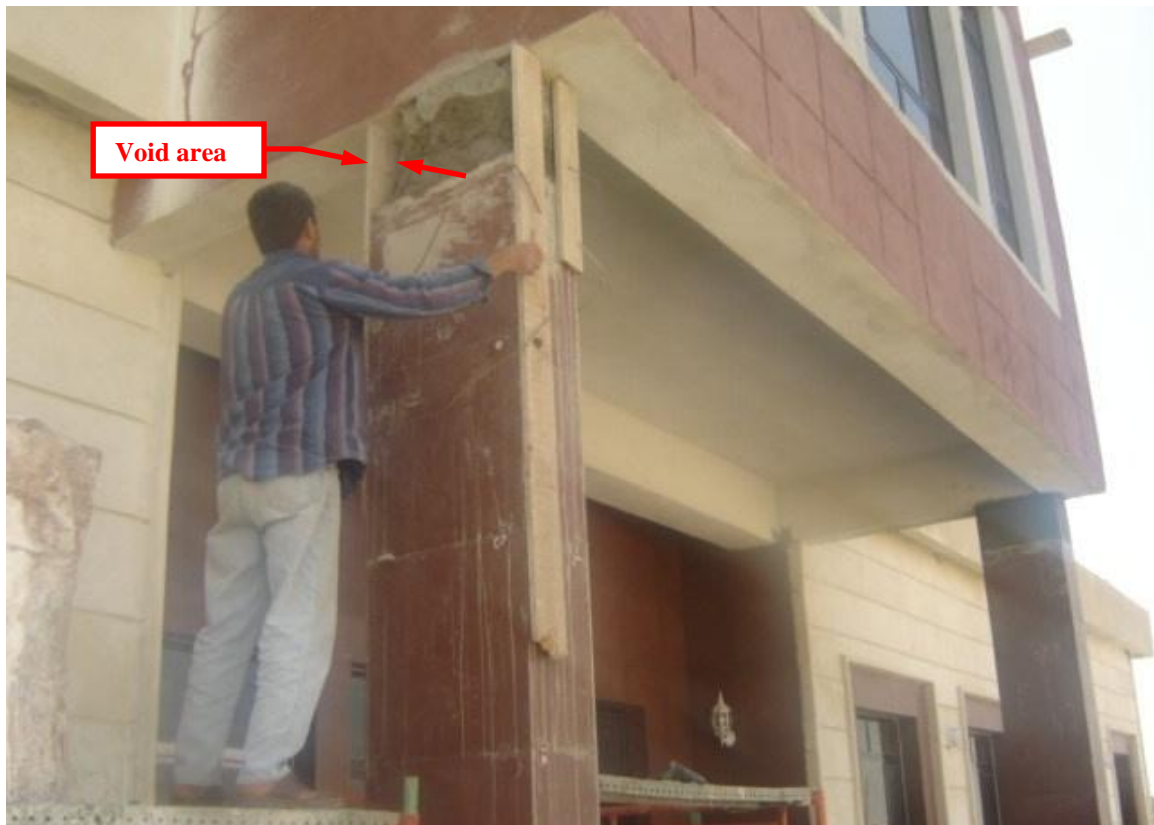
A review of the QA reports and photographs identified an issue with the quality of the connection between the newly constructed column and the original structure. Site Photo 2 shows the exposed connection prior to placement of the finish tile. The column contact area at the connection appears to be significantly less than the cross sectional area of the column. The void area at the connection is also asymmetric and may induce off-center loading of the column that was not anticipated in the design.

**Site Photo 2. Apparent poor quality of beam/column connection
(Courtesy of GRN)**

The poor quality concrete and the reinforcing steel splice would result in a connection with very little shear capacity. This would severely limit the amount of lateral load transfer at the connection and could result in complete failure of the connection under a lateral load caused by wind or seismic activity.

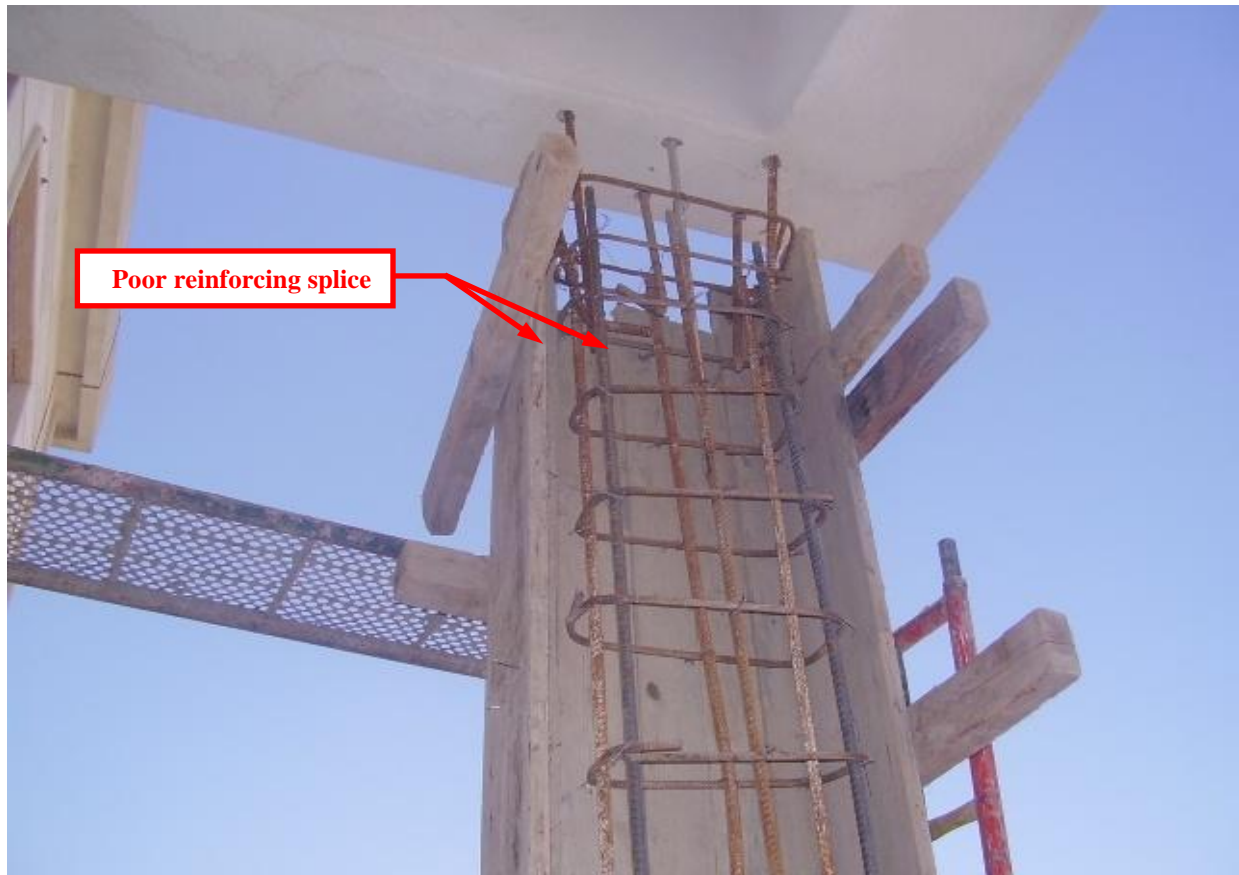
In addition to the poor quality concrete work, the QA representative identified an issue with the reinforcing steel splice. The QA report, dated 7 March 2007, identified Site Photo 3 as “*over lap is not good.*” After reviewing the photograph, SIGIR agreed with this assessment.

Site Photo 3. Poor quality reinforcing splice (Courtesy of GRN)

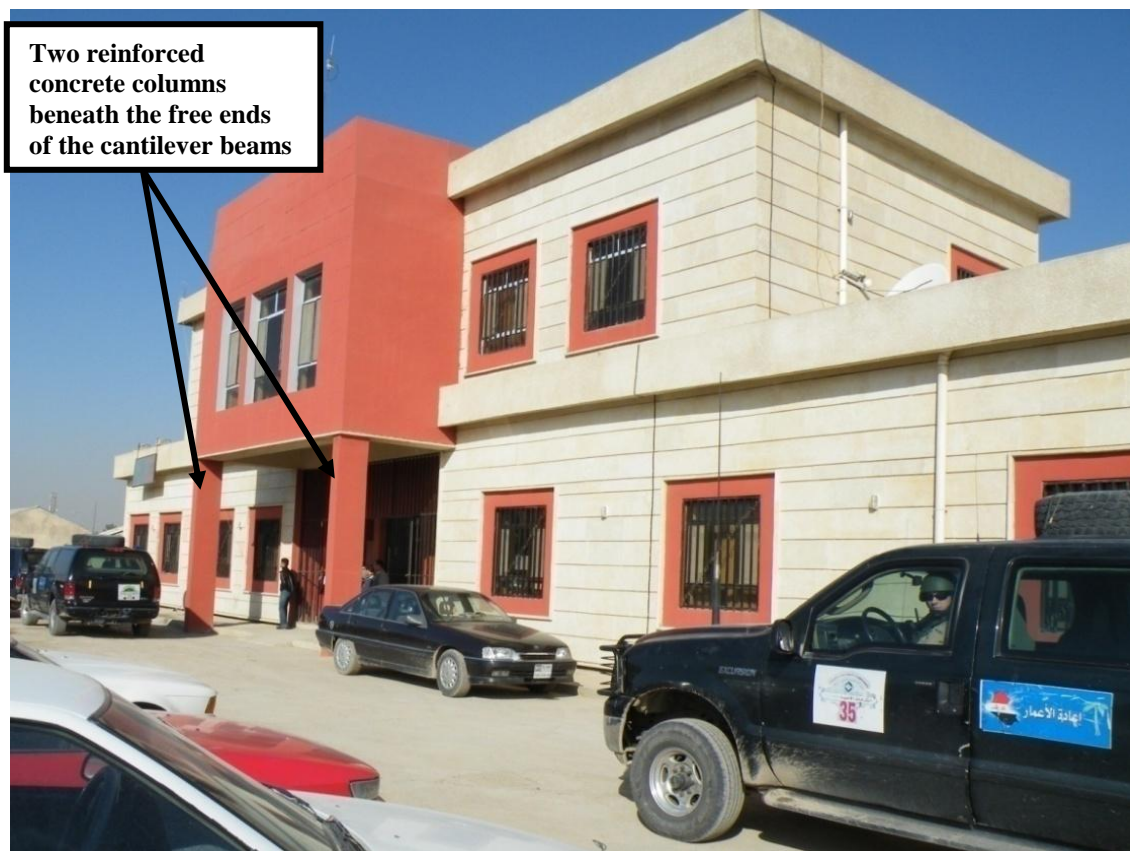
Site Photo 4. Hai Tiseen PHC

On 15 December 2008, SIGIR performed an on-site assessment of the Hai Tiseen PHC (Site Photo 4). A GRN Kirkuk Area Office engineer and the PHC’s administrator accompanied SIGIR during the site visit. Due to security concerns, the time allotted for the site visit was approximately 30 minutes and access to the roof was prohibited. Consequently, SIGIR performed an expedited assessment of the areas available; therefore a review of all work completed was not possible.

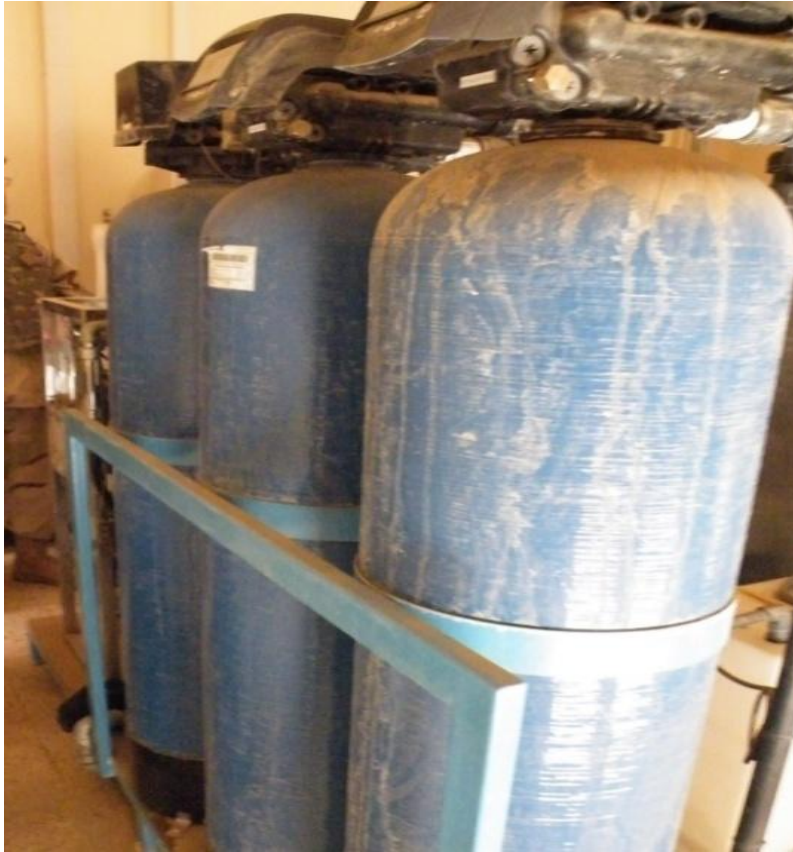
The RO unit appeared to be installed correctly and the administrator stated that the RO unit was functioning properly (Site Photo 7). According to the administrator, a part in the RO unit had failed initially; however, the PHC facility staff dismantled and repaired the RO unit.

Site Photo 7. Functioning RO unit

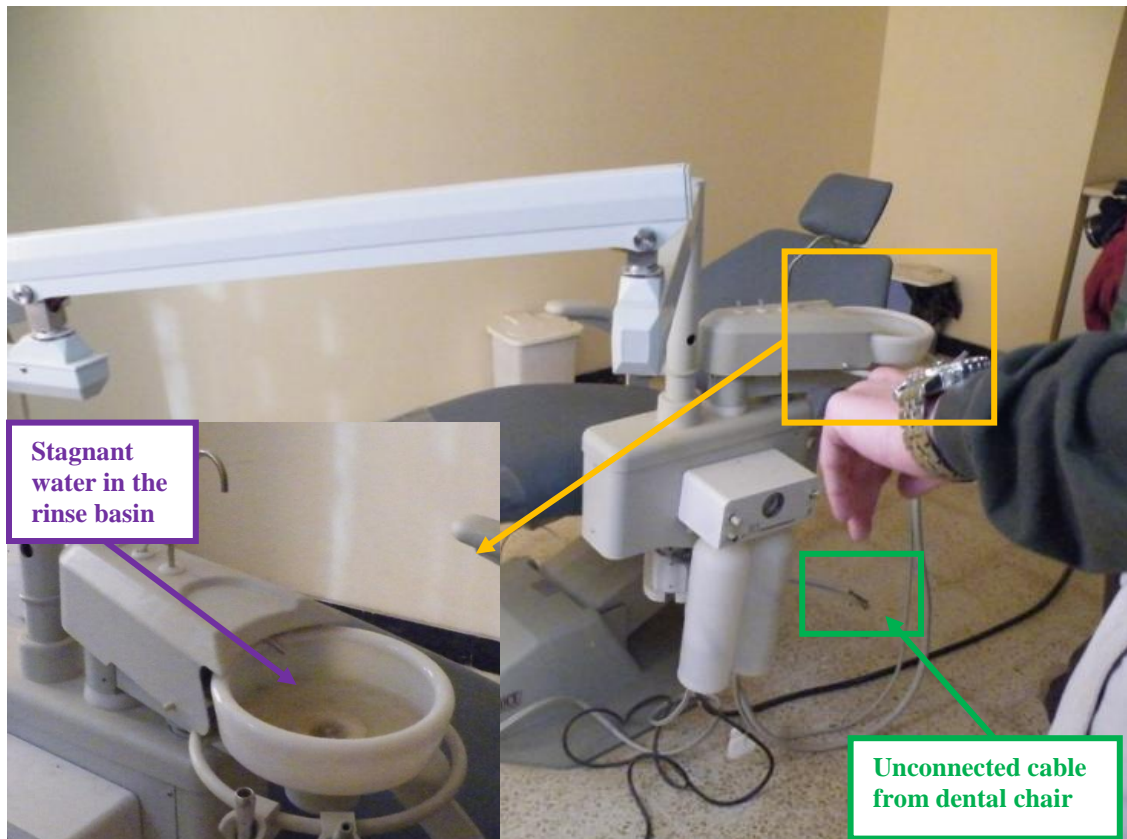
During the site visit, SIGIR observed that the dental chairs were installed. While one dental chair appeared to be in use (Site Photo 8), the second dental chair appeared to have a plugged drain with stagnant water in the rinse basin (Site Photo 9). During the inspection, SIGIR observed a dentist treating a patient while using the working dental chair.

The contractor's installation of the dental chairs, while functional, did not appear to conform to any known plumbing or electric code. The drain for each chair was placed directly into the floor drain with a significant gap between the floor drainpipe and the chair discharge hose. Also, the air lines were not connected for the dental chairs.

Site Photo 9. Second dental chair with stagnant water
