**SHIQAQ HAI MUSALLA
PRIMARY HEALTHCARE CENTER
KIRKUK, IRAQ**

SUSTAINMENT ASSESSMENT

**SIGIR PA-08-157
APRIL 13, 2009**

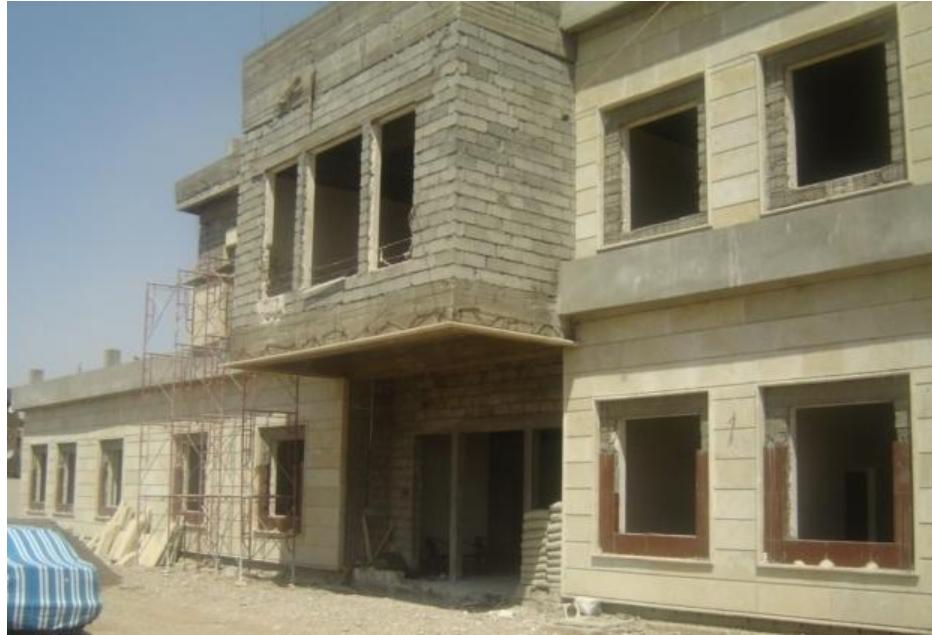
- structural concrete columns and beams
- interior and exterior concrete block walls
- exterior tile on the front of the building
- roof tiles and mastic

Site Photo 1. Condition of partially constructed PHC when new contract was awarded (Courtesy of GRN)

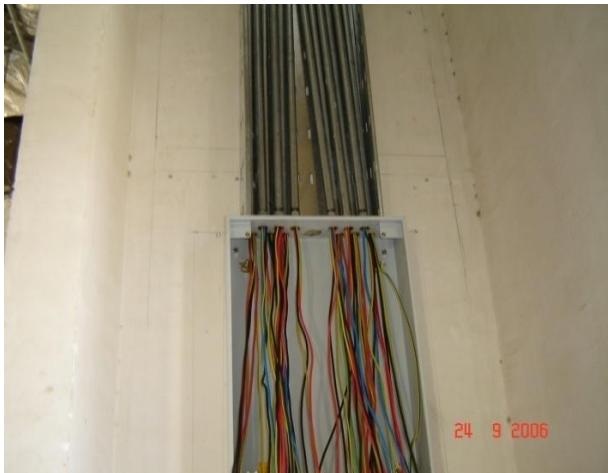
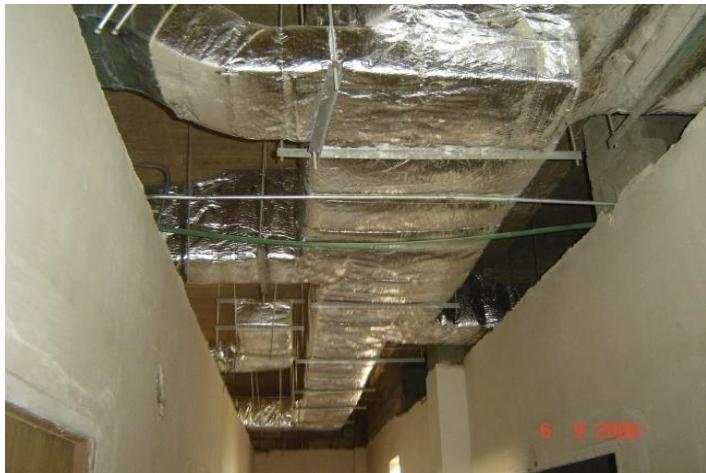
Site Photos 2 and 3. Installation of electrical wiring and HVAC duct work, respectively
(Courtesy of USACE)

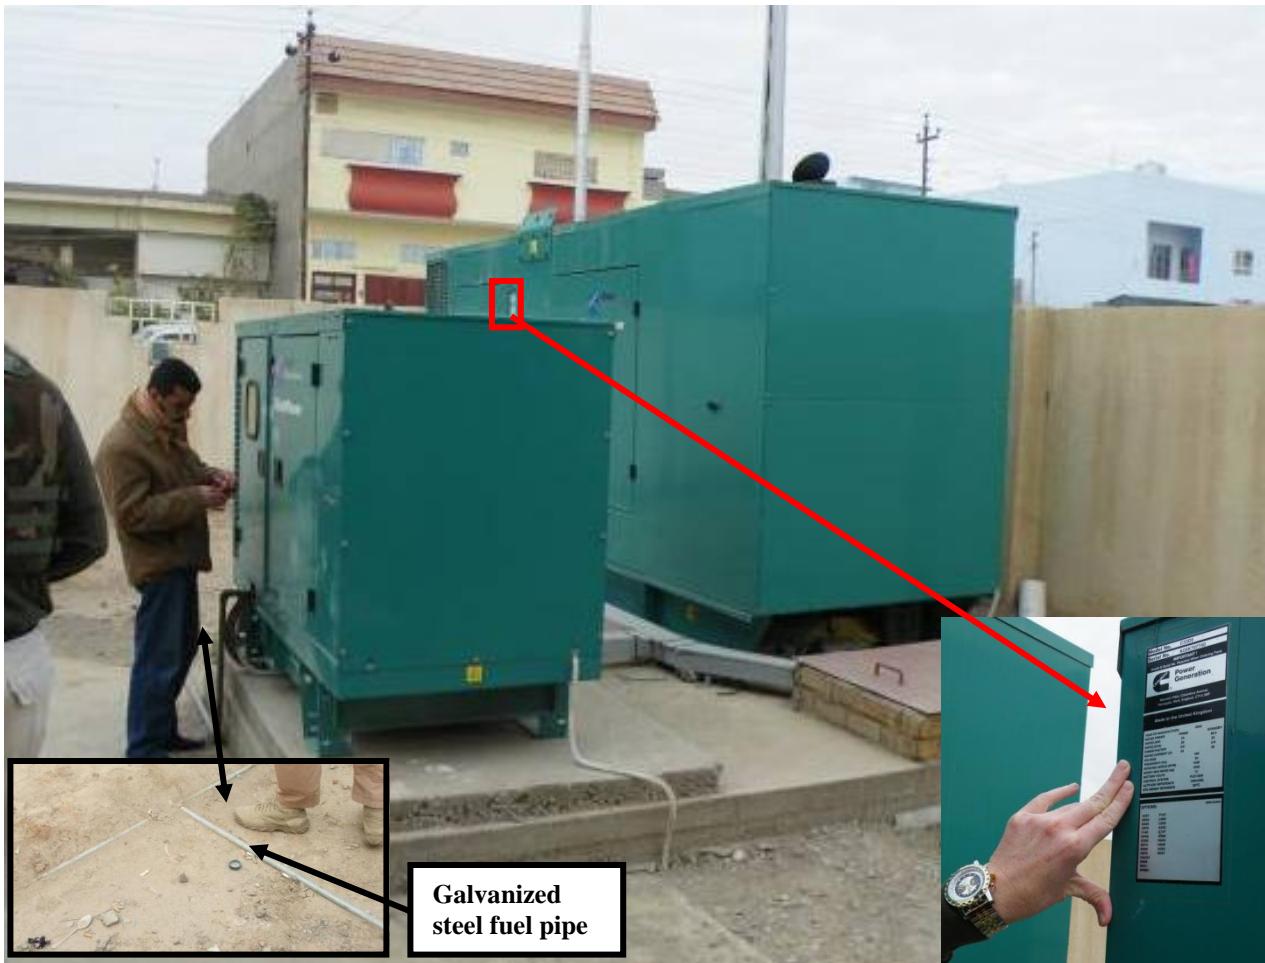
The Shiqaq Hai Musalla PHC is connected to the national grid; however, the national grid is unreliable and provides approximately four hours of electricity per day. The primary source of electricity for the facility is provided from one of the two generators located on site (Site Photo 4). The larger generator, one-megawatt, is used for primary power; while the smaller generator, 500-kilovolt, is for emergency backup. During the site visit, the generators appeared to be relatively clean and in working order. SIGIR verified the generators' specifications via the faceplates.

Since the Shiqaq Hai Musalla PHC is connected to the national grid, an automatic transfer switch is critical to transfer to generator power once electricity from the national grid is lost. The PHC design incorporated the use of an automatic transfer switch. SIGIR verified the installation of the automatic transfer switch, which according to the administrator, was functioning correctly.

Site Photo 4. Two generators providing primary and emergency backup power for the PHC

SIGIR noticed no visible evidence of fuel leaks in the fuel line or inside the generator housing. The fuel line appeared to be galvanized steel pipe that was placed on the surface of the ground (Site Photo 4). Galvanized steel is susceptible to corrosion and may over a long period of time create issues with fuel leaks. Without careful monitoring, small leaks may go undetected, potentially wasting fuel, increasing the risk of fire, harming the environment, and endangering the welfare of the occupants.

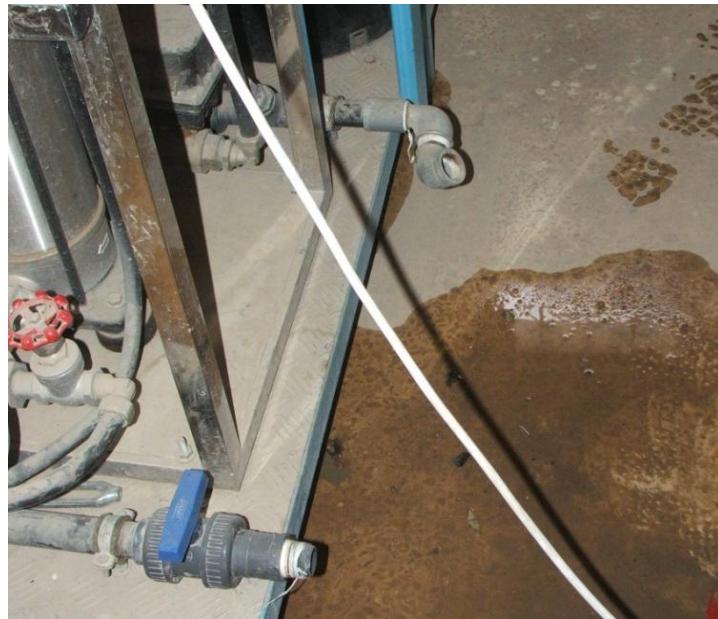
The RO unit appeared to be installed, but had been disconnected from the facility's water system (Site Photo 5). The PHC administrator did not respond to several requests by SIGIR as to who disconnected the RO and why.

Site Photo 5. Disconnected RO unit

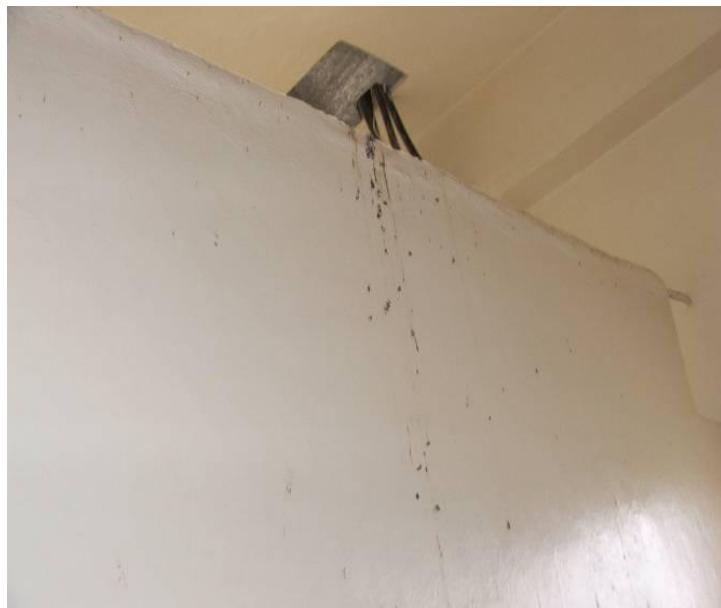
SIGIR observed evidence that birds were nesting in the general vicinity of the RO unit and potable water equalization tanks, with bird feces visible on the partition wall (Site Photo 6). In addition, one of the tank lids was open, permitting contamination of the potable water supply (Site Photo 7). Contamination of the water supply with bird feces increases the risk of exposure to patients and staff of avian born diseases such as histoplasmosis, cryptococcosis, or psittacosis.

Site Photo 6. Possible water contamination source

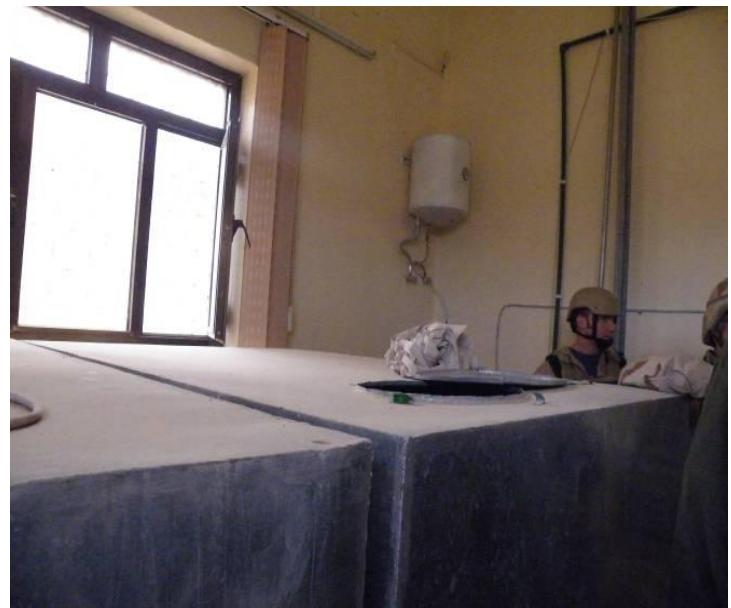
Site Photo 7. Uncovered equilization tank

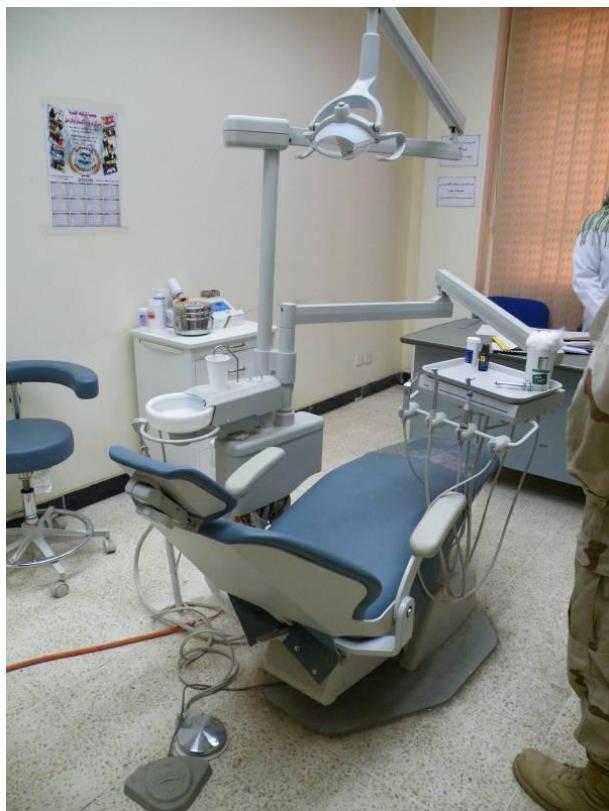
During the site visit, SIGIR observed that the dental chairs were installed and appeared to be in use (Site Photo 8). During the inspection, SIGIR observed a dentist treating a patient while using the dental chair.

Site Photo 8. Dental chair and tools

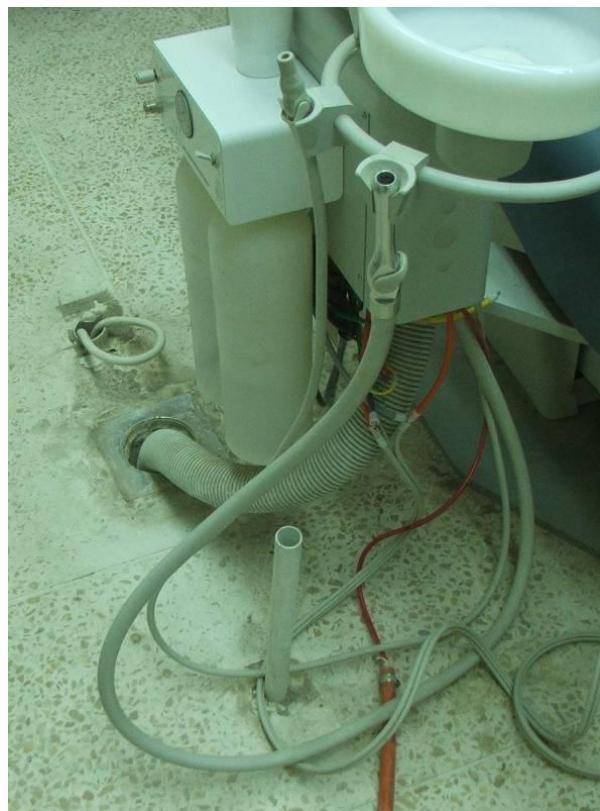
The contractor's installation of the dental chairs, while functional, did not appear to conform to any known plumbing or electric code. The drain for the chairs was placed directly into the floor drain with a significant gap between the floor drainpipe and the chair discharge hose. The electrical connection for the chair was made using a modified extension cord (Site Photo 9).

Site Photo 9. Dental chair connections

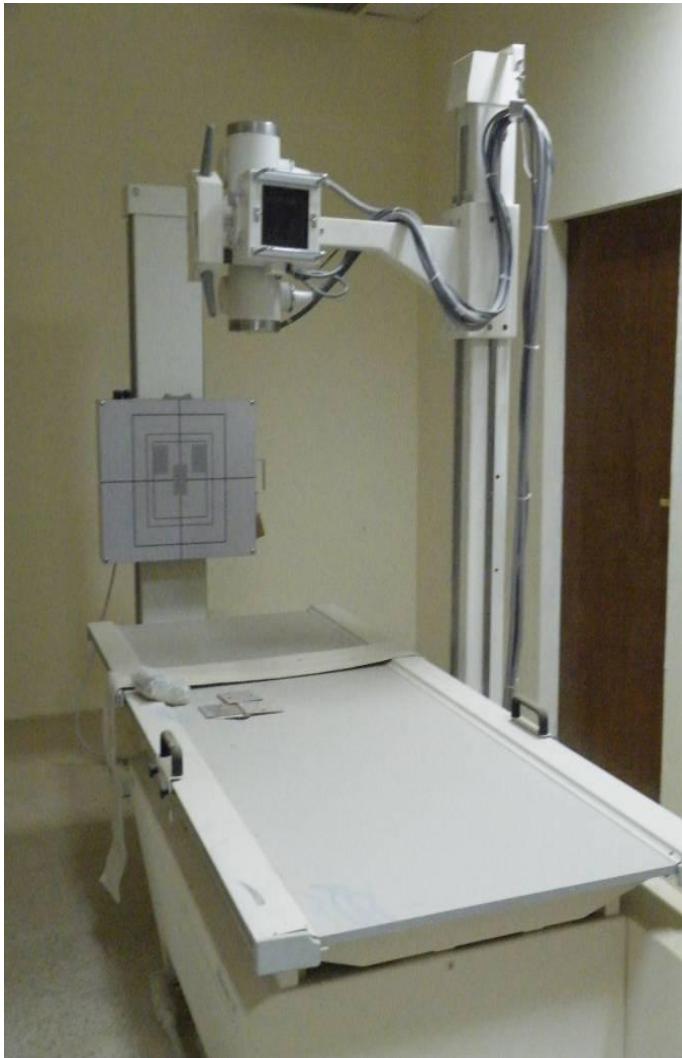
The original design of the facility included medical imaging capabilities, specifically an x-ray room and equipment. SIGIR observed that the x-ray equipment was installed (Site Photo 10); however, according to the administrator, the contractor did not verify the equipment was operational. In addition, the administrator stated that the facility's staff did not have the capability to operate the x-ray equipment; consequently, the facility does not offer x-ray service to its patients.

Site Photo 10. X-ray equipment

Recommendation. SIGIR recommends that the Commanding General, Gulf Region Division, direct that all installation of and training on the equipment currently at the Shiqaq Hai Musalla Primary Healthcare Center be performed according to the prioritization listing.

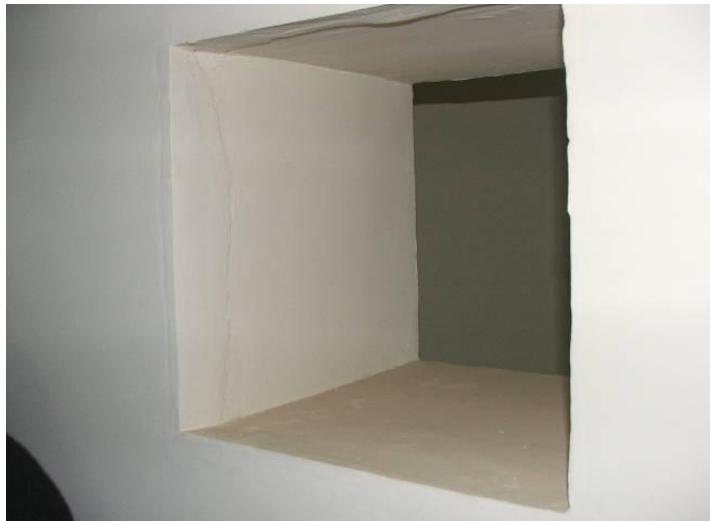
In the 19 July 2007 acceptance letter, one of the two noted deficiencies was “x-ray leaded glass,” which was to be “installed later.” SIGIR noted that the contractor had not installed the required leaded-glass observation window (Site Photo 11). In addition, SIGIR noticed that the x-ray room exterior door and darkroom doors installed by the contractor appeared to be standard wooden doors. The inspection team could not verify the presence of lead lining on the concrete walls.

Site Photo 11. Missing observation window

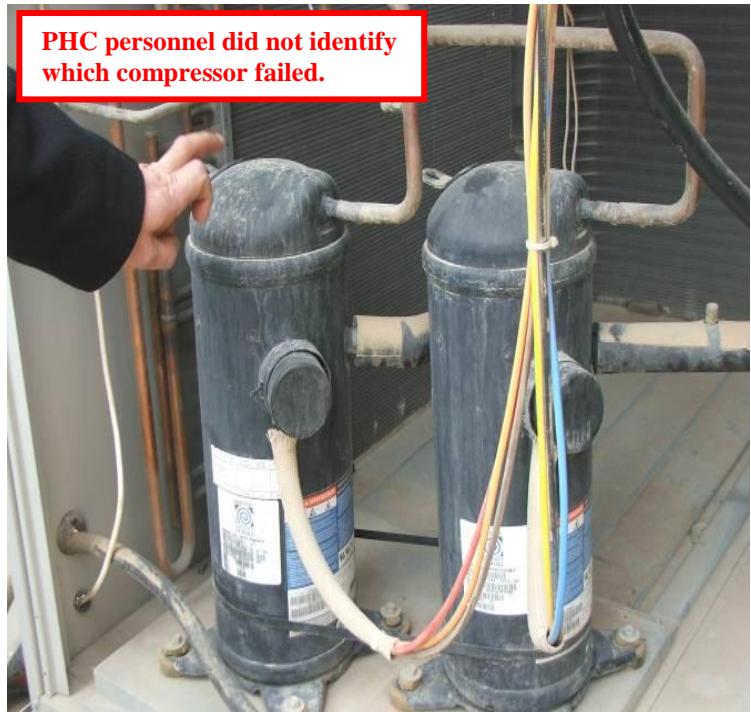
Due to security concerns, only one SIGIR team member was allowed to briefly access the roof to inspect the HVAC units. While on the roof, PHC personnel removed the side panel of one of the primary units for inspection (Site Photo 12). The administrator pointed out that one of the two compressors in the primary HVAC unit had failed, and currently, the facility was operating on reduced capacity.

PHC personnel did not identify which compressor failed.

Site Photo 12. Failed HVAC compressor

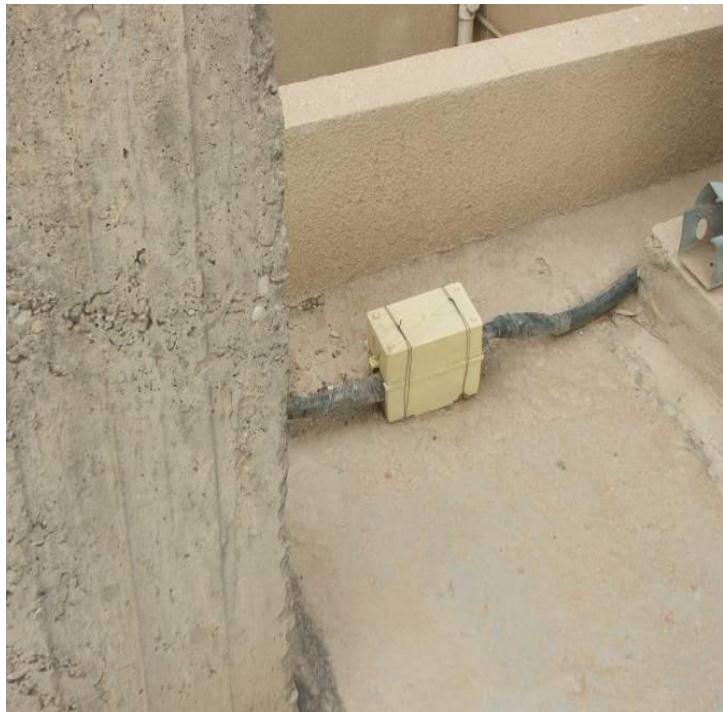
SIGIR noticed several splices of the electric cables for the units. The splices did not appear to conform to the International Electric Code, and in several locations it appeared that plastic index card boxes were modified to act as junction boxes for the electric power supply to the HVAC units (Site Photo 13). Due to the risk of severe shock, SIGIR did not dismantle the makeshift covering, and, as a result, was unable to determine if there was a splice. Since the makeshift junction was located on the roof, the connection was exposed to the harsh weather elements. Due to the significant electric current required to operate the HVAC, shorting of these lines would cause a serious risk of electrical shock and fire.

Site Photo 13. Makeshift electrical junction

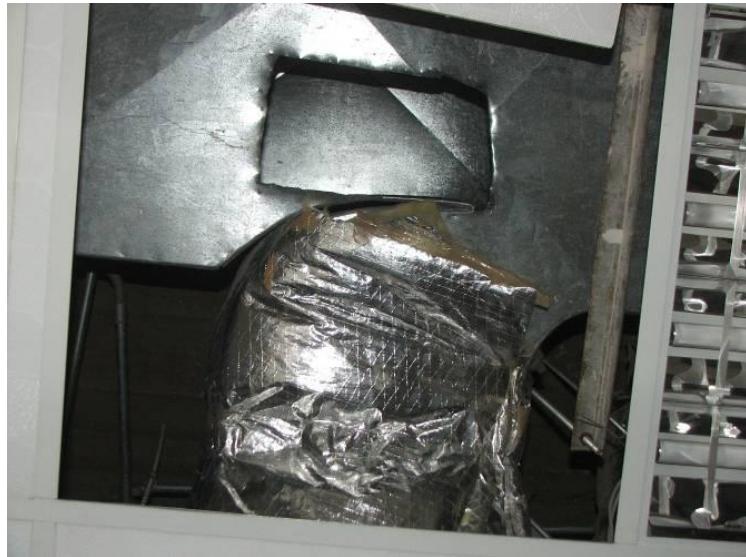
The administrator also stated that the heating units were not working. Based on SIGIR's observations on the roof, it appeared that the HVAC units were equipped with the ability to provide heat; however, the cause of the heating system failure could not be determined. SIGIR noticed that the staff was using small electric heaters to provide heat at individual workstations. The use of the small electric heaters taxes the emergency generator, while being inefficient and a significant fire hazard.

Site Photo 14. Modified HVAC duct

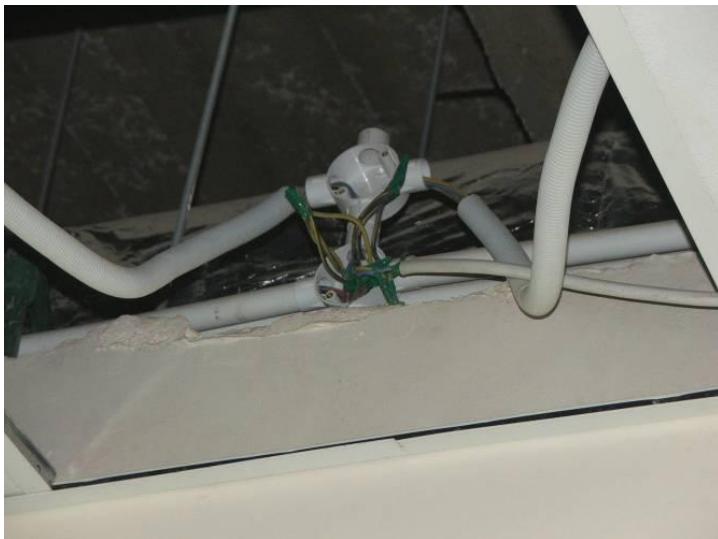
SIGIR observed several questionable electrical connections; none of which conform to the International Electric Code (Site Photo 15). Due to time limitations on site and the fact that the PHC staff had occupied the facility for over a year, SIGIR could not determine if the original contractor performed this work or if it had been "modified" by PHC personnel.

Site Photo 15. Poor electrical connection

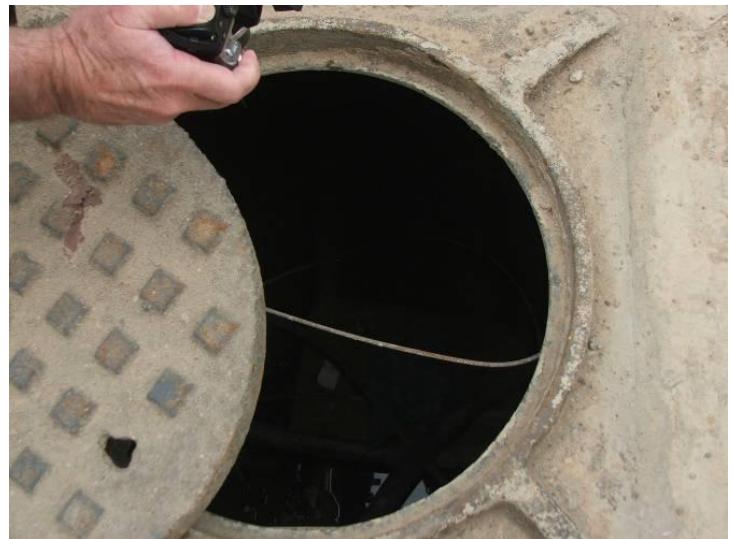
SIGIR noticed that several of the electric manholes had standing water in them (Site Photo 16). Also, there was debris in the manholes, but it was unclear if the debris was left from the original construction, or if it had been deposited recently.

Site Photo 16. Debris and water in electric manhole

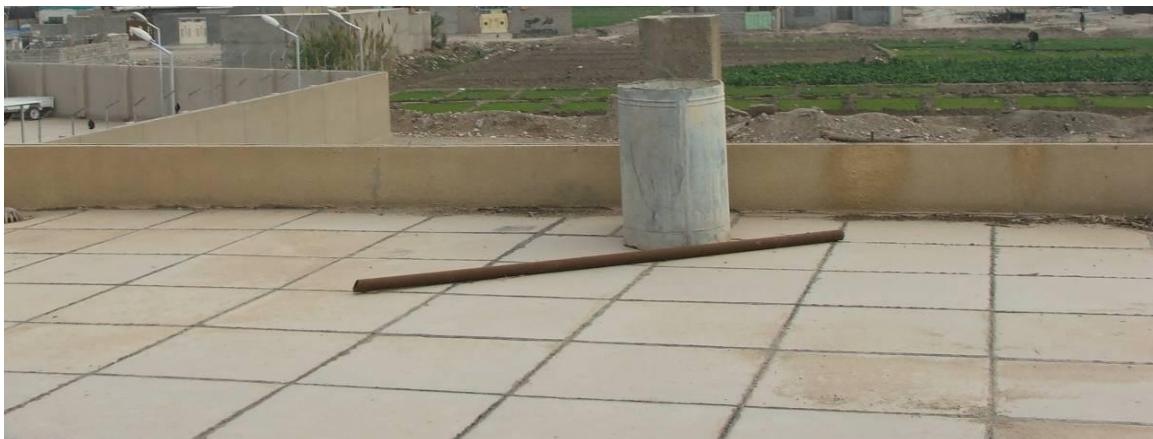
According to the administrator, the mastic between the concrete roof tiles (steigers) was poorly placed and substandard. SIGIR observed that the mastic did not appear inadequate, and the placement of the mastic was typical of other new construction seen at other project sites (Site Photo 17). Poor roof construction would generally lead to interior leaks within the PHC; however, SIGIR did not observe any leaks nor did the administrator mention any interior leaks. The administrator stated that the upper level roof was in worse condition than the lower roof; however, due to security concerns, SIGIR was not allowed access to the upper level roof. Therefore, SIGIR could neither confirm nor deny the administrator's allegation.

Site Photo 17. Quality of roof construction
