**HEET PRIMARY HEALTHCARE CENTER
HEET, IRAQ**

SUSTAINMENT ASSESSMENT

**SIGIR PA-08-133
JANUARY 23, 2009**

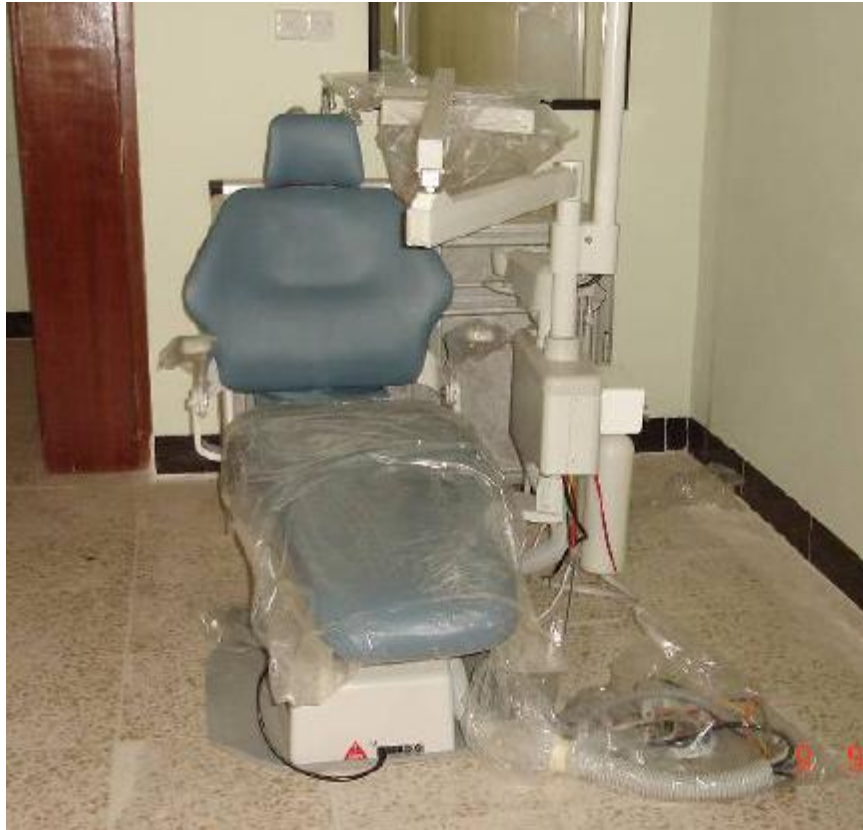
During the site visit, SIGIR observed the dental equipment, specifically one of the dental chairs was not installed and/or connected (Site Photo 16). According to a GRD representative, the "PVC [polyvinyl chloride] and Copper pipes for the dental room were missing so the dental chair was not completely installed." SIGIR noticed that the drain for the dental chair was not properly placed, which will require minor construction to move the drain to an appropriate place in the dentist's office.

The administrator stated the facility has a full time dentist; however, without any dental chairs properly installed and connected to purified water and drainage, there is little benefit the dentist can provide outside of very minor routine dental care. Also, one of the dental chairs, similar to the RO unit, appears to have been sitting in the same position for almost nine months.

Site Photo 16. Delivered dental chair

Recommendations. SIGIR recommends that the Commanding General, Gulf Region Division, perform all installation of, and training on, the medical equipment currently at the Heet PHC, according to its prioritization listing.

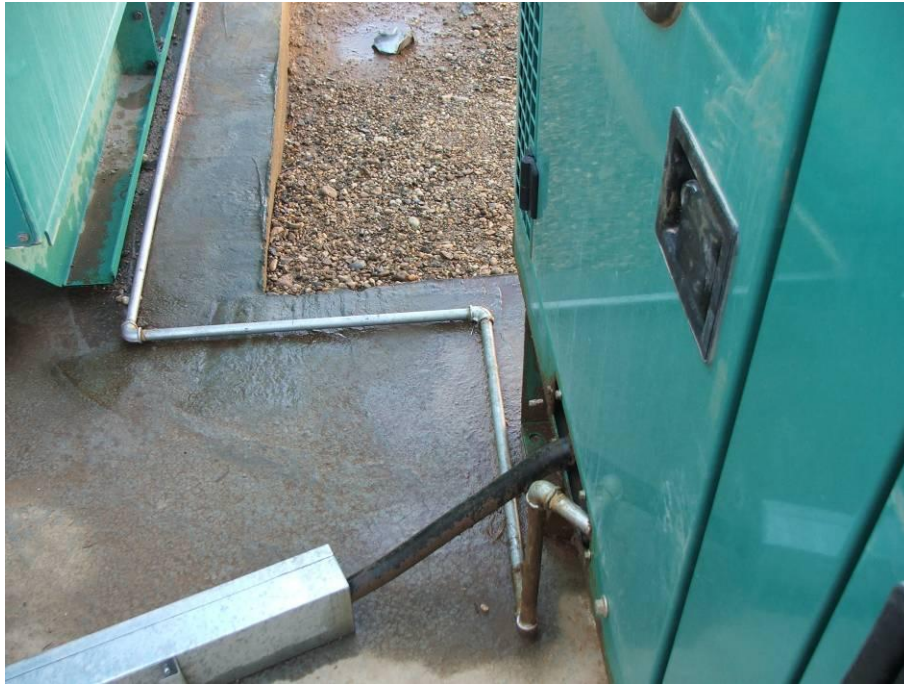
During the site visit, SIGIR noticed a strong smell of diesel fuel throughout the PHC. The source of the leak was one of the supply lines to the generator from the fuel storage tank (Site Photo 17). The diesel fuel was spreading to the main electrical line, which was not installed in a concrete vault (as required by a previous GRC inspection report). Since the generator and fuel tank were located adjacent to the building, the diesel fumes entered the building. The diesel fuel spill not only is a fire hazard, but due to the concentration of fumes throughout the facility, it is a potential respiratory health issue for the PHC staff and patients.

Site Photo 17. Diesel fuel spill and electrical line not installed correctly.

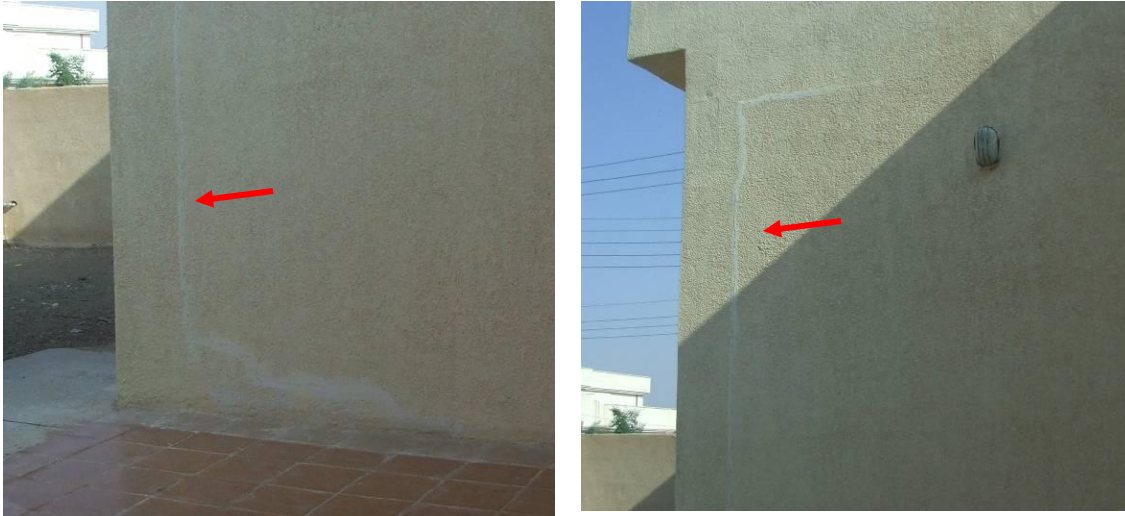
Due to security concerns, SIGIR was not allowed to tour the entire exterior of the facility; instead SIGIR could only quickly gauge the quality of work when entering/exiting the facility. SIGIR did observe cracking of the plaster along the exterior of the building (Site Photos 22 and 23). The cracks followed the location of the connections of the block in-fill to the reinforced concrete columns and beams. Although this is most likely not a serious structural problem, the cracking of the plaster can allow water to penetrate the facility and potentially cause water damage. Some of the cracks had been sealed with an unknown type of sealant that may need maintenance in the future. SIGIR also noticed several areas of water leakage in the interior of the building. Due to lack of time on site, it could not be determined if the water leakage was from the exterior cracking or other problems.

Site Photos 22 and 23. Examples of exterior in-fill cracking

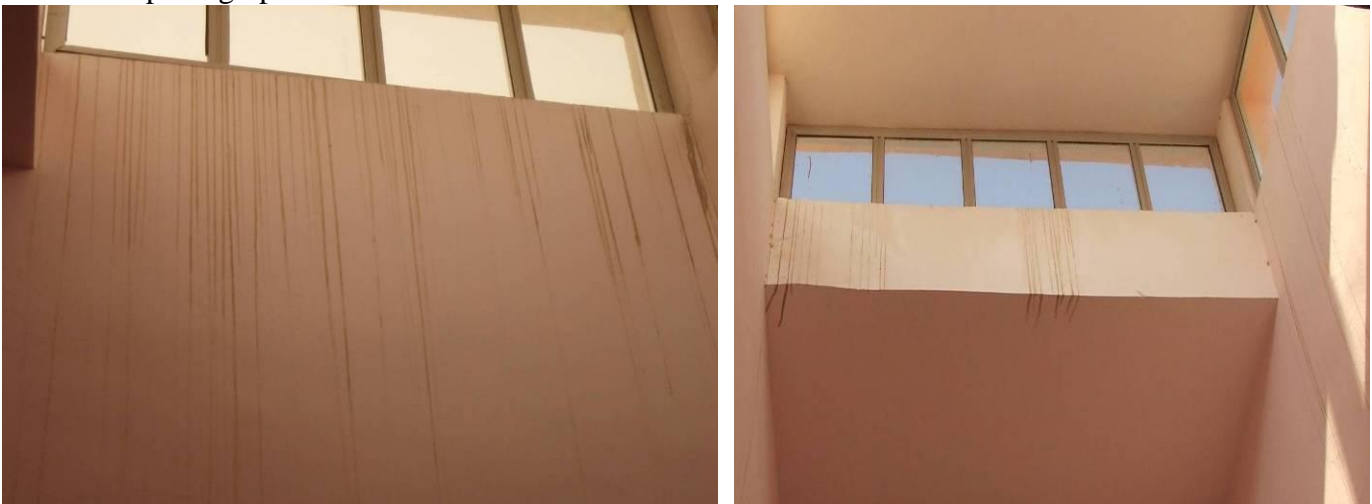
On the GRC's pre-final inspection interior leaks from the skylight were identified (Site Photos 24 and 25). Several days prior to the site visit, the city of Heet had experienced heavy rainfall. During the site visit, several leaks were observed on the interior walls throughout the facility. Specifically, the skylight contained interior leaks that were previously identified in the pre-final inspection. The turnover documentation stated all previously identified deficiencies from the pre-final inspection had been "completed;" however, the interior leaks illustrate the contractor had not corrected the deficiency. While time restraints limited SIGIR's ability to determine the exact cause(s) of the interior leaks, it appeared to be the result of exterior cracking, mastic roof sealants, and improper window seals.

Site Photos 24 and 25. Interior leaks identified in pre-final inspection (left) and during SIGIR site visit (right)
