# 33-KILOVOLT POWER LINE NASSRIYA, IRAQ

**SIGIR PA-08-127**  
**JULY 22, 2008**

SUBJECT: Report on Construction of the 33-Kilovolt Power Line, Nassriya, Iraq (Report  
Number SIGIR PA-08-127)

## **33-Kilovolt Power Line, Nassriya, Iraq**

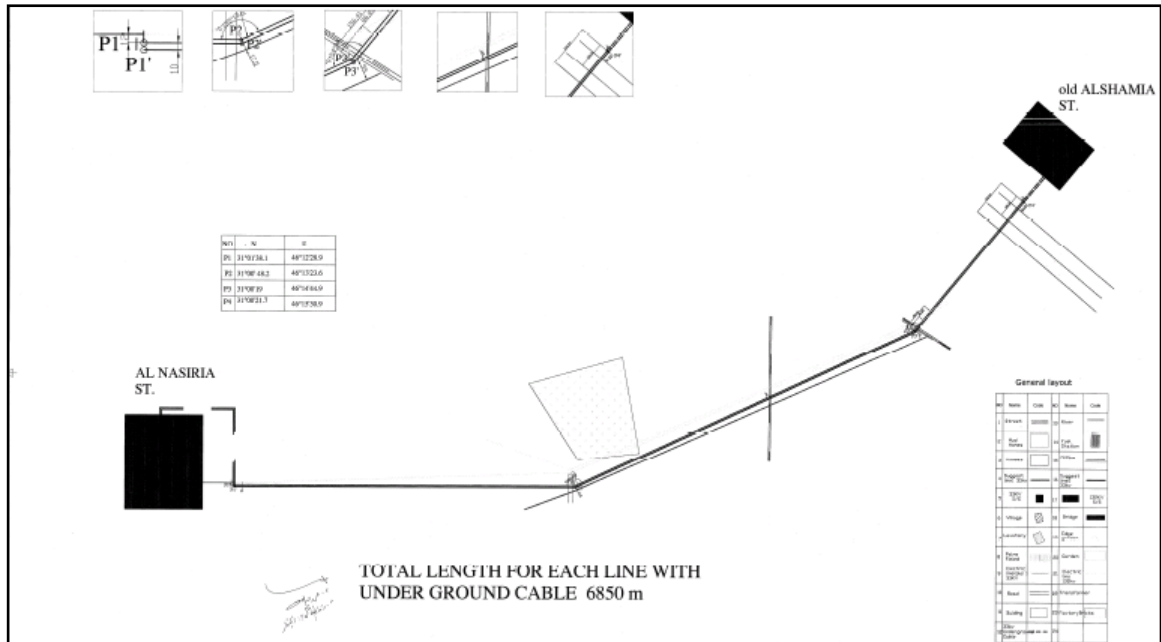
Figure 2. 33-kV power line drawing (Courtesy of the USACE)

The USACE provided SIGIR with the contractor’s 33-kV power line one page “route” drawing and one profile sheet. The design documents consisted of the route drawing (Figure 2), which provided the total length for each line with underground cable and a profile sheet that determined the height and length between structures. The contractor’s design documents did not provide complete engineering drawings, including construction, civil, mechanical, and electrical, or single line diagrams.

After reviewing the design drawings and specifications supplied, SIGIR determined the design package available was not complete; it lacked sufficient details and did not meet the contract requirements. Specifically, the design documents did not provide any preliminary alignment plans with topographic survey, soil reports, right-of-way plans, construction drawings (which typically includes plan and profile sheets, detail sheets, quantity sheets, and environmental protection plan sheets), structural calculations, foundation calculations, technical specifications, catalog cuts of equipment specified, general design notes with assumptions made, or standard drawings referenced.

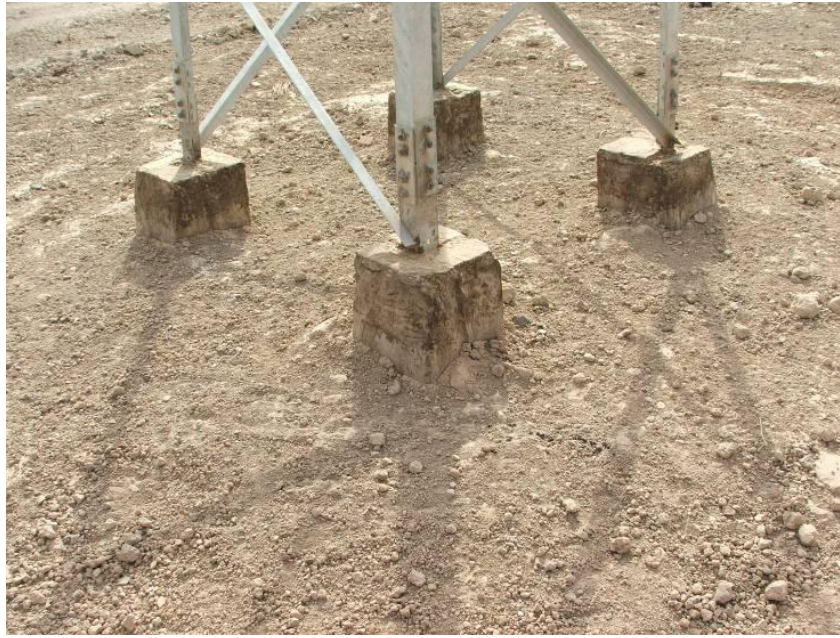
Prior to erecting the completed tower, the contractor performed the required excavation, then formed and poured the concrete foundation for the tower (Site Photo 1). The structural concrete SIGIR observed did not have any noticeable cracking, segregation, or honeycombing areas.

**Site Photo 1. Completed tower foundation**

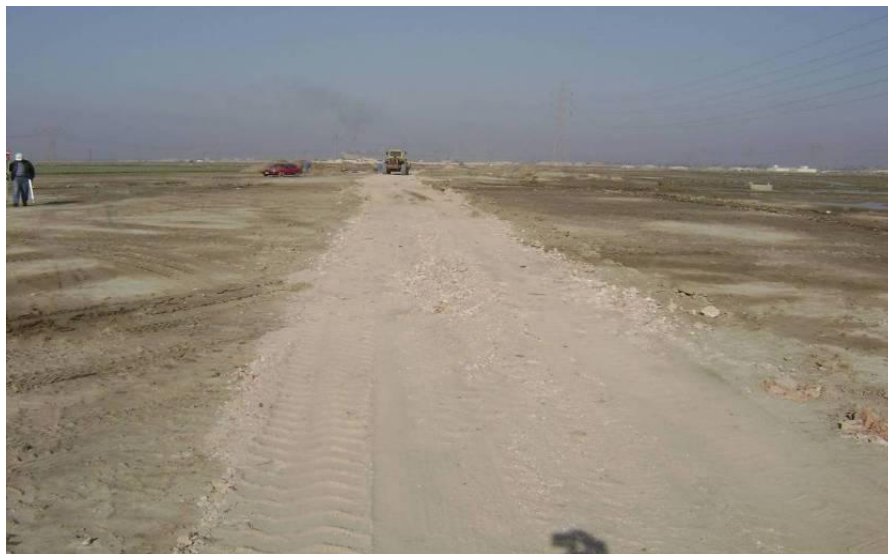
At the time of our site visit, the contractor had not completed the 33-kV power line or the service road (Site Photo 2), which provides access to the towers. For example, the contractor was still excavating tower foundation sites (Site Photo 3), forming up the tower foundations (Site Photo 4), erecting tower bases (Site Photo 5), pouring the concrete base of the towers (Site Photo 6), vibrating concrete base towers (Site Photo 7), finishing the concrete for the tower bases (Site Photo 8), curing the concrete of the tower bases (Site Photo 9), and delivering aggregate to the site (Site Photo 10).

**Site Photo 2. Construction of service road (Courtesy of the USACE))**

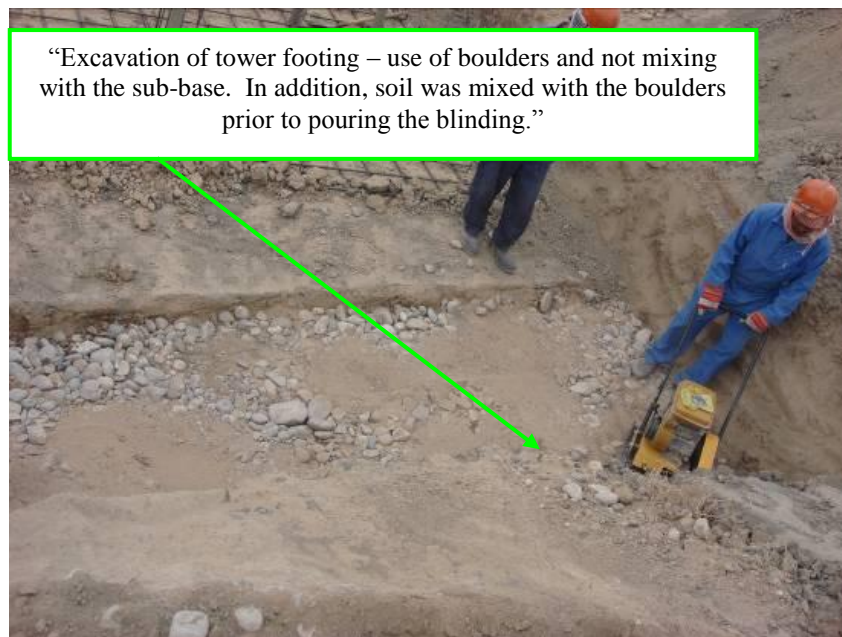
The USACE GRS trained the Iraqi Construction Engineers (ICE), local nationals with engineering backgrounds working for the USACE, and deployed them to the project site to perform QA oversight of the contractor. The ICE were on site during construction events, and monitored field activities and completed daily QA reports, which were forwarded to the USACE GRS project engineer for review. The QA reports documented significant construction activities, such as work performed by building, equipment on site, safety concerns, testing done, and the name and location of the testing facility. In addition, the ICE submits photographs of construction activities taking place throughout the day. Further, the ICE notes any problems/deficiencies identified and the correction actions taken via deficiency logs. Examples of problems noted by the QA representative on site were the “improper excavation and foundation mixing for the tower footing” (Site Photo 11); the potential confusion between the sand that failed the salinity test and the new sand (Site Photo 12); and cube tests (Site Photo 13), which failed the 28-day cure test (Figure 3).

**Site Photo 11. Improper excavation and mix for tower footings (Courtesy of the USACE)**

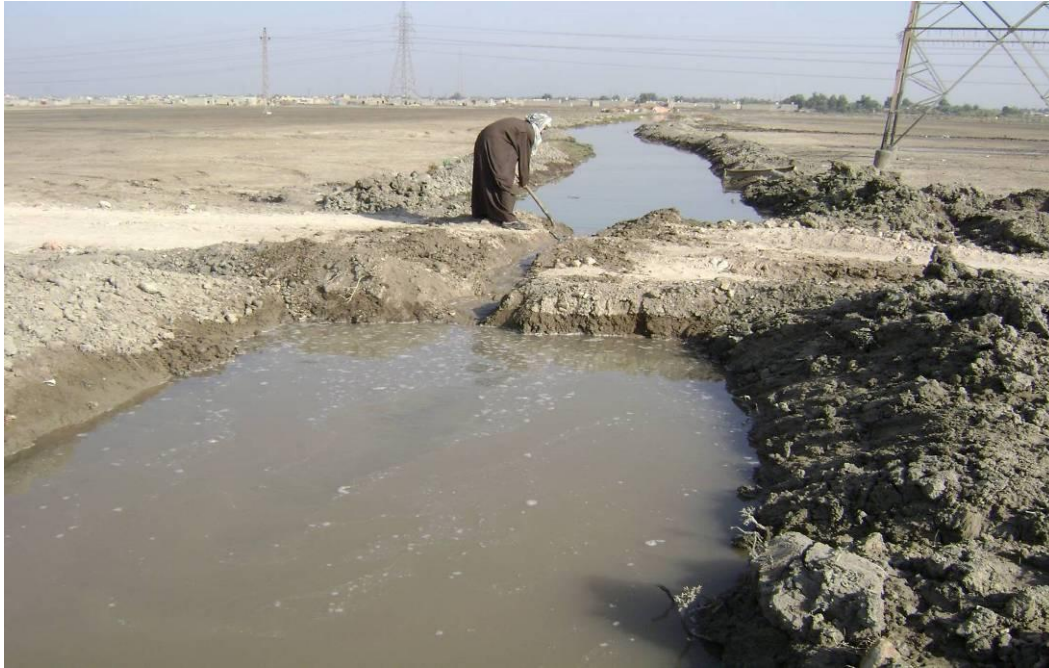
On 2 January 2008, the USACE issued a letter of concern to the contractor regarding the contractor’s failure to install pipe culvert under the service road at points where it crossed irrigation channels (Site Photo 14). As a result local farmers were digging trenches across the service roads at the irrigation canal crossings to allow irrigation water to move from one side of the road to the other. The trenches rendered the service roads unusable. In addition, the QA noted that the contractor’s employees were not QC testing the sub-base material for the service road.

**Site Photo 14. No pipe culvert on service road (Courtesy of the USACE))**
