A BRIEF DISCUSSION OF TWO RECENT MAGAZINE ACCIDENTS AT THE NAVAL SURFACE WARFARE CENTER

M. M. Swisdak, Jr.

Indian Head Division/Naval Surface Warfare Center

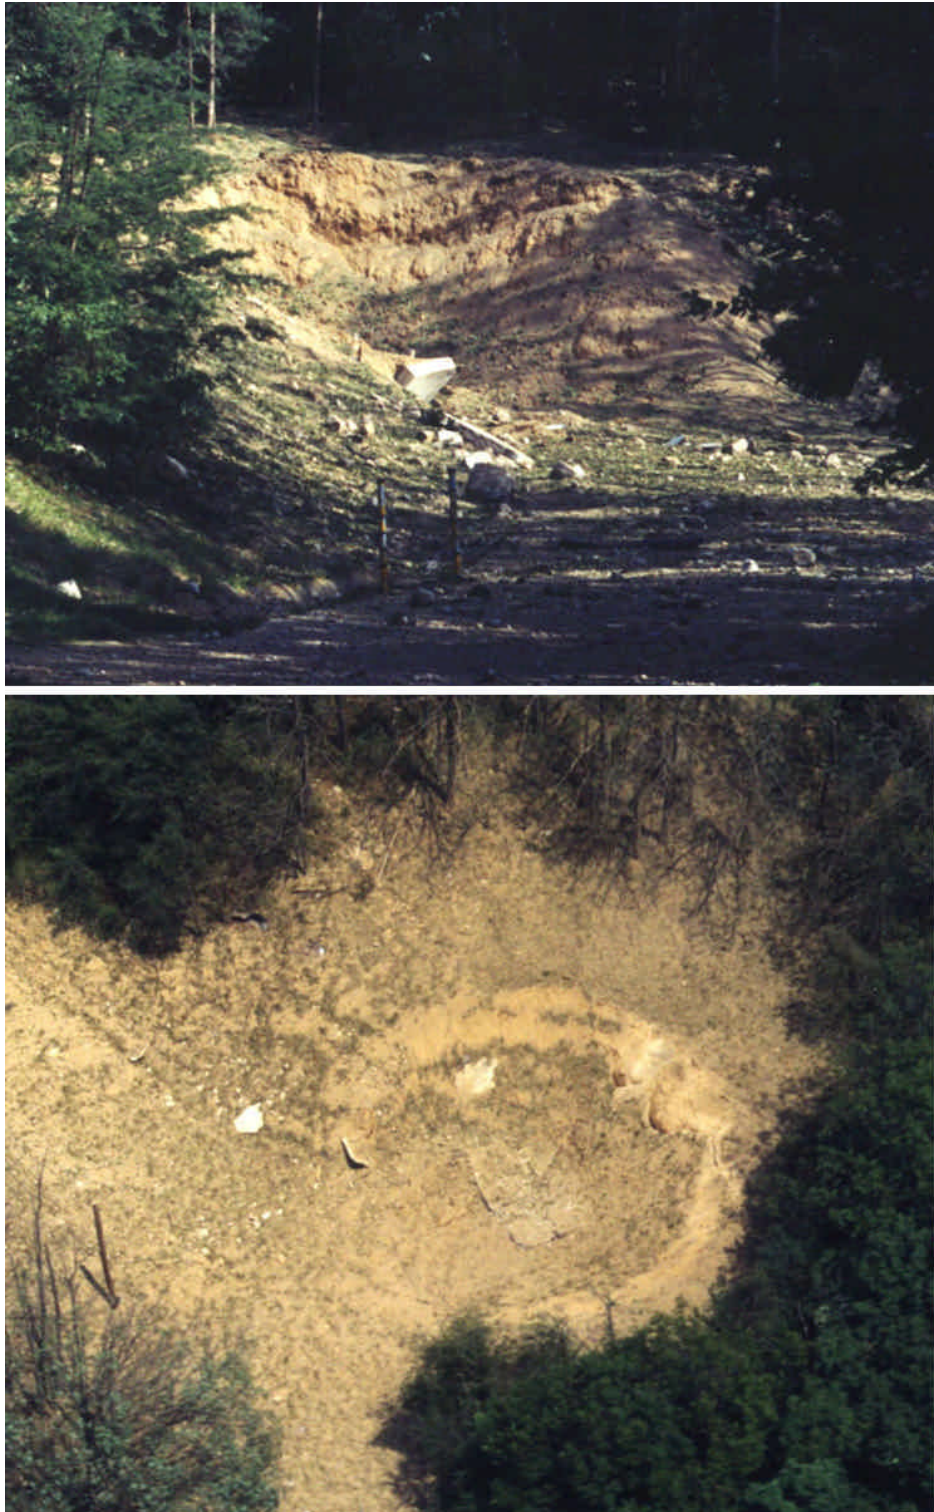
FIGURE 5. MAGAZINE 355 DAMAGE

The radius of complete destruction was limited to the immediate vicinity of the magazine itself. Figure 5 contains two photographs that show the damaged area in and around the magazine. The explosions removed all of the earth cover and the structure itself--down to the depth of the floor slab. The floor slab was broken into several pieces. Some of these pieces were driven several feet into the earth below their original location. Large portions of the slab were missing entirely. Figure 6 is a plot of the crater and the remains of the floor slab. Superimposed on this plot is an outline of the original building. Figure 7 is a more detailed view of the floor slab--showing the locations of the pieces that remained after the accident. The origins of the coordinate systems used in Figures 6 and 7 have been translated to the center of the original floor slab. The average radius of the crater that was formed was 32.4 feet. No depth determination was possible.

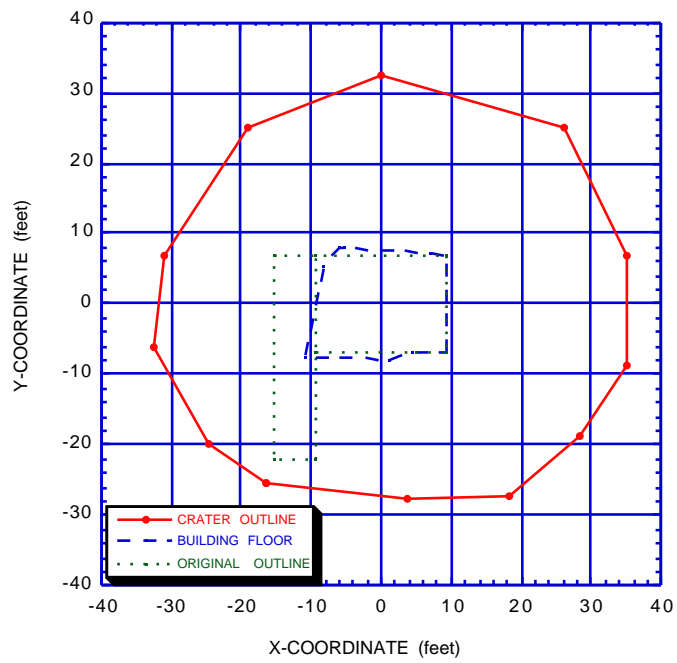
FIGURE 6. MAGAZINE 355 CRATER AND FLOOR OUTLINE

White Oak. Based on the crater dimensions shown in Figure 6, the yield is estimated to be between 3,000 and 5000 pounds of HD 1.1 material³. This estimate cannot be refined further because of the construction of the magazine itself--earth covered on and partially built into an earthen bank.

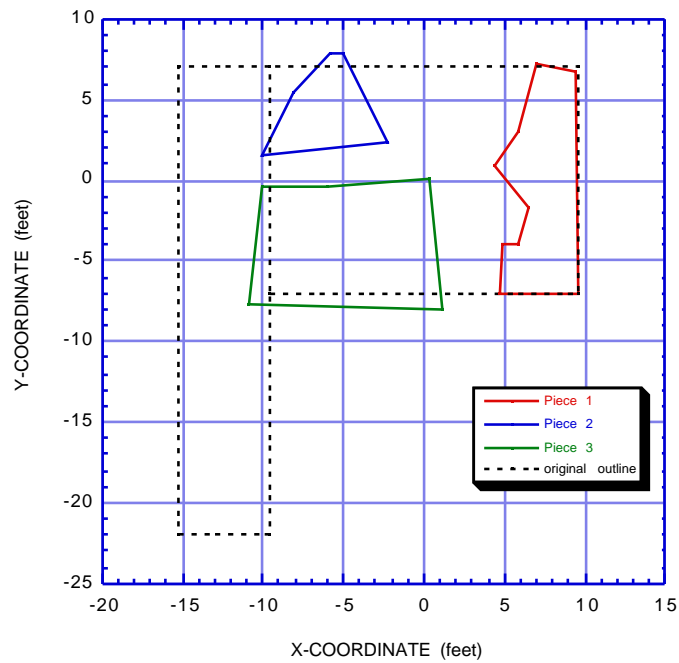
FIGURE 7. MAGAZINE 355--FLOOR SLAB PIECES

As indicated previously, the location of the floor slab pieces are shown in Figure 7. Only about 62% of the original floor material remained in the crater. The floor directly under the explosion should suffer the greatest damage. If so, then Figure 7 shows that most of the material that detonated was located in a T-shaped pattern, with the crossbar of the Tee located about 10 feet from the door.

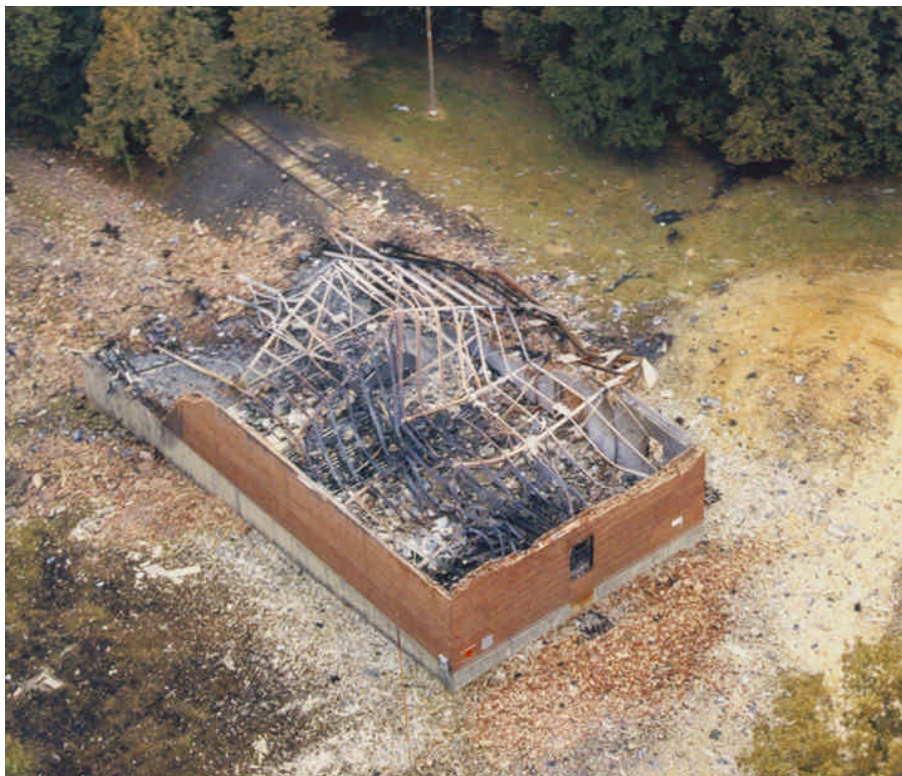
FIGURE 8. MAGAZINE 518 (NE TO SW VIEW)

Indian Head. The structure was damaged beyond economical repair but was not totally destroyed. Figures 8 and 9 present two aerial views of the remains of the structure. Approximately two-thirds of the West wall and one-third of the East wall were destroyed. The South wall was totally destroyed. The foundation below the South wall was bowed outward by as much as 12 inches. There was spalling evident over an 8-10 foot diameter area on the South foundation. Also present on this foundation were black striated deposits as well as cracks radiating from the center of the spall.

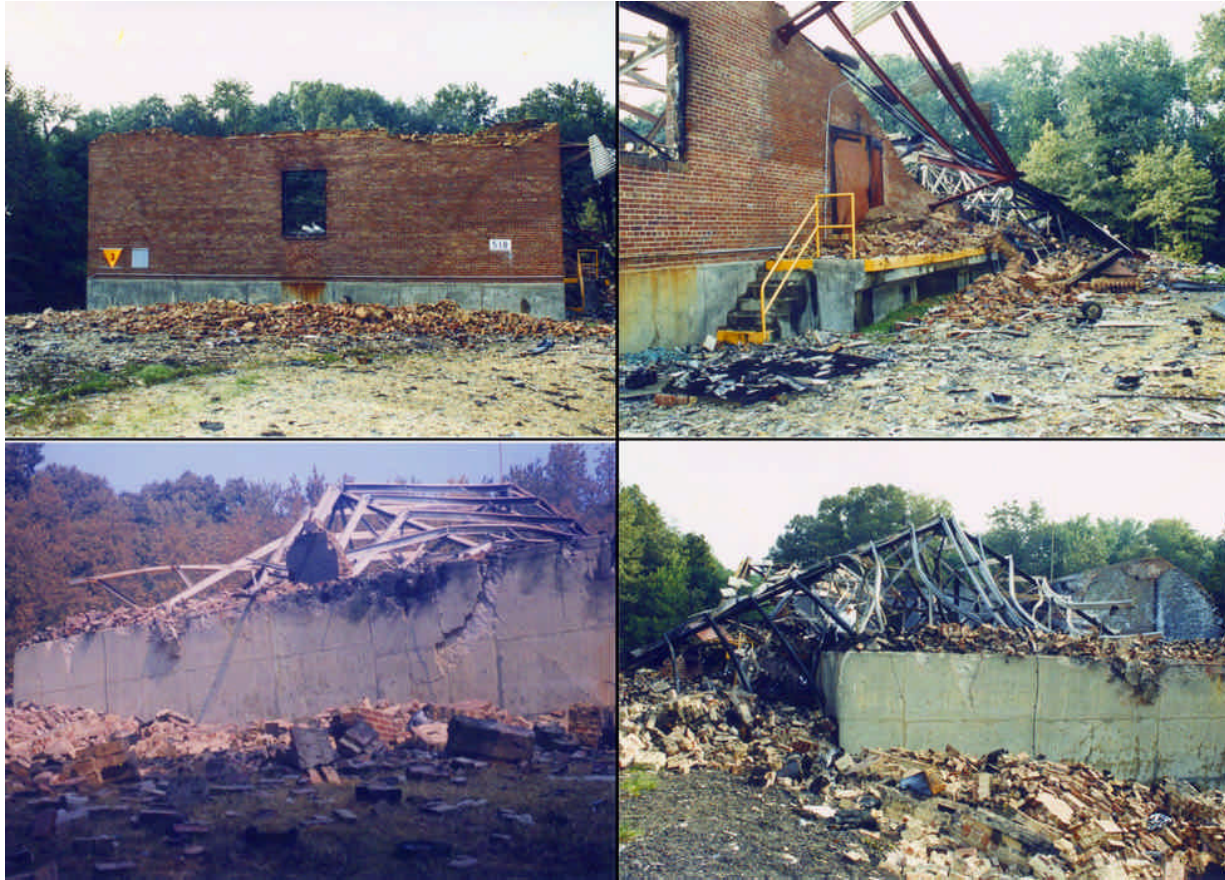
FIGURE 10. MAGAZINE 518 REPRESENTATIVE DAMAGE

The East end of the South wall cracked away from the South end of the East wall. The Northeast (NE) corner of the East wall was bulging outward 2-3 inches. The NE corner of the North wall was pushed outward 4-6 inches. One of the roof trusses was thrown approximately 250 feet from its original position. Figure 10 shows four views of the damage that the structure received.

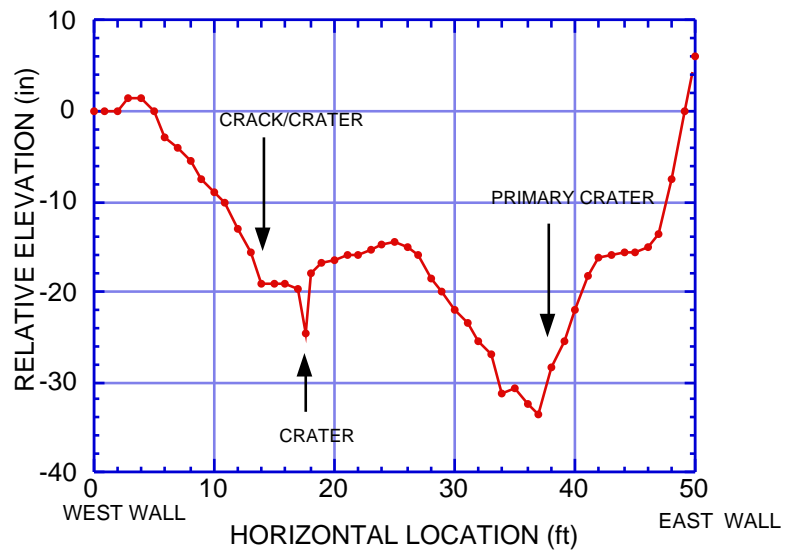
FIGURE 11. BUILDING 518 FLOOR PROFILE
(PROFILE TAKEN ALONG SOUTH WALL)

A crater was formed in the Southeast (SE) corner of the building. The crater was oblong with the following nominal dimensions: 3'1" deep at its center, 7'1" East-to-West, and 4'2" North-to-South. The center of the crater was located 6'11" from the exterior of the South wall and 12'1" from the exterior of the East wall. The floor was depressed along the entire width of the South wall. In addition to the primary crater, smaller craters were also observed along the South wall. Figure 11 is a profile of the floor taken along the South wall.
