HAMMAM AL ALIL DIVISION TRAINING  
CENTER  
MOSUL, IRAQ

**SIGIR PA-09-174**  
**JANUARY 7, 2010**

### Summary of Report: PA-09-174

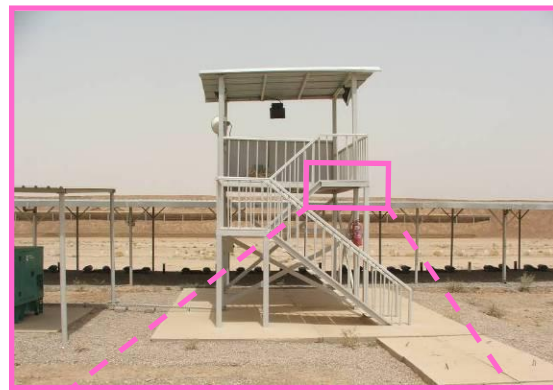
**Site Photo 3. Range tower**

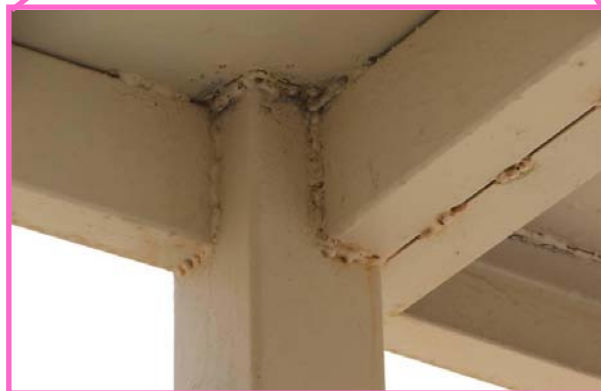
The contractor furnished metal containers for target storage and administrative materials that were located inside the chain link fence. Range towers were constructed directly behind the firing positions and had a roof, staircase, and spotlight. The range towers were constructed with steel framing and metal plate decking which were joined together with what SIGIR observed to be poor quality welding (Site Photo 3). However, the connections used the entire perimeter of the joining members as faying<sup>5</sup> surfaces, and relatively light loads were expected in the tower, so the connections appeared adequate (Site Photo 4).

**Site Photo 4. Poor weld quality at connections**

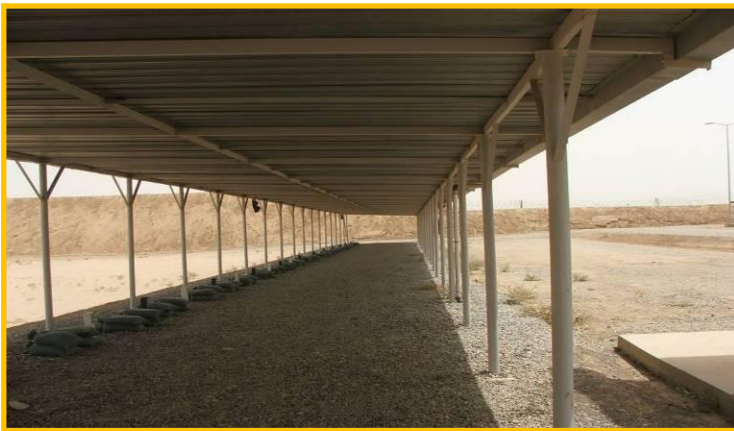
At the time of the SIGIR site assessment; there were no overhead baffles present between the firing positions and the terminal end of the range. The GRN Mosul Area Office representative stated that the overhead baffles were constructed. However, GRN visited the site and determined that the quality of construction of the overhead baffles was extremely poor and non-compliant with the specifications as stated in the SOW. The contractor was asked to remedy the deficiencies noted for the overhead baffles. The contractor attempted to address the deficiencies, but upon further inspection of the overhead baffles, the Multi-National Security Transition Command-Iraq (MNSTC-I) made a decision to completely remove the defective work. This resulted in a descoping of the overhead baffle requirement.

Site Photo 5. Firing positions

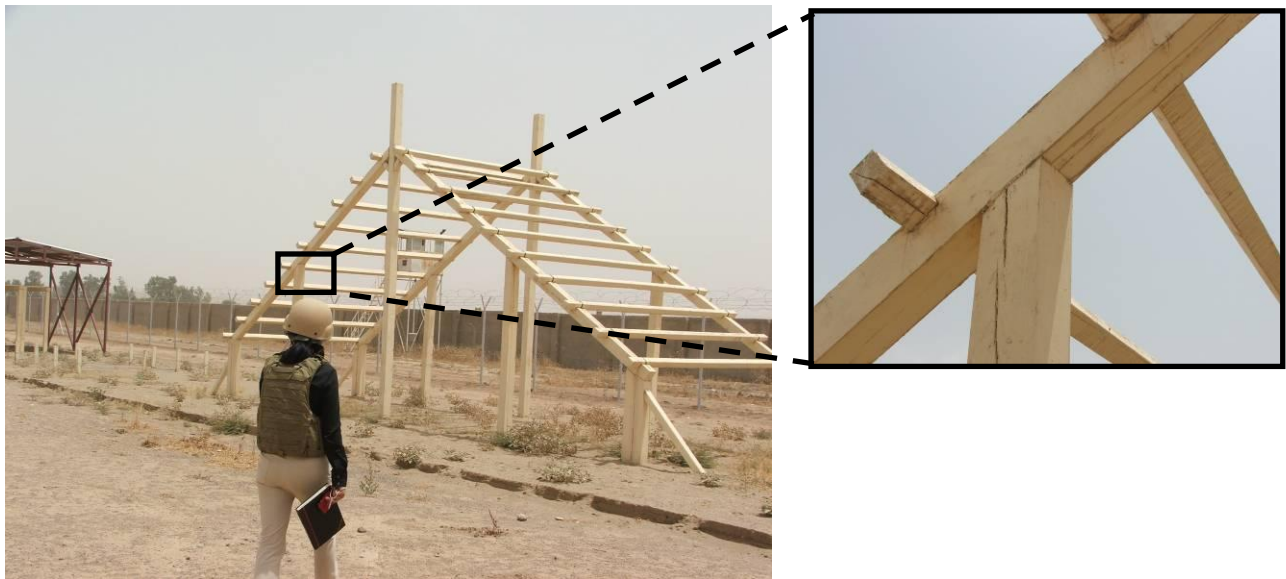
The SOW required that areas surrounding and underneath the obstacles should consist of a deep bed made of sand, sawdust or crushed/ground rubber. SIGIR observed that the obstacles were constructed over native material similar to the ground cover on other areas of the project. It does not appear that provisions were made to place the required ground cover beneath the obstacles.

**Site Photo 20. Obstacles for combat assault course**
