**AMMANA MARKET RENOVATION
MAJJASIM, IRAQ**

SUSTAINMENT ASSESSMENT

**SIGIR PA-09-171
JULY 30, 2009**

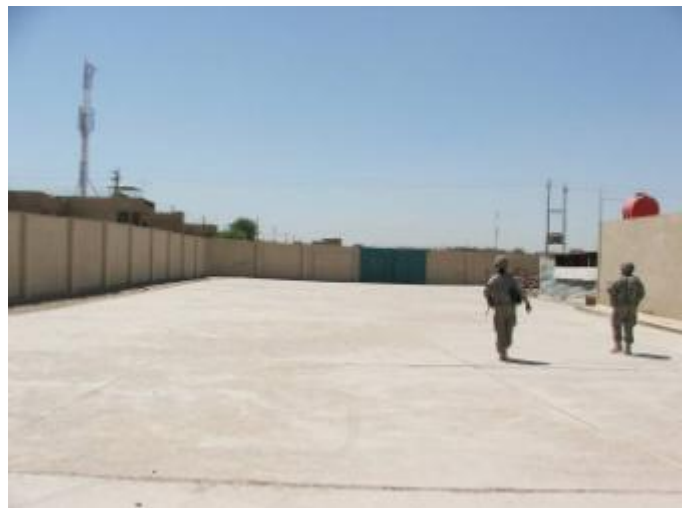
The concrete pad was constructed with expansion joints along the edges of the existing shops (Site Photo 2) and in the parking area (Site Photo 3); however, it was not apparent whether expansion joints were constructed in the slab beneath the steel truss roofs of the market stalls. Also, the contractor did not maintain the site: a bicycle had been ridden through the wet concrete.

Site Photo 3. Slab at parking area

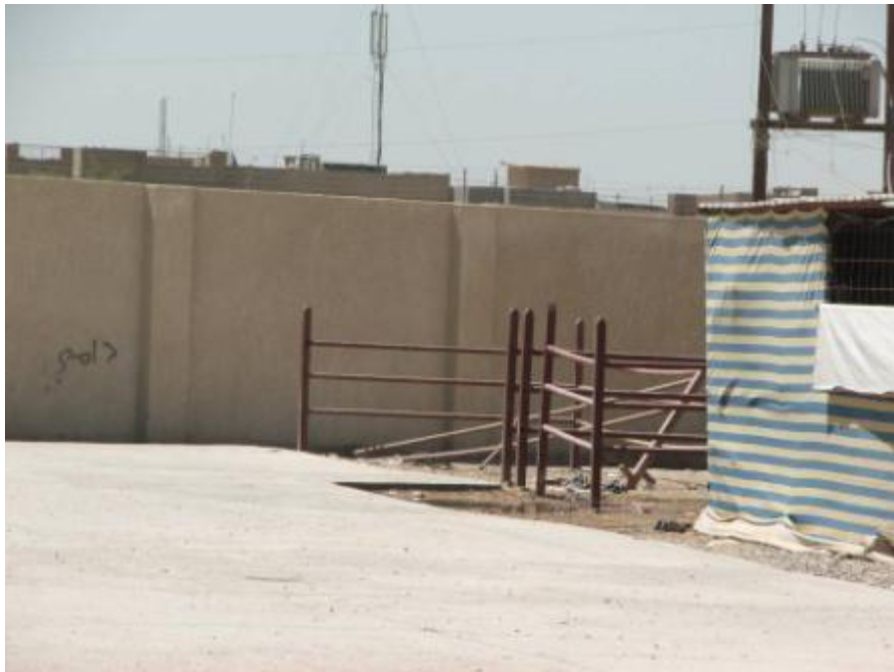
The SOW required the contractor to construct six animal corrals. Because of time limitations, SIGIR was unable to physically inspect the corrals; however, SIGIR did verify the existence of some of the corrals (Site Photo 15).

Site Photo 15. Animal corrals

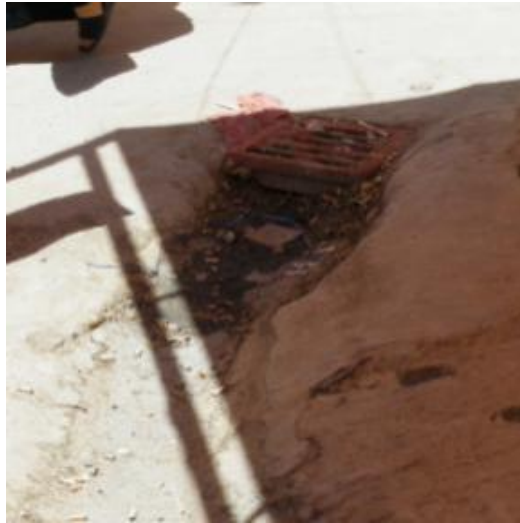
During the site visit, SIGIR identified drainage gutters in the concrete slab around the perimeter of the market courtyard. The drainage gutters consisted of a V-channel slope and allowed drainage to flow to the cast iron inlet grate (Site Photo 17). Because of time constraints, SIGIR was unable to determine whether the inlets were connected to a larger drainage system.

Site Photo 17. Gutter inlet

The drainage gutters were not covered with a perforated cover as required in the SOW. However, the use of perforated covers could be problematic. Perforated covers on the drainage channels would likely become clogged with debris, reduce their effectiveness, and require continual maintenance.
