# **ANALYSIS OF DEBRIS FROM HELICOPTERS FROM THE FIELD**

**INTERIM REPORT  
TFLRF No. 402**

**U.S. Army TARDEC Fuels and Lubricants Research Facility  
Southwest Research Institute® (SwRI®)  
San Antonio, TX**

**January 2010**

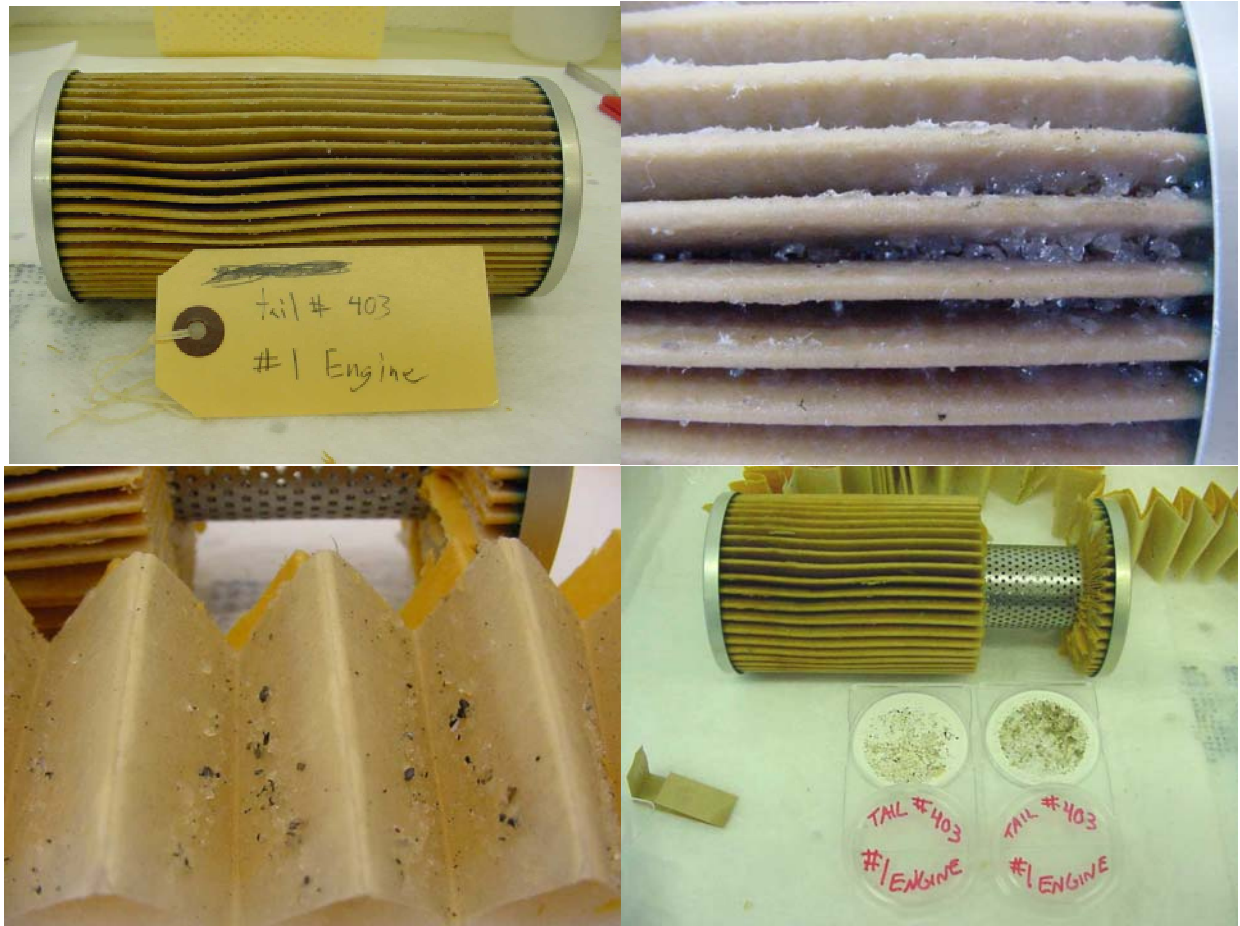
**Figure 1. #1 Engine**

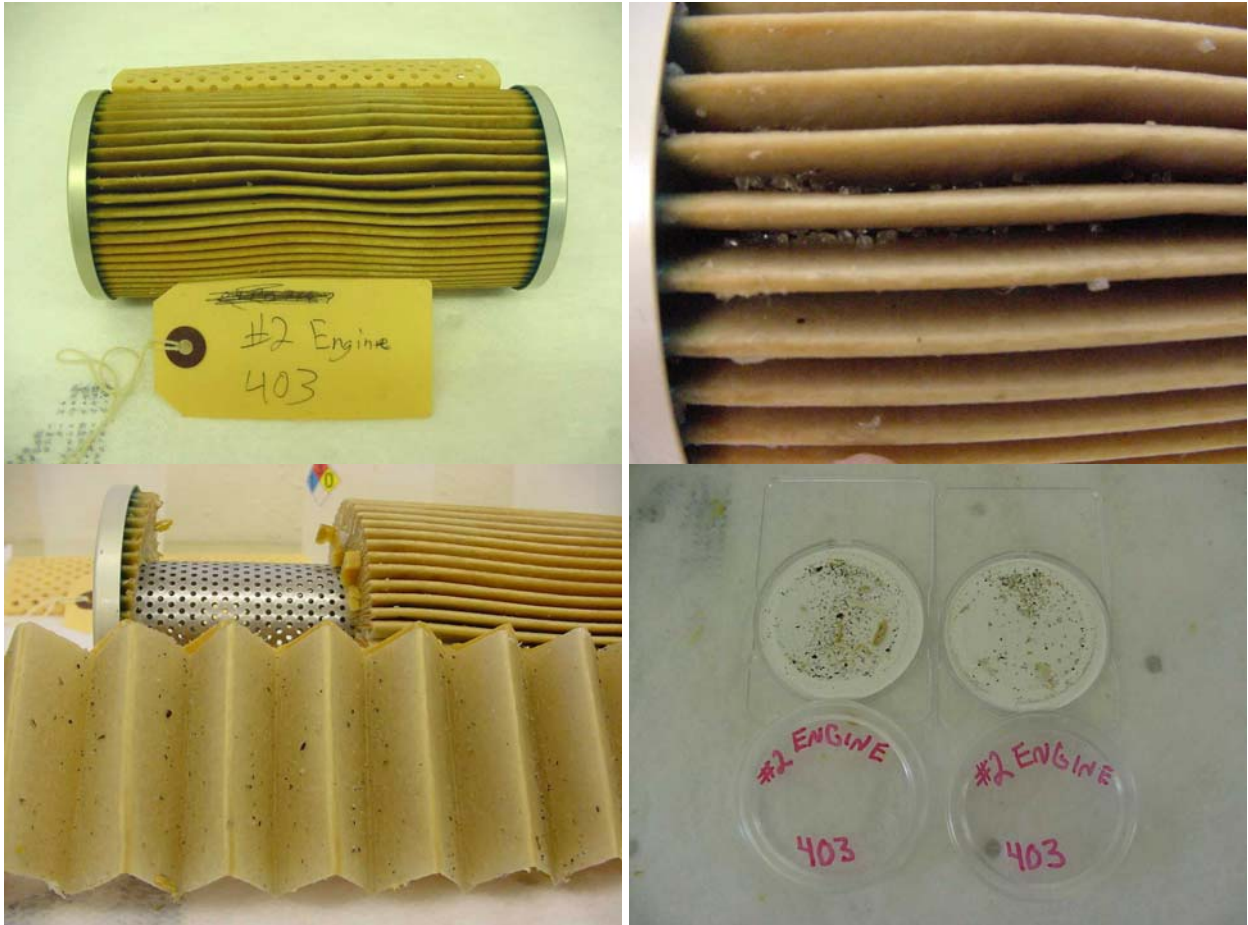
**Figure 2. #2 Engine Filter, as Received**

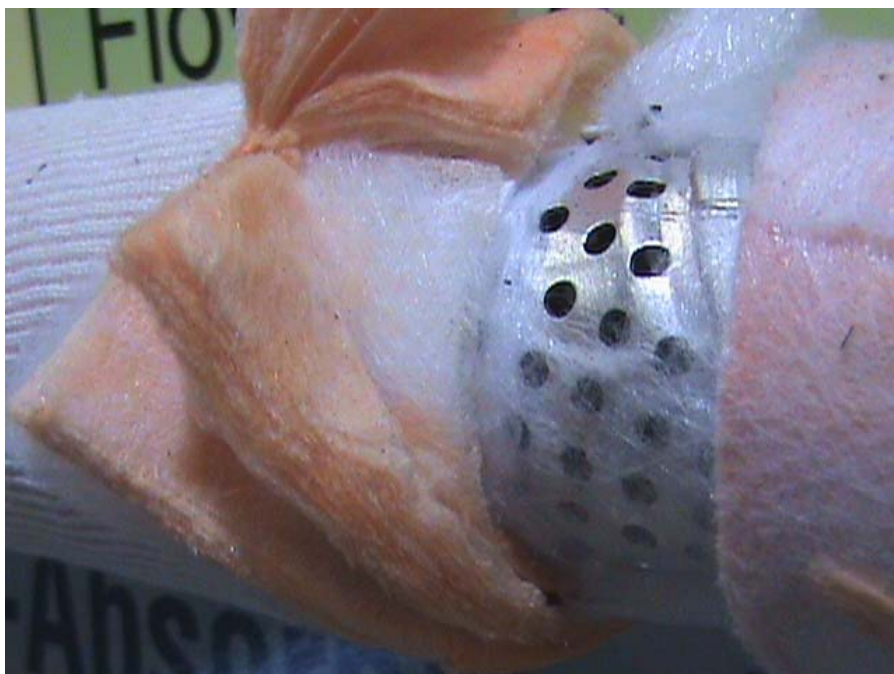
**Figure 18. Cut Away of New Water Absorbent Monitor**

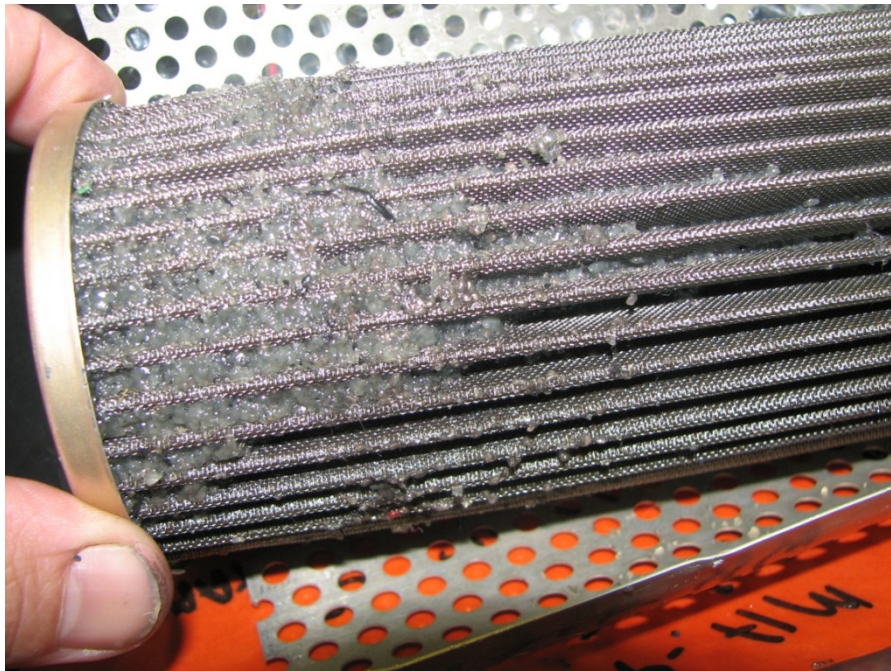
**Figure 22. #1 Main Filter (Photo Provided by Goodrich)**

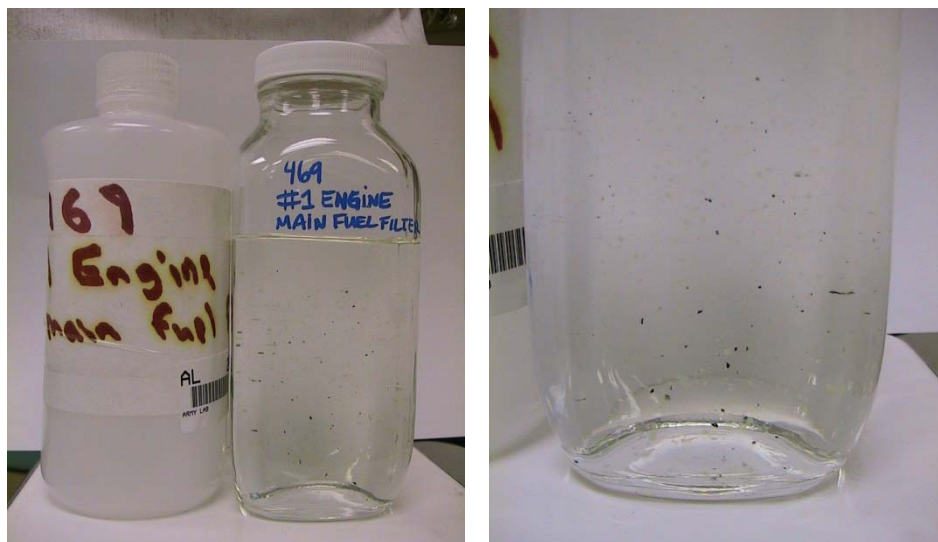
A fuel sample and debris from the left hand tank from 469 were sent to SwRI for analysis (Figures 24 and 25, respectively). The fuel arrived in a plastic bottle but was transferred to a glass container to illustrate the floating debris in the fuel. Two 100-mL samples were filtered through 0.8- $\mu$ m membranes, and the gravimetric results are shown in Table 2. The fuel sample contained a large quantity of dark particles that appeared to be elastomeric or rubber. There were also large white particles floating in the fuel. All the debris would eventually settle to the bottom of the container. Upon completion of the gravimetric and elemental analysis, the membrane was treated with copper sulfate to determine if SAP was present.

**Figure 24. Fuel Sample From 469**

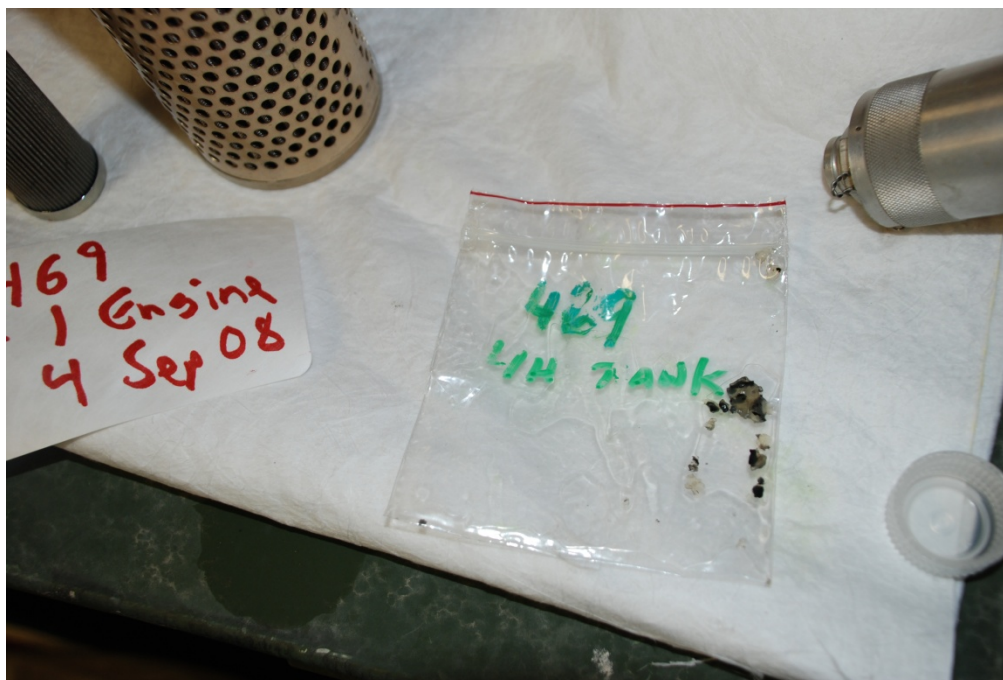
The debris from the left hand fuel tank was dried when received. When water was applied to the debris, it had the consistency of SAP.

**Figure 25. Debris From L/H Tank – 469**

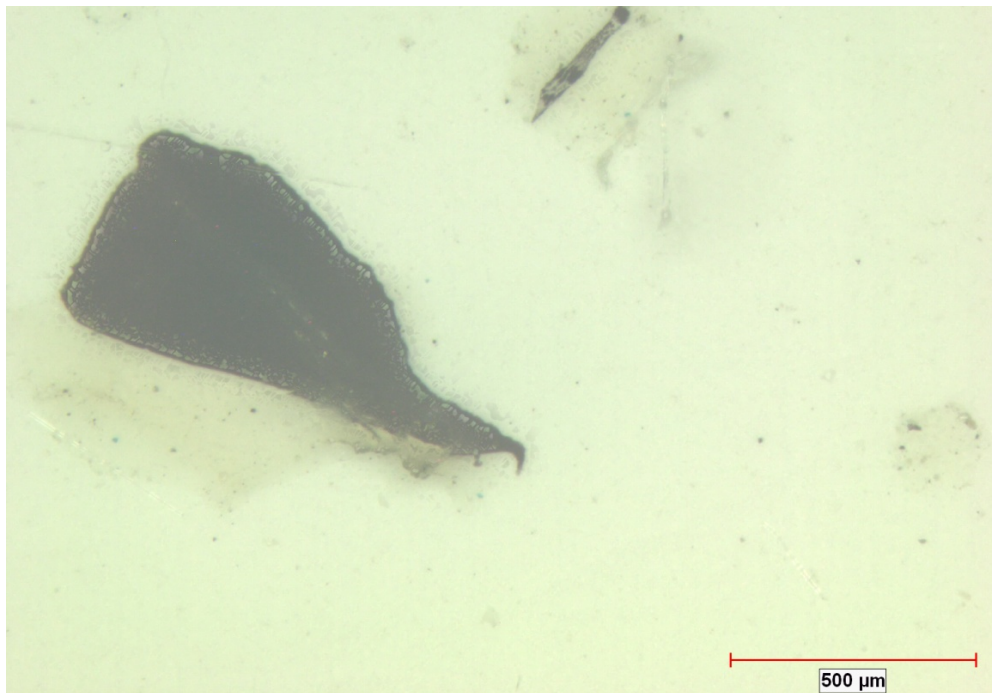
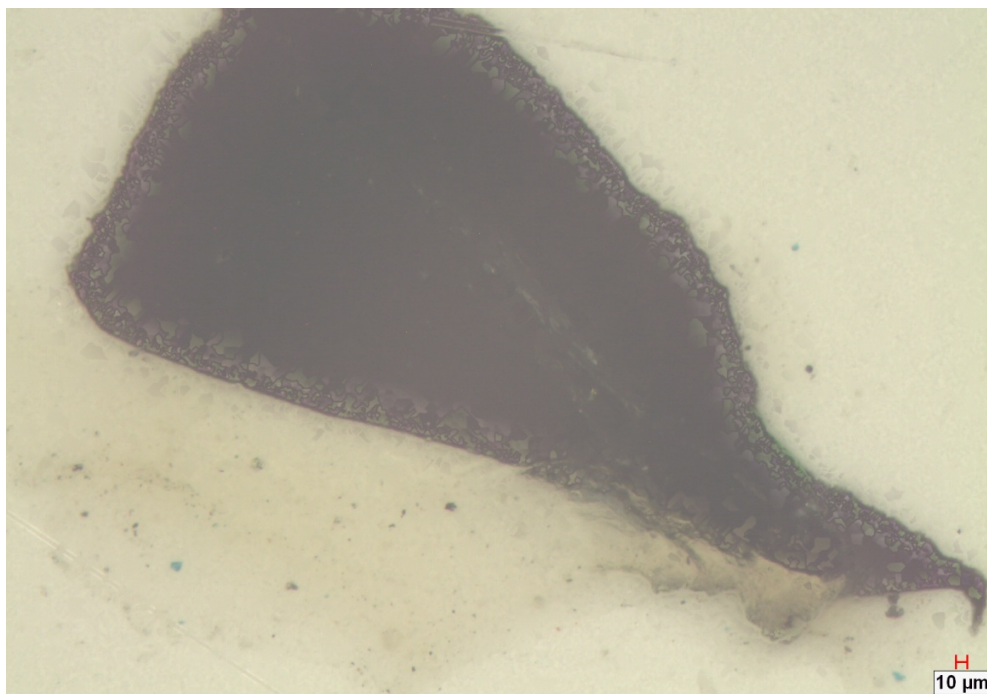
Optical analysis of the debris revealed the size of the darker debris to be 1,000- $\mu\text{m}$  or larger (Figures 26–27). Figures 28–29 illustrate the other debris from the supplied fuel sample. Small blue particles can be seen in Figures 28–29. These particles reacted with the copper sulfate solution that was applied to the membrane to determine if super absorbent polymer (SAP) was present. A few positives were found indicating some SAP migration occurred. It is difficult to determine exactly what the white debris was, but it did look gelatinous and would plug a fuel filter rapidly.

This fuel sample was heavily contaminated with black and white large particles. The black particles appear to be part of the fuel tank or particles from a refueling hose. The white debris shows indications there is SAP present. If the rest of the gelatinous material is not SAP, at this time it is not known what it is. The material, however, would definitely plug fuel filters. One possible explanation for the gelatinous debris not turning blue when treated with copper sulfate is that the magnesium and/or aluminum have already reacted with the metal in the SAP. Therefore, the copper would not react, and the polymer would not turn blue.

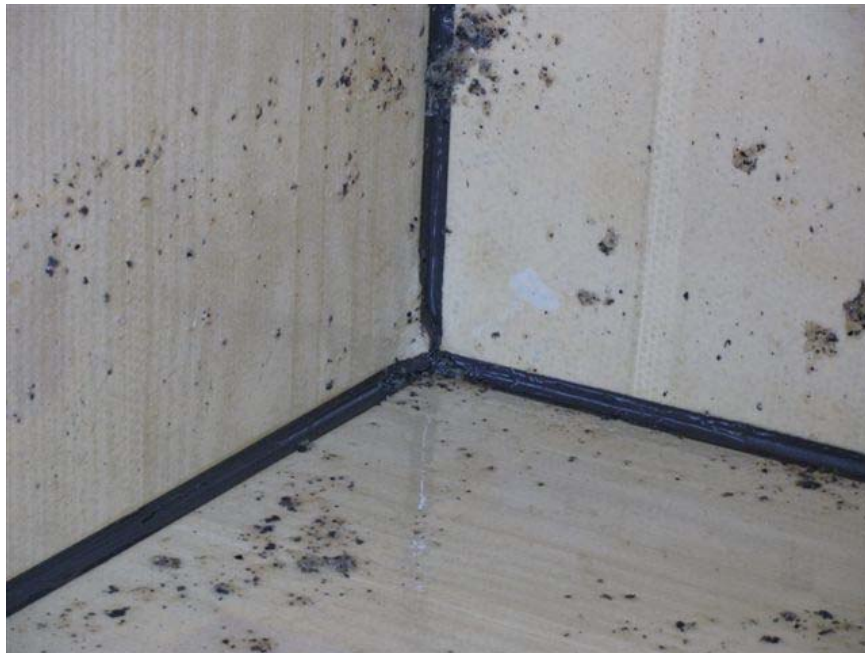
**Figure 31. Unknown Contaminant in Fuel Bladder**

The debris has the appearance and consistency of apple jelly which is typically caused by the combination of water, fuel system icing inhibitor, and super absorbent polymer (SAP) from water absorbent monitors. However, none of the analysis supports this conclusion. It appears that this contaminant very well may have been dispensed into the bladder (Figures 31 and 32).

It is recommended that further analysis of the internal surface of the bladder and support structure be performed to determine failure mechanism and/or identify any corrosion activity.

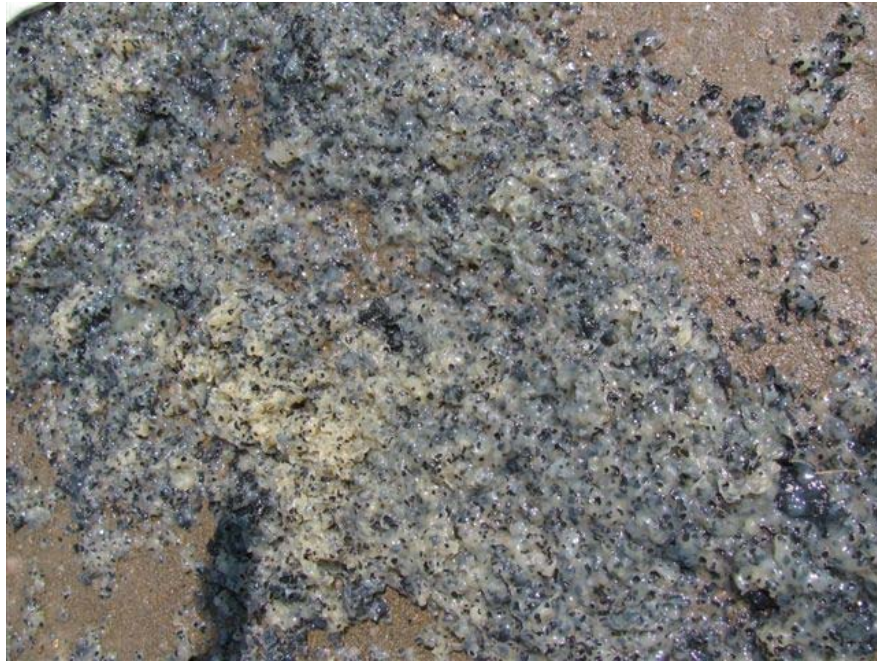
**Figure 32. Close up of Fuel Contaminant in Fuel Bladder**

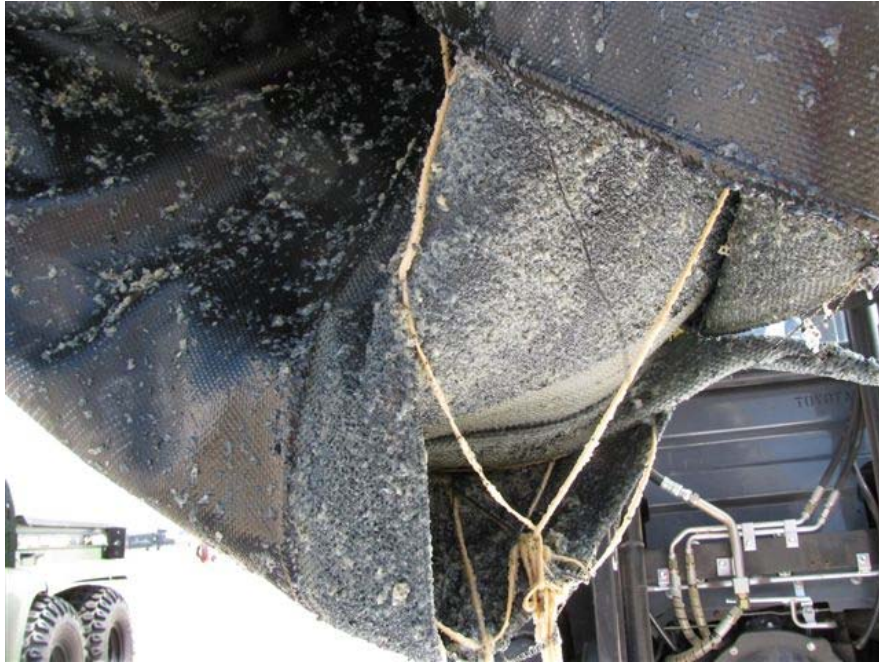
**Figure 34. External View of the Degraded Fuel Bladder – View 1**

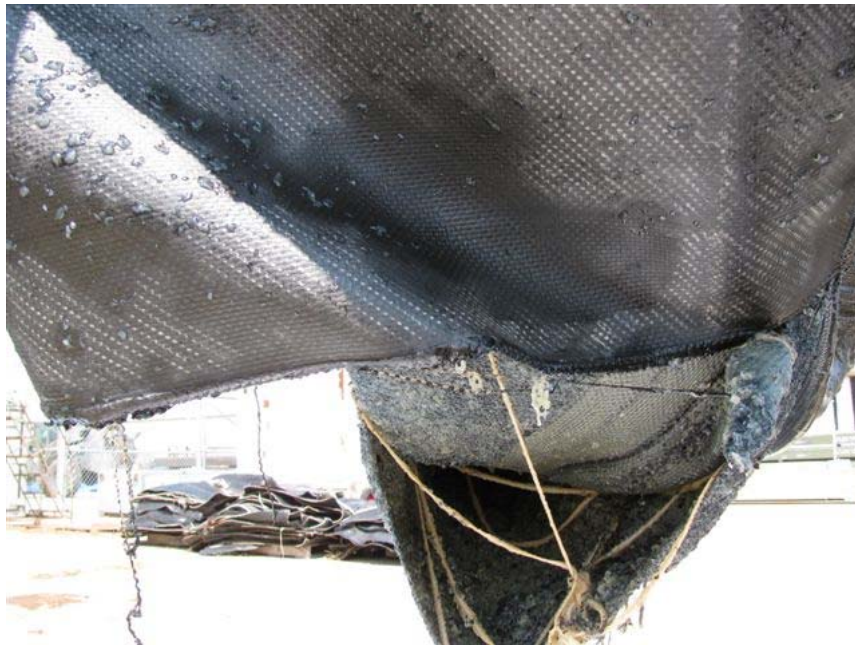
**Figure 35. External View of the Degraded Fuel Bladder – View 2**

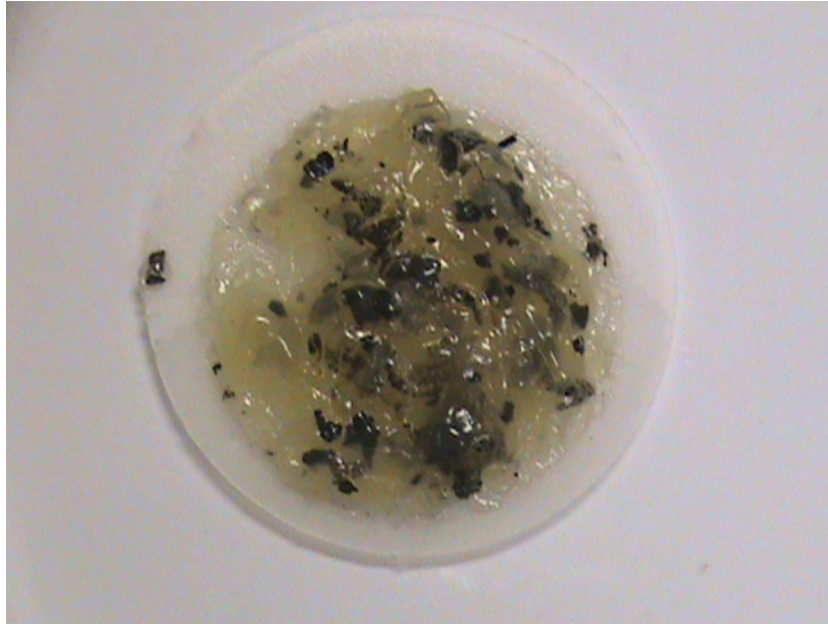
Approximately 100 mL of fuel was provided from the fuel bladder. The furnished fuel was filtered through laboratory membranes to capture the dark particles, Figure 36. The debris plugged the laboratory filters very quickly. Multiple membranes were required to filter all of the debris, Figure 37.

**Figure 36. Fuel Debris Captured on Laboratory Membrane**

Elemental analysis of the bladder and jelly-like material was performed by EDS, Table 4. The jelly-like debris did contain the dark particles shown in Figures 36 and 37. The jelly-like debris is tacky and if left in the air, it will dry out.

The dark particles do not appear to have come from the fuel bladder, but from another source such as o-rings or sealants.

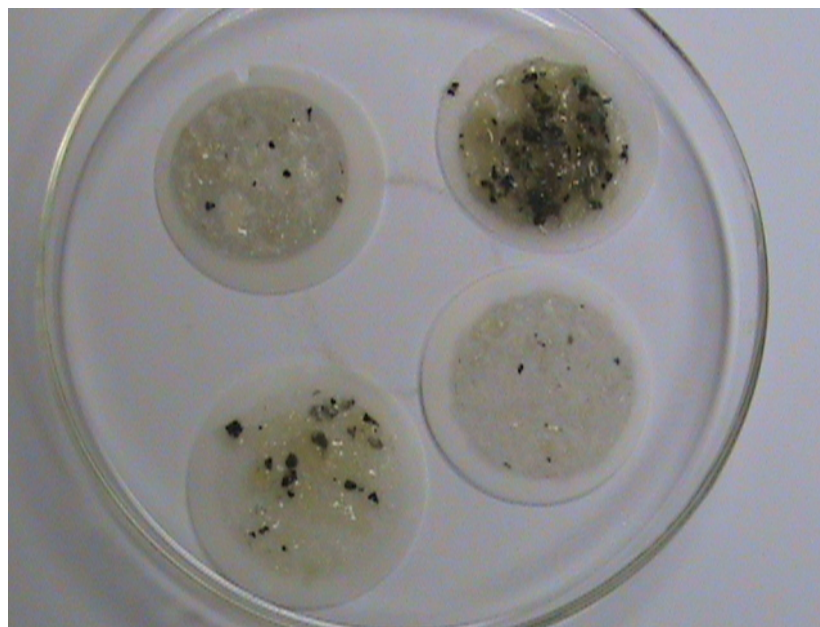
**Figure 37. Multiple Laboratory Membranes Containing Fuel Debris**

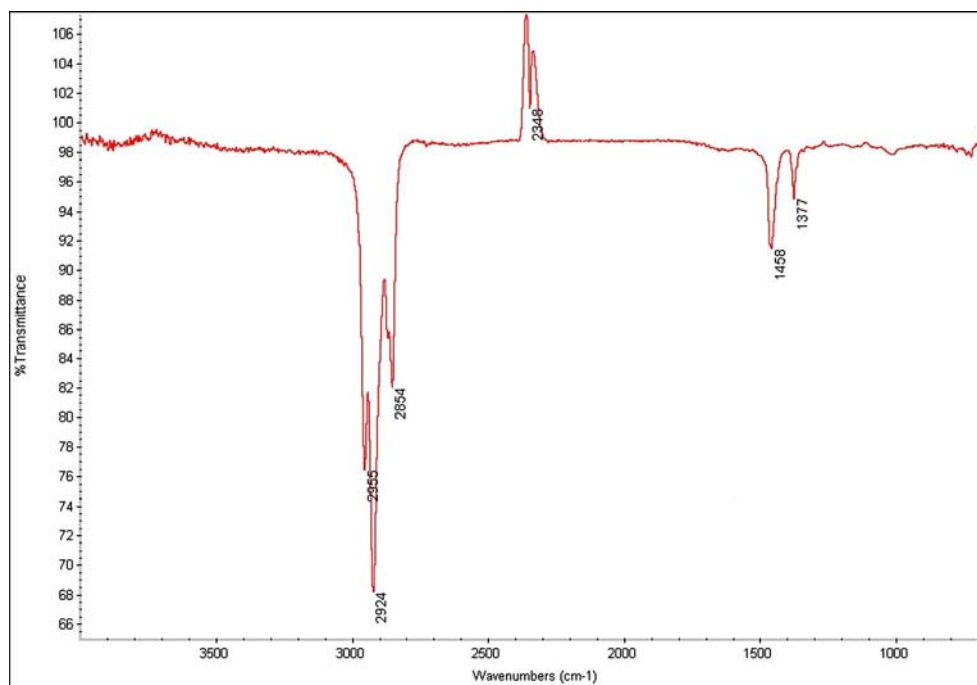
**Figure 38. FTIR of Jelly-Like Debris**

The FTIR scan only shows carbon and hydrogen peaks.
