## Fiber-Optic Strain Monitoring on a Navy Cruiser

**Introduction:** A number of CG class vessels in the U.S. Navy are experiencing cracking at various locations on the aluminum superstructure. The cracking has been observed on the 04 level deckplate, the overhead of one of the AN/SPG-62 Illuminator (radar) rooms, the intake bulkhead, and several other locations on one particular class of vessel.<sup>1,2</sup> The cracking is, in many cases, persistent, recurrent (even after repairs), and has the potential to influence mission critical operations aboard ships.

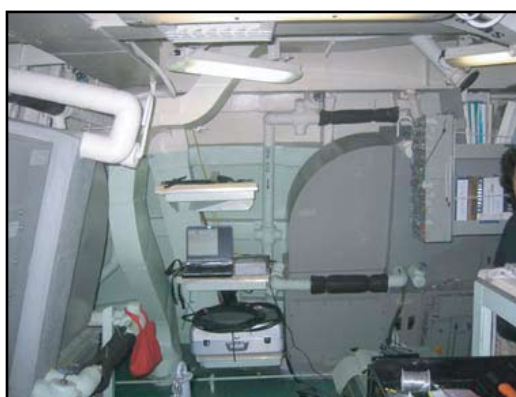
FBG sensors, were used to monitor the principal strains experienced by the deck plate. Figure (7(a)) shows the inside of the radar room and the sensing equipment used to record the strain data while Fig. (7(b)) shows the locations of the strain rosettes.

(a) The computer and demodulation hardware are located on the middle shelf in the back corner of the radar room. (b) The overhead directly above the shelves is where the gratings were located. The four FBG rosettes (A, B, C, and D) are shown with most of the insulation replaced.

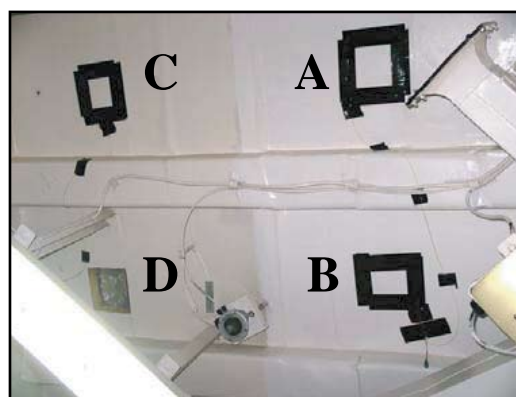
(b)

The sensing system was installed during a single day on May 15, 2007. Four fiber Bragg grating (FBG) rosettes (referred to as A, B, C, and D in this article) were installed in the overhead of #4 Radar (05-316-0-C) where the ship had previously experienced cracking. This space houses mission-critical equipment (both communications and weapons) and was therefore deemed an ideal candidate for monitoring. Additionally, this particular location allowed for the simplest, most unintrusive installation of all potential areas surveyed. The FBG strain rosettes, each consisting of three

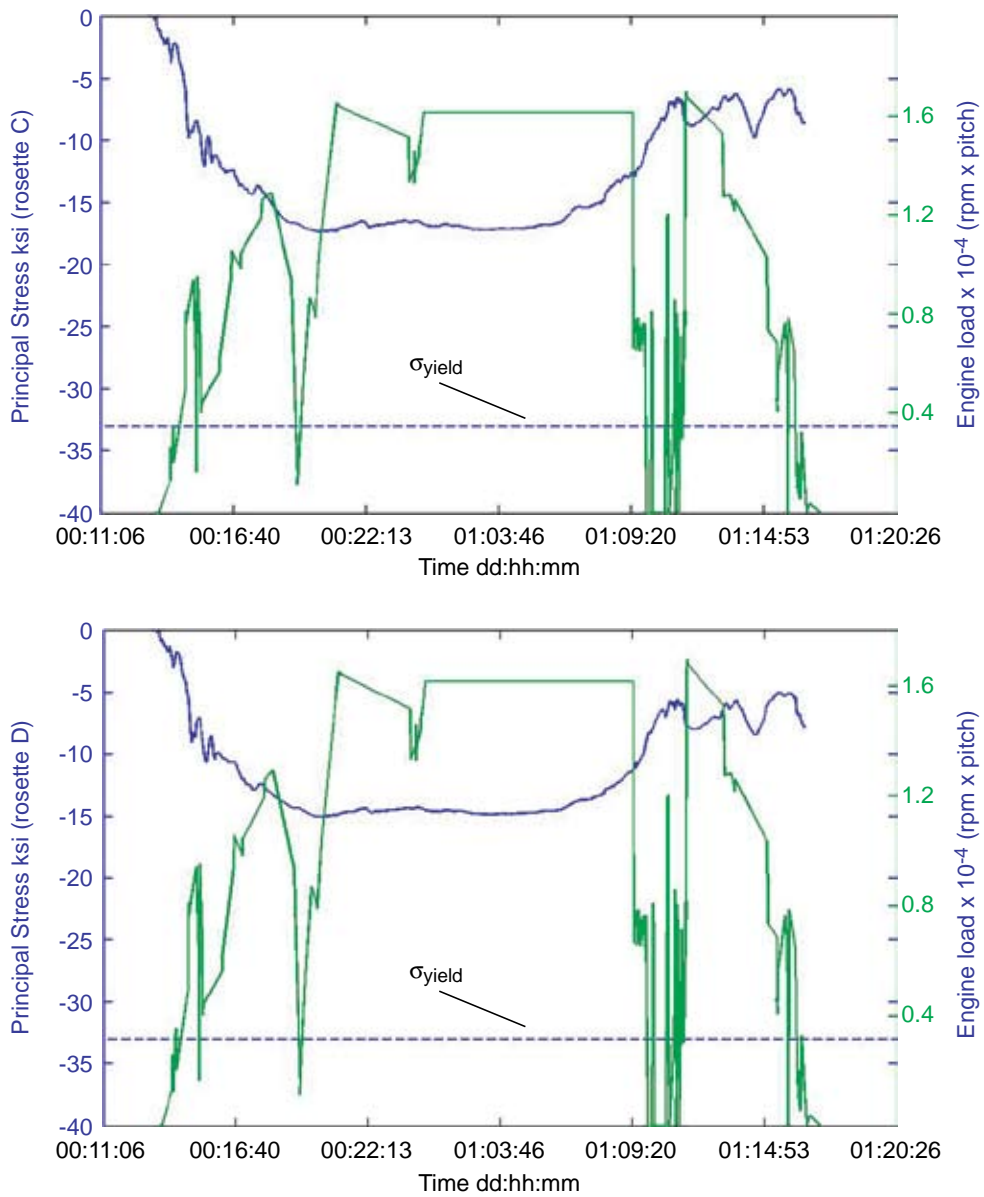
**Deck Plate Response to Ship Maneuvers:** Figure 8 shows plots of the principal stresses vs time for rosettes C and D (see again Fig. 7 for rosette placement). In this figure, note that the measured stresses are all compressive, with the largest magnitudes beginning about 2000 hours and ending near 0600 the next morning. Also plotted is a measure of engine load (shaft rpm  $\times$  pitch). The data shows a strong correlation between engine load and deckplate compressive stress. As the ship picks up speed, the stress observed in the deckplate tends to increase. This may be due to thermal loading from the engine transferring to and stabilizing in the ship structure or perhaps direct structural loading resulting from drag created by speed increases. Engine load appears to be one of the primary mechanisms causing excessive stress in the deckplate. Also plotted in Fig. 8 is the yield stress for the deckplate material,  $\sigma_{\text{yield}}$ . The observed strain variations are 50% yield of the base metal.

**Conclusions and Recommendations:** The data collection from this particular ship was largely successful and resulted in some preliminary results that are useful in understanding the cause of the recurring deck cracking. First of all, the primary source of strain on the deckplate cannot be attributed to ship maneuvers or slewing of the AN/SPG-62 Illuminator. Neither action resulted in more than  $10 \mu\epsilon$  of load. Secondly, the primary strain does not appear to be the result of thermal affects. Rather there exists a large compressive load, correlated with engine speed, that forms in the deckplate as the ship gets under way.

**FIGURE 8**  
Principal stresses recorded during the trip from rosettes C and D. Also shown is the yield stress for the deck material. Note that the largest stresses began near sunset on 6/7/07 and ended about sunrise on 6/8/07. Stress correlates well with engine load.

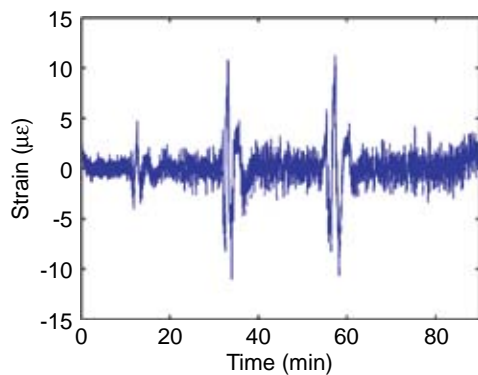
A series of turns was performed at varying speeds to determine the influence of ship maneuvers on the deck strains. Beginning at approximately 19:24, the ship's speed was reduced to 8 knots. The speed was then slowly increased to 20 knots over the course of the next 45 min. At 20:11, moving at 20 knots, the ship performed a sharp right turn ("hard rudder right"), followed by a hard left turn, followed by another hard right turn. The entire sequence lasted approximately 5 minutes. The ship's speed was then increased to 27 knots and the same sequence of turns was conducted. Finally, the ship's speed was set in excess of 27 knots and the sequence repeated once more. This final set of turns was completed at 21:00. Figure 9 displays the sequence of data recorded during maneuvers. The time axis shown in Fig. 9 is shown relative to the beginning of the maneuvers. Several observations can be made regarding the deckplate response to high speed turns. First and foremost, the maximum strains observed due

to the ship maneuvers were roughly  $\pm 10 \mu\epsilon$ . These values are extremely small and are not likely to be the cause of any significant structural damage. Although the magnitudes of the strain values do increase with speed, the ship will not likely see maximum knots for prolonged periods, thus hard turns at speed are not an issue in deckplate cracking.

**FIGURE 9**  
Sensor data recorded from sensor 3 of rosette C showing the strain values recorded during a series of hard turns at high speed.
