ASC-TR-2010-5002

THREATS TO AIRCRAFT STRUCTURAL SAFETY, INCLUDING A COMPENDIUM OF SELECTED STRUCTURAL ACCIDENTS / INCIDENTS

**Engineering Directorate (ASC/EN)
Aeronautical Systems Center**

**MARCH 2010
Final Report**

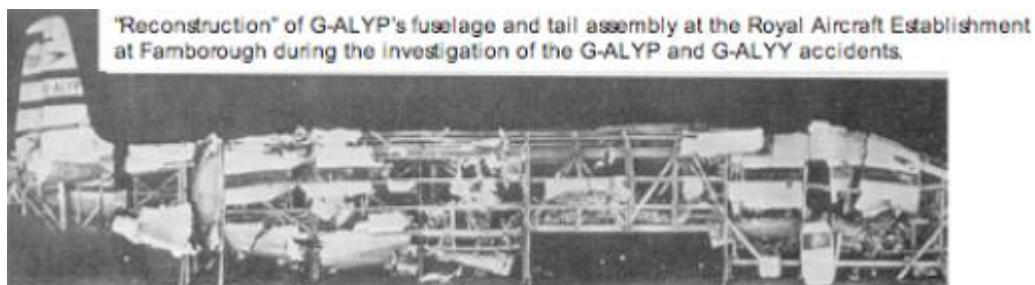
Figure A2: Photo of Comet (G-ALYP) Reconstruction of Fuselage and Tail Units at Royal Aircraft Establishment at Farnborough during the Investigation of Accidents [A2]

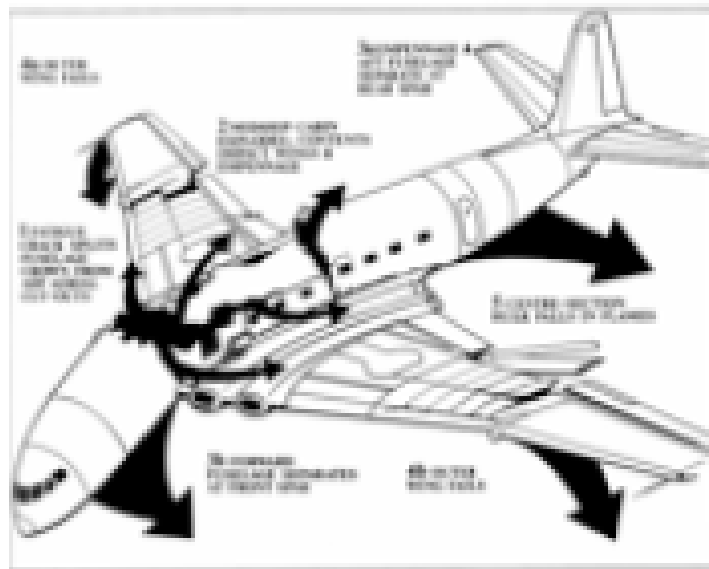
According to Swift [A3], the origin was believed to be at the end fastener hole at a frame cut-out adjacent to the ADF window. Swift has provided a detailed analysis, which describes the loss in residual strength with crack progression and the reason for the lack of crack arrest and fail-safe capability [A3-A5].

Figure A3: Uncontained Running Cracks Led to Aircraft Breakup. Poor Detail Design of Cutouts Led to Running Cracks in the Highly Stressed Low Toughness Skin

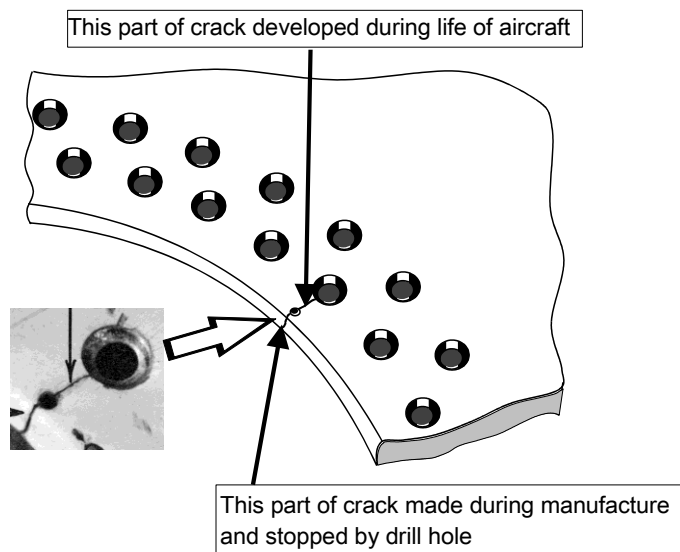
During the reconstruction of G-ALYP, a pre-existing manufacturing crack or tear was found at the edge of the ADF window cut-out (See Figure A4). This crack had been stop-drilled, which was the accepted repair practice at that time. Several other locations in this aircraft had similar kinds of manufactured cracks or tears that had also been stop-drilled in the factory [A4].

-VI-3. Crack and Drill Hole in Reinforcing Plate at Starboard Rear Corner of Front ADF Aerial Window Comet G-ALYP

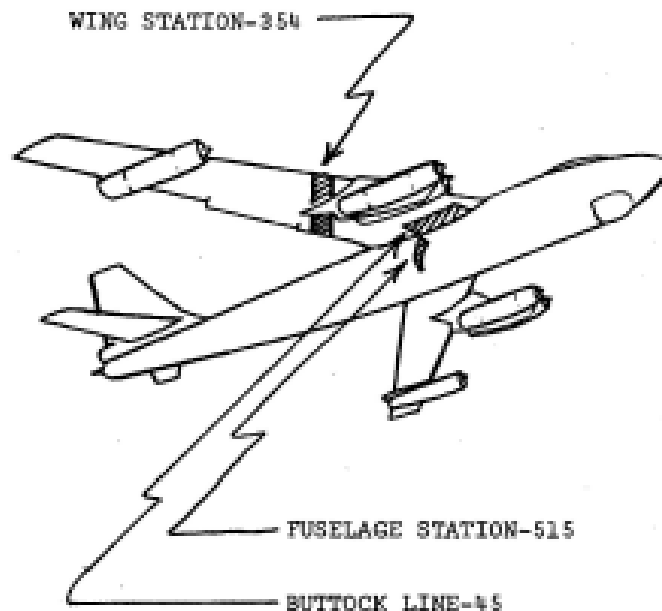
A structural crisis was reached within the USAF Strategic Air Command on 13 March 1958, when two aircraft broke up in midair in separate incidents. Near Homestead Air Force Base, Florida, a B-47B disintegrated at 15,000 feet, three minutes after takeoff. Its center wing section failed due to fatigue cracking at buttock line 45. The aircraft had a total of 2,077 hours at the time of the accident. See Figure A11 for the critical locations on the B-47.

Figure A11: Sketch Illustrating Critical Locations of the B-47 Aircraft

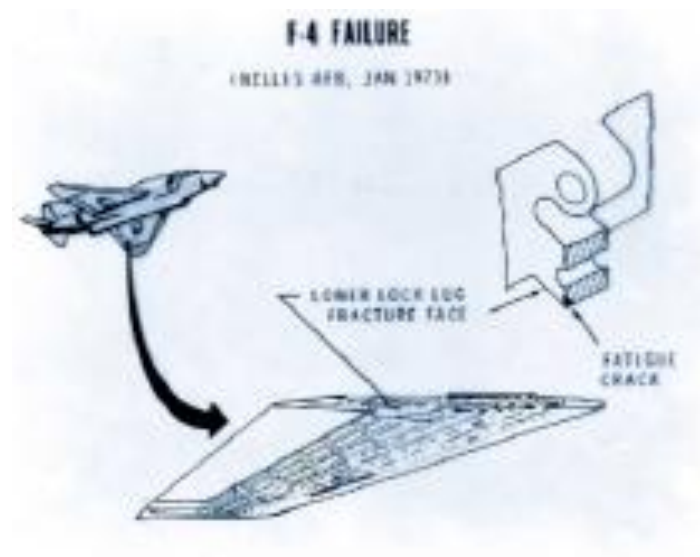
This failure is an example of multiple element damage (MED) overcoming the limited fail-safety associated with the wing fold lugs. The possible contribution of deficient manufacturing quality to this failure was never defined.

Figure A13: Sketch of F-4 Aircraft Illustrating Location of Failure

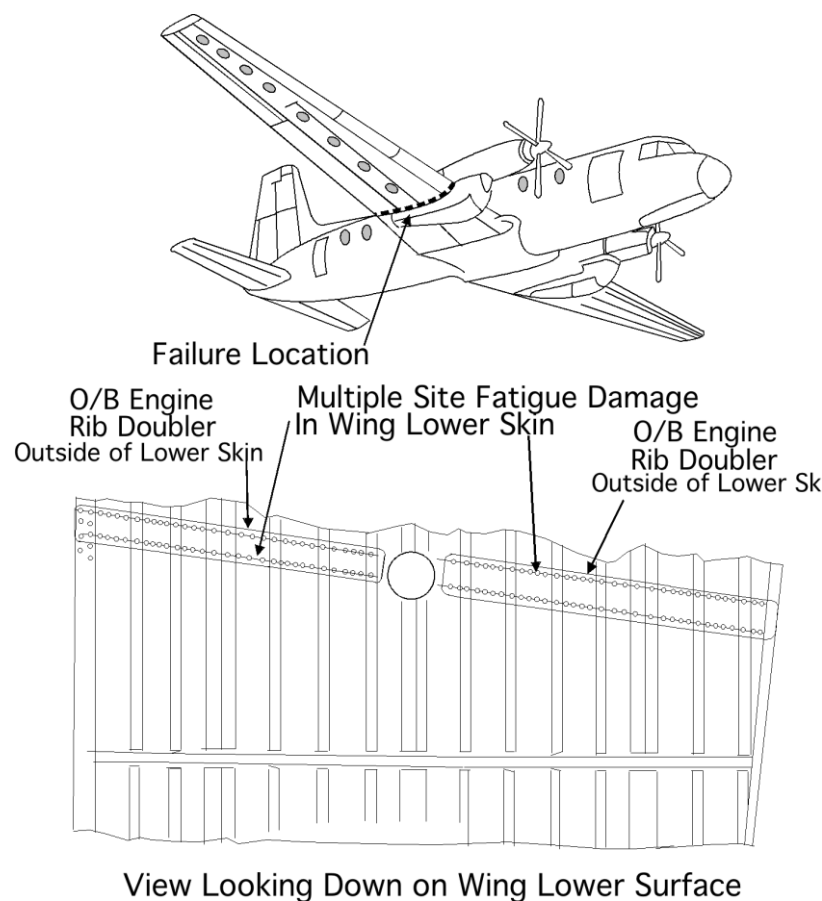
Figure A16: Sketch of AVRO 748 Aircraft Illustrating Failure Location

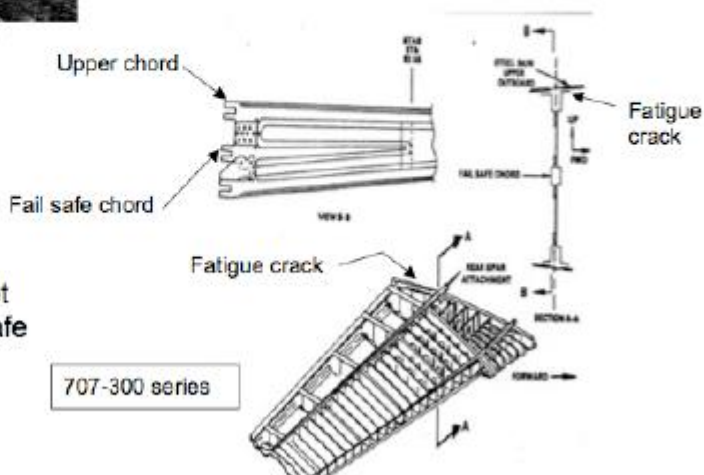
Upper spar chord fracture not
Found prior to failure of Fail safe
chord and loss of aircraft

Figure A18: Photo of Right Horizontal Stabilizer that Separated from B-707-321C Aircraft and Details of “Fail-Safe” Structure Associated with the Accident

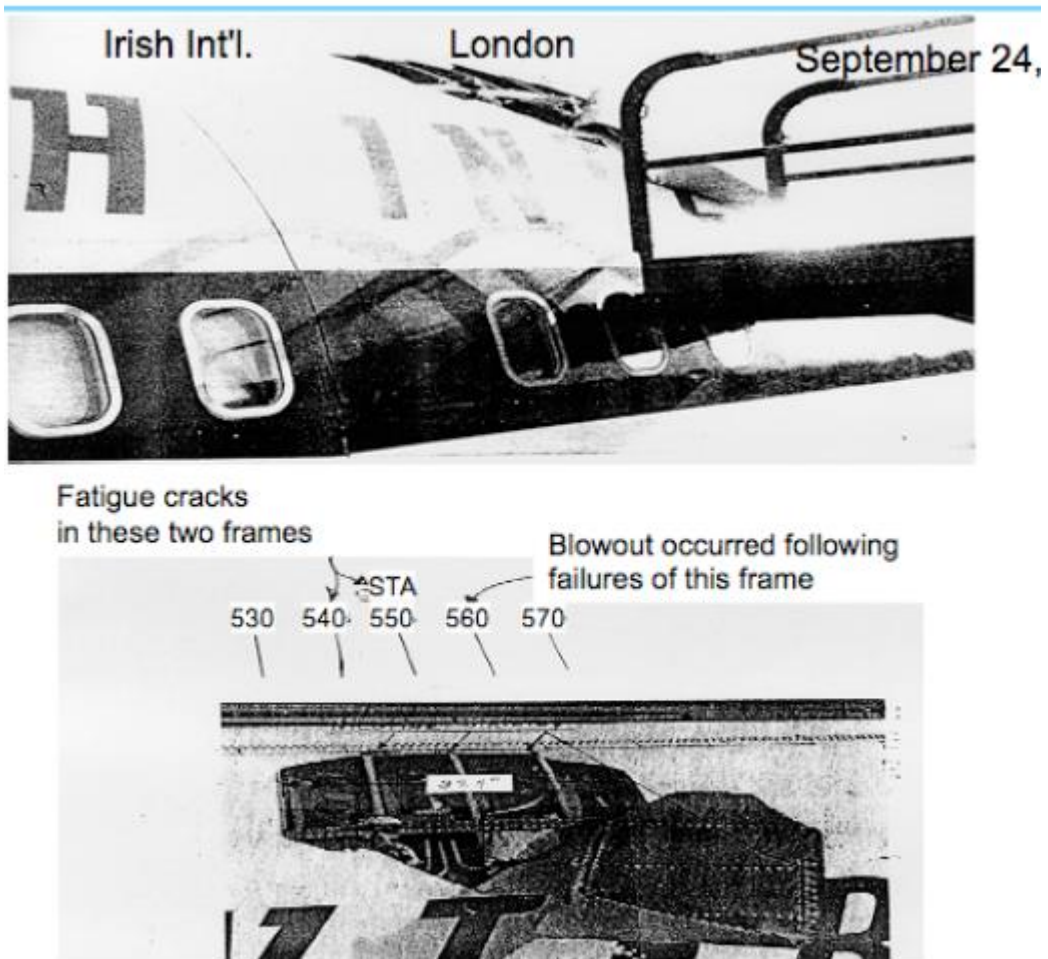
The location of the failure was in the main deck cargo door with frame failure and skin cracking along the upper hinge line. Note that the frame spacing in the cargo door is 10 inches rather than the normal 20 inch spacing throughout the rest of the fuselage. It is believed that the frame cracking occurred first followed by the skin cracking and the blowout. While the specific cause of the frame fatigue failures and skin cracking was not identified, it is expected that unanticipated high local frame stresses was the primary factor. It is not known whether or not there was any manufacturing or maintenance damage present. The main deck cargo door apparently was not included in the hydro fatigue test that was performed in the 1950s; thus, this critical area was not identified by the test. A photograph of the damage is shown in Figure A20.

Figure A20: Photo of Section of Boeing 707-300 Aircraft Lost Due to Fatigue Failure

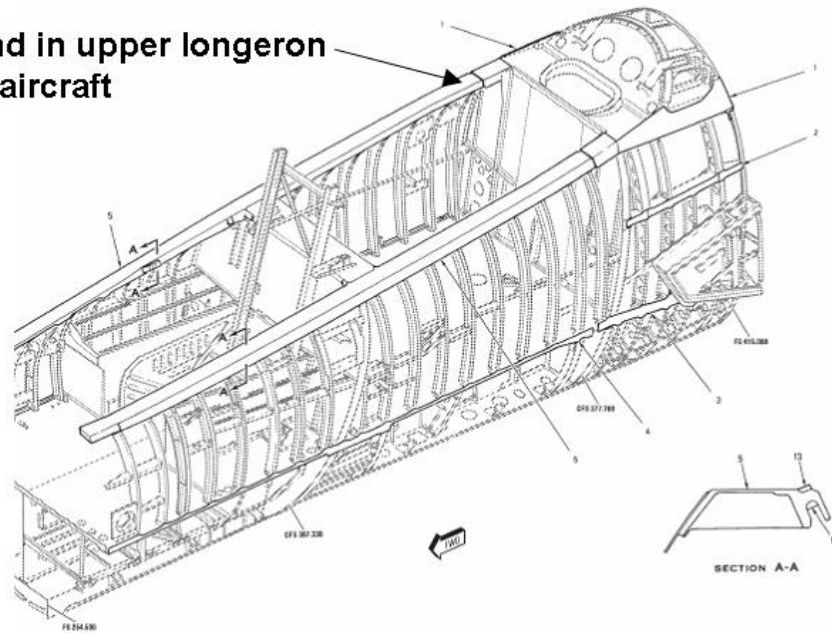
**Crack found in upper longeron
of mishap aircraft**

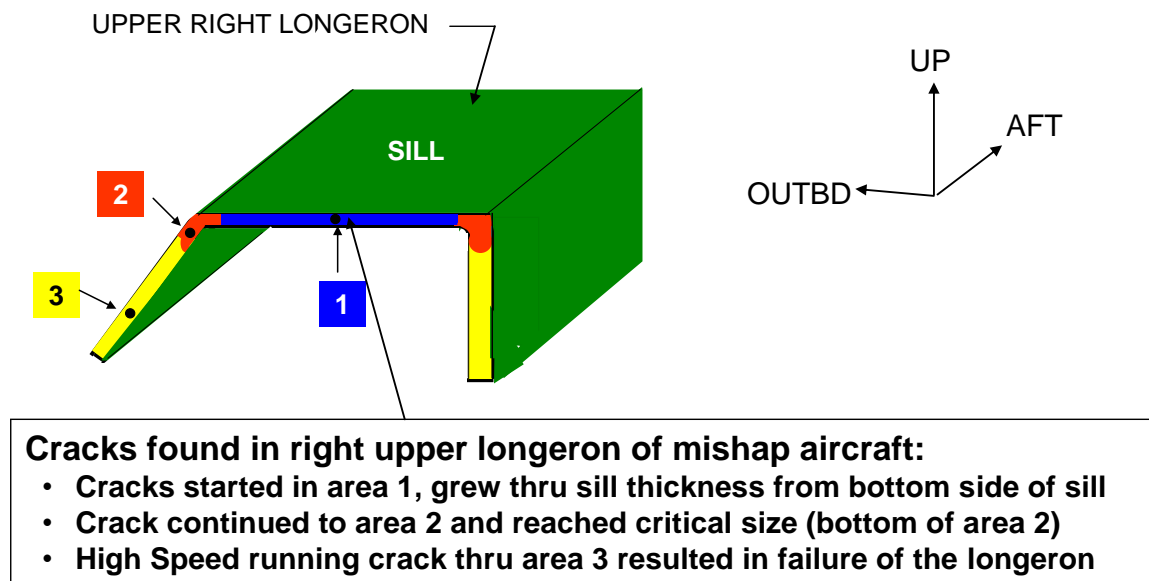
Based on the AIB report [A24], it appears that the fatigue cracking and failure are due to high stresses that were the result of poor workmanship and quality control (i.e., inadequate receiving inspection of fracture critical parts that were improperly manufactured and inspected by a subcontractor). This failure demonstrates the vulnerability of single load path (i.e., non fail-safe) structures to manufacturing discrepancies and emphasizes the importance of developing and enforcing rigid fracture control procedures (including factory inspections to ensure conformation to blueprint and in-service damage tolerance based inspections) on those parts where fail-safe designs are not practical.

Figure A24: Cracking Events Occurring in the F-15C Forward Fuselage Upper Longeron at FS377

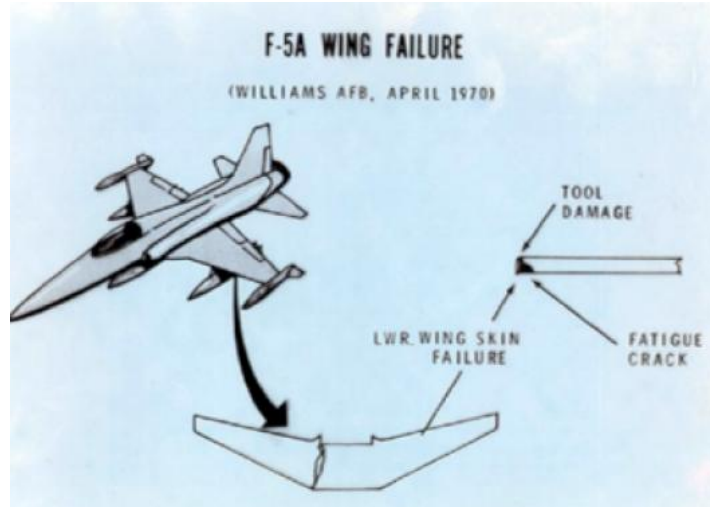
Figure B1 illustrates two T-38 aircraft; the T-38 aircraft is the two seat trainer version of Northrop's F-5 fighter. The sketch shown in Figure B2 depicts the failure of an F-5 at Williams AFB, which originated at a tool gouge in a radius of the single piece, 0.42-inch thick wing plank. The critical crack length of the fatigue crack was about 0.20-inches. A photo of the failure origin is shown in Figure B3. As a result of this failure a damage tolerance assessment was performed and damage tolerance inspection requirements established; however, these inspections were not completely successful in that additional catastrophic wing failures occurred at Randolph AFB and in PACAF in the mid 1970's. The final solution to this problem was a wing redesign to substantially reduce the stress levels, incorporate a tougher aluminum alloy and cold working of the fastener holes [B1, B2].

Figure B2: Identification of Tool Damage Location and Resulting Wing Separation Point

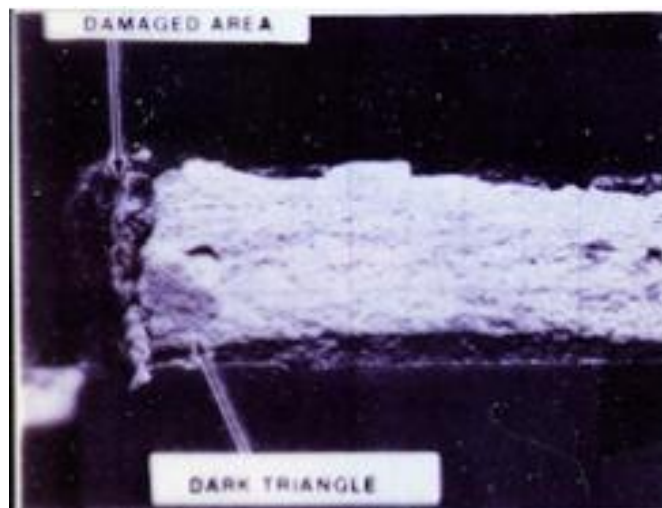
Figure B3: Tool Damage Led to Early Fatigue Cracking and Resulting Failure of the Monolithic Wing

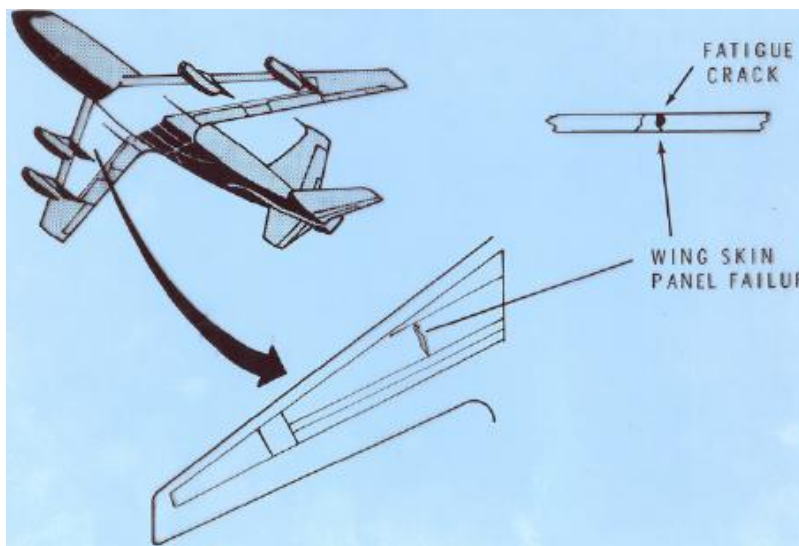
3. All of these failures were readily detectable or malfunction evident. Most were discovered post flight as result of fuel leakage.
4. An example of one such panel failure that occurred in 1972 at Fairchild AFB is illustrated in Figure B5. A picture of the failure origin is shown in Figure B6. Note that the fatigue crack was still underneath the countersink, when it attained its critical size and caused the panel failure.

Figure B5: Illustration Shows Location of Fatigue Crack Resulting in a 28-inch Panel Failure in Lower Surface of a KC-135 Wing (Fairchild AFB, February 1971)

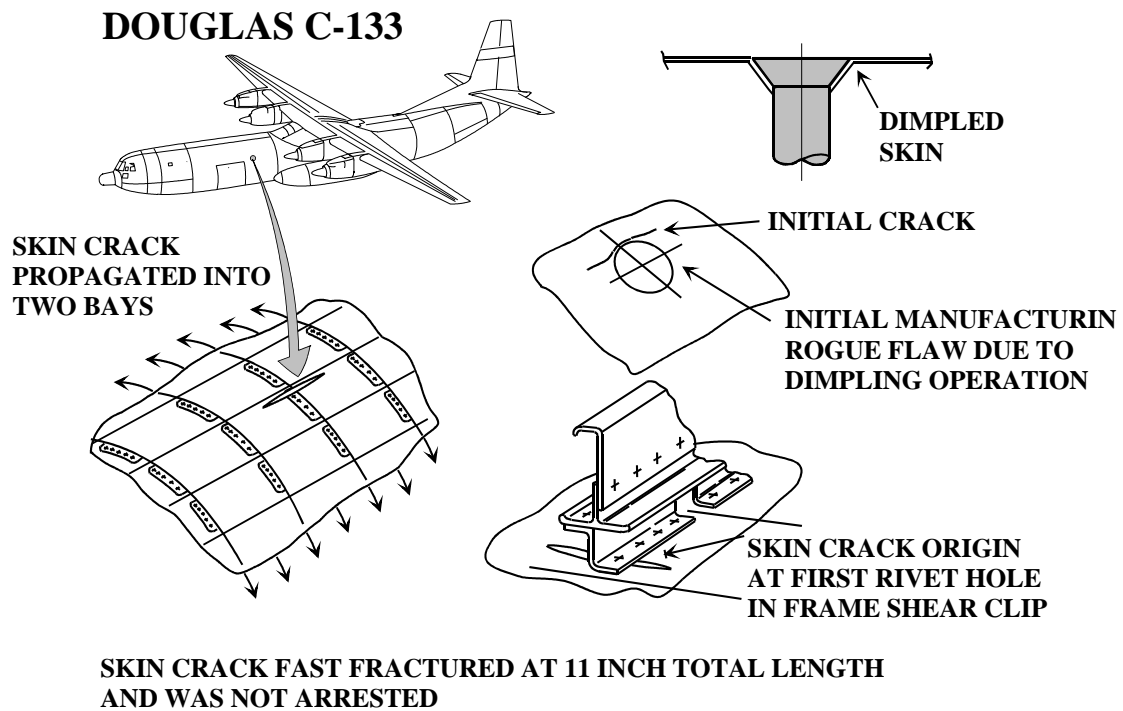
The fasteners were countersunk into dimpled skin. The crack that propagated to failure grew from a manufacturing flaw caused by the dimpling operation. A C-133 was successfully full-scale fatigue tested to 38,000 simulated flight hours. The high time airplane at the time of the accident had accumulated 16,000 flight hours. A Douglas Aircraft team designed a crack arresting system, so as to achieve fail-safety in the remaining C-133 fleet. A sketch of the initial manufacturing flaw and subsequent fatigue crack is shown in Figure B8.

Figure B8: Details of the Cracking that Led to Failure of C-133 Transport Aircraft

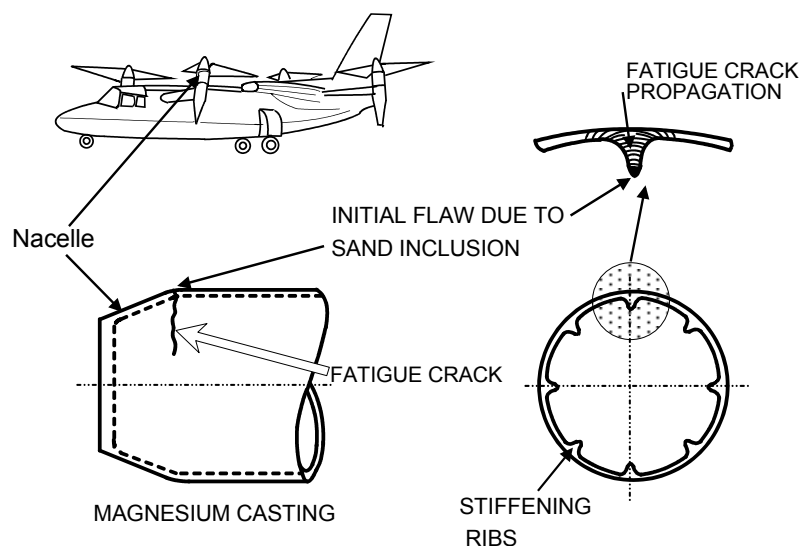
The Curtis Wright X-19 VTOL Experimental Aircraft, a tri-service research project, crashed during a flight test at the FAA Test Center in Atlantic City New Jersey in mid 1965. The aircraft crashed after a propeller nacelle magnesium casting failure. The cause of the crash was a manufacturing defect in the magnesium sand casting used in the propeller nacelle. This material flaw was a sand inclusion at the tip of one of the stiffening ribs in the most highly loaded location of the nacelle structure. Some of the details of this flaw are illustrated in Figure B10 [B5, B7].

Figure B10: Sketch of Flaw Details Associated with X-19 Aircraft Accident

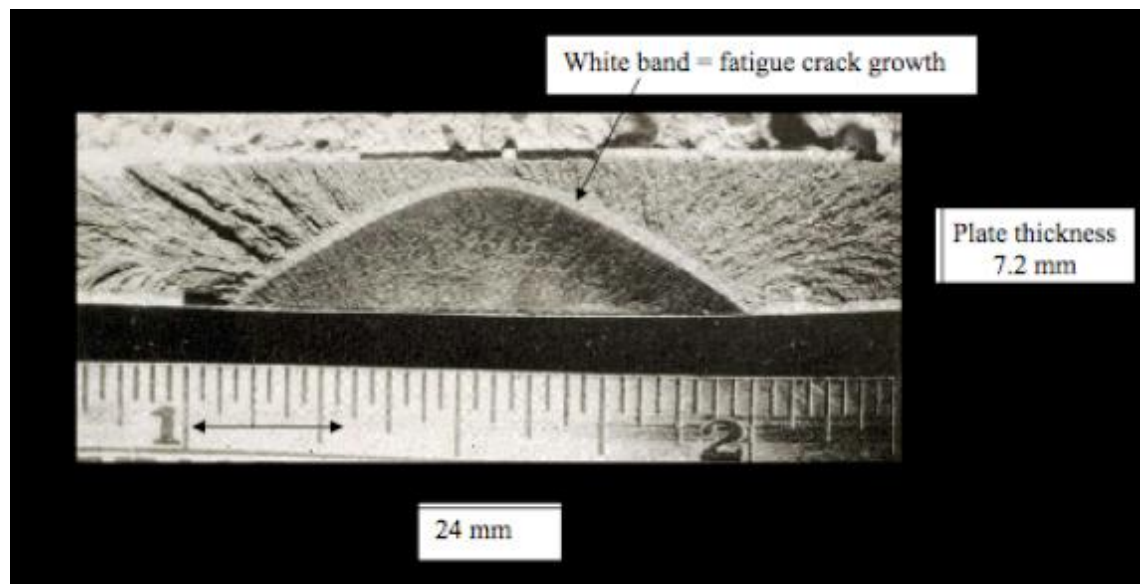
Figure B12: Photo Illustrating Forging Flaw and Subsequent Fatigue Crack that Caused the Failure of F-111 Aircraft after 105 Hours of Flight Time

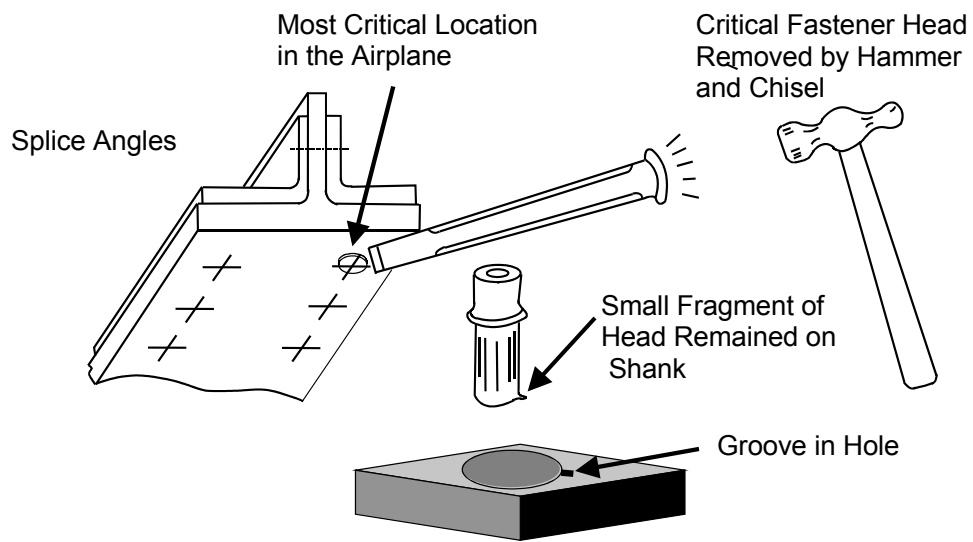
A Beech 99 commuter aircraft with a single spar wing was being maintained. During this maintenance a fastener was removed by knocking the head off with a hammer and chisel as illustrated in Figure C2. This action left a sharp fragment of the head on the shank of the fastener, which gouged the side of the fastener hole as the fastener was being driven out. The spar was re-assembled without removing the groove and the aircraft was returned to service. During a routine inspection, 2100 flight hours later in July 1990, a fatigue crack was found that had nucleated at the groove and propagated to the edge of the flange as shown in the photo in Figure C3. A limit load application would have failed the wing. The spar had a 10,000 hour fatigue life limit based on the most critical fastener hole in the spar cap. The gouge in the side of the hole is clearly a *“maintenance defect”*[C1].

Figure C2: Details of Maintenance Action that Led to Damage

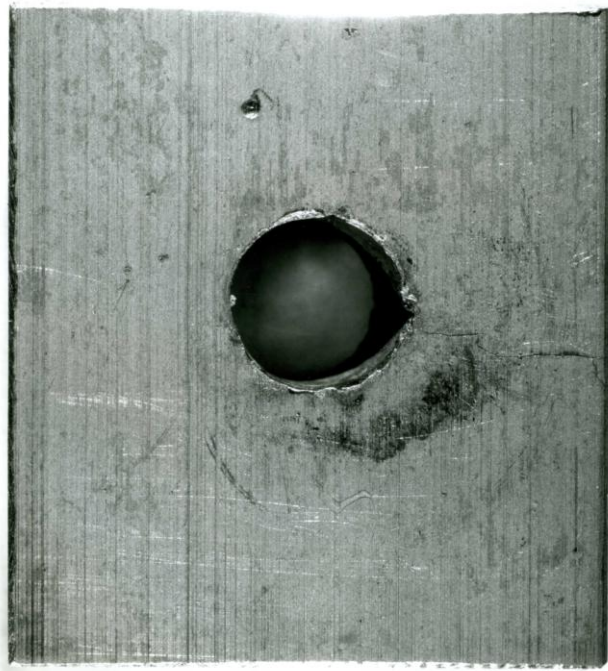
Figure C3: Photo of Damaged Hole and Cracked Spar Cap

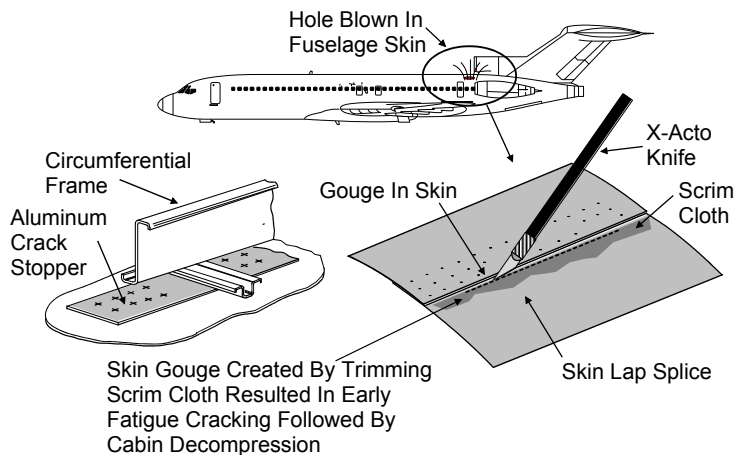
The second example concerns an Eastern Airlines 727 that suffered sudden cabin decompression caused by fatigue cracking induced by the X-Acto knife maintenance induced damage as shown in Figure C5. The rivets in the lap splice had been removed to clean out corrosion in the splice. Cold cure adhesive tape had been replaced and the excess tape trimmed off with an X-ACTO knife. The knife created a sharp gouge in the skin that became sites for the nucleation of fatigue cracks. Separate fatigue cracks linked together to form a long crack which eventually fast fractured and caused decompression. Fortunately, the fast fracture was successfully arrested by the aluminum crack stoppers located at the circumferential frames as shown in the sketch. The very large damage ‘crack arrest fail-safe’ capability designed into this fuselage saved this aircraft [C2, C3].

Figure C5: Maintenance Action that Led to Skin Failure by Fatigue

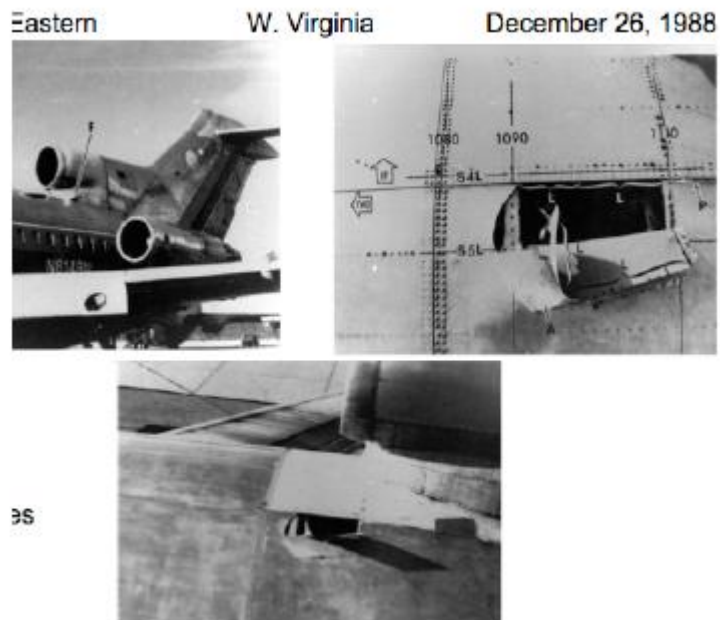
Photographs of the arrested damage are shown in Figure C6.

Figure C6: Photos Illustrating the Structural Damage Resulting from Fatigue Skin Failure

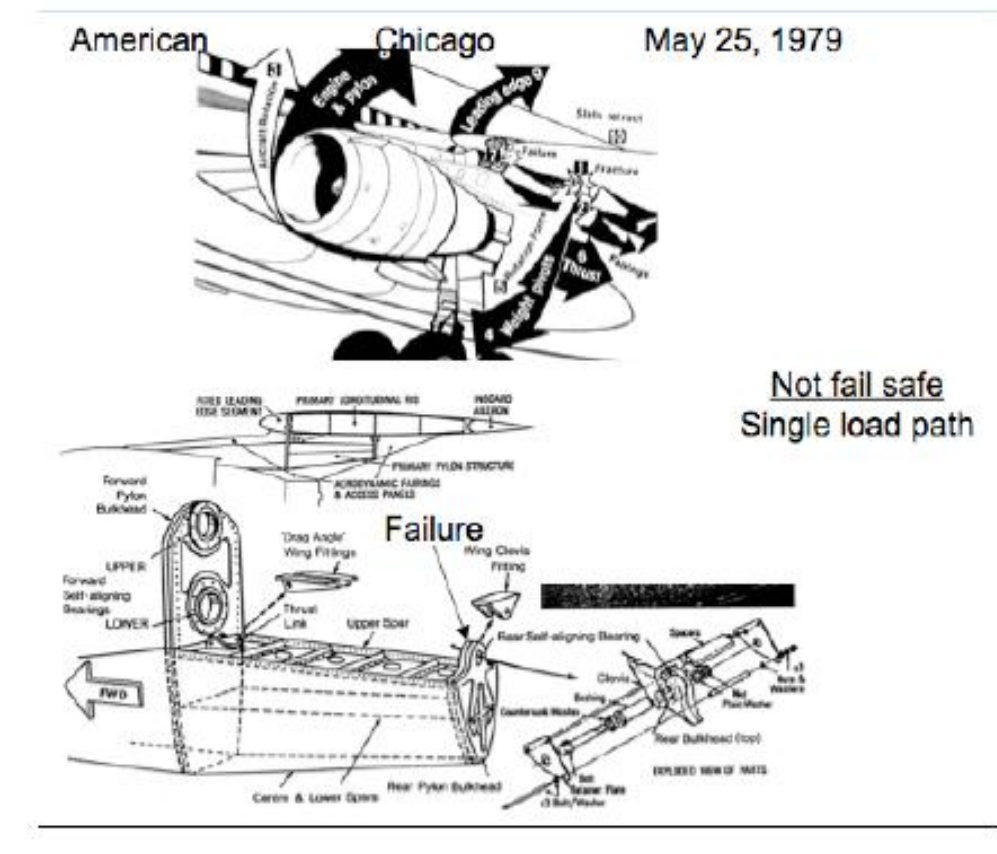
circumstances could result in very large impact loads at the rear bulkhead attachment point and inflict the type of damage observed. Inspection of other DC-10s where this expedited removal procedure was used revealed eight other aircraft with cracks ranging from 3 to 6-inches long. While the manufacturer, McDonnell-Douglas Aircraft, had designed the airplane including many areas of the pylons to be fail-safe, it was not fail-safe for this particular failure scenario. The rear bulkhead itself was split to achieve fail-safety, but the upper flange on the forward half of the bulkhead was a single load path, and when the upper flange failed, the loss of the pylon and engine ensued.

Figure C8: Diagrams Illustrating Nature and Result of the Maintenance Damage in the Cause of a DC-10 Pylon Failure

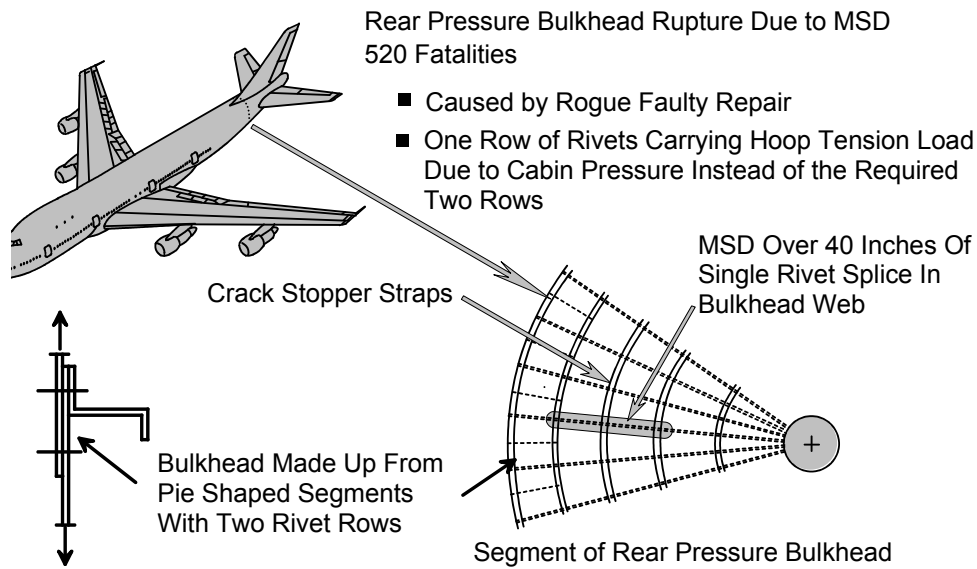
The rear pressure bulkhead of this aircraft had been damaged due to a tail strike in Osaka on June 16, 1978. At that time the aircraft had experienced 6516 pressurized flights. Boeing sent a maintenance team to Japan to conduct the repair. The domed bulkhead is made up of pie shaped pieces of 2024-T3 spliced together with two rows of rivets as shown in the sketch below. The lower half of the bulkhead was replaced due to damage. During the repair one row of the rivet holes had insufficient edge distance so a splice plate was installed over a 36-inch length of the bulkhead web as also shown in Figure C10 [C2, C7, C8].

Figure C10: Sketches of Location of Failure in 747SR Rear Pressure Bulkhead

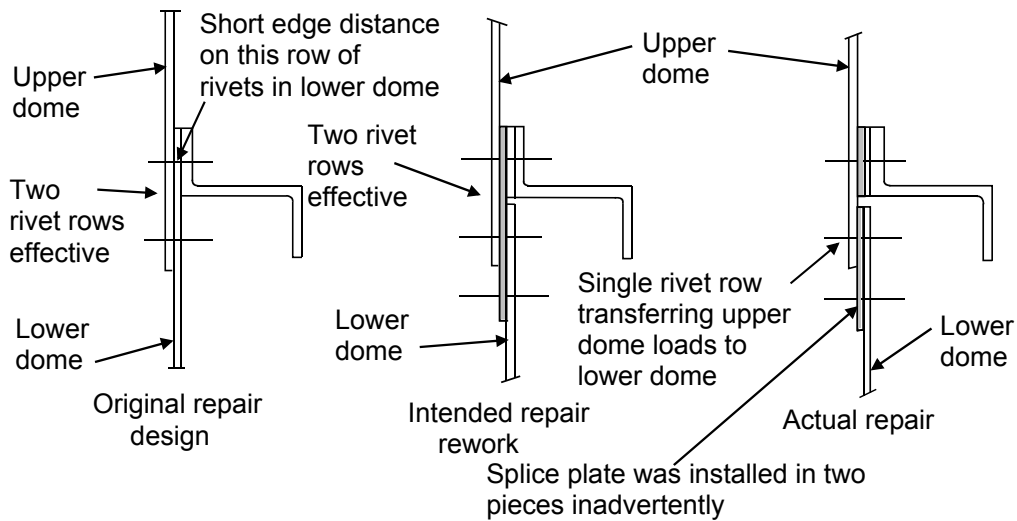
The splice plate was incorrectly installed in two pieces as shown in Figure C11 such that only one row of rivets was carrying load. Because of this overload, multi-site-damage initiated over a 40 inch length of the bulkhead web splice at the single row of rivets. The multi-site damage linked up into a critical crack, which did not arrest, because of the MSD, and caused the bulkhead to fail. Subsequent to this accident Boeing redesigned the bulkhead with heavier “super” tear straps.

Figure C11: Construction Details Associated with Initial and Repaired 747SR Rear Pressure Bulkhead

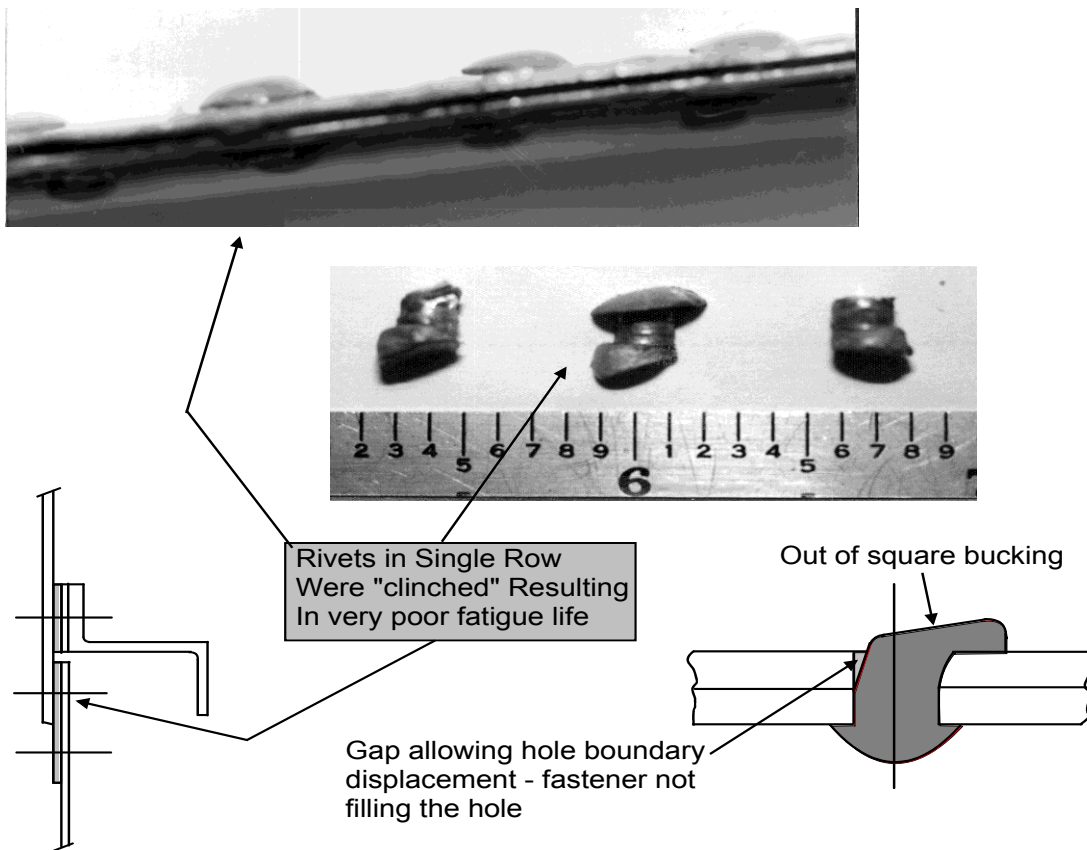
Figure C12: Photos Illustrating Rivet Damage on 747SR Rear Pressure Bulkhead

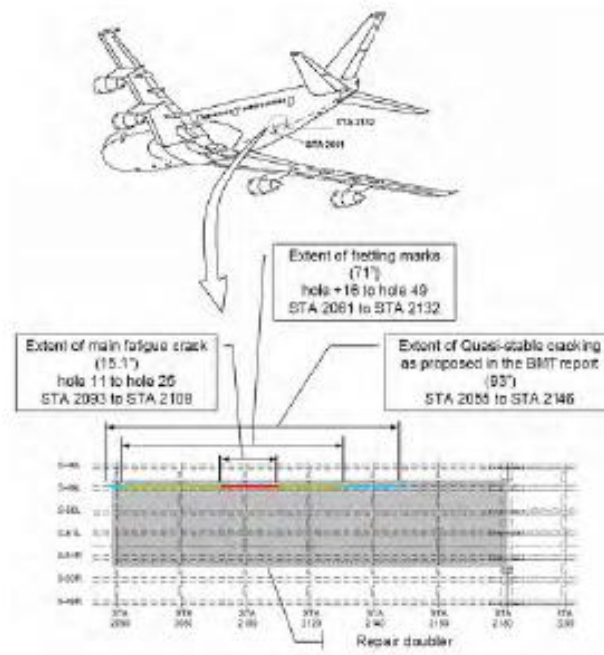
Figure C14: Crack Location under Edge of Repair Doubler [C9]

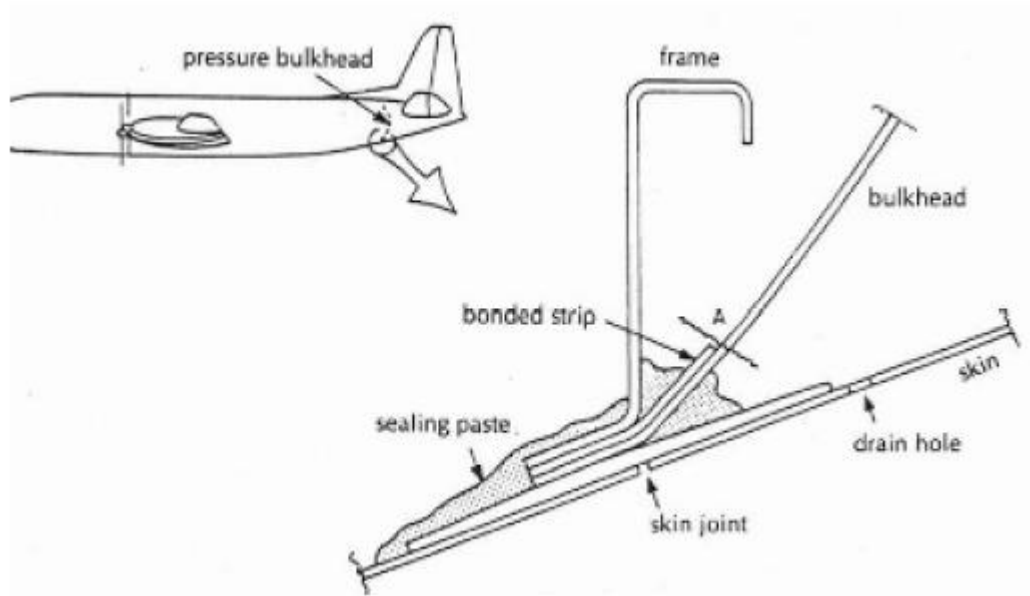
Figure D2: Sketch of Construction Details that Led to Corrosion and Subsequent Catastrophic Failure of the Vickers Vanguard 951 Aircraft

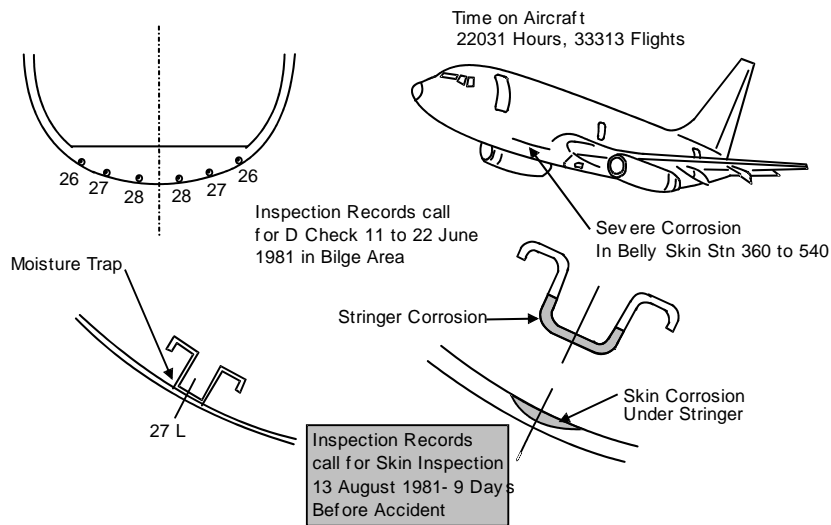
Figure D4: Sketches Illustrating the Locations and Causes of Corrosion on B737 Aircraft

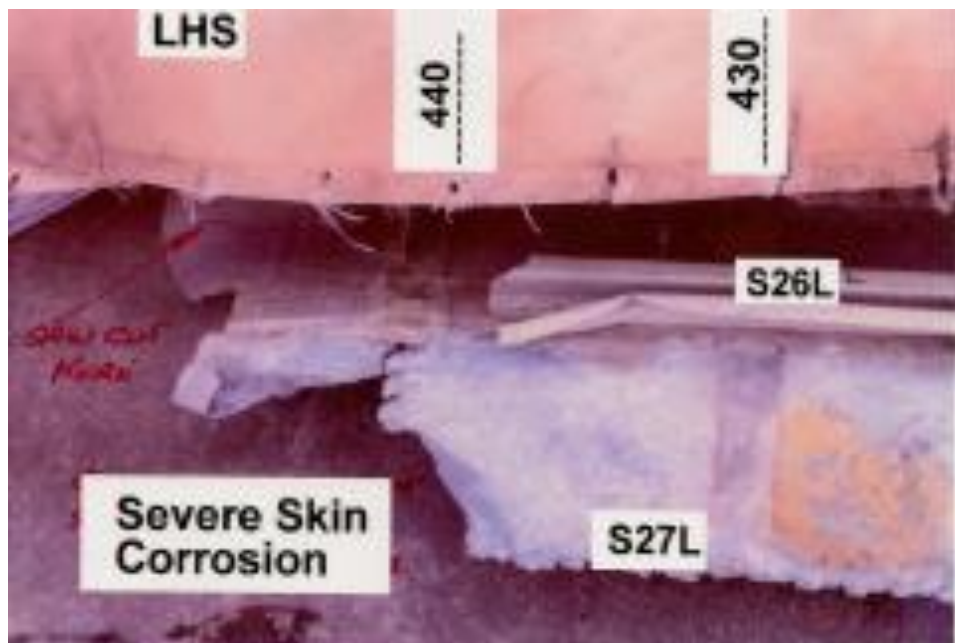
Figure D5: Photo of Skin Corrosion in Lower Lobe of B737 Aircraft

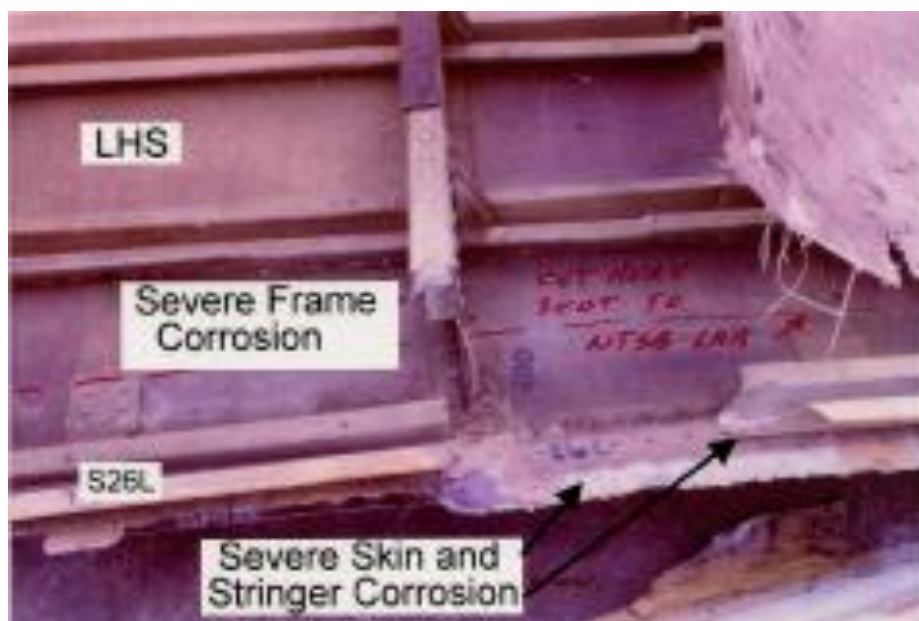
Figure D6: Photo Illustrating Loss of Frame and Stringer Due to Severe Corrosion

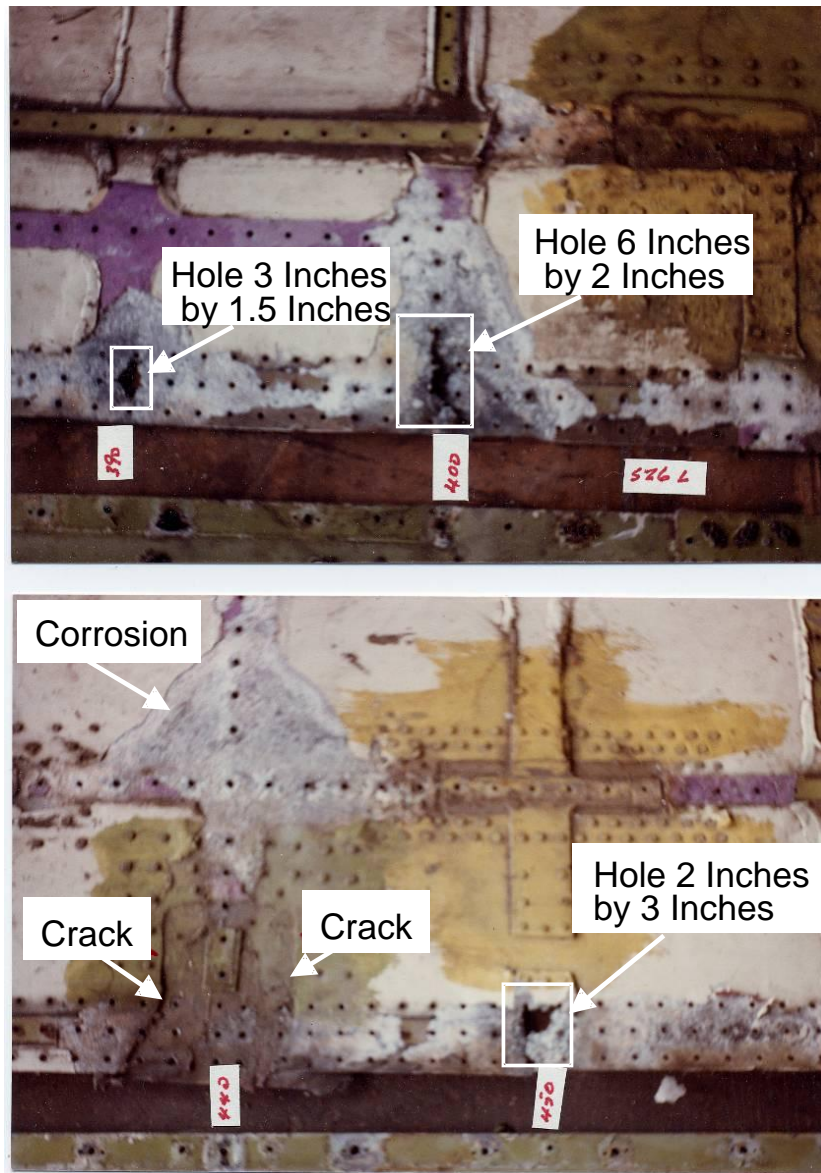
Figure D7: Photos Illustrating Severe Corrosion of FEAT B737 Aircraft

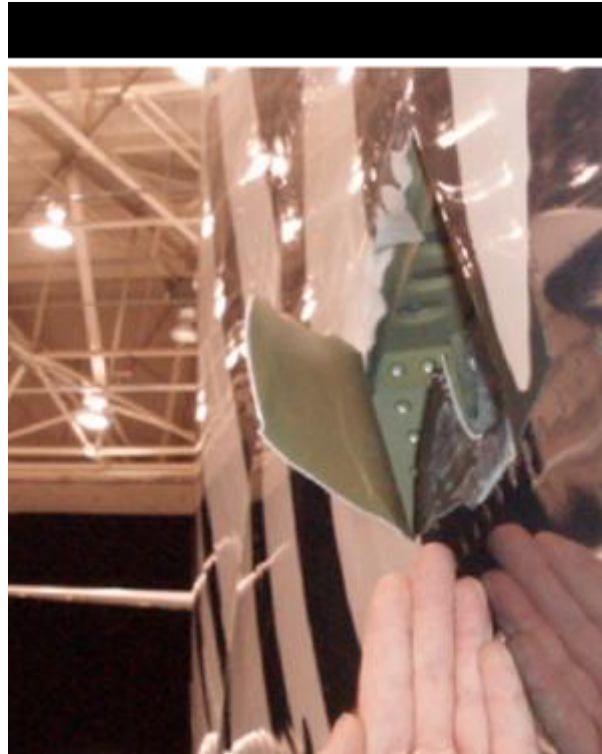
Figure E2: Photo of Skin Failure Following Ground Handling Damage

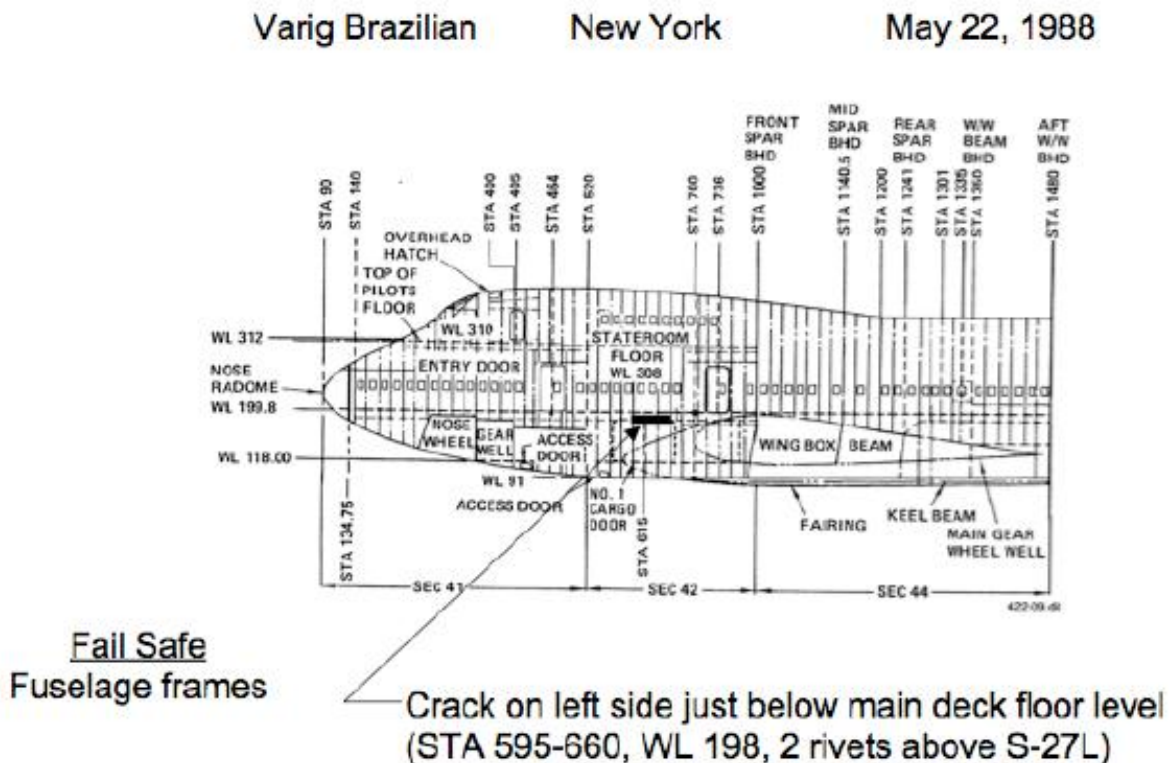
Figure E4: Sketch Illustrating Location of Handling Damage Induced Crack on the B`747 Aircraft

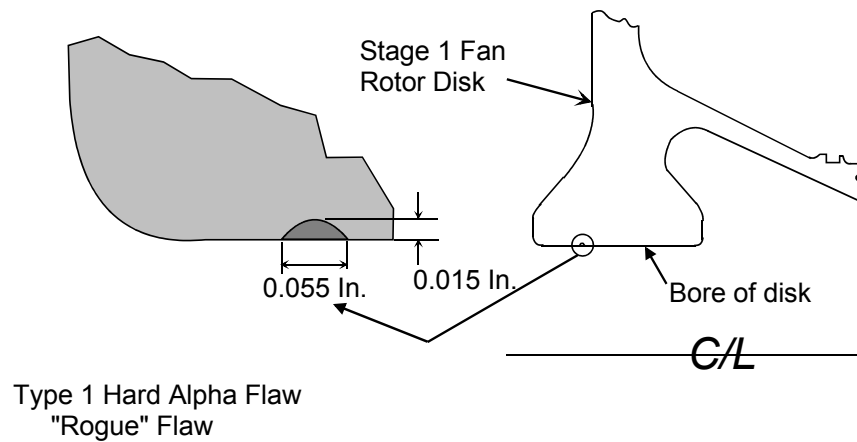
Sketch of Defect Size & Location

Figure F3: Sketch of General Electric Engine Defect Size and Location

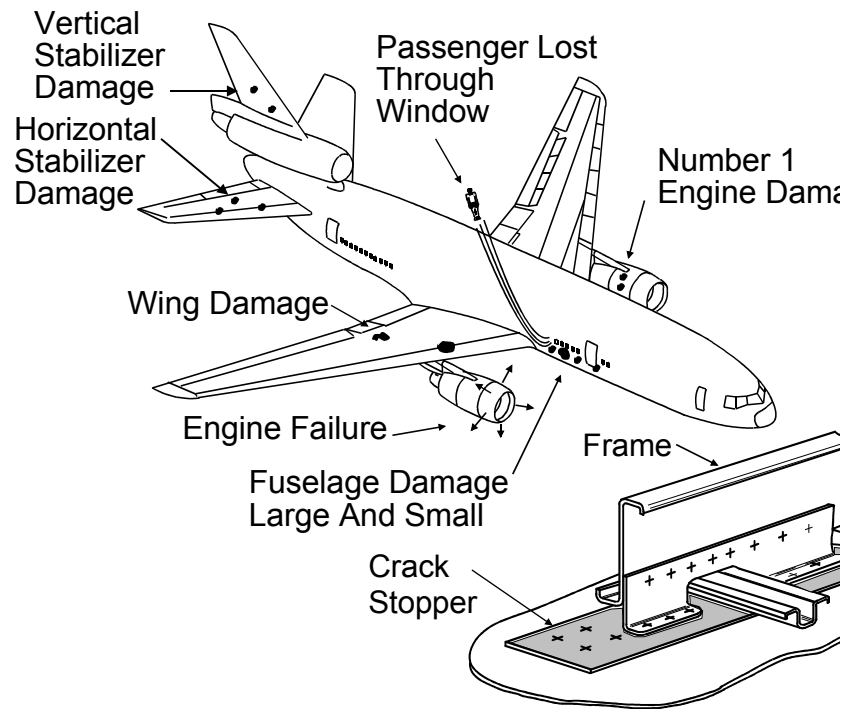
Figure F5: Sketch Illustrating Location of Fuselage Damage Due to an Uncontained Engine Failure and Construction Details

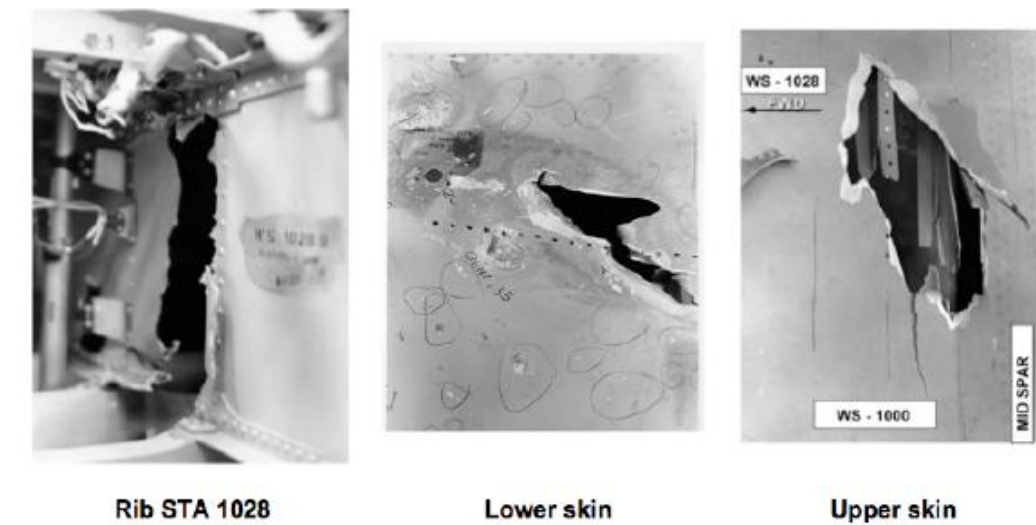
Figure F7: Photos of Wing Damage on the B747 Aircraft Caused By Engine Failure
