ASC-TR-2010-5002

THREATS TO AIRCRAFT STRUCTURAL SAFETY, INCLUDING A COMPENDIUM OF SELECTED STRUCTURAL ACCIDENTS / INCIDENTS

**Engineering Directorate (ASC/EN)
Aeronautical Systems Center**

**MARCH 2010
Final Report**

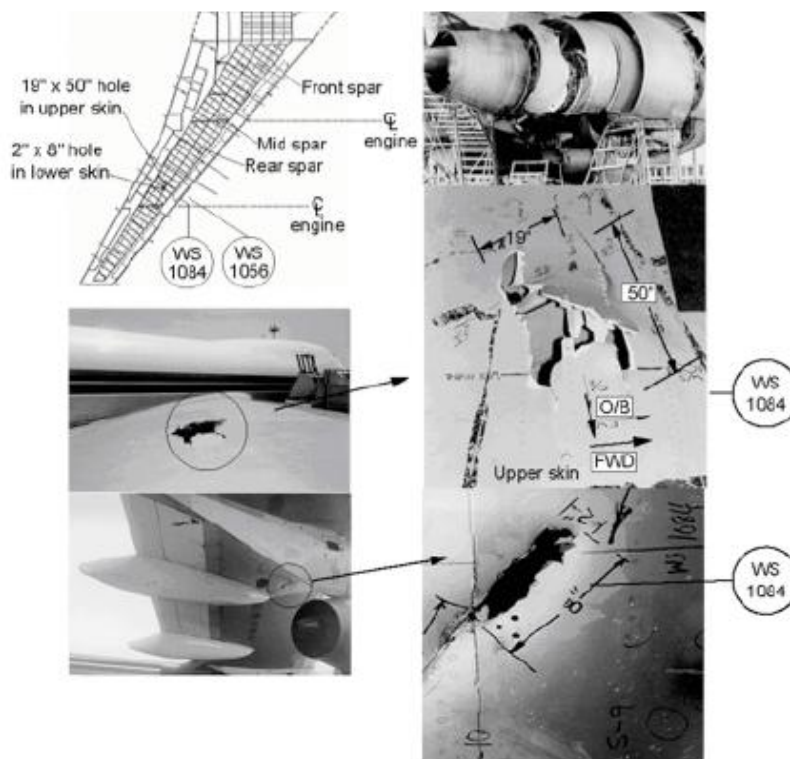
Figure F9: Photos of Wing Damage Caused by Engine Failure

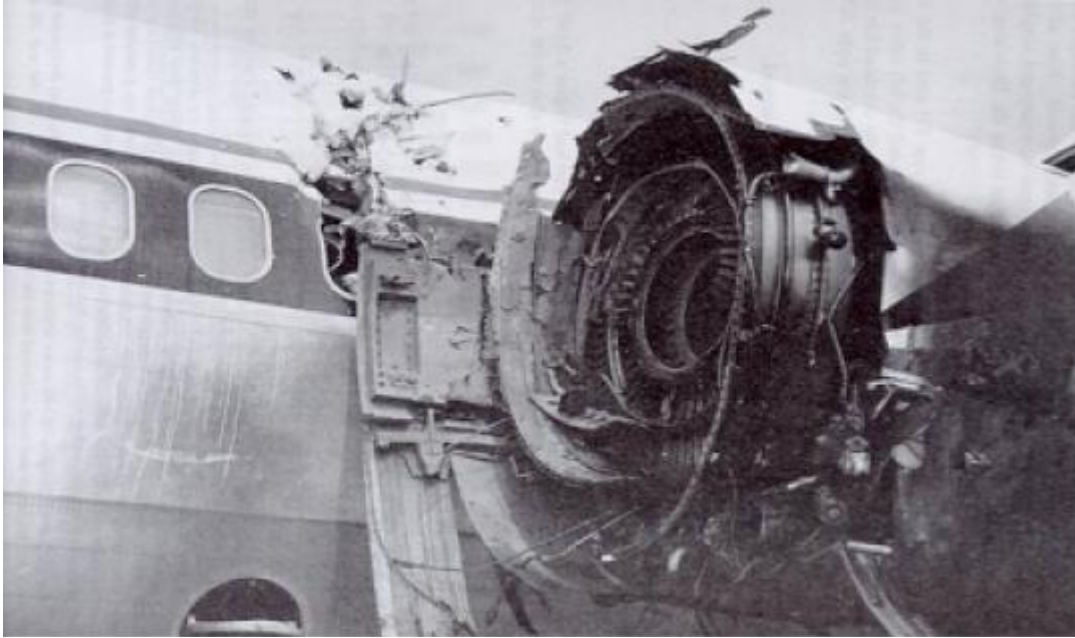
Figure F11. Photo of Engine and Fuselage Damage as a Result of Engine Failure

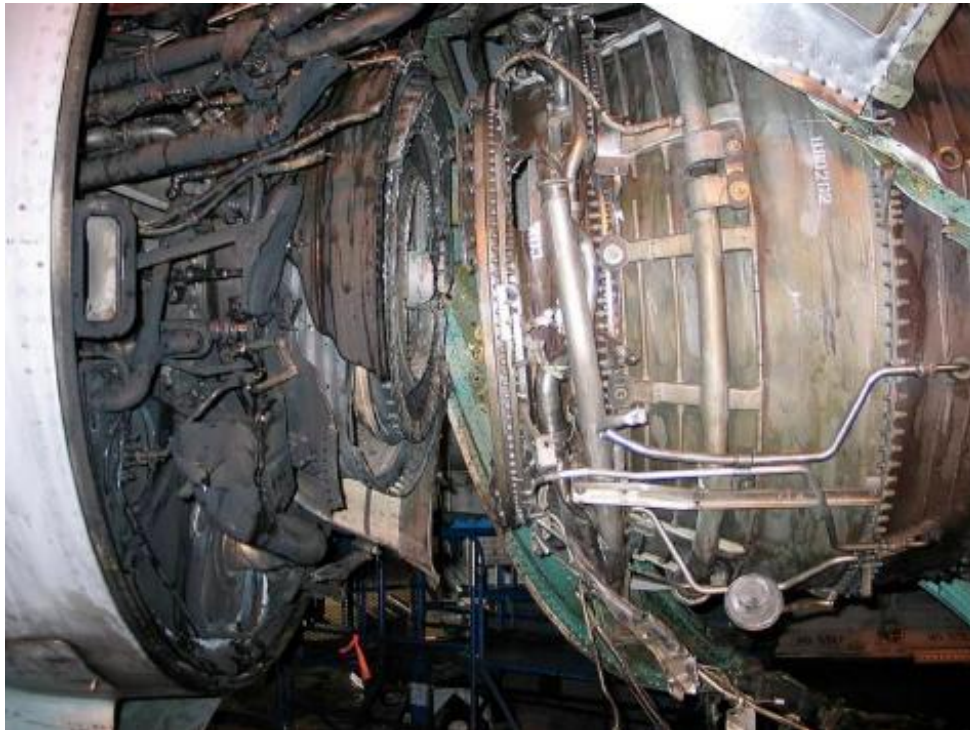
Figure F15: Photo of Damage Associated with Uncontained Rotor Failure in a GE CF6 Engine

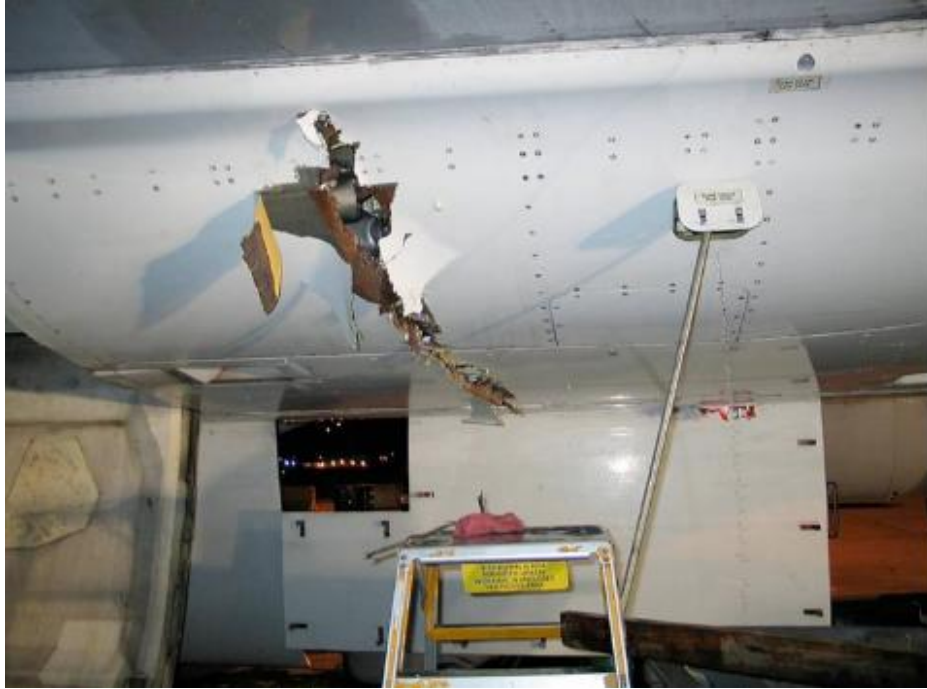
Figure F16: Photo of B747 Fuselage with Disk Penetration Damage Caused by Uncontained Rotor Failure

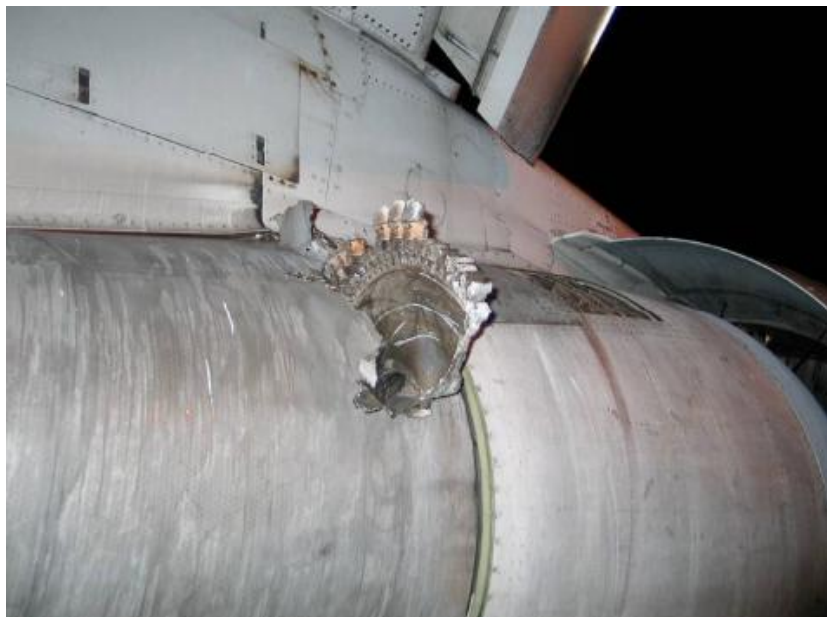
Figure F17: Photo of B747 with Disk Embedded in No. 2 Engine Resulting from Uncontained Rotor Failure in No. 1 Engine

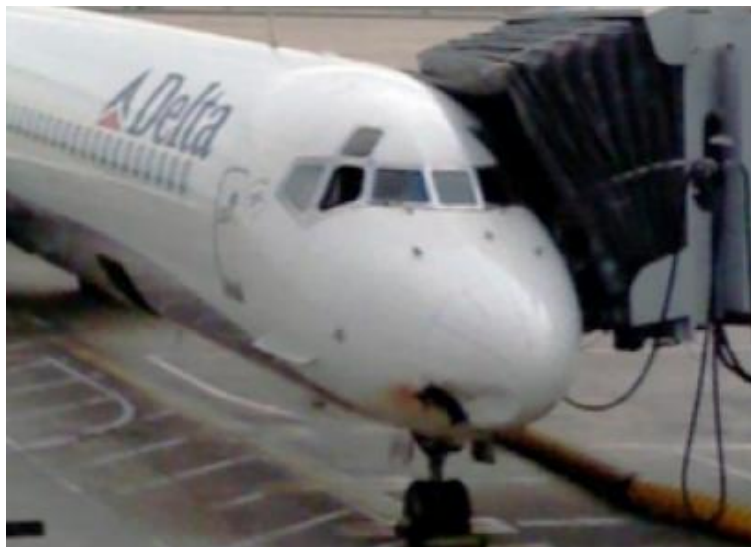
Figure G2: Photo of Bird Strike Damage to Radome

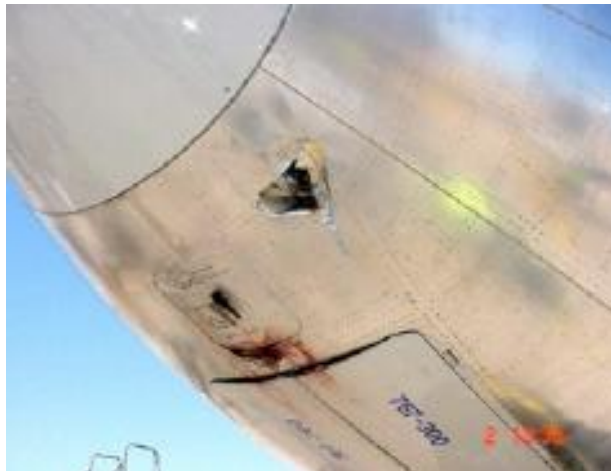
Figure G4: Photo of Bird Strike Damage to Underside of Fuselage of B767 Aircraft

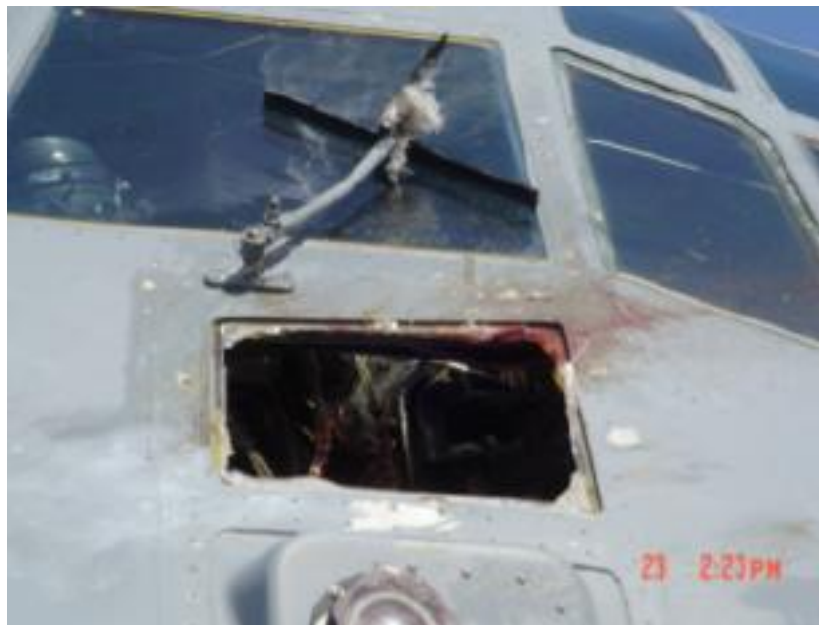
Figure G7.: Photo of Bird Strike Damage to Outside of the C-130 Aircraft

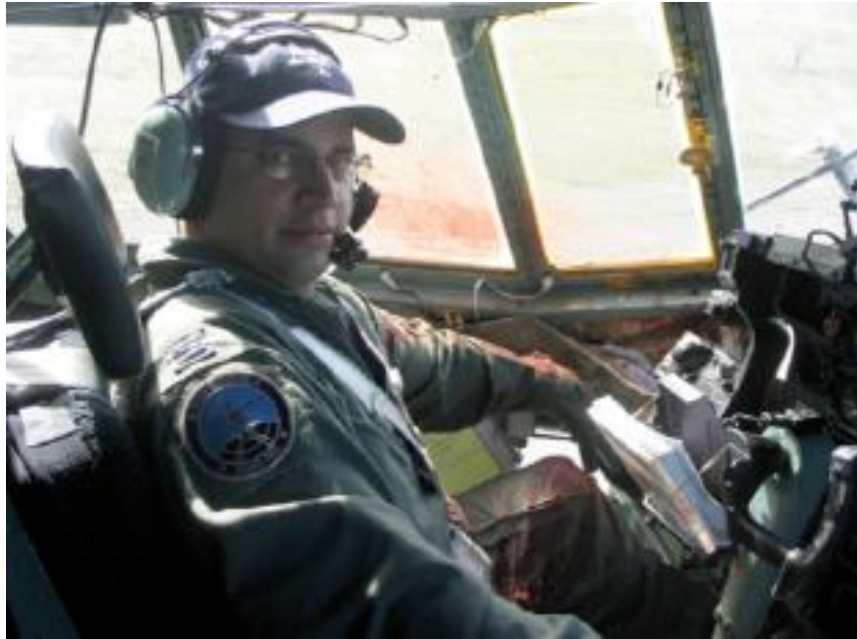
Figure G8: Photo of Bird Strike Damage to Front of C-130 Cockpit

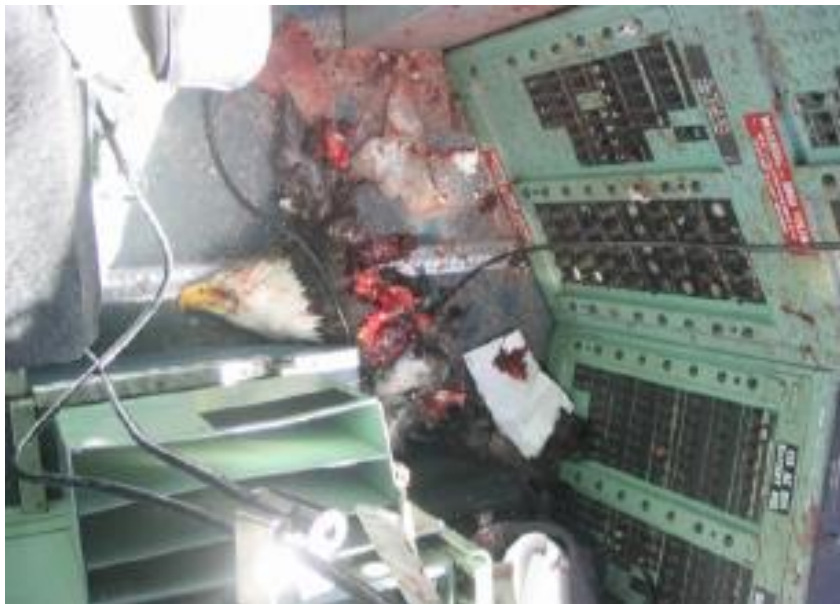
Figure G9: Photo of Bird Strike Damage to Interior of the C-130 Aircraft

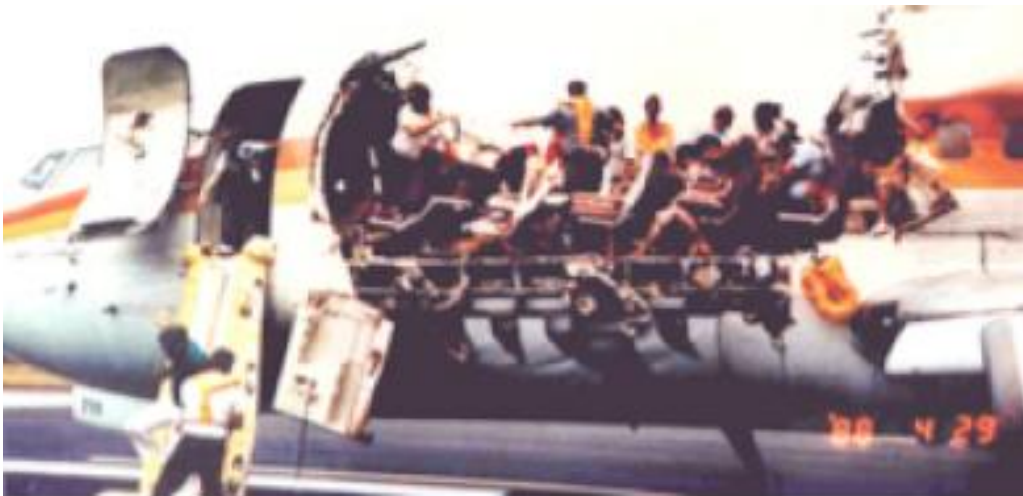
Figure J2. Photo Illustrating Extent of Aircraft Damage to Boeing 737 Aircraft Following Failure Due to Widespread Fatigue Damage

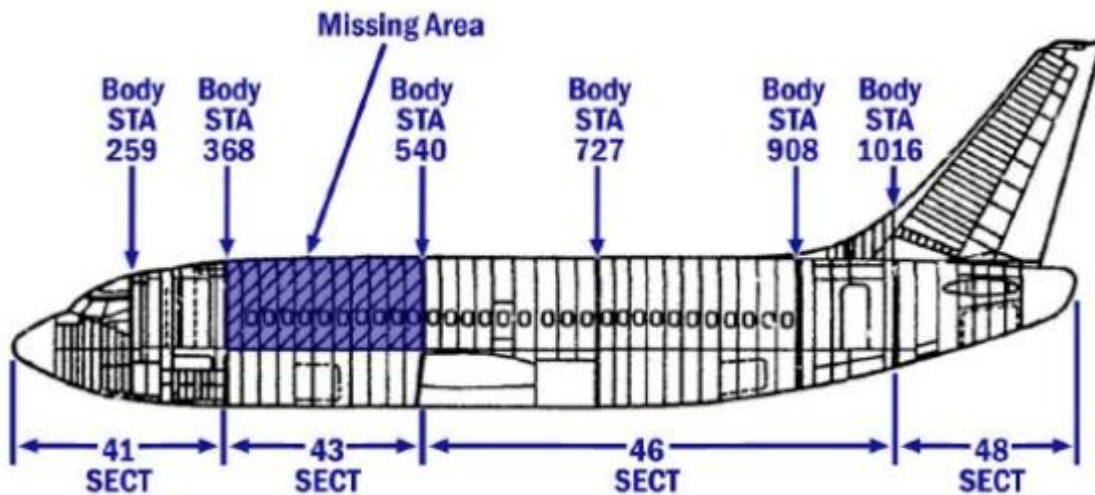
Figure J3: Sketch Illustrating Side View of Fuselage with Missing Area of Boeing 737 Aircraft

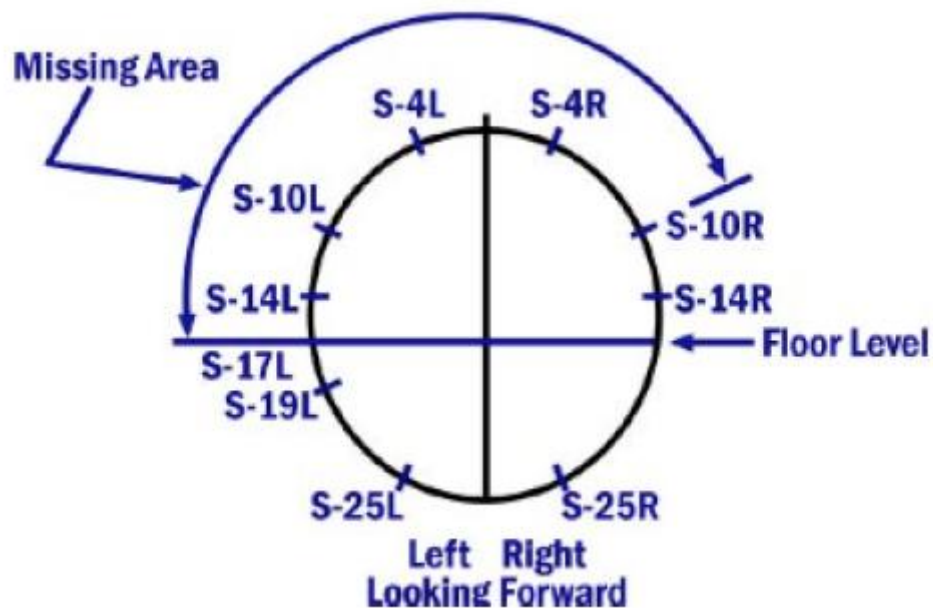
Figure J4: Sketch Illustrating the Fuselage Missing Area from a View Looking Forward

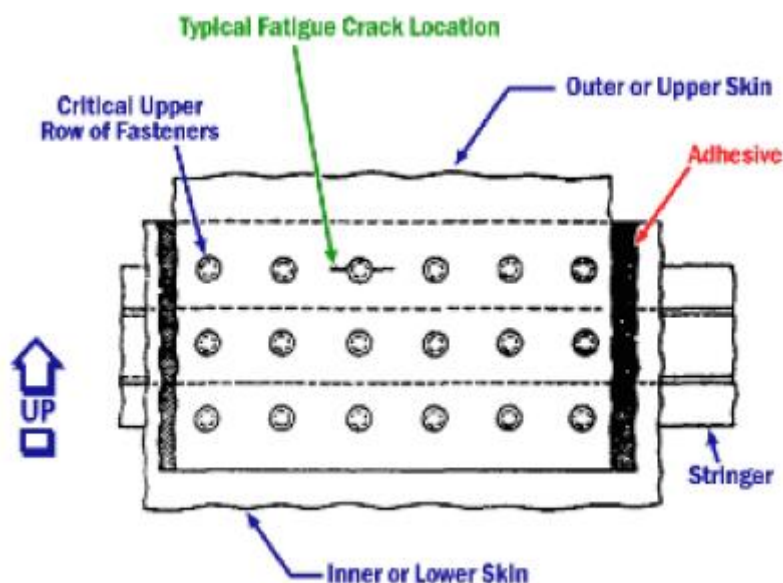
Figure J6: Sketch Illustrating the Location of Small Fatigue Cracks in the Skin

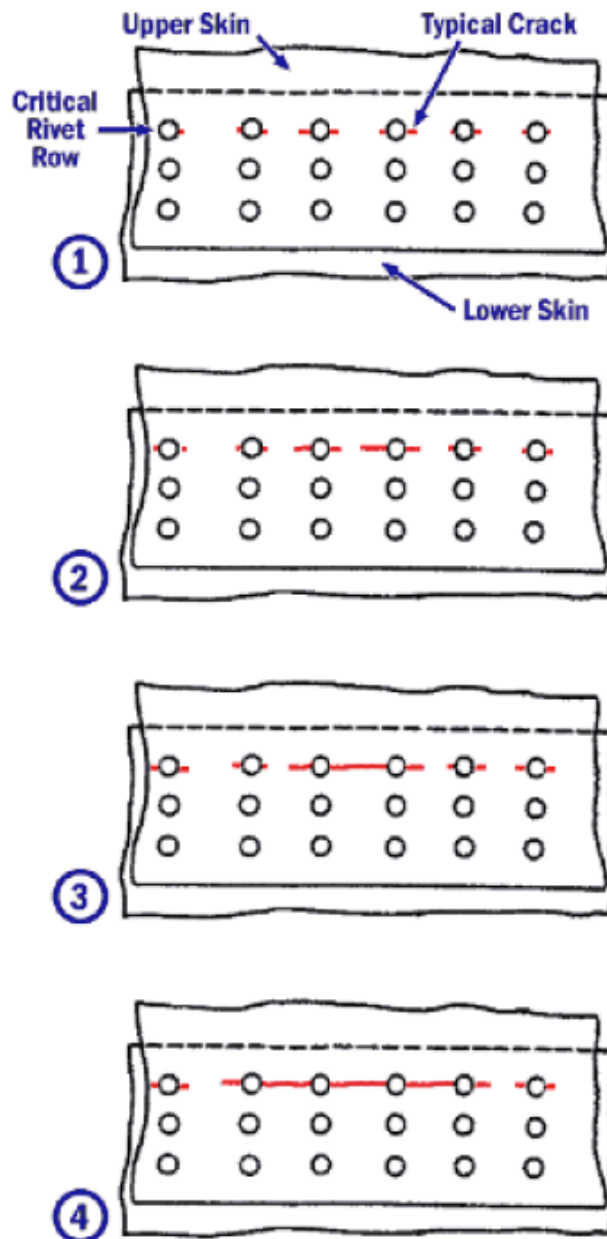
Figure J7: Sketches Illustrating the Development of Small Fatigue Cracks in the Skin

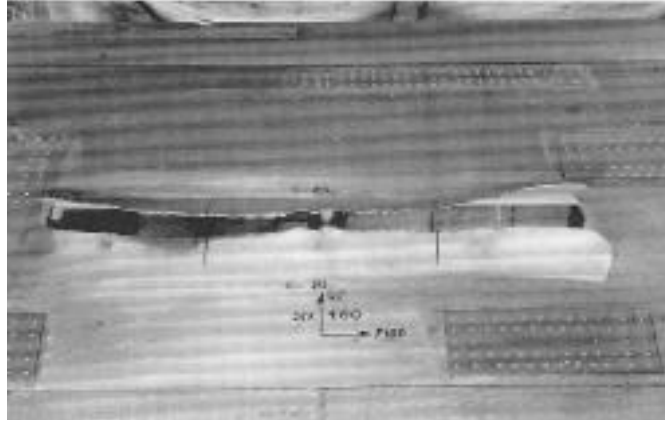
Figure K4: Arrested Two-Bay Crack with Fractured Frame in Boeing 737 Fuselage

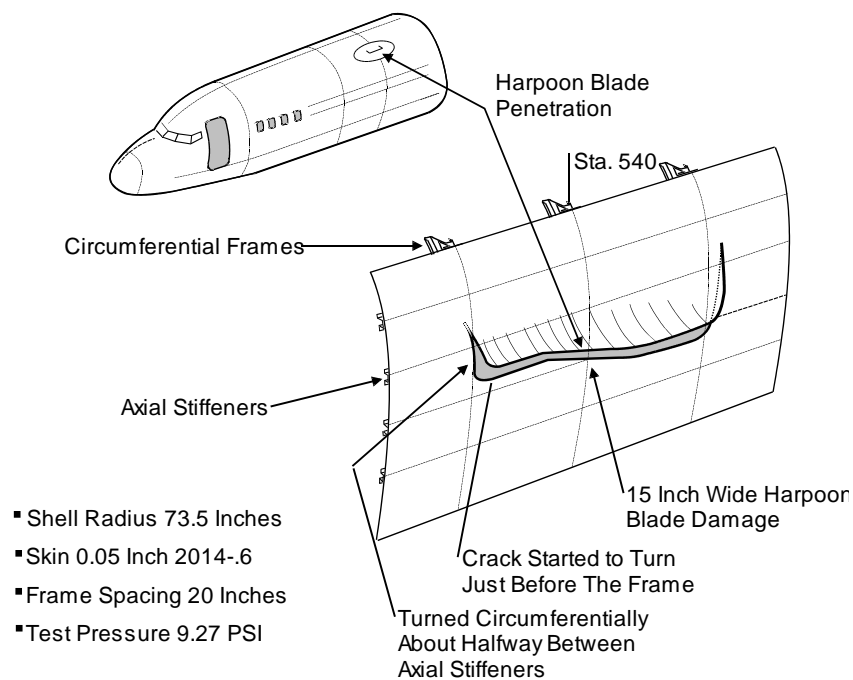
Figure K6: Details of DC-8 Arrested Fuselage Crack
