RELIEF AND RECONSTRUCTION
FUNDED WORK AT MOSUL DAM
MOSUL, IRAQ

SIGIR PA-07-105
OCTOBER 29, 2007

SUBJECT: Report on Relief and Reconstruction Funded Work at Mosul Dam, Iraq
(Report Number SIGIR PA-07-105)

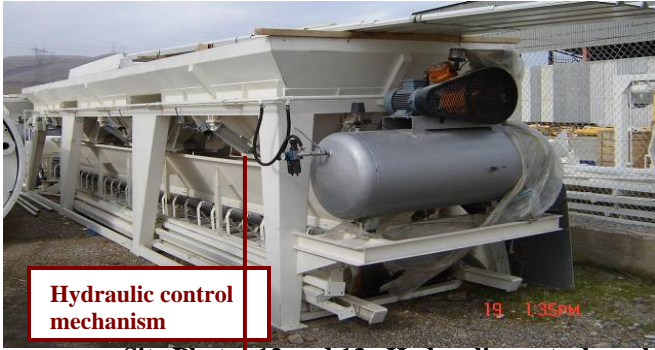
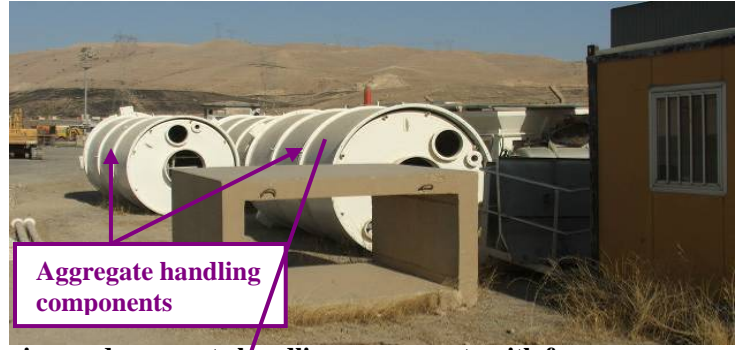
Site Photos 12 and 13. Hydraulic control mechanism and aggregate handling components with for the delivered 30-m³/hour concrete-mixing plant.

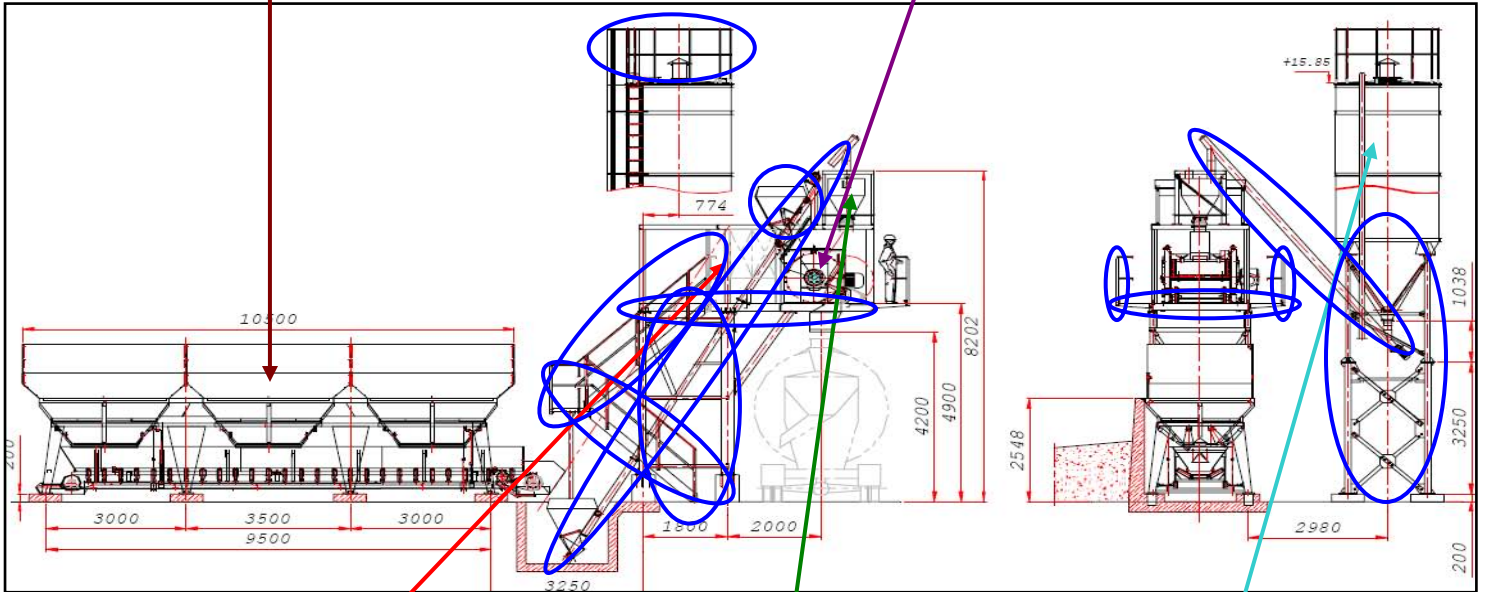
Figure 27. The contractor's design drawing for the 30-m³/hour concrete-mixing plant (Colored arrows identify pieces found at the site and what relationship they are to the design) (Areas circled in blue are equipment required by the design that could not be accounted for/located during site visit)

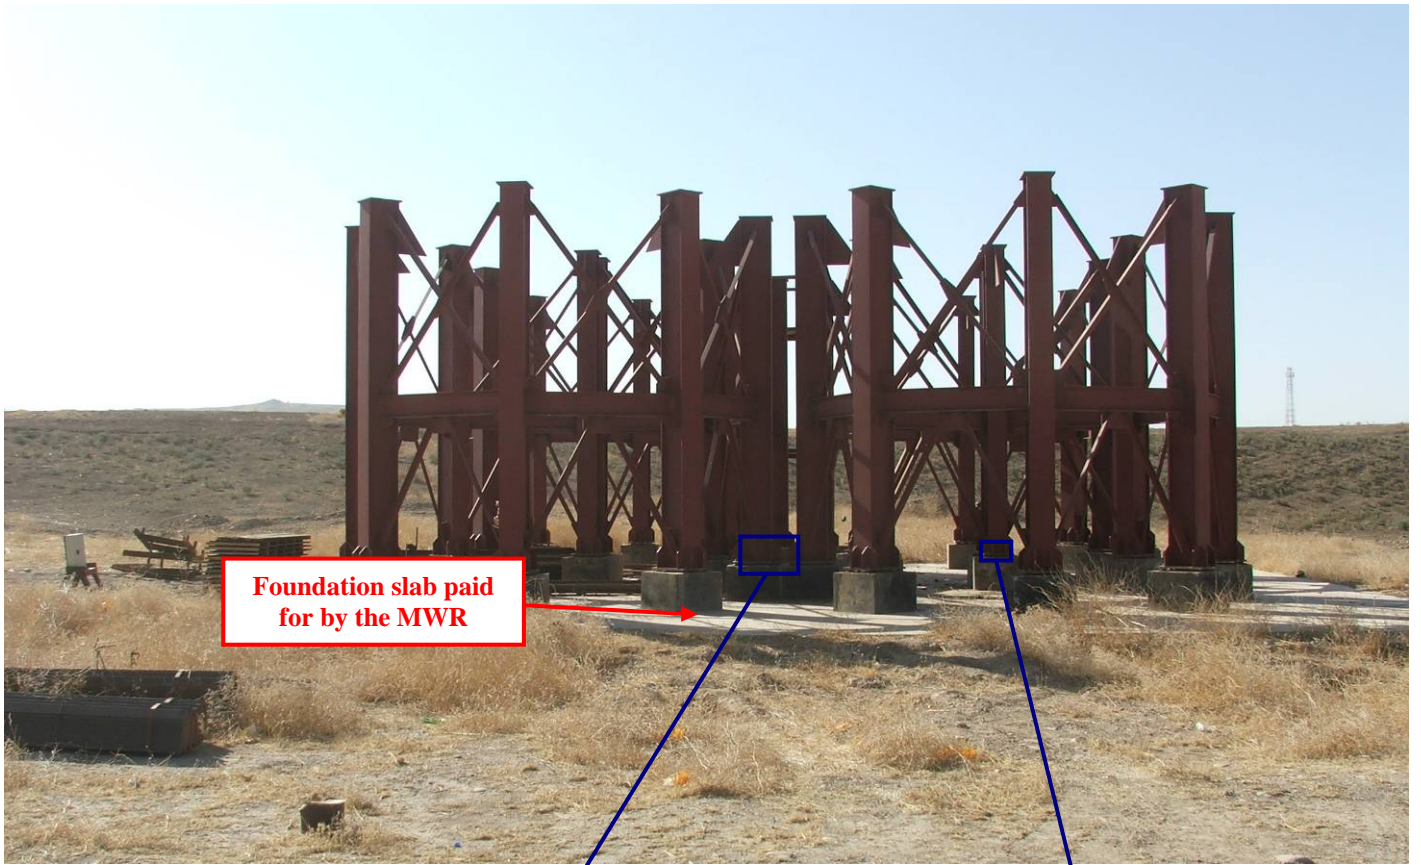
Foundation bolts are essential for the stability of the structure. The contractor erected steel columns, bracings, and beams by welding structural steel elements together. We observed foundation bolts cast within concrete columns so deficient that there was insufficient thread available to properly fasten the nuts on. (Site Photos 18 and 19). A foundation bolt is essential to secure the steel columns. Inadequately installed foundation bolts increase the probability of the structure's failure. We identified 43 of 144 (30%) foundation bolts inadequately installed. The installation of the foundation bolts also contradicts the contractor's own design construction techniques, which required bolt threads to extend higher than the nut (Figure 28 and Site Photo 20). In some instances, the contractor extended the foundation bolt well beyond the nut and continued to use poor installation practices, such as the use of too many washers (Site Photo 21). Considering that the stationary silos are to hold approximately 6,000 tons of cement, along with the weight of the steel superstructure with columns, we believe that inadequate installation of the foundation bolts leaves this structure in a potentially dangerous condition.

Site Photo 17. View of the partially constructed stationary silos

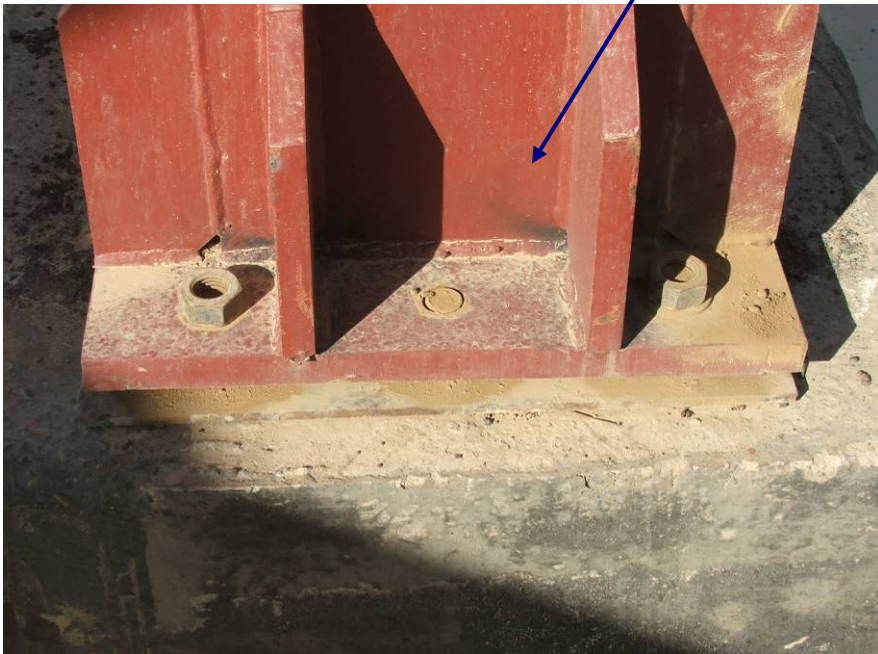
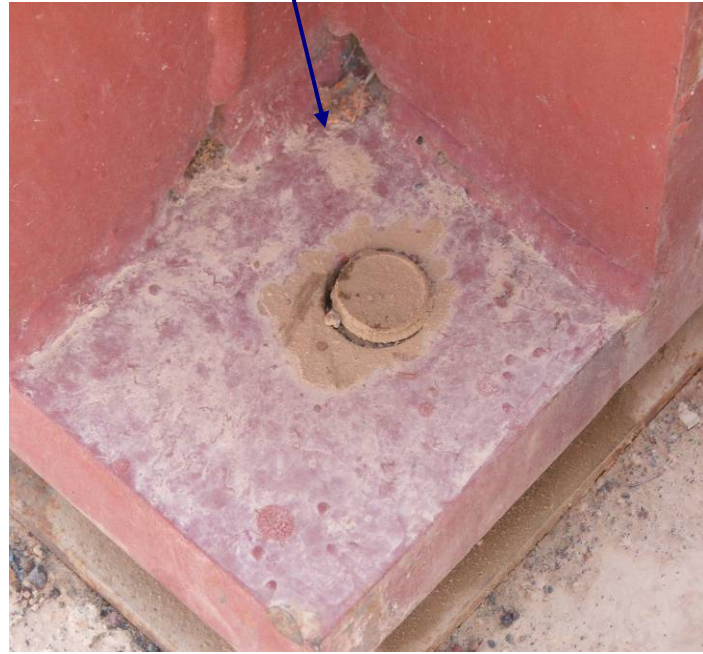
We identified an instance where construction did not appear to be adequate. The inspection team observed that some foundation bolts cast within concrete columns had insufficient thread to properly fasten the nuts. Specifically, we determined that 43 of the 144 (30%) foundation bolts were inadequately installed. Further, the installation of the foundation bolts also contradicted the contractor's own design construction techniques, which required bolt threads to extend higher than the nut. Complete design drawings are needed to determine if the remaining foundation bolts are adequately secured within the foundation or pose a serious threat of failure. Because each stationary silo will hold approximately 1,500 tons of cement, we believe that the inadequate installation of the foundation bolts leaves this structure in a potentially dangerous condition.

Site Photos 18 and 19. Close-up view of foundation bolts for the stationary silos

Contractor's design drawings required bolt threads extend beyond the nut and washer

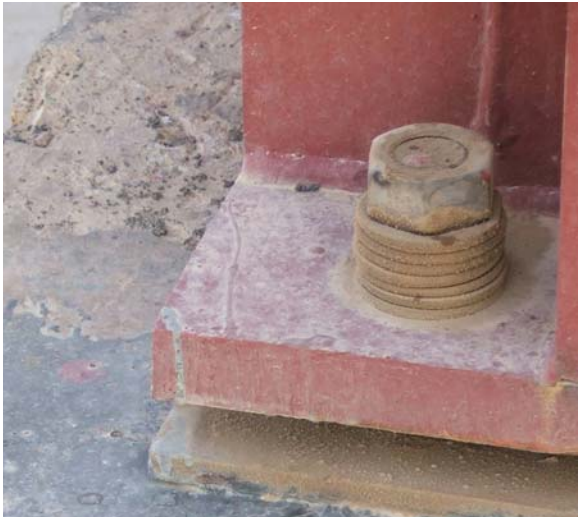
Site Photo 21. Poor installation technique (the use of 7 washers)

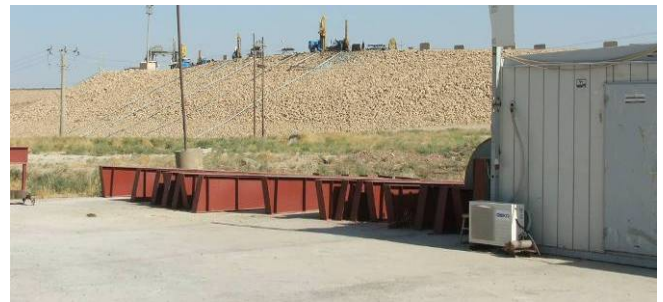
Site Photo 23. Miscellaneous pieces of metal for the stationary silos

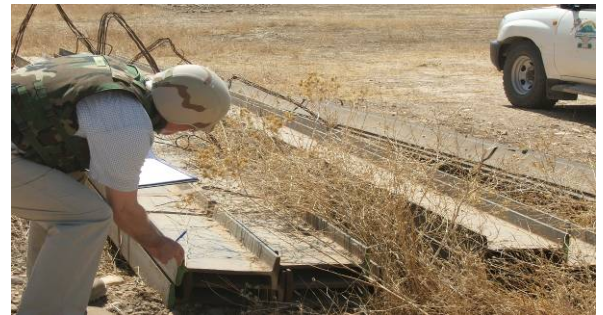
Site Photo 24. Additional pieces of metal

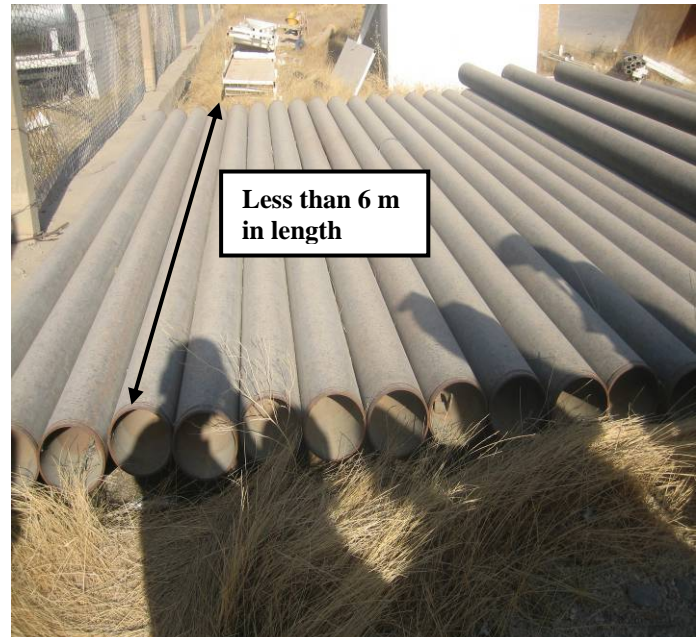
Mosul Dam personnel stated that because the pipe sizes are not accurate, workers will have to cut and weld two pieces together (which is very difficult to do) or simply not use the pieces. Currently, the pipes sit unused located outside a warehouse.

Site Photo 26. Pipes delivered by the contractor

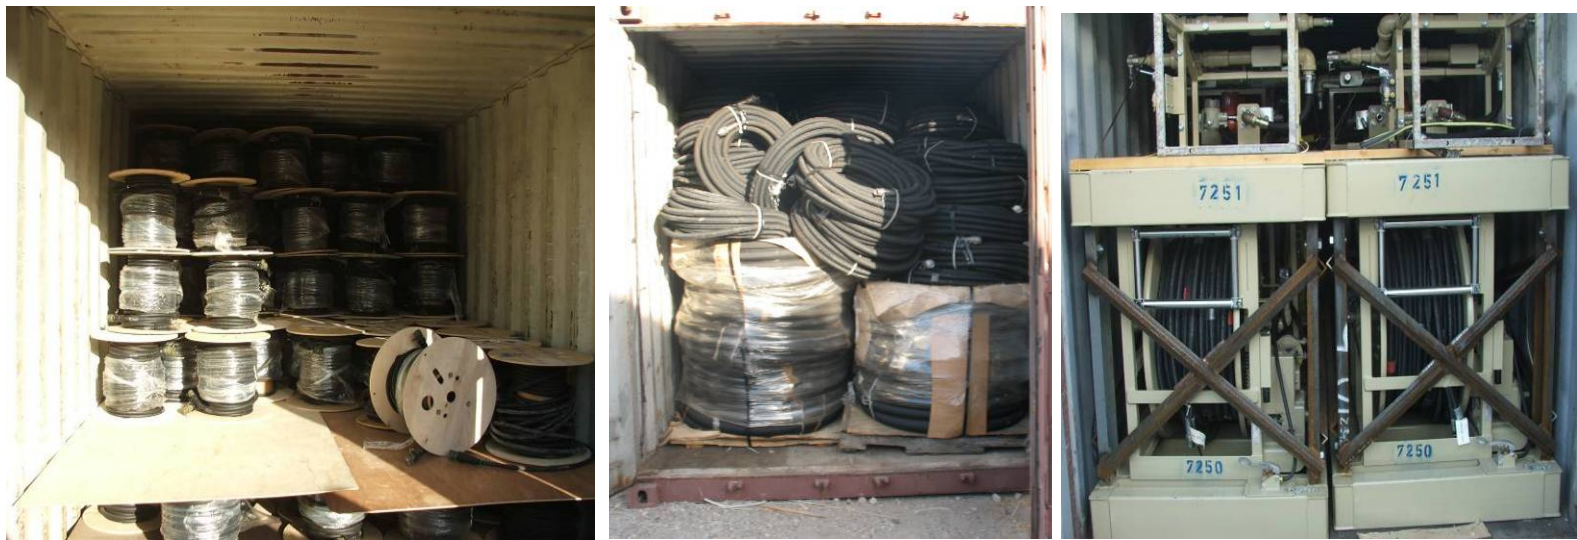
Site Photos 33, 34, and 35. Conex boxes with partially assembled enhanced grouting equipment

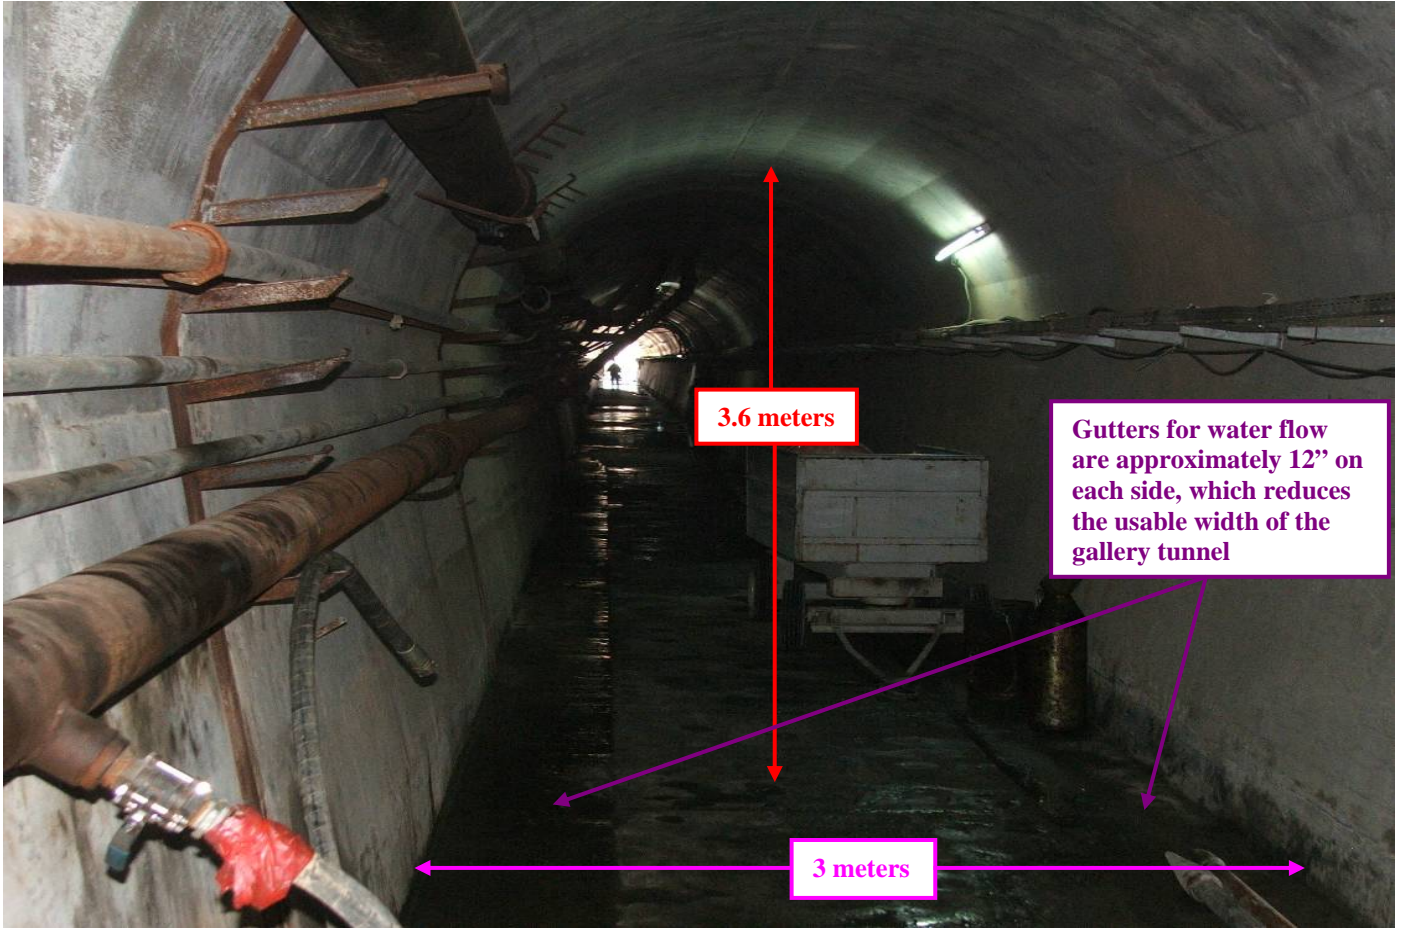
We later spoke with the dam manager, who stated that this equipment is not appropriate for the Mosul Dam. The gallery is very small and tight, with dimensions of 3 m wide by 3.6 m high (Site Photo 36) and there are sharp turns and steep inclines throughout the length of the 3.4 km gallery (Site Photo 37). In the manager’s opinion, the equipment is too large and heavy to be used within the Mosul Dam gallery. Since the equipment was not completely assembled at the time of our site visit, the only visuals of the assembled equipment available are photographs taken during its commissioning in Harrisburg, PA (Site Photos 38-40). While Site Photo 40 shows the two pieces of equipment at 90 degrees, according to the USACE’s grouting expert, the “two units would be in-line with each other.” In the dam manager’s opinion, which is based upon more than 20 years of experience at the Mosul Dam, the equipment procured was too wide and long to fit inside the gallery. Until the equipment is completely assembled, operational, and schematics provided for its use; it will not be known whether the equipment will fit in the gallery or not.

Site Photo 36. View of the dimensions within the Mosul Dam gallery tunnel
