**RENOVATION OF THE KHANDEK
INTERMEDIATE SCHOOL
UNDER THE ECONOMIC SUPPORT FUND PROGRAM
YOUSEFIYA, IRAQ**

SUSTAINMENT ASSESSMENT

**SIGIR PA-08-136
APRIL 21, 2009**

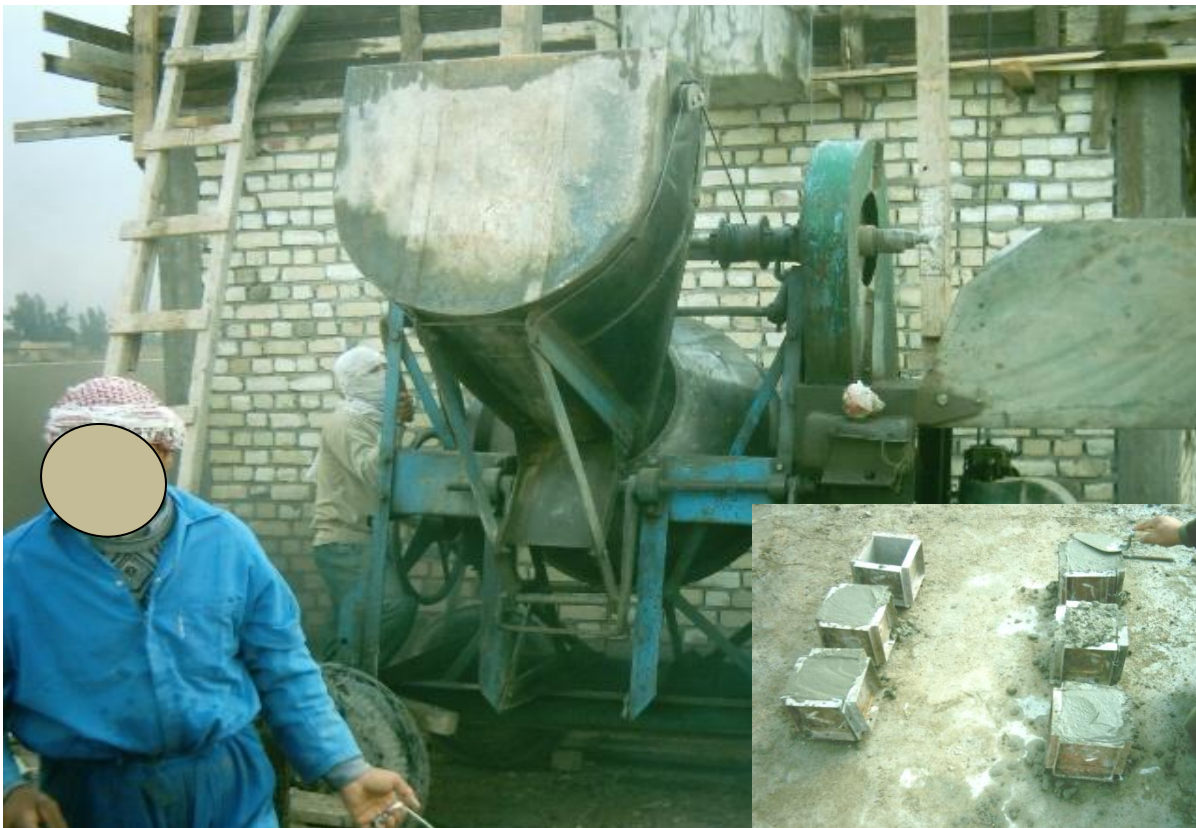
The contractor performed materials inspection and tested the concrete used. The project file documentation lacked concrete mix designs; however, from the available contractor quality control (QC) photos, it appears that the concrete was mixed onsite (Site Photo 2). Concrete test cubes were molded from the concrete used in the project. The BOQ required all concrete incorporated into this project to have a minimum 28-day compressive strength of 25 megapascals (amount of pressure an area can withstand). According to project file documentation, the contractor's compressive strength test results indicate the concrete had a minimum strength of 32.0 megapascals.

Site Photo 2. Site-mixed concrete and concrete test cubes (lower right corner)
(Courtesy of GRC)

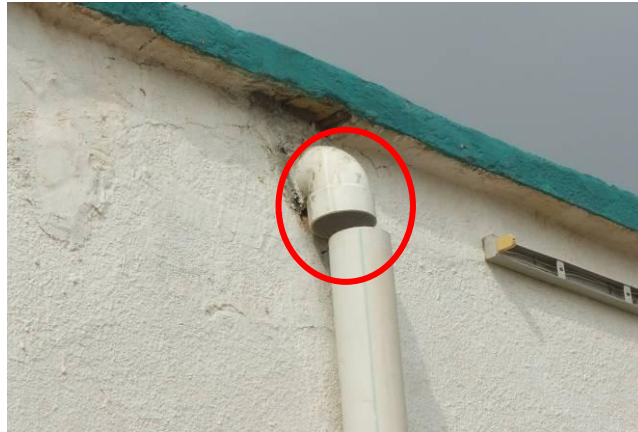
SIGIR did observe one downspout was disjointed from the roof scupper (Site Photo 5). Since this was located in a new construction area, it may have been caused by ongoing construction activities. However, due to the ease of separation of the downspout, it appears that the joints were not solvent welded. In addition, splash blocks or extensions were not provided to direct runoff away from the foundation.

Site Photo 5. Loose connection

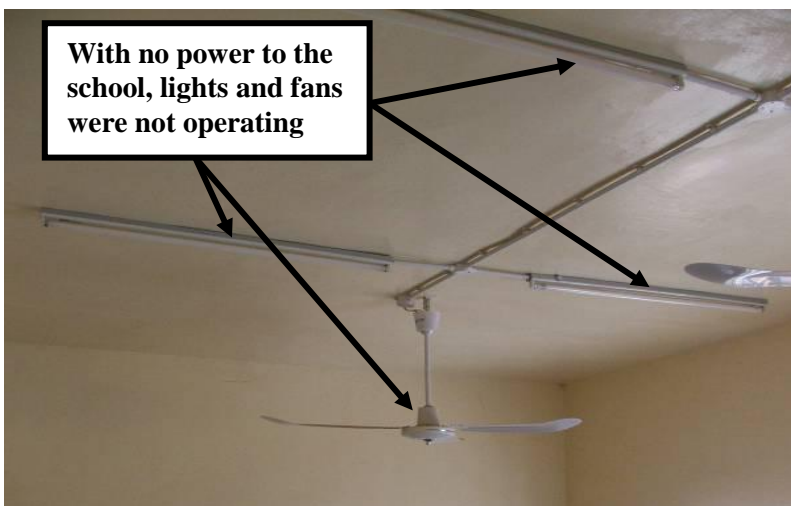
A new main circuit breaker, lights, and ceiling fans were installed in the classrooms (Site Photos 11). At the time of the site visit, the school was operating without power; therefore, SIGIR was unable to verify the operability of the electrical system. It appeared that all wiring was in conduit; however, exterior wiring did not use elbows at changes in direction (Site Photo 12).

Site Photo 11. Electric fixtures (lights and ceiling fans)

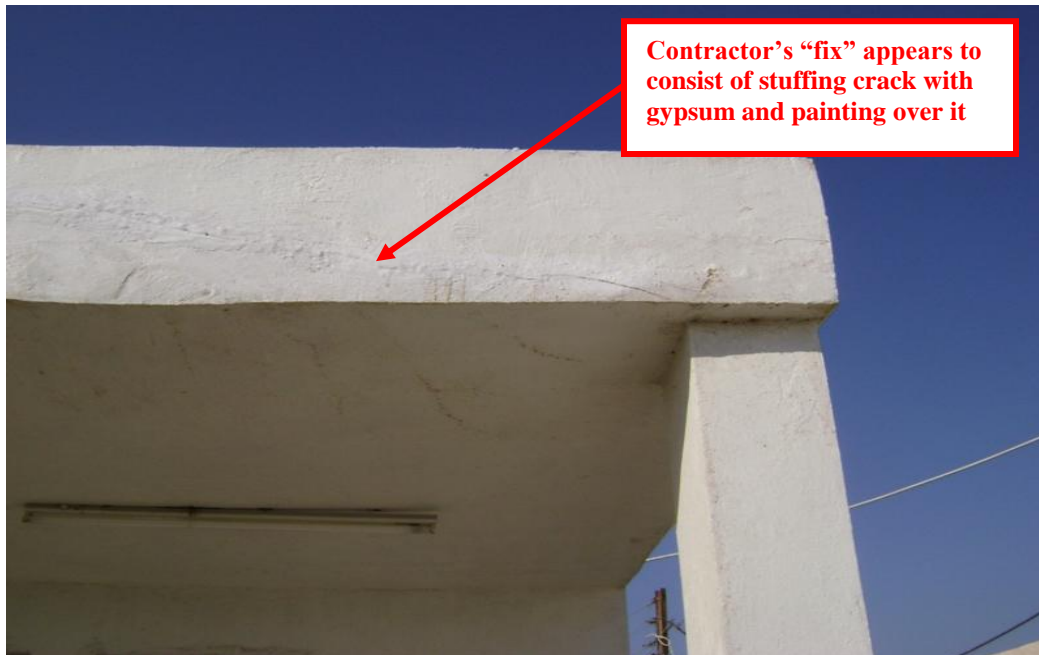
During its site visit, GRC representatives stated that the crack in the concrete beam was "currently being worked" by the contractor. GRC representatives took a photograph of the contractor's corrections, which appeared to be stuffing the crack with gypsum and then painting over it (Site Photo 13). GRC representatives did not ascertain the depth of the crack.

SIGIR does not believe the contractor's "fix" is adequate. The depth of the crack needs to be determined in order to identify the most appropriate correction.

Site Photo 13. Contractor's fix for the reinforcement beam crack (Courtesy of GRC)
