**REBUILDING OF THE SAGRAH SCHOOL
UNDER THE COMMANDER'S EMERGENCY RESPONSE PROGRAM
SAGRAH, ANBAR PROVINCE, IRAQ**

SUSTAINMENT ASSESSMENT

**SIGIR PA-08-140
APRIL 15, 2009**

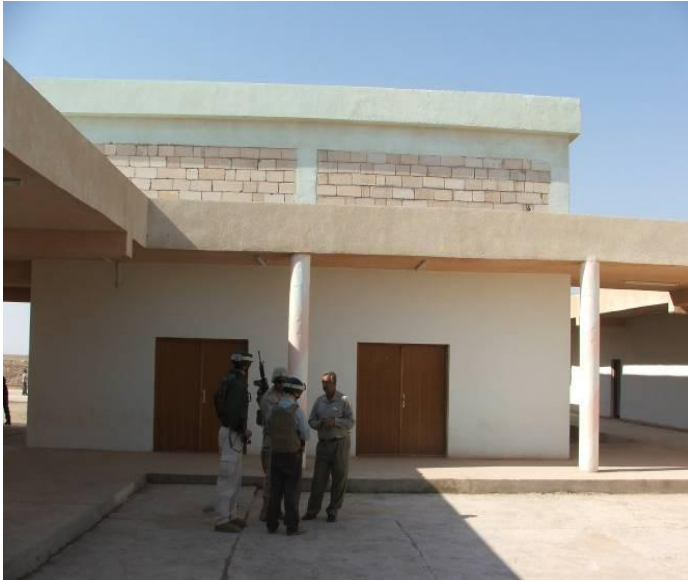
Both the new and existing construction appeared sound. The reinforced concrete frame of the new construction was exposed and appeared to be adequate, with no apparent or noticeable defects (Site Photo 3). Several sections of the new construction had exposed concrete masonry units, which appeared to be of above average quality (Site Photo 4).

Site Photo 3. Structure with reinforced concrete frame

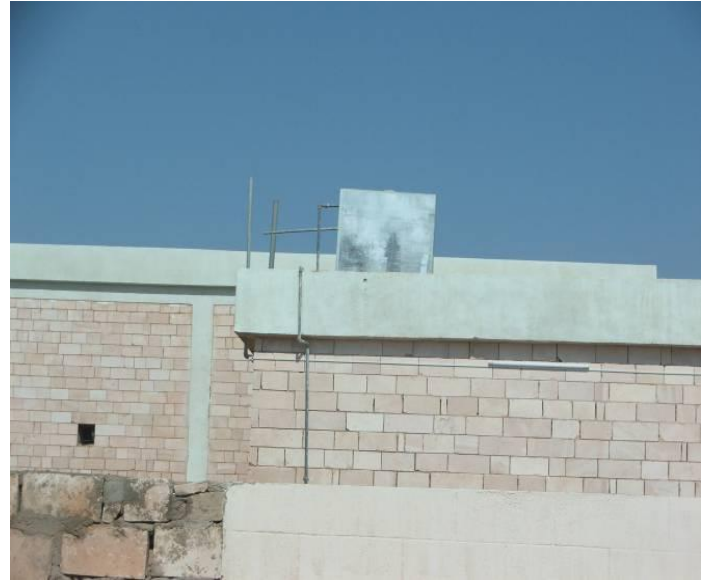
Site Photo 4. Exposed concrete masonry units

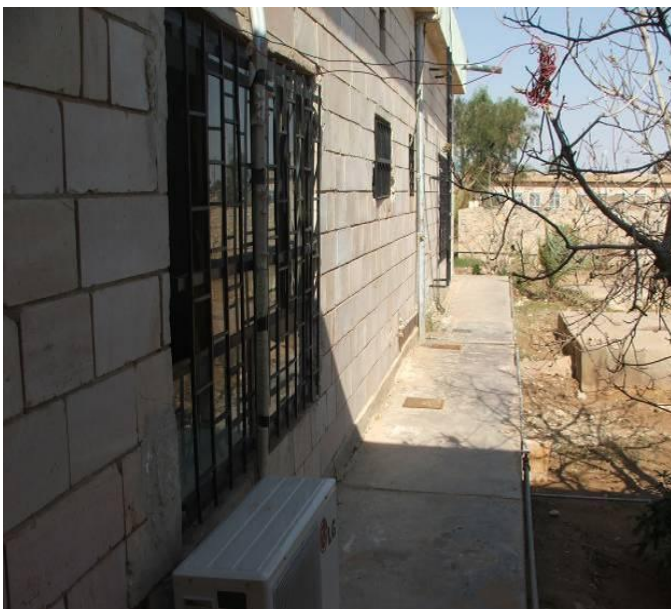
The doors and hardware were installed and functioning. The window glazing appeared to be intact, and latching hardware had been installed (Site Photo 5). The concrete courtyard appeared to be well constructed with no areas of settlement or indications of ponded water (Site Photo 6).

Site Photo 5. Newly constructed exterior windows

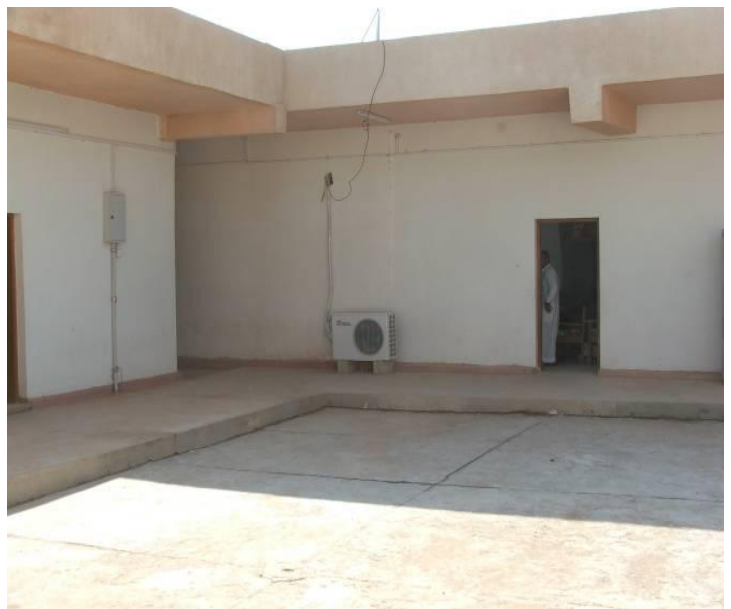
Site Photo 6. School courtyard

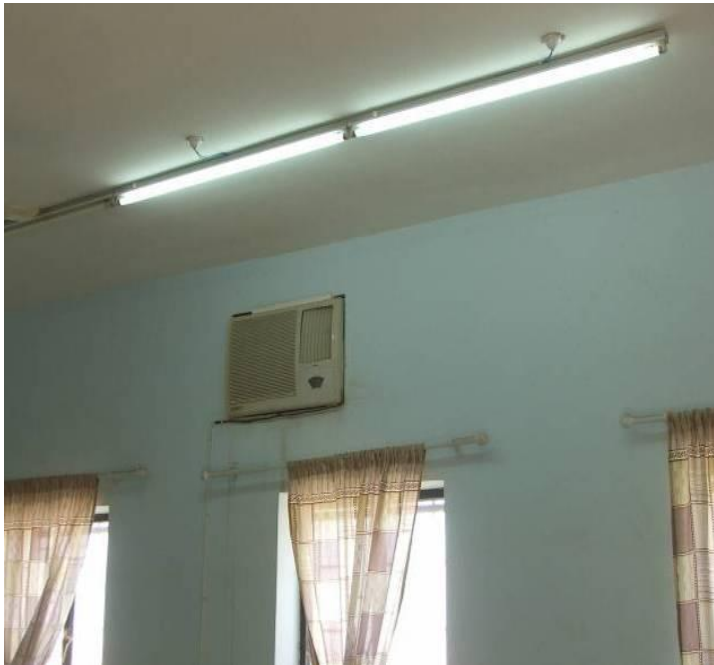
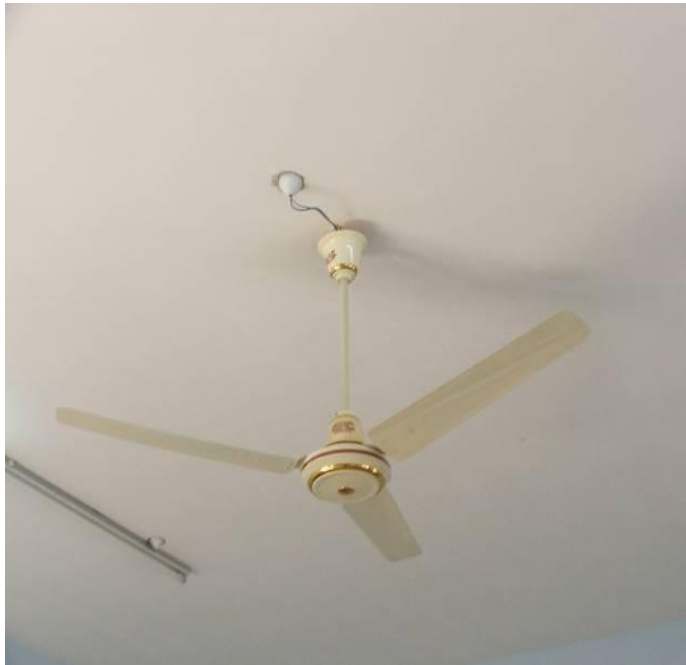
The electrical components were installed and functioning. Most of the wiring was installed in conduits and appeared adequate. Also, the main power panel, fluorescent lighting, and ceiling fans were properly installed (Site Photos 7 and 8).

Site Photos 7 and 8. Fluorescent lighting and ceiling fans inside each classroom

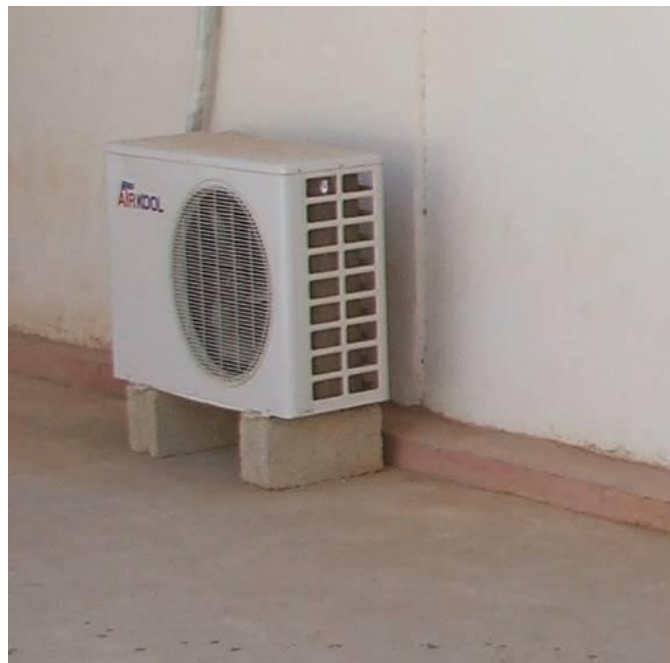
SIGIR observed two types of air-conditioning units installed at the school. The majority of the classrooms were cooled by wall mounted units (Site Photo 9); while some were cooled by split air-conditioning units (Site Photo 10).

Site Photo 10. Split air-conditioning unit
