REFURBISHMENT OF THE
KURDISTAN REGIONAL GOVERNMENT
MINISTRY OF INTERIOR COMPLEX
UNDER THE COMMANDER'S EMERGENCY RESPONSE PROGRAM
ERBIL, IRAQ

SIGIR PA-08-119
APRIL 17, 2008

SUBJECT: Report on Project Assessment of the Refurbishment of the Kurdistan
Regional Government's Ministry of Interior Complex, Erbil, Iraq
(Report Number SIGIR PA-08-119)

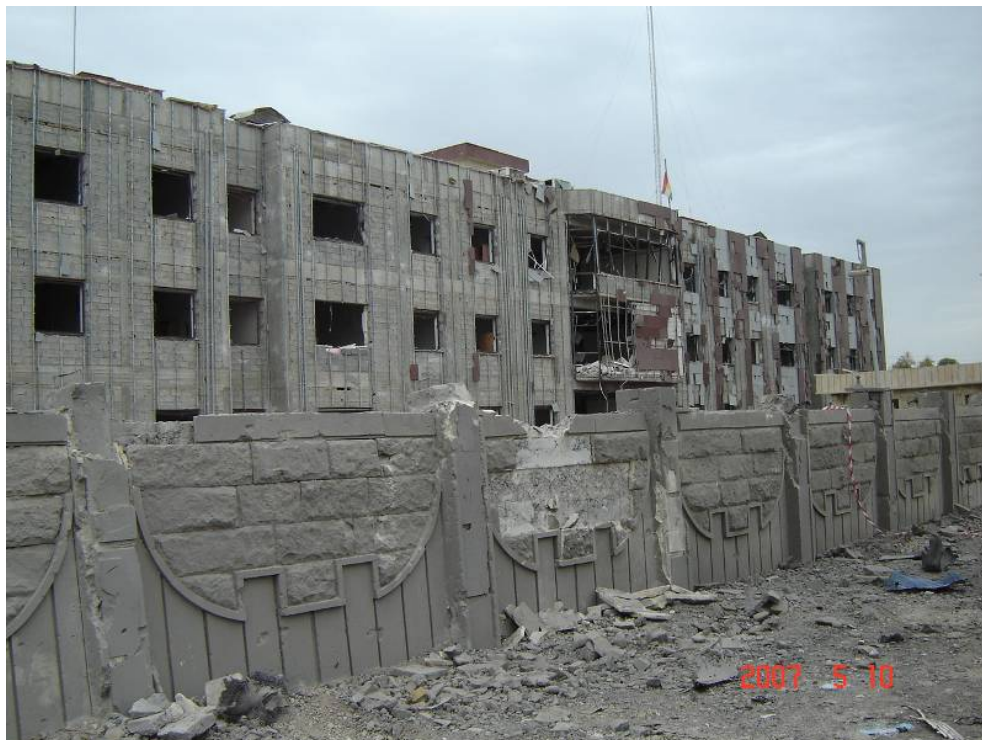
**Site Photo 1. Damage to the north side of the services building & perimeter wall.
(Photo courtesy of USACE)**

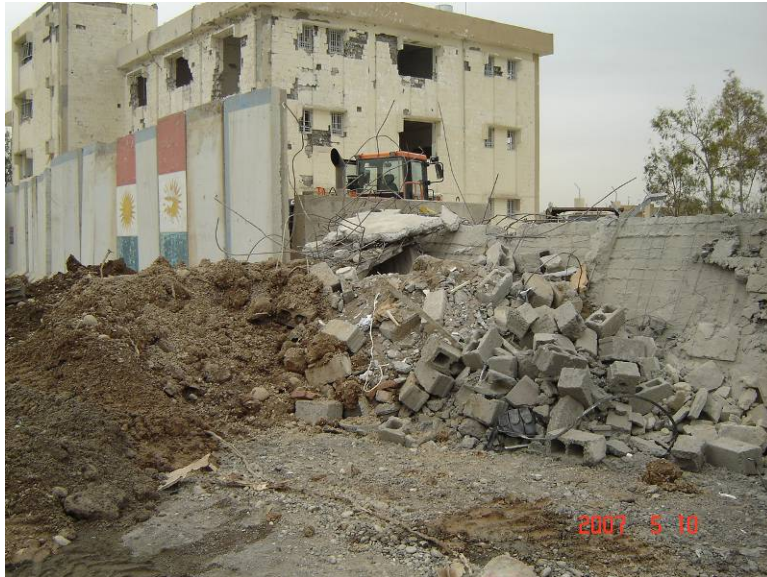
Site Photo 2. Security building damage (Photo courtesy of USACE)

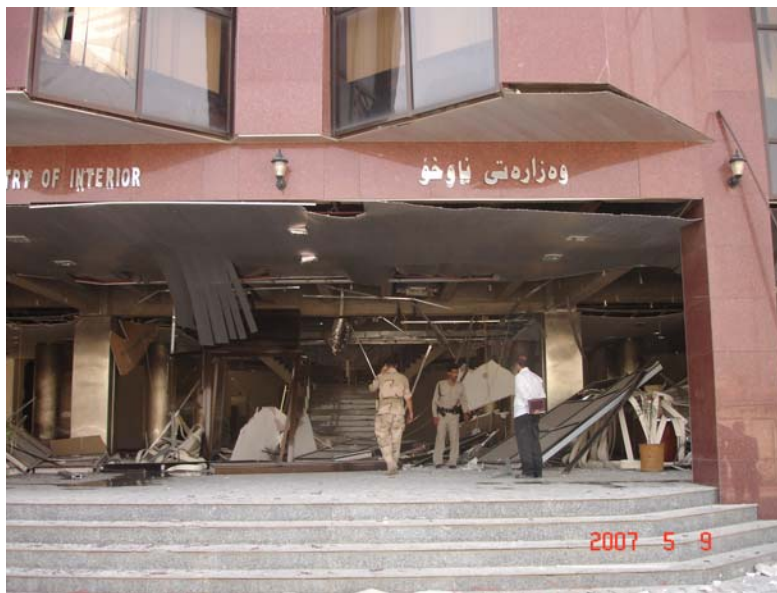
Site Photo 3: Entryway to MOI building (Photo courtesy of KRG)

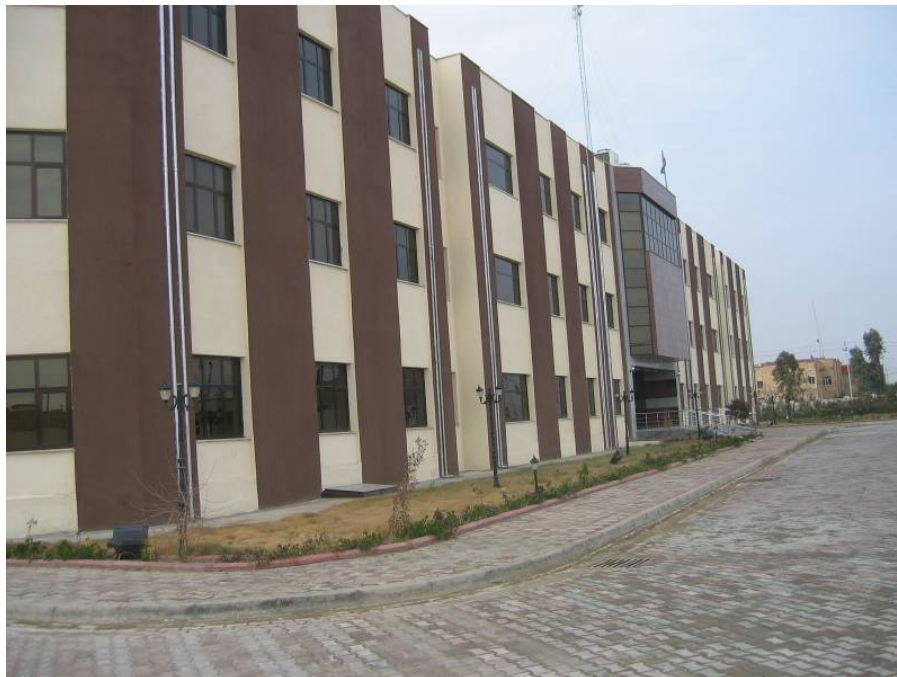
Site Photo 5: Refurbished services building

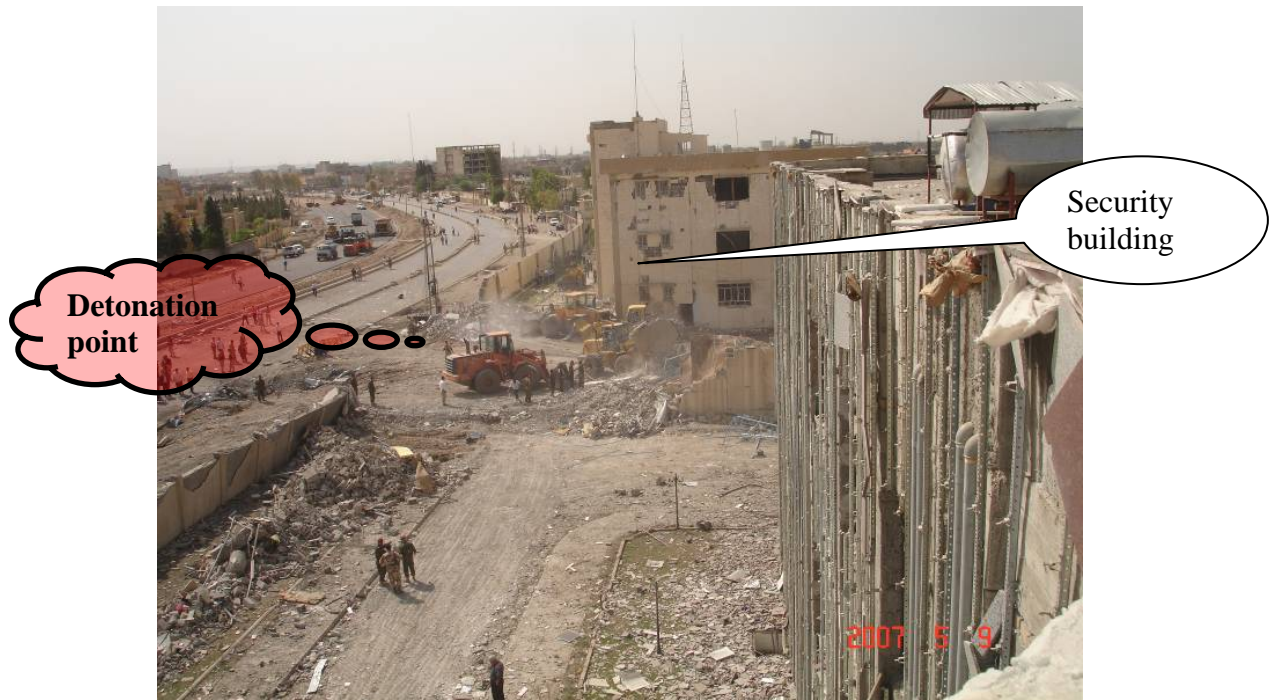
The VBIED detonated at the northeast entry gate, destroying the guard shack and severely damaging the perimeter wall. The guard shack was rebuilt, the perimeter wall repaired, and T-walls were erected along the “60-Meter” road that passes the complex. Site Photos 6 and 7, taken from the roof of the services building show the destruction and completed repairs.

**Site Photo 6: Damage to the perimeter wall, services building and security building.
(Photo courtesy of KRG)**

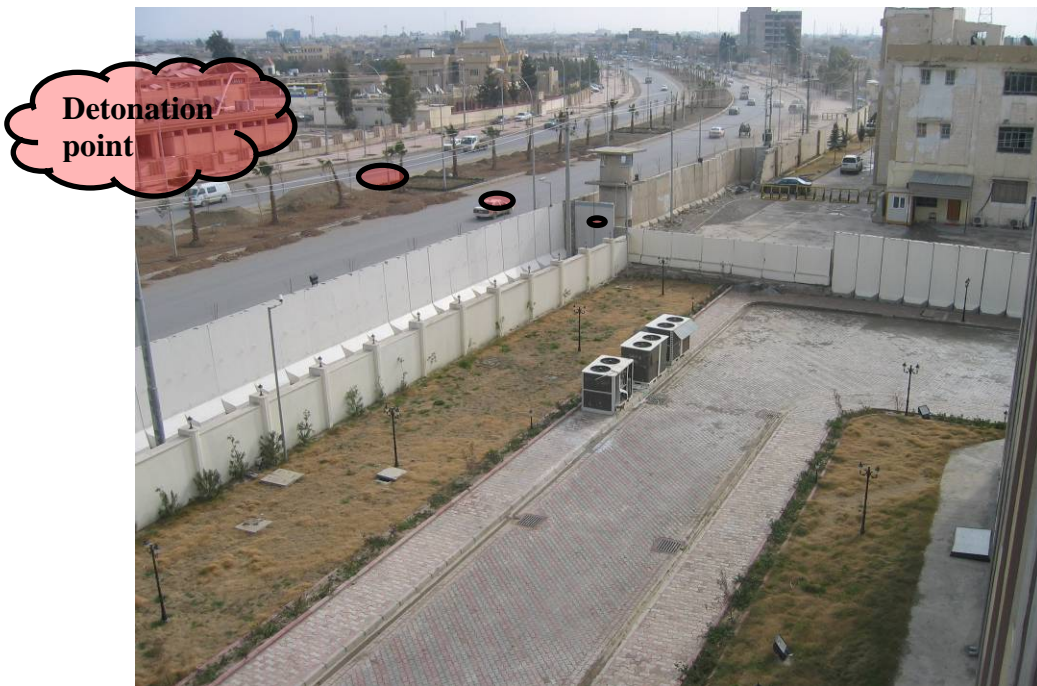
**Site Photo 7: Repaired wall, installed T-walls and reconstructed guard shack.
Photo taken from the roof of the services building.**

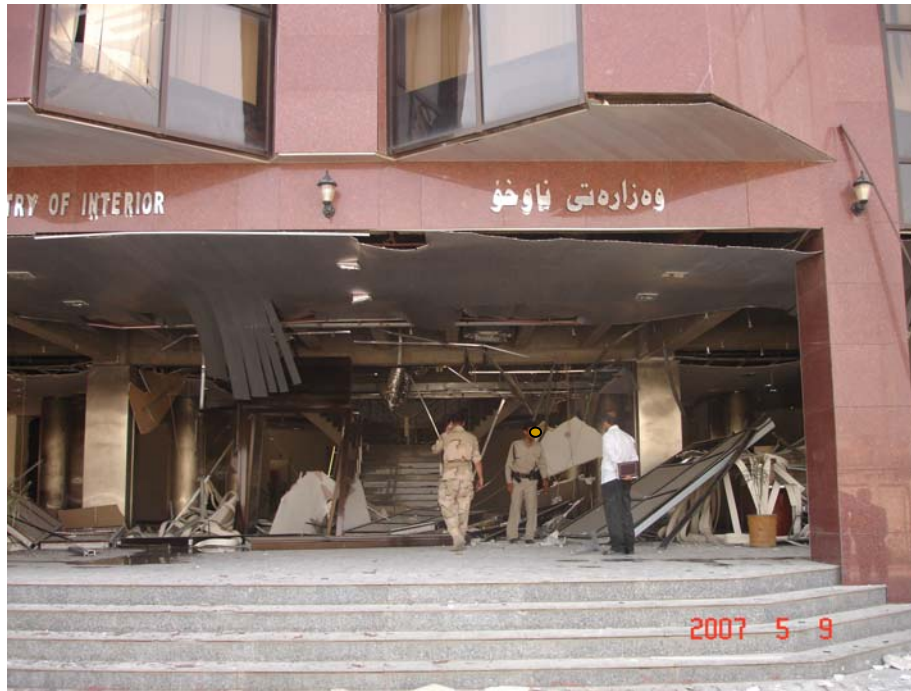
The MOI main entrance is located at the southwest part of the complex. The blast carried through the building interior and blew out the entrance doors, windows, and ceiling. The

Site Photo 8: The MOI entrance was located at the opposite side of the complex from the blast which carried through the building interior. (Photo courtesy of KRG)

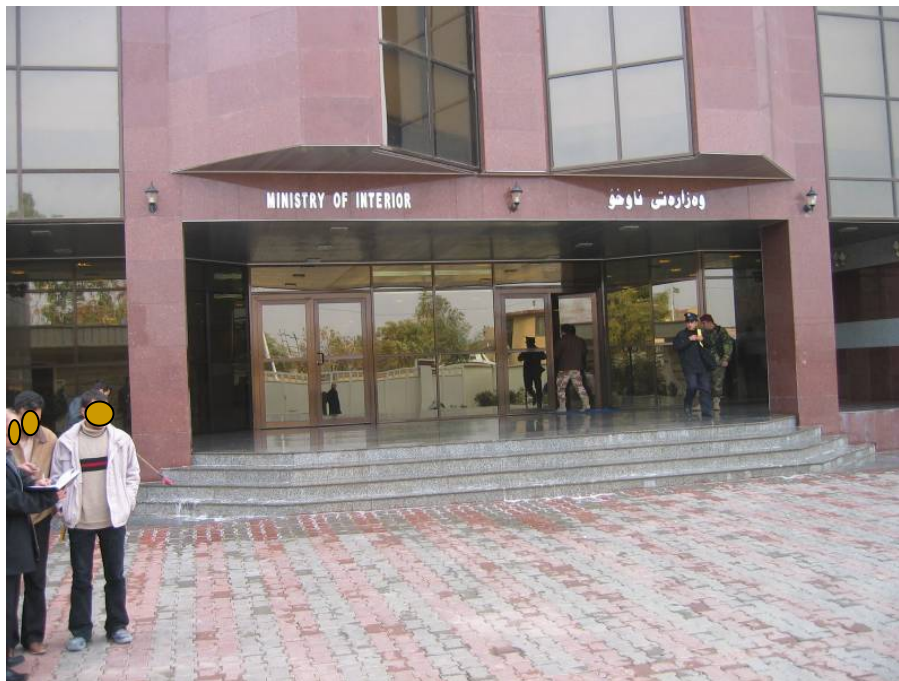
Site Photo 9: Repaired MOI entrance

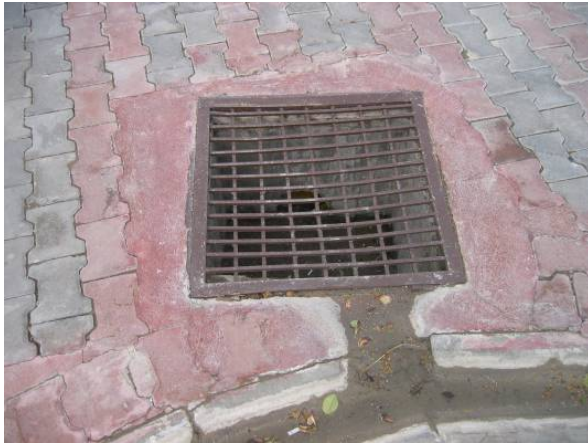
Site Photo 10. Roadside drainage ditch emptying into a manhole

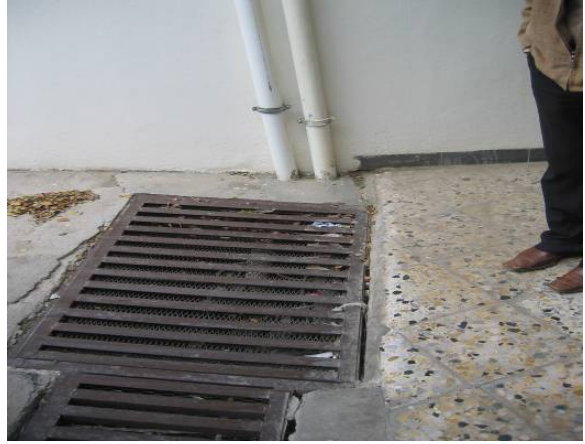
Site Photo 11. Garage culvert with a sump pump that moves water vertically to the roadway approximately three meters above the driveway

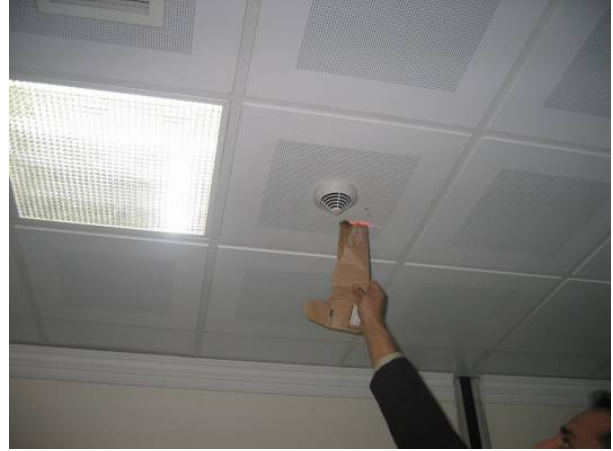
We observed fire alarm sensors and fire fighting equipment and found them to be in good condition. We also tested the alarm system in the services building by holding a burning piece of cardboard to a sensor. The first test did not work and they discovered the system

had been turned off by an employee who was performing maintenance in the control room. When the system was re-energized, the test with the burning cardboard passed. The GRN RE noted that the system should not be that easy to deactivate and added a punch list item securing the system from being deactivated unless authorized. Site Photos 19 and 20 show sample fire extinguishers and the system test.

Site Photo 20. Fire alarm test

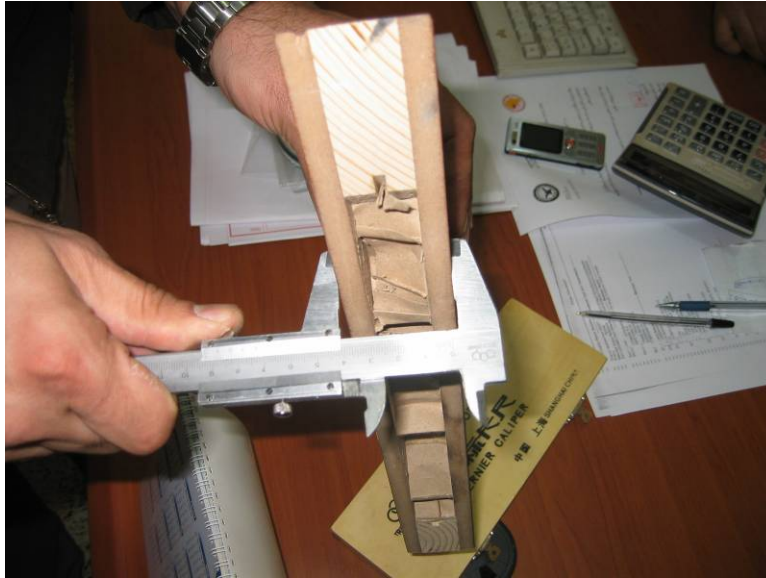
We observed and photographed a crosscut section of a new door (Site Photo 34) and tested a sample of doors which operated properly.

Site Photo 34. Cross section of an upgraded interior wooden door

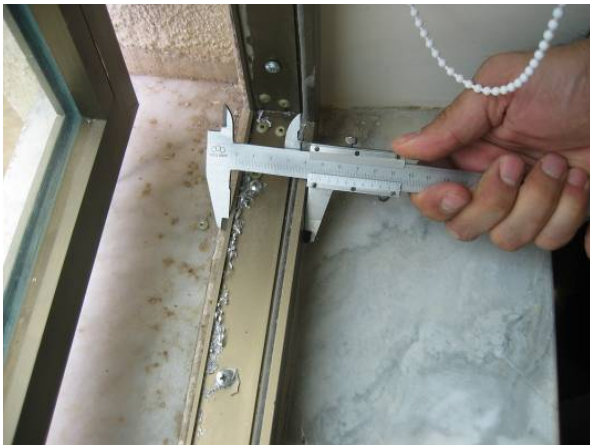
- a. The contract required installation of blast proof windows in the minister's office, reception room, and secretary's office. We observed, photographed, and measured the blast proof windows installed in the minister's reception room and adjacent secretary's and entry rooms.
- b. The windows in the remaining parts of the complex were replaced with thicker aluminum frames {(2.0-cm vs. 1.5-cm) (Site Photo 38)} and double paned glass with a vacuum sealed space between. The interior glass was coated with 21-mil (equals 0.021 inches) protective film (Site Photo 39) to prevent shattering in the event of another blast.

Site Photo 38. MOI blast resistant window

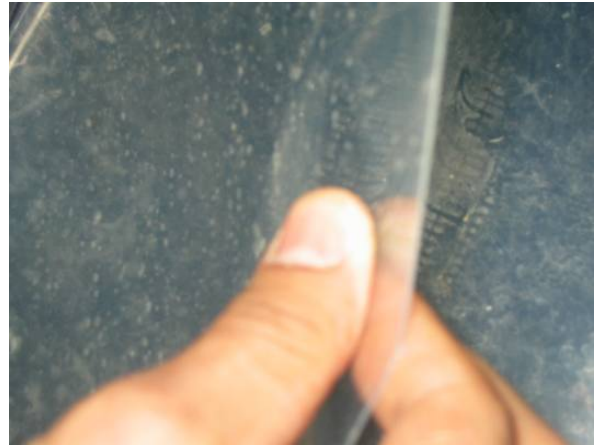
Site Photo 39. Protective film was installed on interior side of windows to prevent shattering
