**ORPHANAGE AND SENIOR CITIZEN  
ASSISTED LIVING CENTER  
ERBIL, IRAQ**

**SUSTAINMENT ASSESSMENT**

**SIGIR PA-09-178  
OCTOBER 21, 2009**

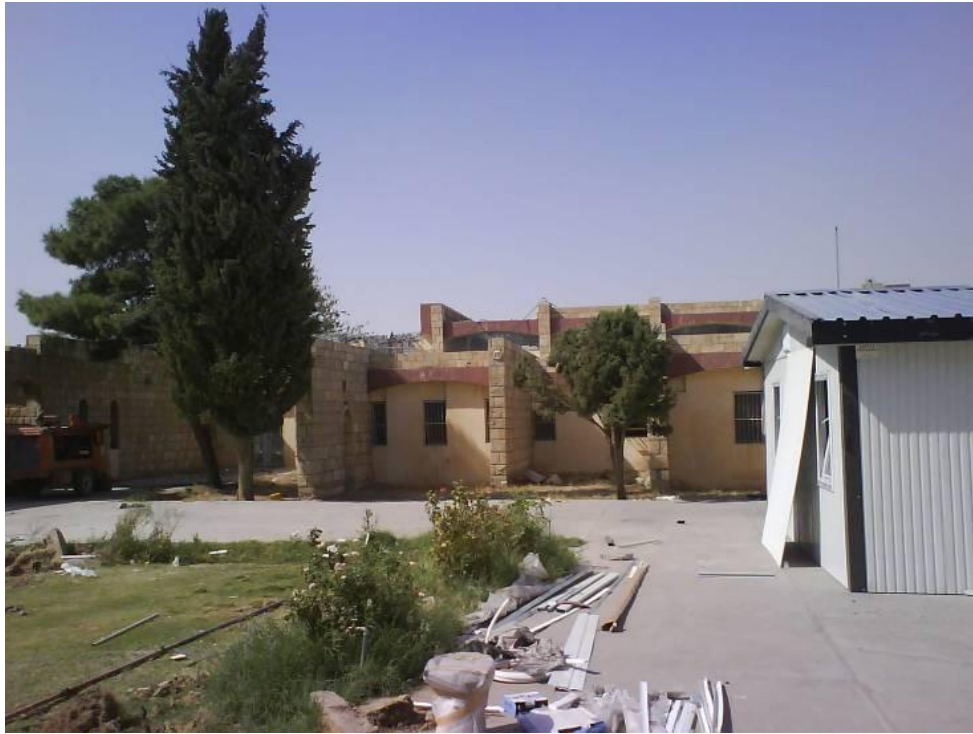
(QA) report on 22 October 2007 shows the original orphanage building in disrepair (Site Photo 1).

**Site Photo 1. Pre-construction orphanage building site (Courtesy of the USACE)**

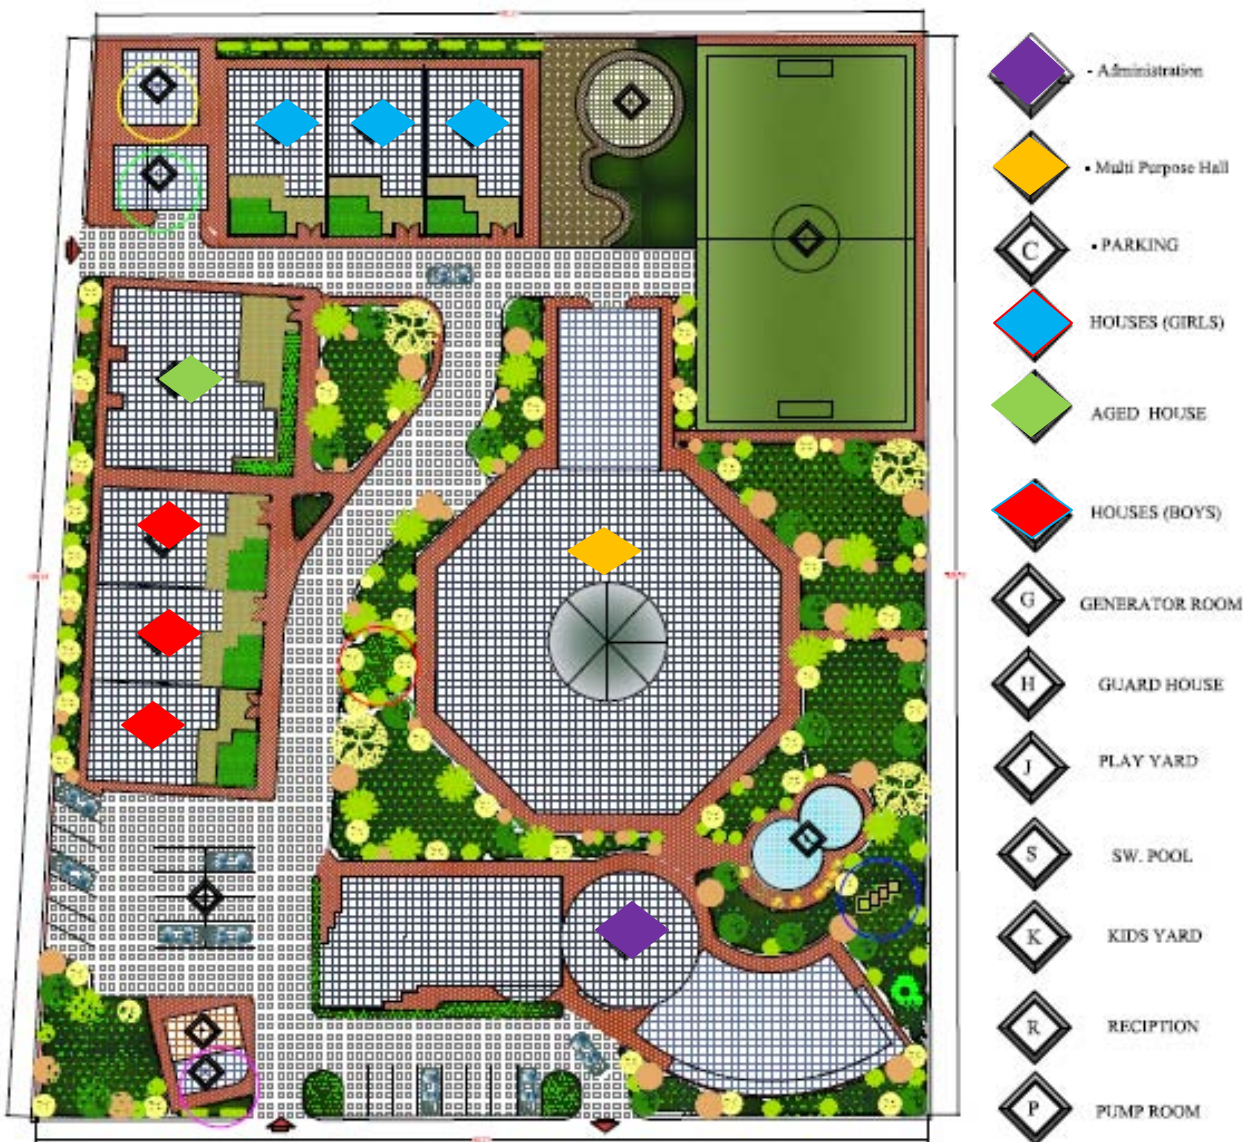
Figure 1. General site plan (Courtesy of the USACE)

The contractor-furnished site plan appeared well-planned and maximized the use of the limited space available. Landscaping and walkways were indicated on the site plan; the walkways provided good internal circulation around the buildings, and the landscape provided a buffer from the main and side streets, allowing the residents some privacy.

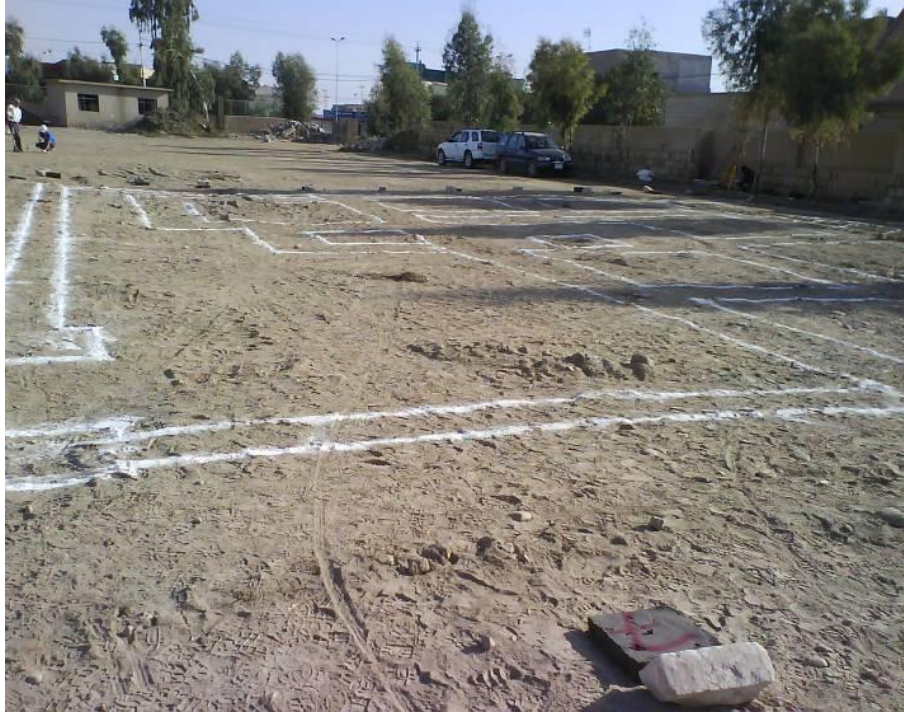
**Site Photo 2. Layout of project site (Courtesy of the USACE)**

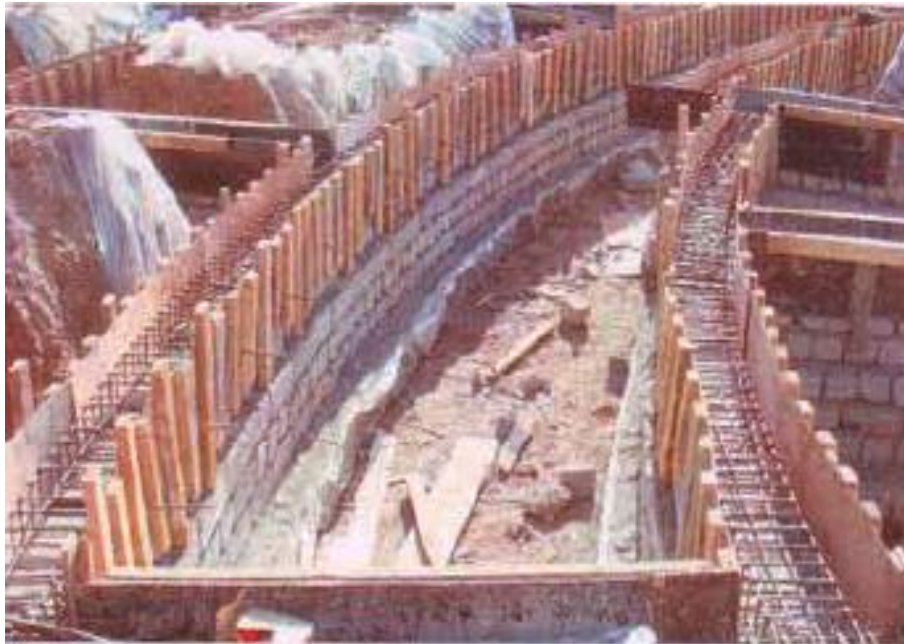
**Site Photo 3. Administrative building -- rebar and form work (Courtesy of the USACE)**

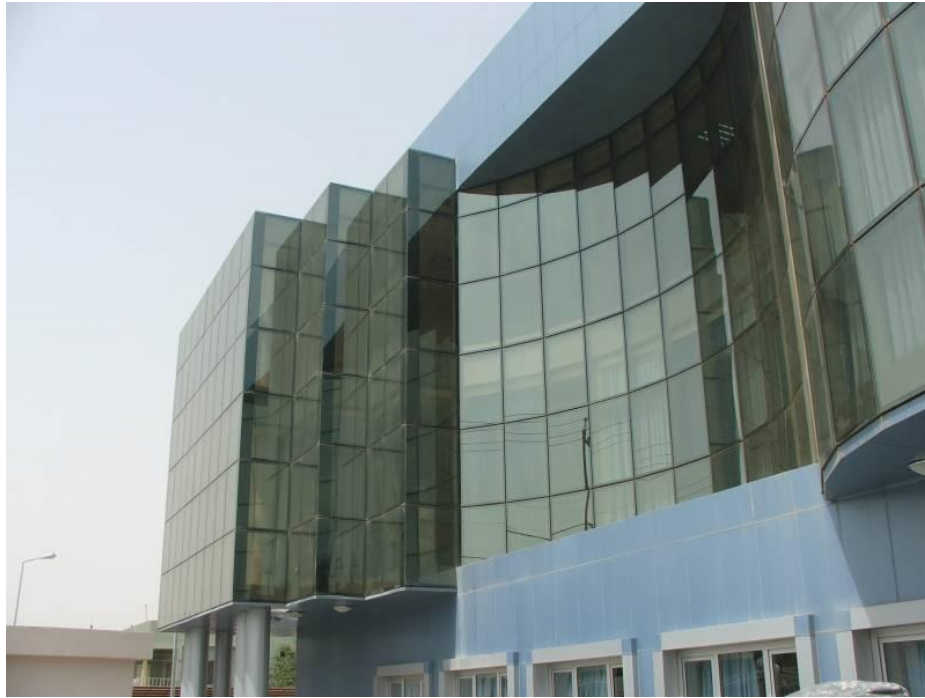
The building was configured around a central rotunda with two wings. The exterior of the administration building consisted of composite aluminum panels with a prominent glass facade. The workmanship of the building's exterior appeared satisfactory.

**Site Photo 4. Exterior view of administration building**

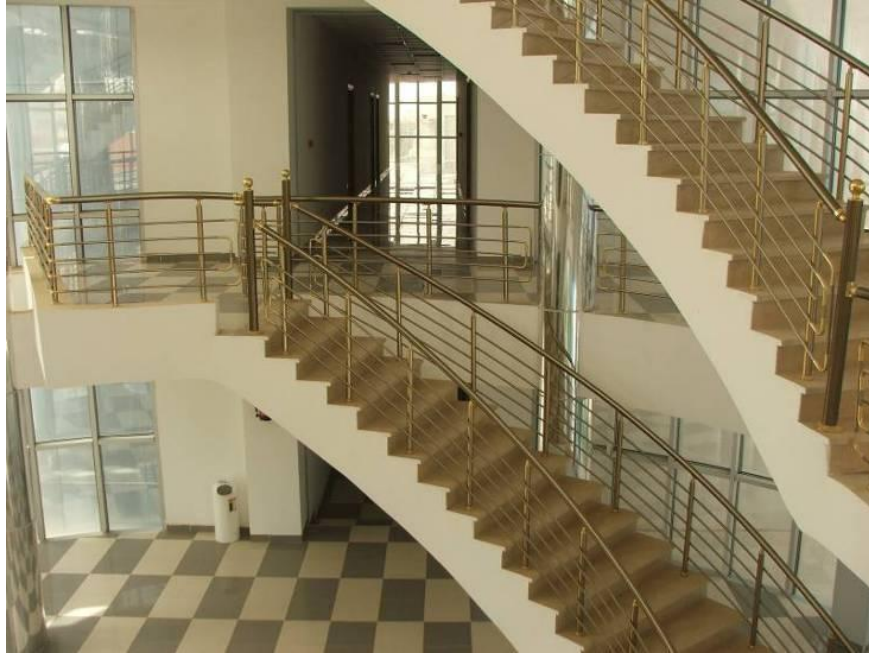
The primary stairways are located in the central rotunda. The stairways are constructed of reinforced concrete with cultured marble treads. Decorative brass and stainless steel railings are on both the stairs and at the balconies (Site Photo 5).

**Site Photo 5. Central rotunda primary stairwell**

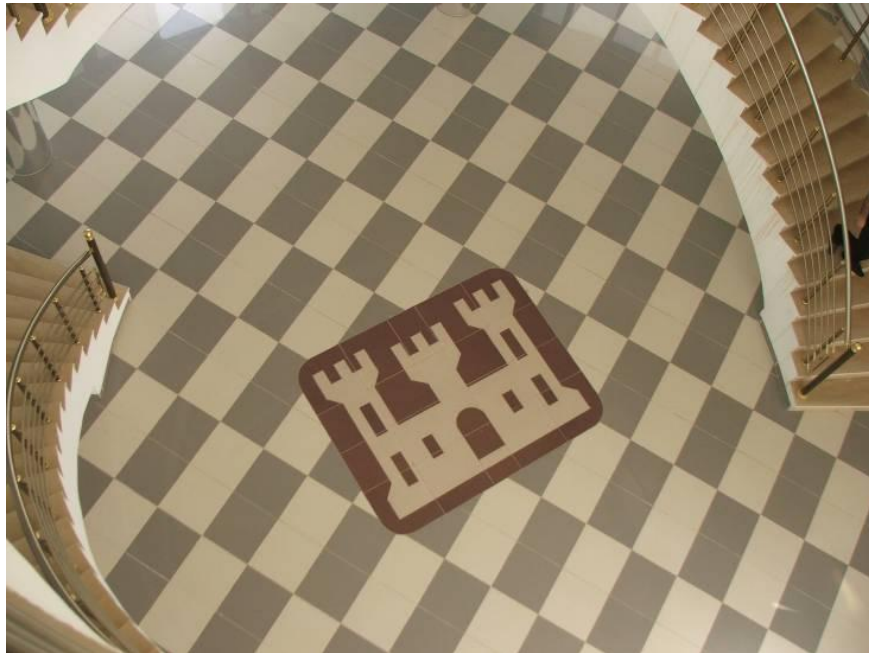
**Site Photo 6. Decorative inlay in rotunda tile flooring**

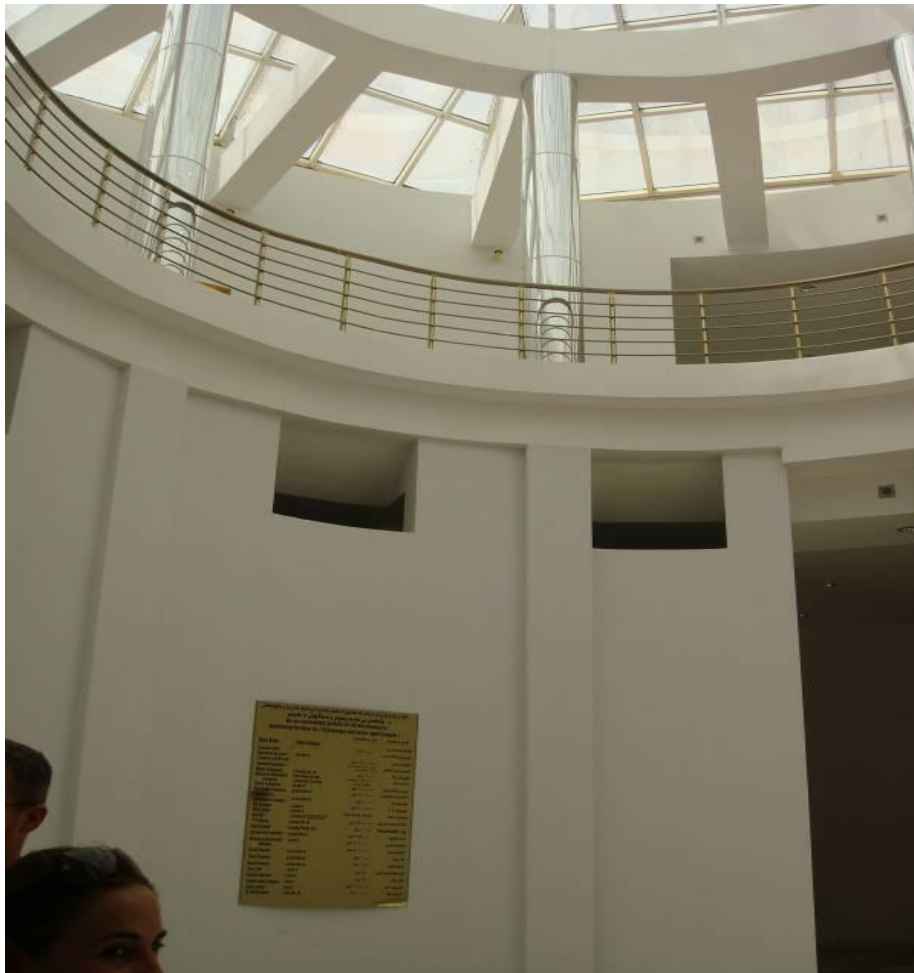
A balcony surrounds the rotunda at the second level. Decorative brass and stainless steel handrails, similar to that used in the administration building, were constructed at the edge of the balcony. The columns are covered in stainless steel (Site Photo 7).

**Site Photo 7. Rotunda of the multi-purpose building**

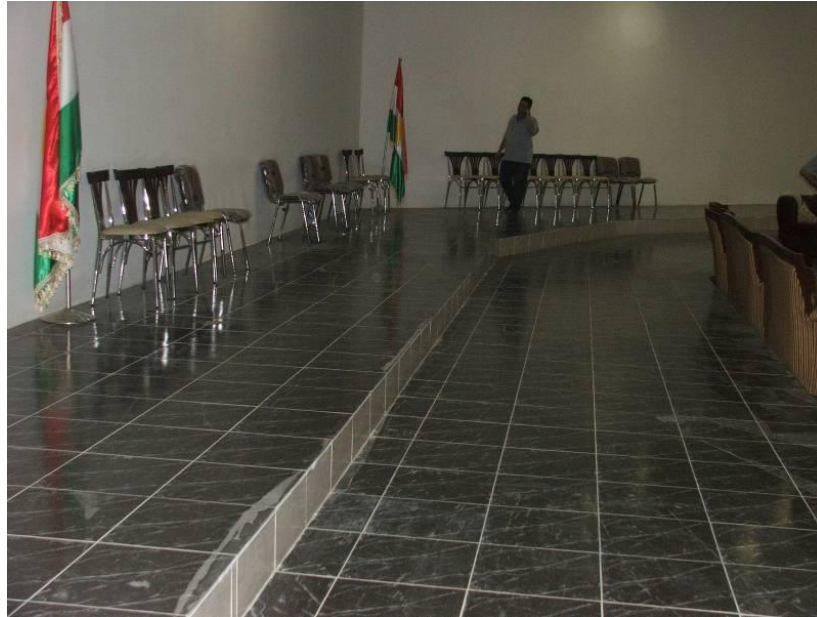
The multi-purpose building contains a large auditorium with a tiered seating area and a raised stage (Site Photo 8). The auditorium was finished with plaster walls and ceramic tile flooring.

At the time of the inspection, the plastered walls were in good condition with only minor hairline cracking, which is typical in new structures due to initial settlement. The quality of the tile was good, and the placement exhibited quality workmanship.

**Site Photo 8. Multi-purpose building auditorium**

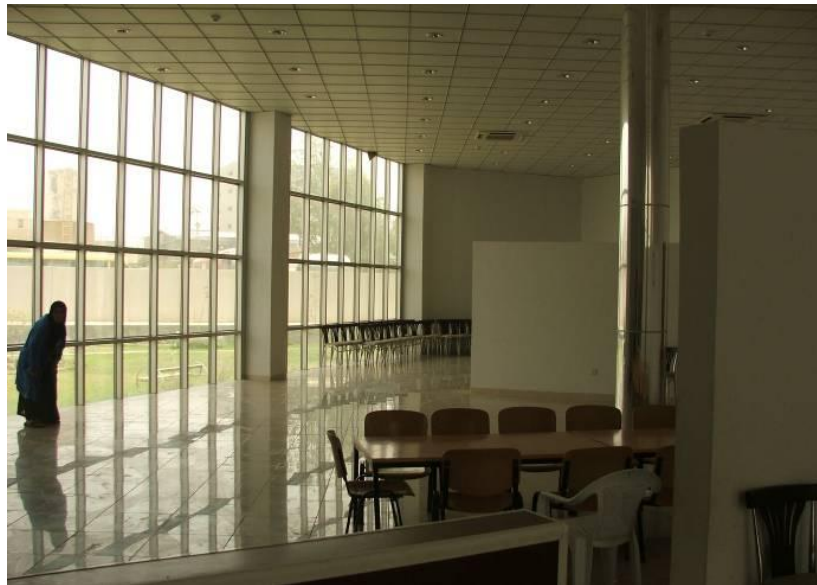
The cafeteria incorporates a floor to ceiling glass exterior wall as an architectural feature that permits ambient light and creates a pleasant atmosphere in the cafeteria (Site Photo 9). The cafeteria was finished with plaster walls and ceramic tile flooring. The placement and quality of the tile was similar to the construction seen in the auditorium. The cafeteria was furnished by MOSA with commercial grade furniture.

**Site Photo 9. Multi-purpose building cafeteria**

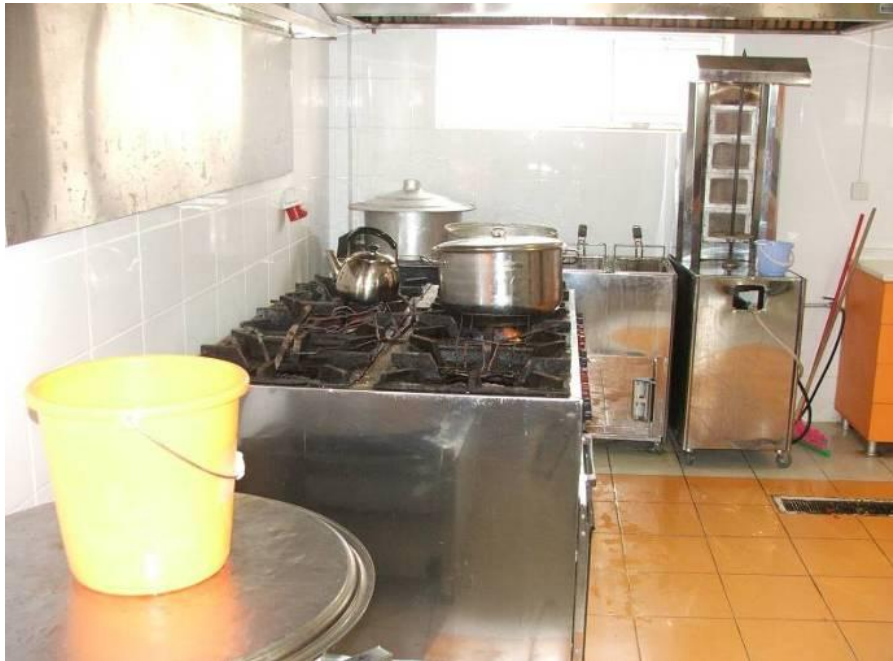
A single-story kitchen was annexed to the multi-purpose building. The kitchen consisted of commercial grade appliances, which included large gas cooking surfaces and deep fryers with stainless steel ventilation hoods (Site Photo 10). At the time of the site assessment, cafeteria personnel were preparing the noon meal.

**Site Photo 10. Commercial grade kitchen appliances**

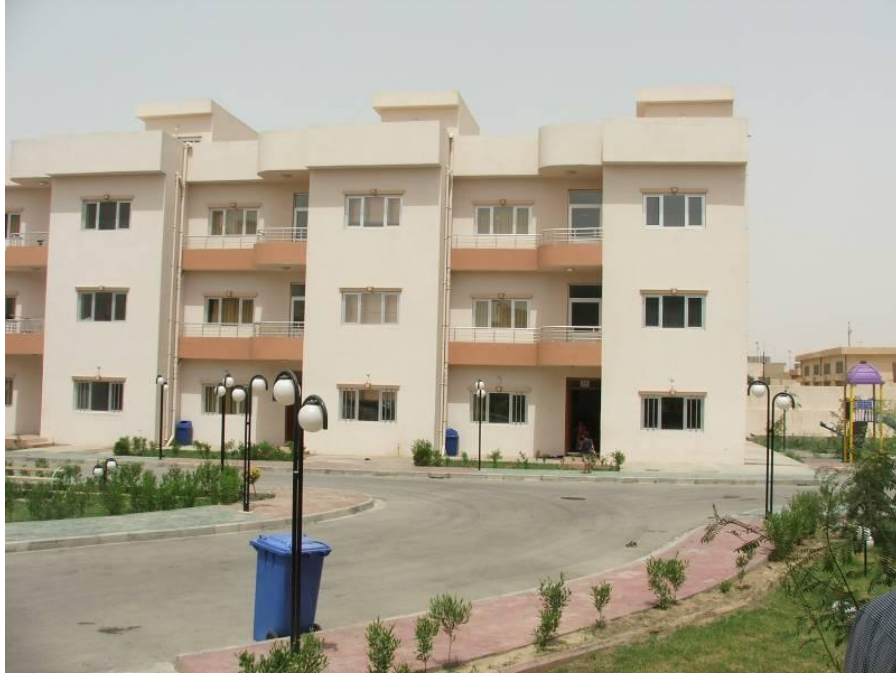
**Site Photo 11. Exterior view of residential house for boys**

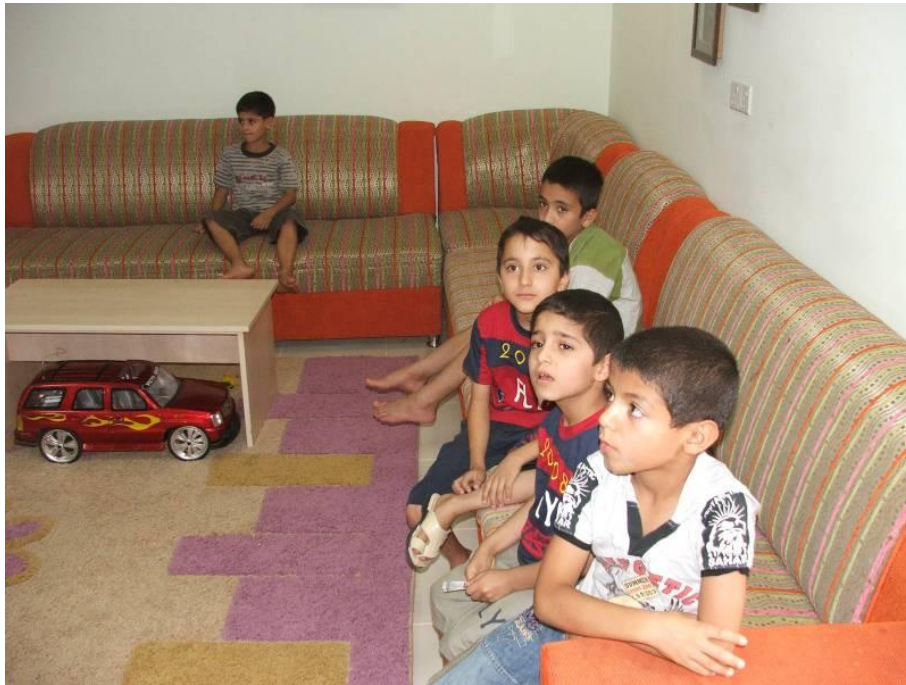
Each floor contains a suite of two bedrooms, kitchen, bathroom, and a common area. The common area was built to accommodate the occupants of each individual floor (Site Photo 12). The interior walls were finished with plaster; the floors were covered with carpet in the bedrooms and ceramic tile in the remaining areas. SIGIR did not note any significant defects in the quality of construction.

**Site Photo 12. Male residential house common area**

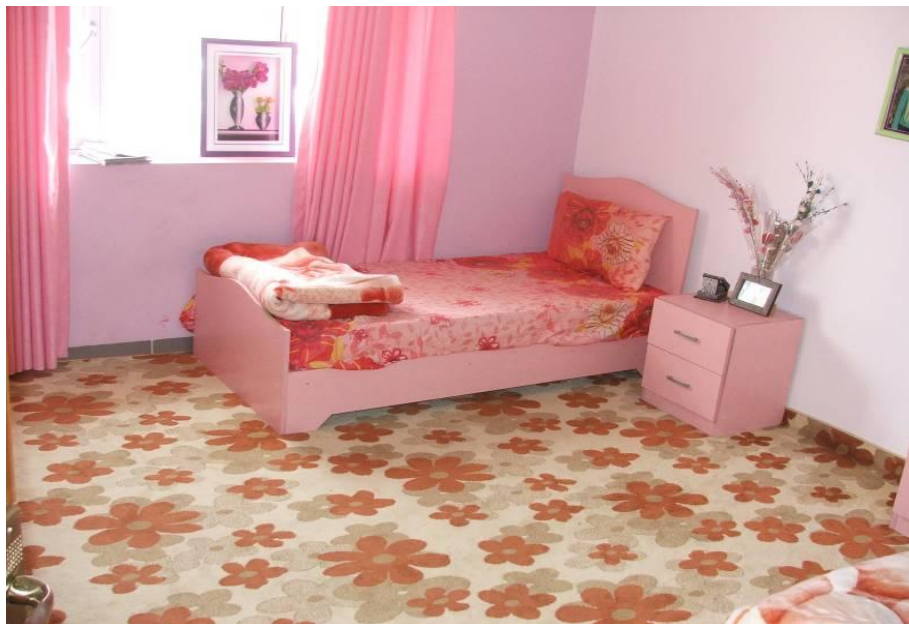
The bedrooms were arranged to accommodate three younger children or two older children. During the assessment, SIGIR noted that the bedrooms were satisfactorily furnished and maintained (Site Photo 13).

**Site Photo 13. Female residential house bedroom**

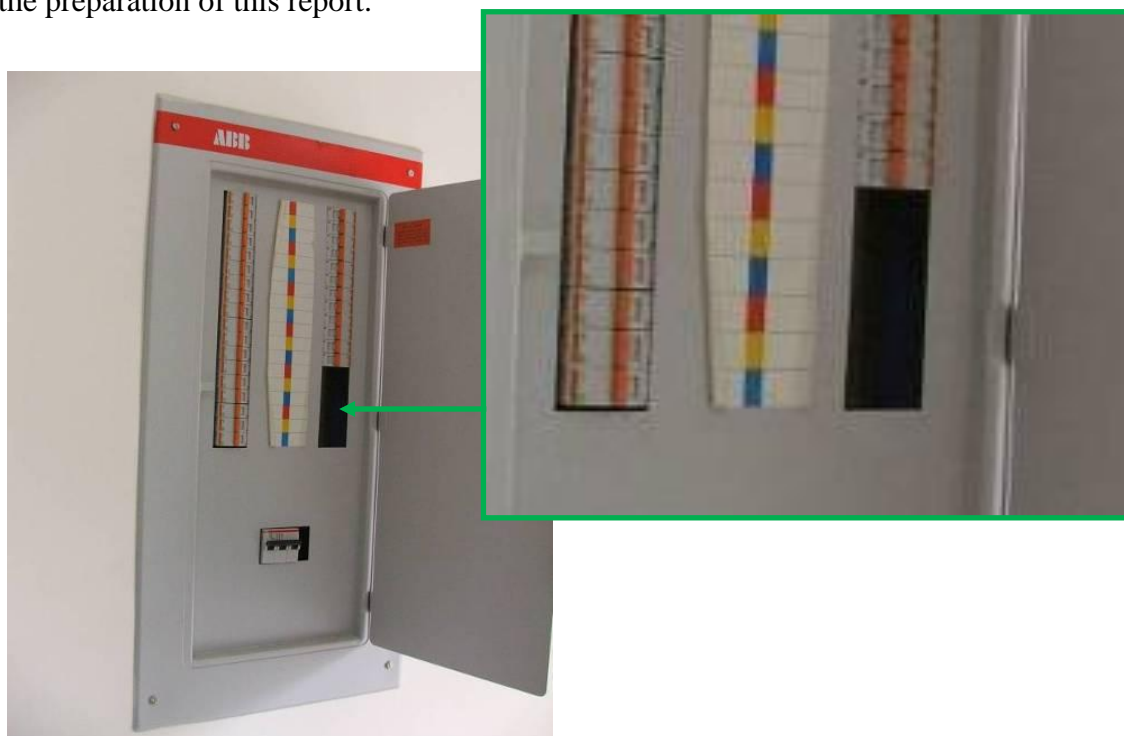
During the site assessment, SIGIR noted the primary circuit breaker panels for each unit in the children's residential houses were located on the exterior of the building. The primary circuit breaker panels were not locked and access was readily available (Site Photo 14). At the time of the site visit, SIGIR noted that there was no barrier in place over the unused panel circuits; however, the Erbil Resident Office rectified the situation prior to the preparation of this report.

**Site Photo 14. Primary circuit breaker panel with no barrier**

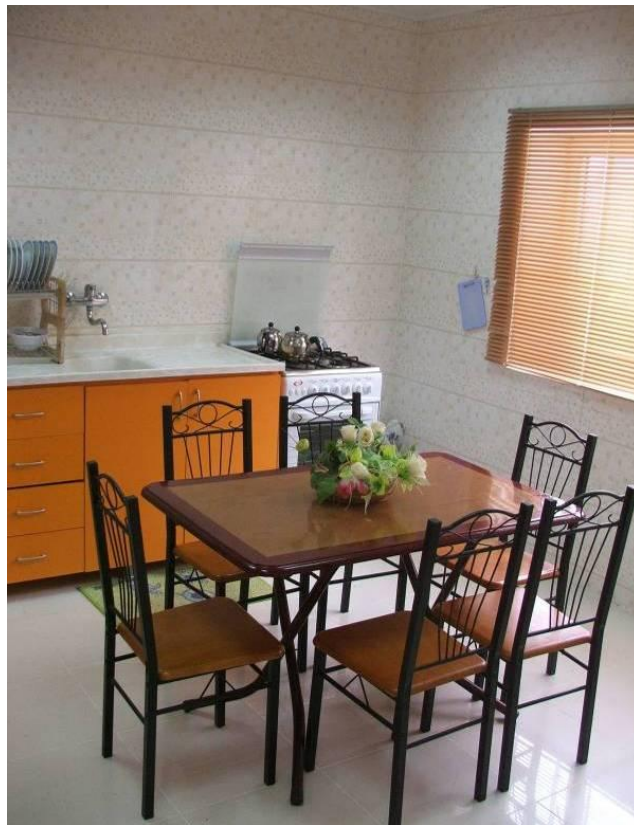
**Site Photo 15. Senior citizen's living suite**

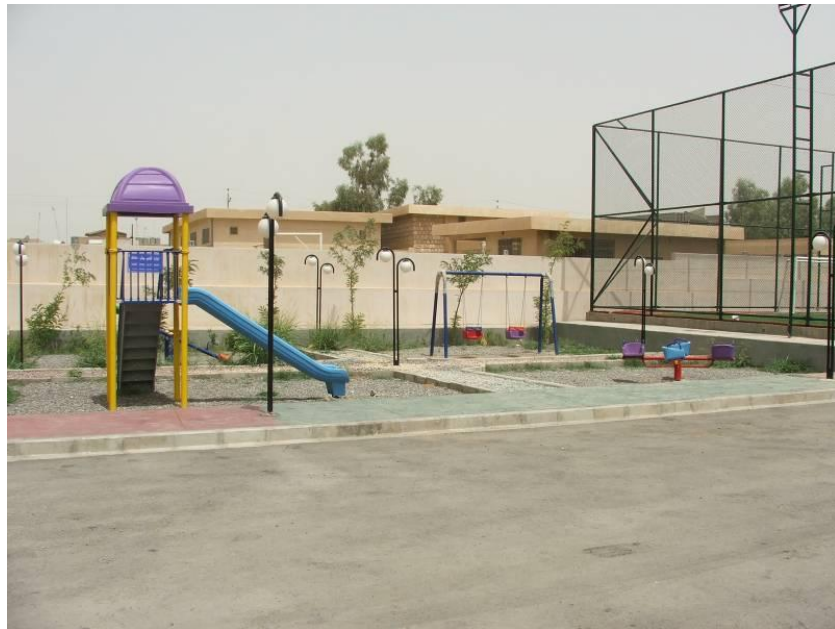
**Site Photo 16. Playground**

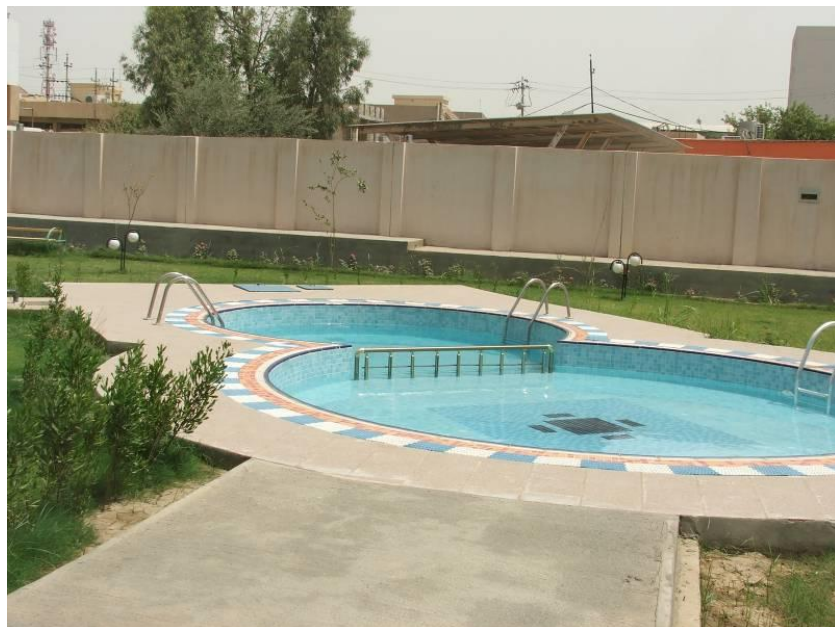
The swimming pool was located on the opposite side of the administration building, away from the dormitories (Site Photo 17). The facility's manager stated that the pool was located there to prevent unauthorized access by the children. Also, the swimming pool was surrounded by a security fence with a gate to limit access by unauthorized individuals.

**Site Photo 17. Swimming pool**

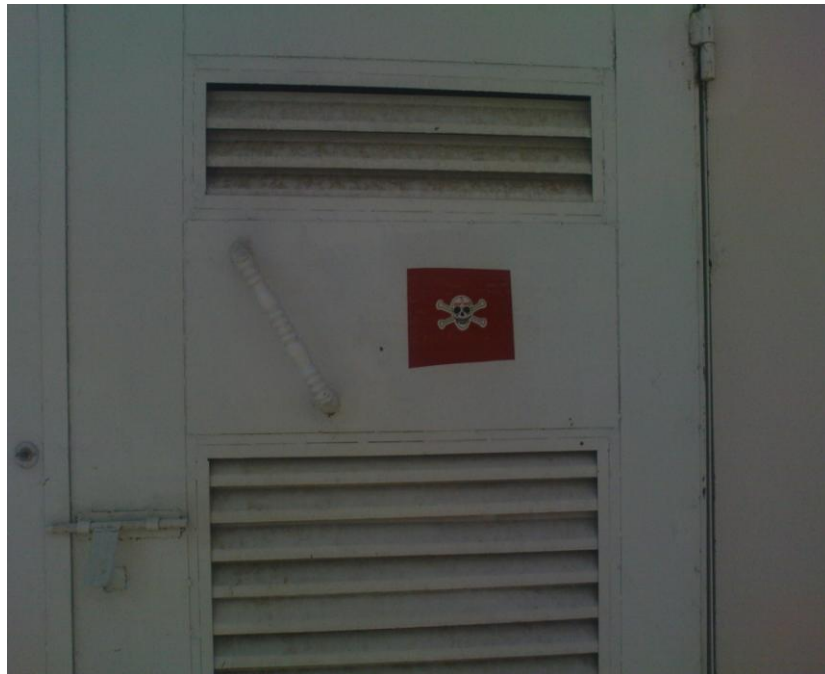
A method of securing the generator and transformer enclosures was provided. The doors to the building were lockable with both a deadbolt and an exterior padlock. At the time of the inspection, the deadbolts to the generator and transformer building were not locked. Also, SIGIR noted that there were no signs on the generator and transformer building warning of high voltage or shock hazard.

**Site Photo 18. Warning sign on generator building (Courtesy of the USACE)**

However, since the site assessment, the Erbil Resident Office worked with the contractor to have warning emblems installed on the generator building (Site Photo 18) who will also supplement the symbols with warning text.
