**SARWARAN PRIMARY SCHOOL**  
UNDER THE COMMANDER'S EMERGENCY RESPONSE PROGRAM  
**ERBIL, IRAQ**

**SIGIR PA-08-120**  
**APRIL 21, 2008**

SUBJECT: Report on Project Assessment of the Sarwaran Primary School, Erbil, Iraq (Report Number SIGIR PA-08-120)

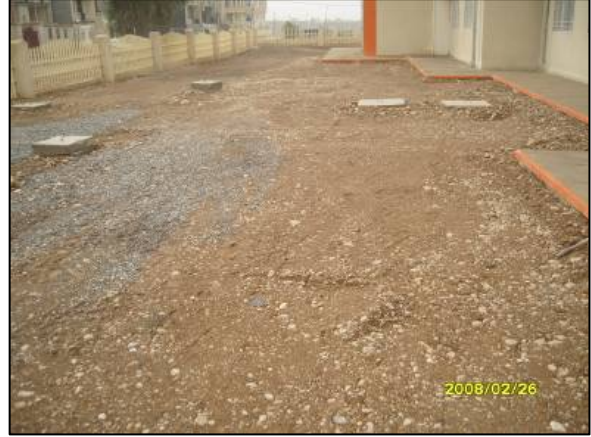
**Site Photo 2.** Correction of grading and grading level subsequent to site visit (Photo courtesy MND-NE).

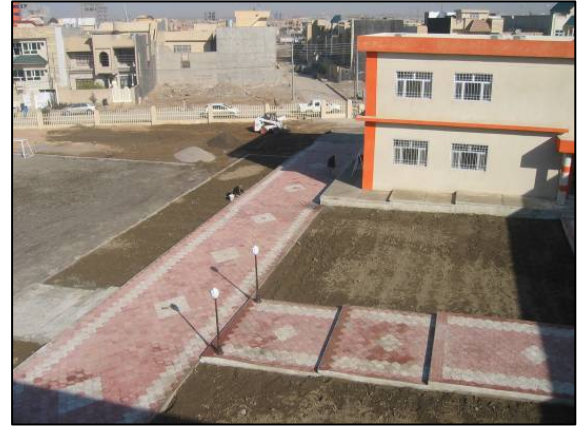
**Site Photo 4.** Outside building finish

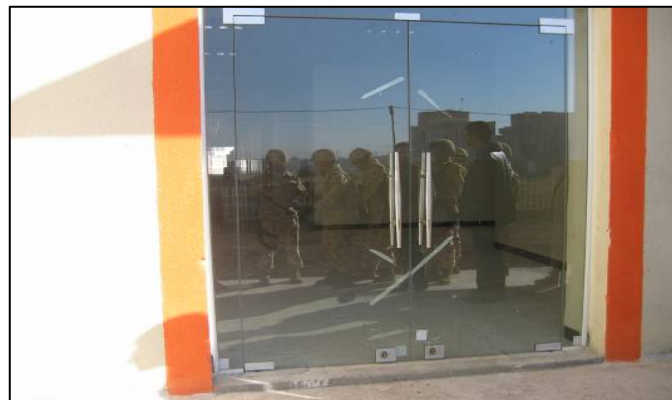
**Site Photo 5.** Tempered glass entry door

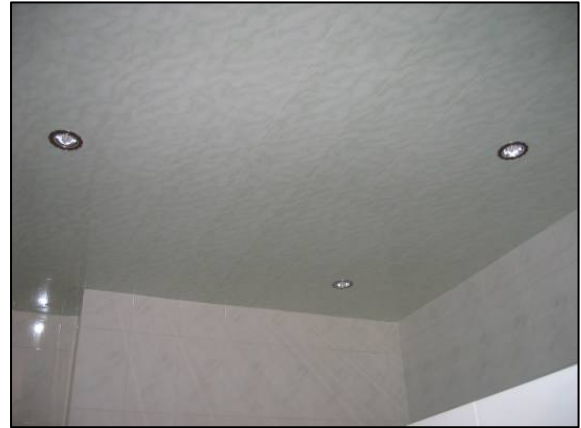
Site Photo 11. Bathroom ceiling

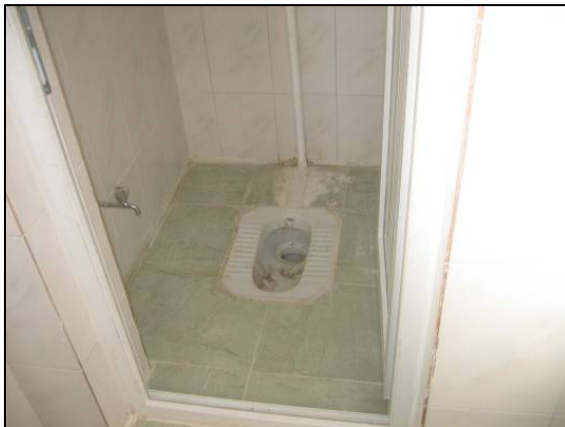
Site Photo 12. Eastern toilet

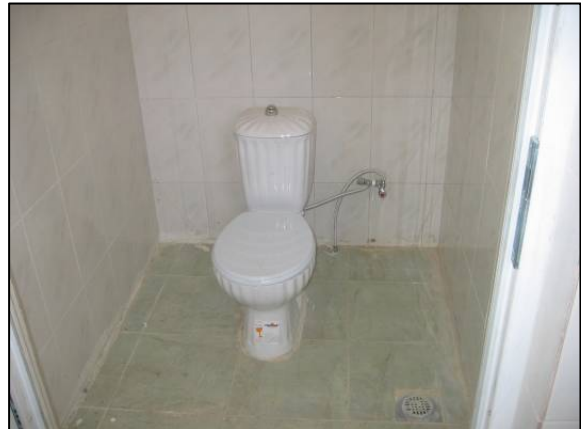
Site Photo 13. Western toilet

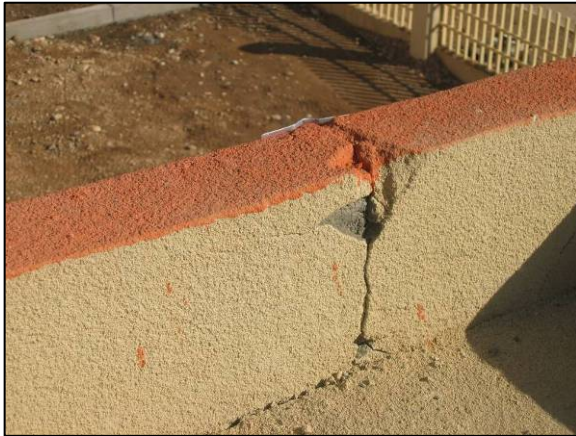
Expansion joints were installed to prevent stress cracks in the structural walls as the concrete expands and contracts during temperature changes. One expansion

joint on the roof was covered with concrete and experienced a stress crack about 8 cm long. SIGIR recommended that the parapet and the expansion joint be reconstructed. Site Photo 19 shows the stress crack along the roof. Site Photo 20 shows the corrective action taken subsequent to the site visit.

**Site Photo 19. Stress crack in concrete covering an expansion joint.**

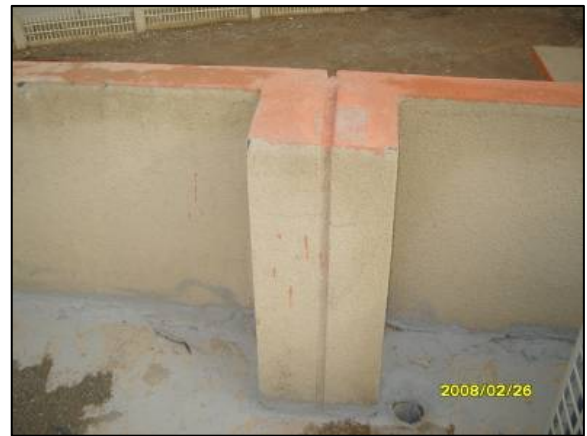
**Site Photo 20. Corrective action subsequent to site visit to reconstruct parapet and expansion joint. (Photo courtesy of MND-NE).**

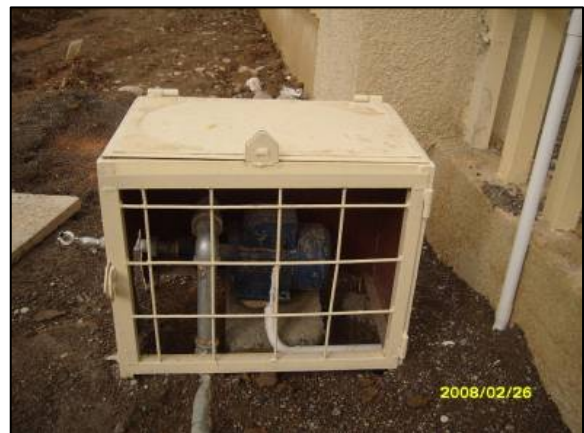
**Site Photo 26. Corrective action subsequent to site visit to provide a cover for the pump.  
(Photo courtesy of MND-NE).**
