**REPAIR OF THE AL GHAZALIYAH
G-7 SEWAGE LIFT STATION**

UNDER THE COMMANDER'S EMERGENCY RESPONSE PROGRAM

BAGHDAD, IRAQ

**SIGIR PA-07-118
JANUARY 25, 2008**

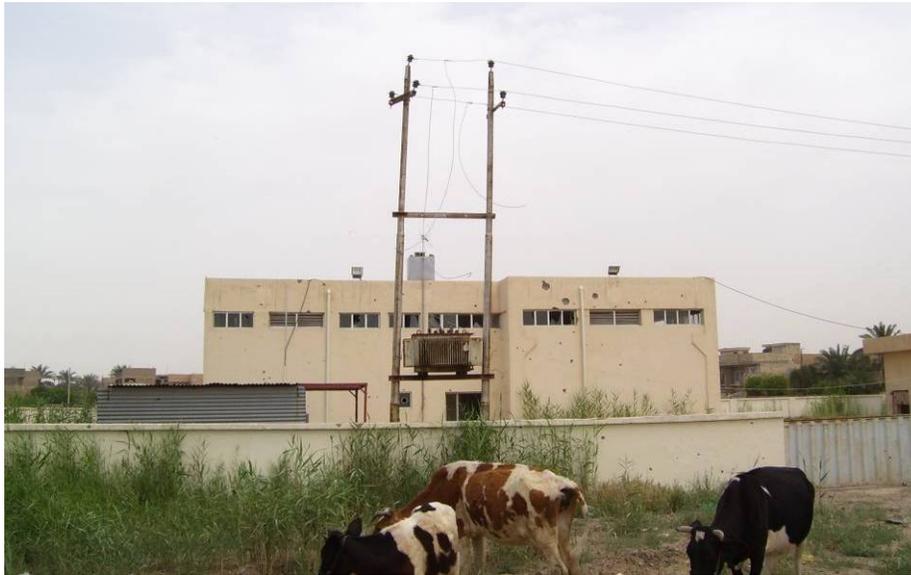
Site Photo 1. Exterior view of the Al Ghazaliyah G-7 Sewage Lift Station

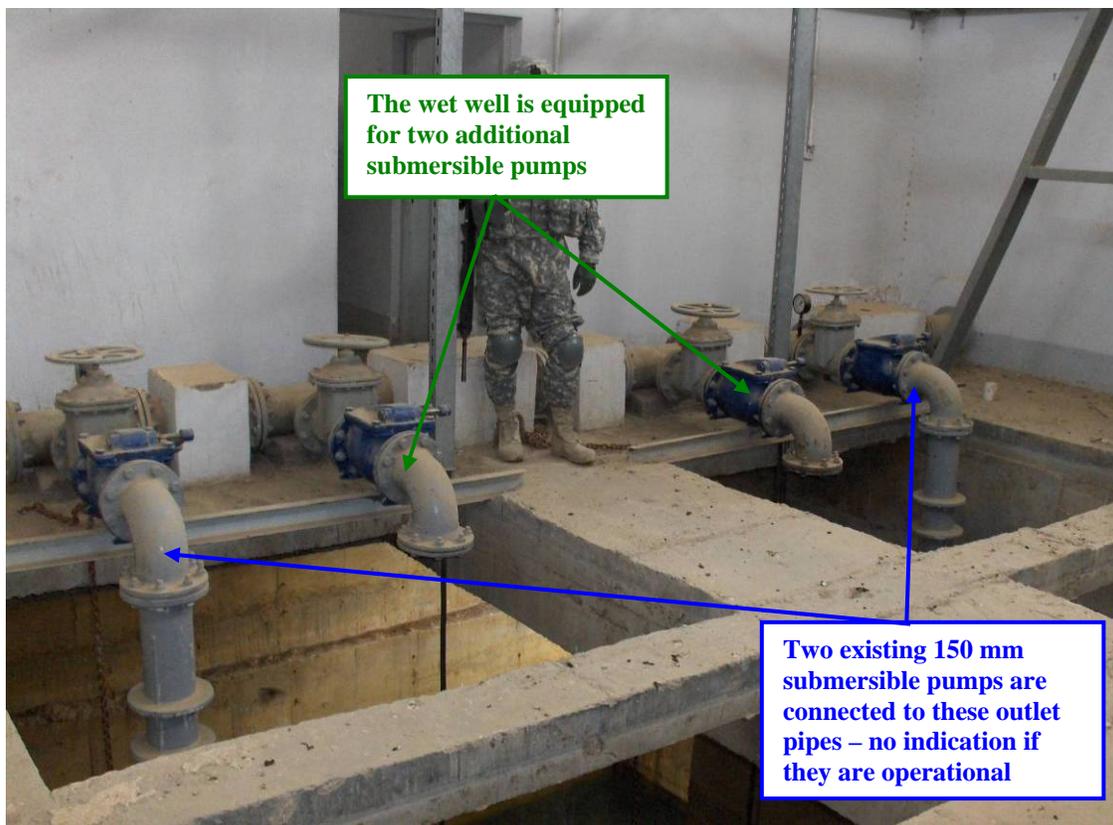
Site Photo 2. Interior view of Al Ghazaliyah G-7 Sewage Lift Station building

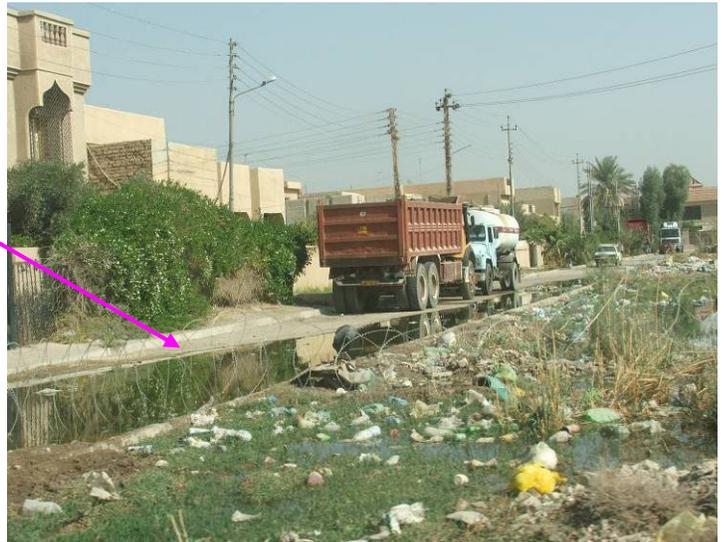
Site Photo 3. Backed-up sewer water

The degree of the streets' backed-up sewer water varied from several inches deep near the gutters to the entire width of the street.

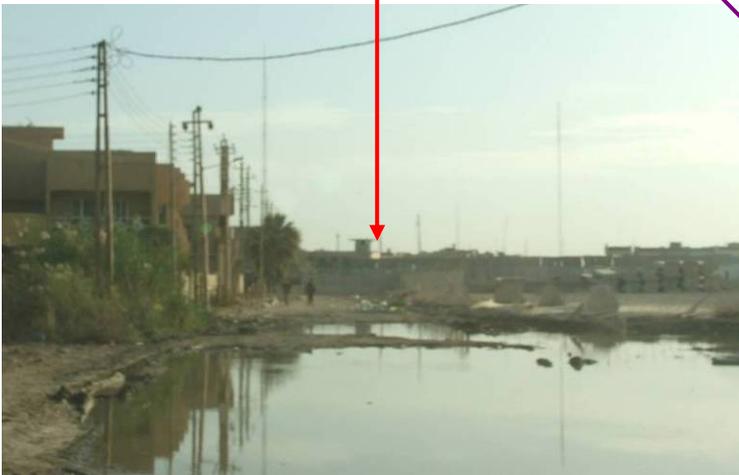
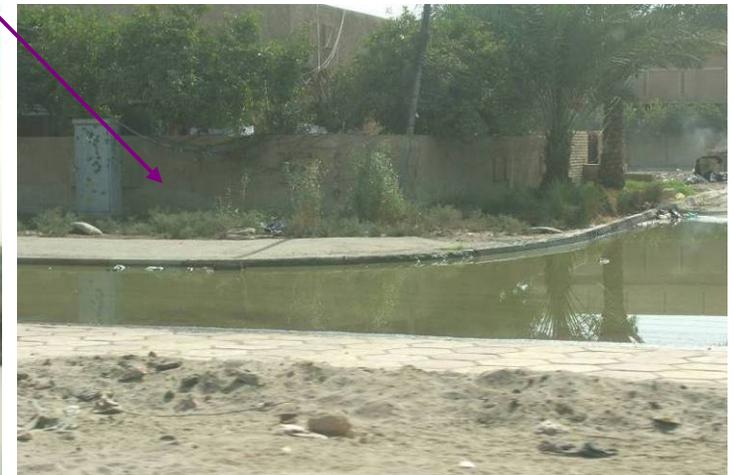
Site Photos 4 and 5. Backed-up sewer water in the Al Ghazaliyah area of Baghdad

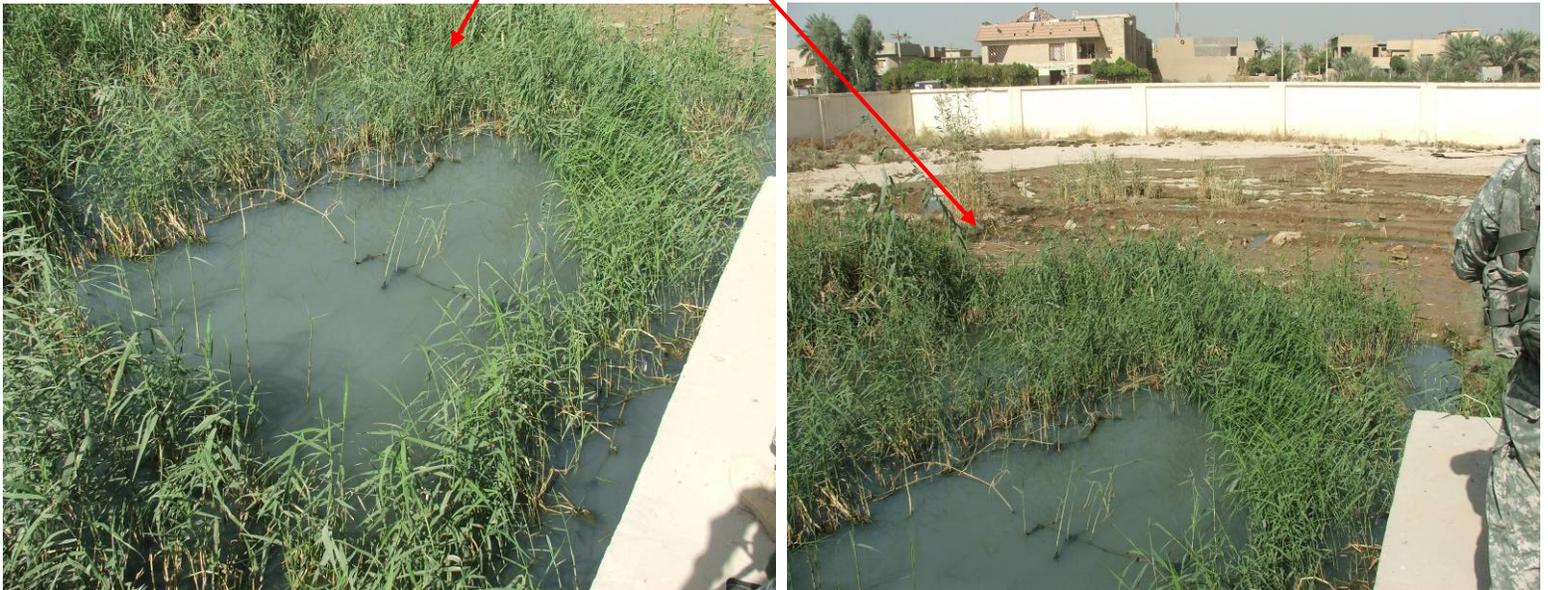
Inspectors also viewed a large pool of collected sewer water outside the sewage lift station building (Aerial Image 4 and Site Photos 6 and 7). During our site visit, maneuver unit personnel stated that the sewer pipes leading into the facility were old and broken. Considering the depth of the sewer water pool and the growth of weeds around it, the sewer line was broken for an extended period. However, the SOW did not address the problems with the broken sewer pipes. Without addressing this problem, the completion of this project will not lead to a "complete and useable facility" because the sewer water will not enter the lift station's wet well (to be pumped out to the next manhole).

Site Photos 6 and 7. View of pool of accumulated sewage water outside the G-7 lift station

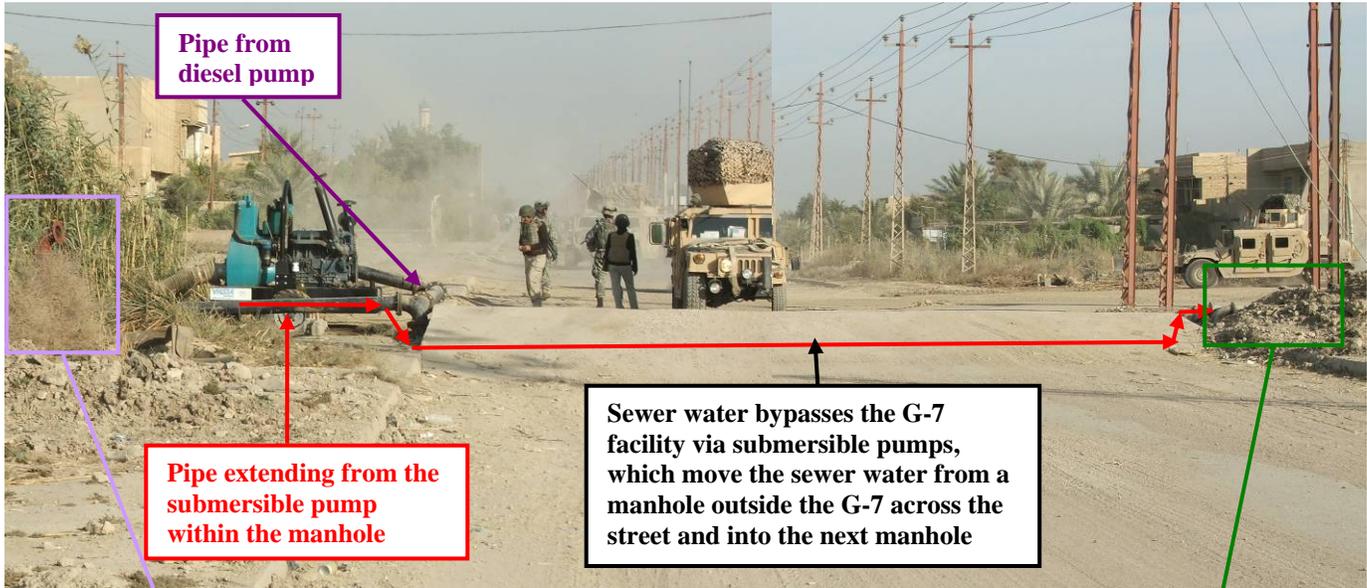
During our site visit, inspectors noticed two pipes exiting a manhole outside the lift station (Site Photo 8). One pipe was attached to an above ground diesel pump; while the other pipe was attached to a submersible pump. The two out-flow pipes rose out of an existing manhole and passed under a concrete hump to cross the street in order to use a higher elevation manhole as an outlet point (Site Photos 9 and 10).

Site Photo 8. View of bypass system employed to allow sewer water to flow to the next available manhole

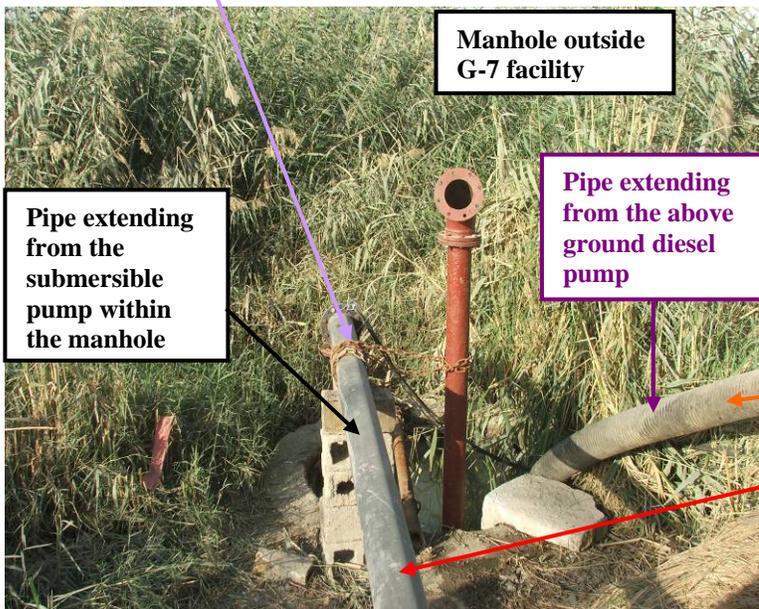
Site Photos 9 and 10. Enlarged views of Site Photo 8.

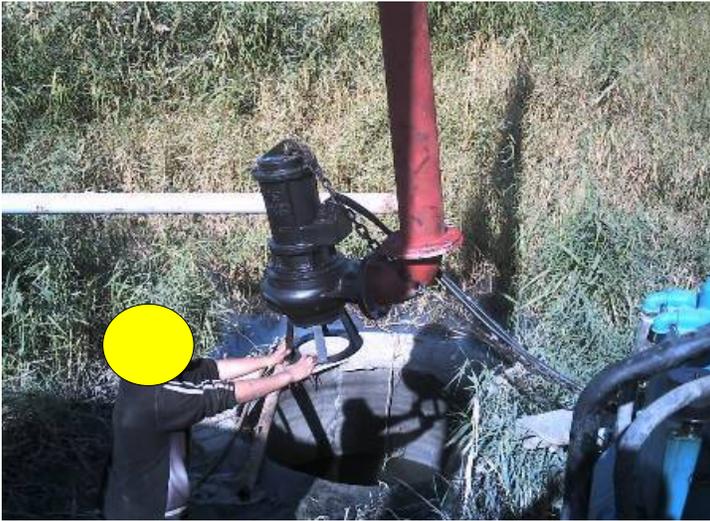
On 4 December 2006, the daily contractor's quality control (QC) report documented the delivery and installation of the single 150 mm submersible pump (Site Photo 11); while

Site Photo 11. Installation of 150 mm submersible pump into manhole outside G-7 lift station (Photo courtesy of USACE)

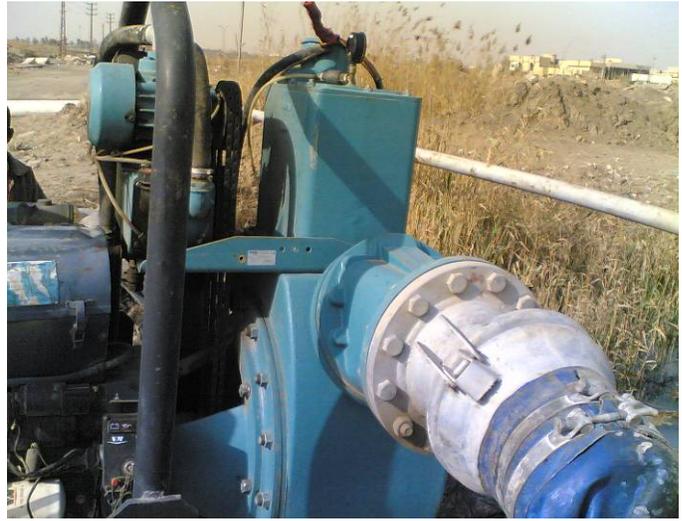
the 5 February 2007 daily government quality assurance (QA) report documented the arrival of the diesel pump at the facility (Site Photo 12).

Site Photo 12. Diesel pump used at the manhole outside the G-7 lift station (Photo courtesy of USACE)

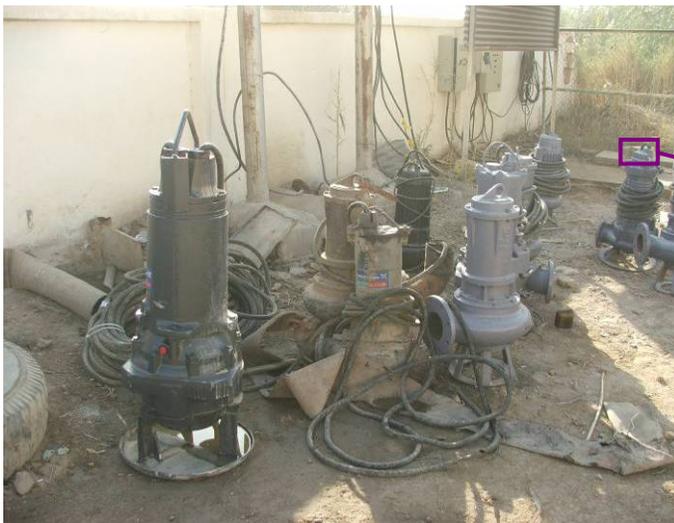
Site Photo 13. Submersible pumps located outside the G-7 lift station

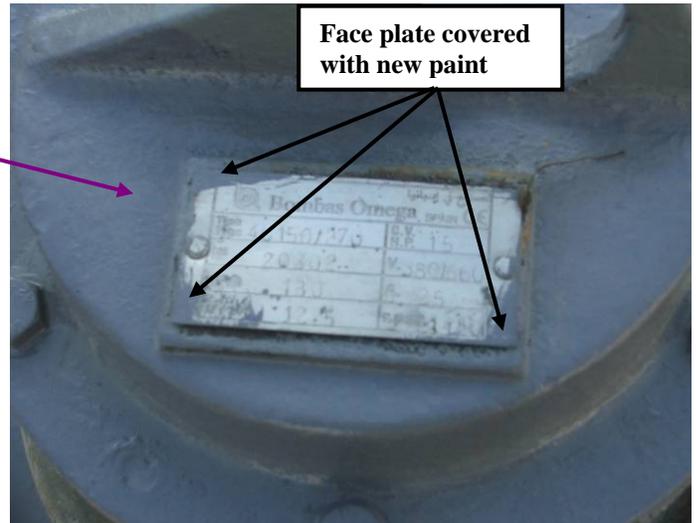
Site Photo 14. Close up view of a submersible pump (appears old pumps were just painted)

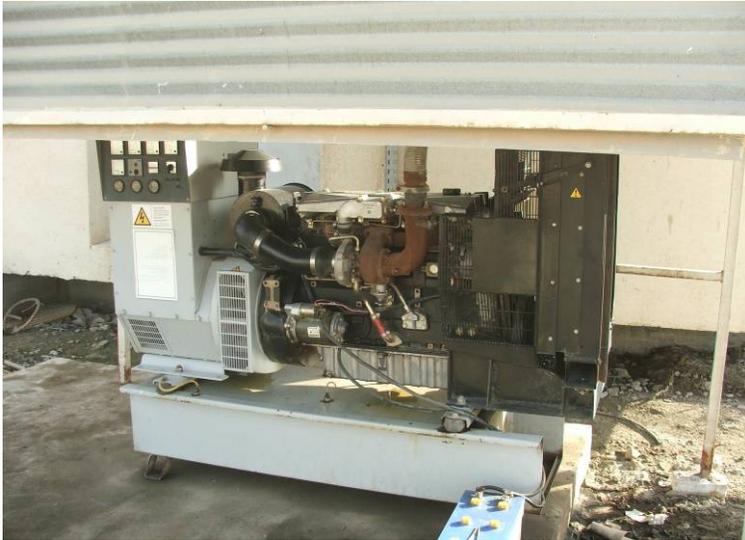
During our site visits, SIGIR identified two generators at the lift station site – one in front of the lift station and one in the rear. According to GRC documentation, the contractor supplied the generator in the rear of the facility (Site Photo 15). GRC personnel verified the contractor provided the contract required size generator (Site Photo 16). The generator was installed on a reinforced concrete pad, as required by the SOW.

Site Photo 15. Contractor provided 100 kVA generator

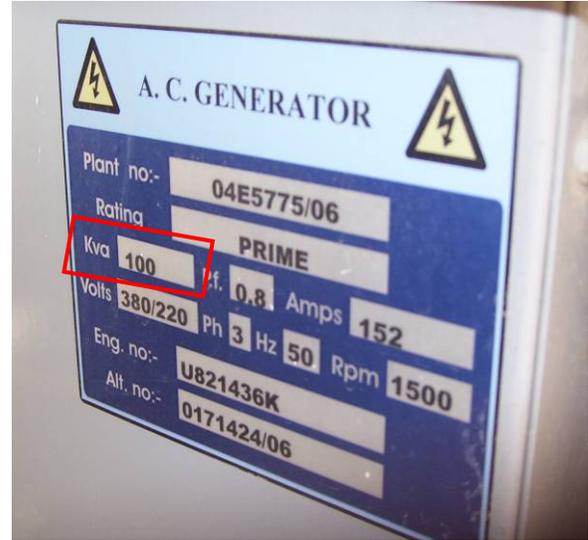
Site Photo 16. 100 kVA generator face plate

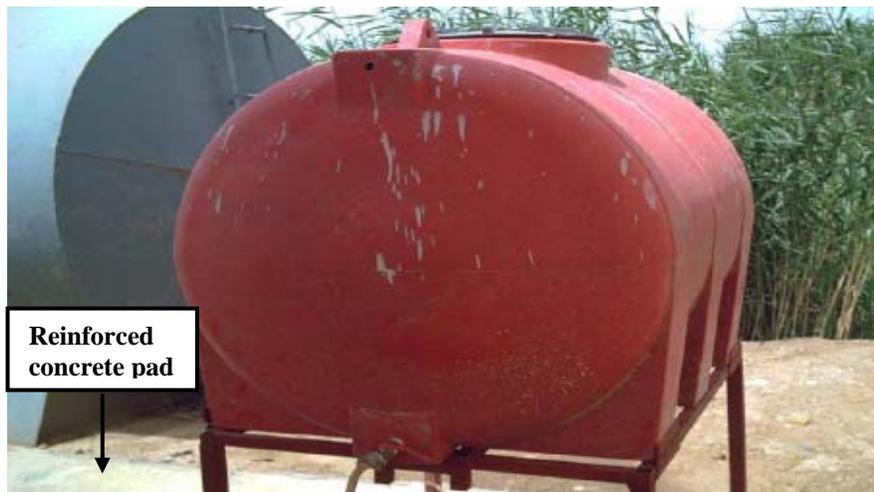
SIGIR identified two fuel tanks at the lift station. According to the daily QC reports, the smaller tank was the SOW required 1,000 liter fuel tank. The contract file lacked documentation to confirm this fuel tank is the required size. The fuel tank was installed on a reinforced concrete pad, as required by the SOW (Site Photo 17).

Site Photo 17. 1,000 liter generator fuel tank

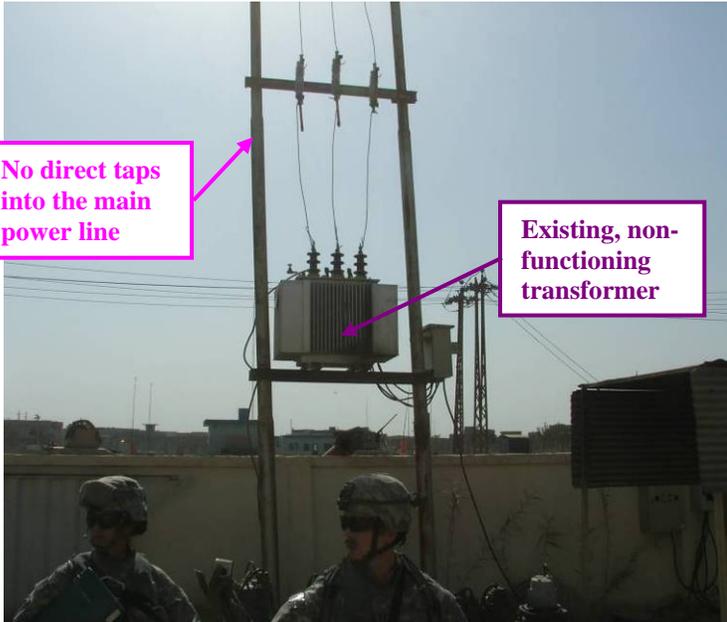
During our first site visit, SIGIR identified the old, non-operational transformer (Site Photo 18). The transformer was subsequently removed and the facility was directly tapped into the main power line by jury-rigging the electrical wires (Site Photo 19). This is an extremely dangerous practice and likely will damage and/or destroy the facility's electrical equipment and controls as well as endanger the safety of the operator. Iraqi main power lines normally carry 400 volts. Without a step-down transformer, turning on the control panel could potentially short circuit the equipment and potentially electrocute

Site Photo 18. Existing transformer

The lift station requires a new transformer to take advantage of the electrical grid and also the two on site generators.

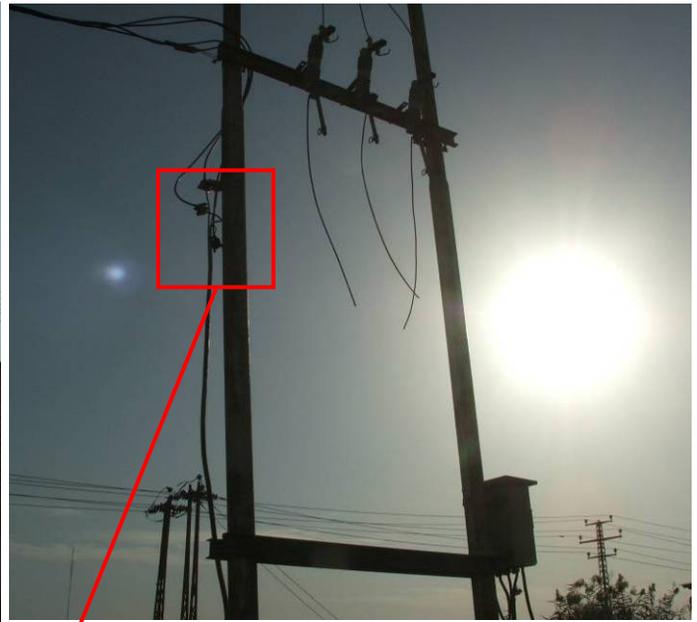
Site Photo 19. Missing transformer and direct tapping into the main power line

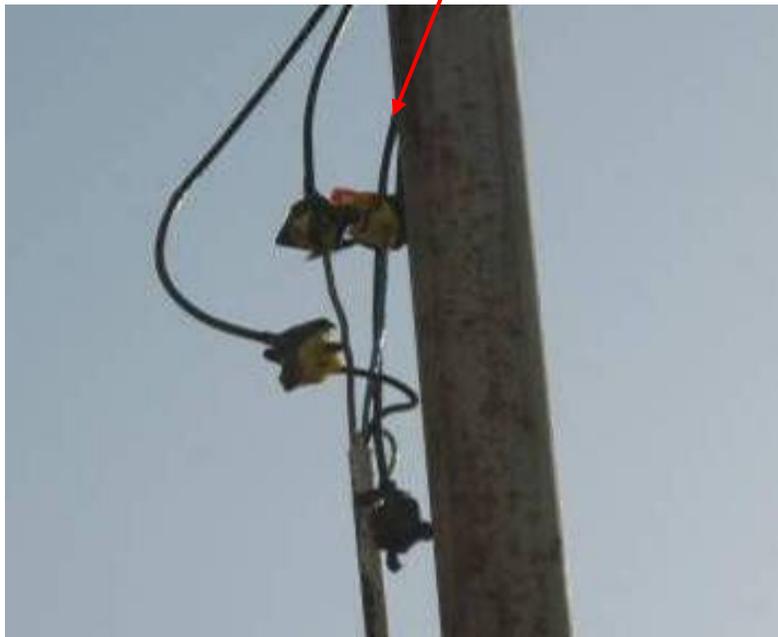
the operator. It is extremely unsafe to have unregulated splices in power cables carrying relatively high voltage since the splices are unsupported and unprotected (Site Photo 20). As a result, it is possible that a loose wire could come free and potentially electrocute someone in the vicinity of the lift station.

Site Photo 20. Unsafe splices directly into the main power line

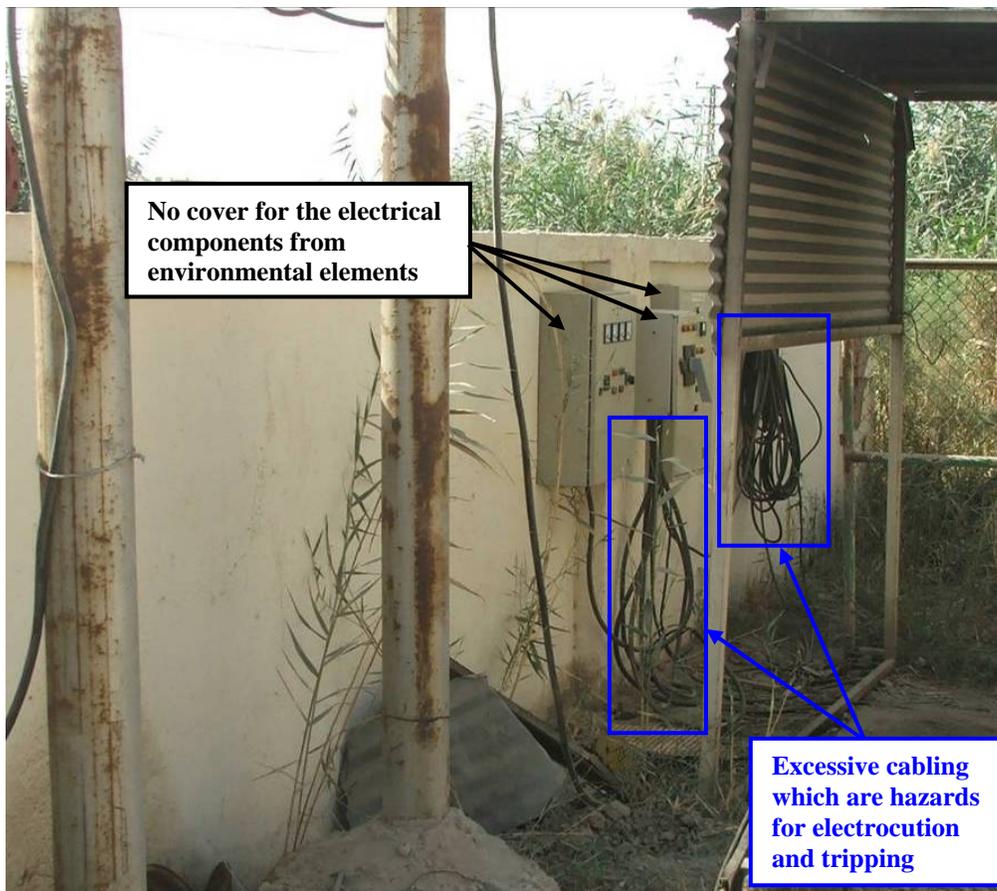
SIGIR identified the Main Distribution Panel and the cabling supplied and installed by the contractor to connect the facility to the main distribution grid (Site Photo 21). The installation technique used by the contractor was not adequate. For example, the contractor situated the control panel outside the facility without any method to protect the electrical components from the environmental elements, such as rain, excessive heat, sand, and dirt, which over time, will reduce the lifespan and usefulness of the control panel. In addition, an excessive amount of cabling was used, which resulted in electrical cable dangling down on the ground. The dangling cabling poses not only a tripping hazard, but could become damaged and also lead to electrocution.

In view of the previously noted fact that the electrical control panels were improperly directly tapped from the main distribution grid and without use of a step-down transformer, inspectors did not feel it was safe to touch the electrical control panels. As a result, we could not assess the quality of the contractor's performance.

Site Photo 21. Main Distribution Panel for the G-7 lift station
