**REHABILITATION OF THE MANSOUR
PUMP STATION**

UNDER THE COMMANDER'S EMERGENCY RESPONSE PROGRAM

BAGHDAD, IRAQ

**SIGIR PA-07-111
JANUARY 24, 2008**

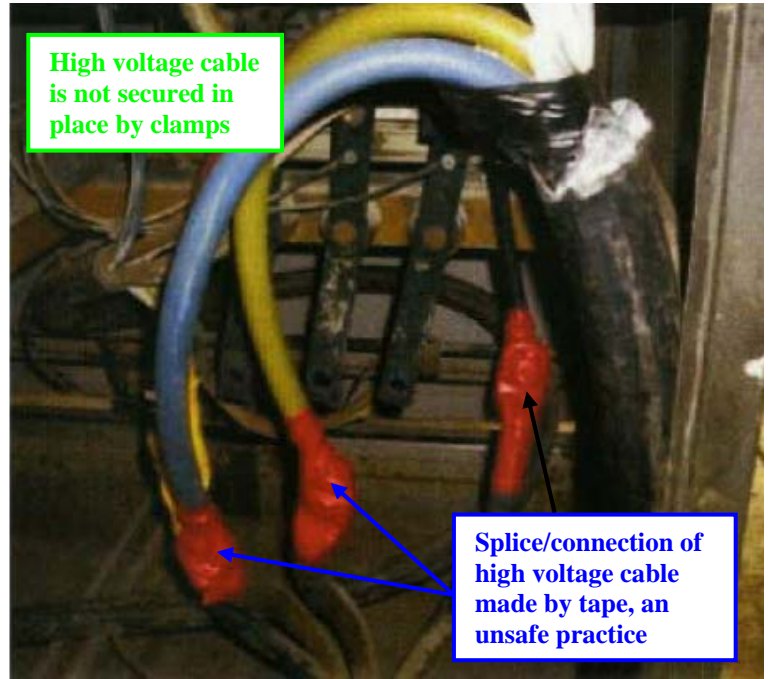
A review of the photographs taken during the final inspection provides insight into the installation techniques and practices employed by the Phase 3 contractor. For example, the contractor used very poor and potentially dangerous installation techniques while attempting to connect a vertical pump motor (Site Photo 6) and the 100 mm submersible pump control panel (Site Photo 7). Finally, the USACE representative performing the final inspection had to point out that an electrical fire within the 300 mm vertical pump control panel necessitated repair of the control panel (Site Photo 8). The electrical fire is evidence of poor installation techniques used by the contractor.

Site Photos 6 and 7. Dangerous installation connecting the vertical pump motor and the 100 mm submersible pump control panel. (Photos courtesy of USACE)

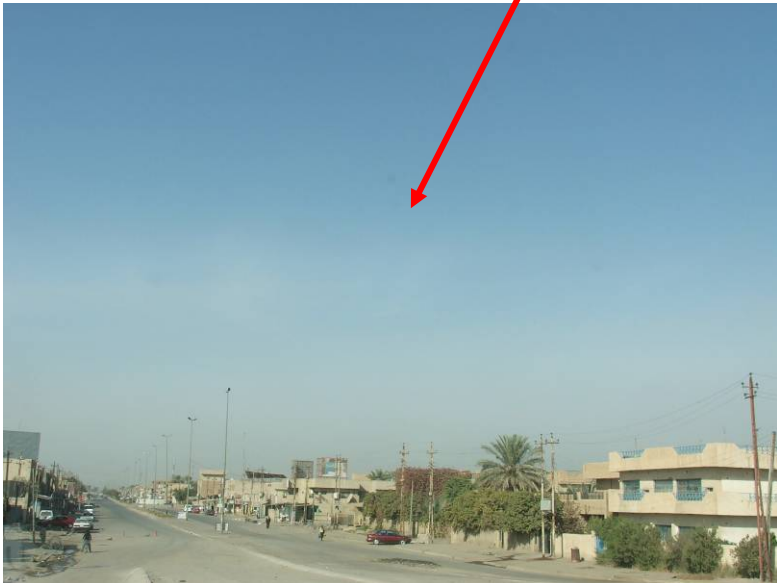
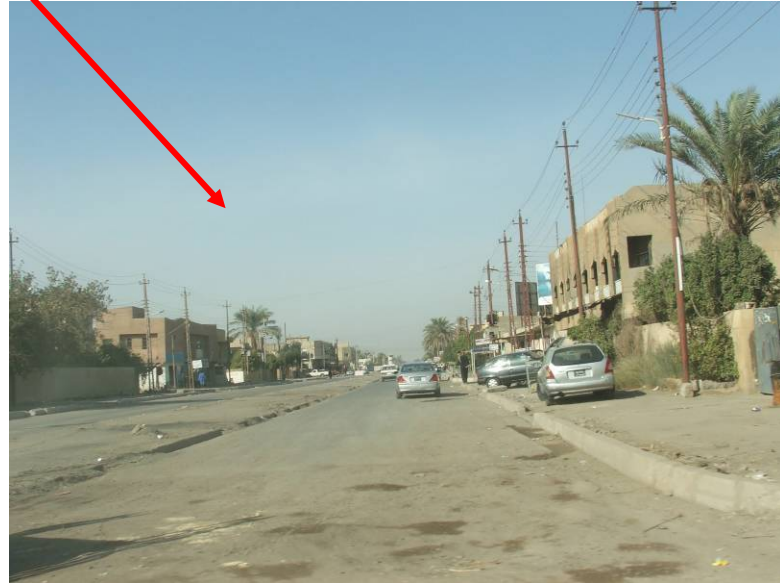
In an effort to determine if backed up sewer water was still affecting the Al Amerea area, we conducted a second site visit. The streets we previously identified with backed up sewer water were dry (Aerial Image 3 and Site Photos 12 and 13).

Site Photos 12 and 13. Previously flooded streets in the Al Amerea area are now dry

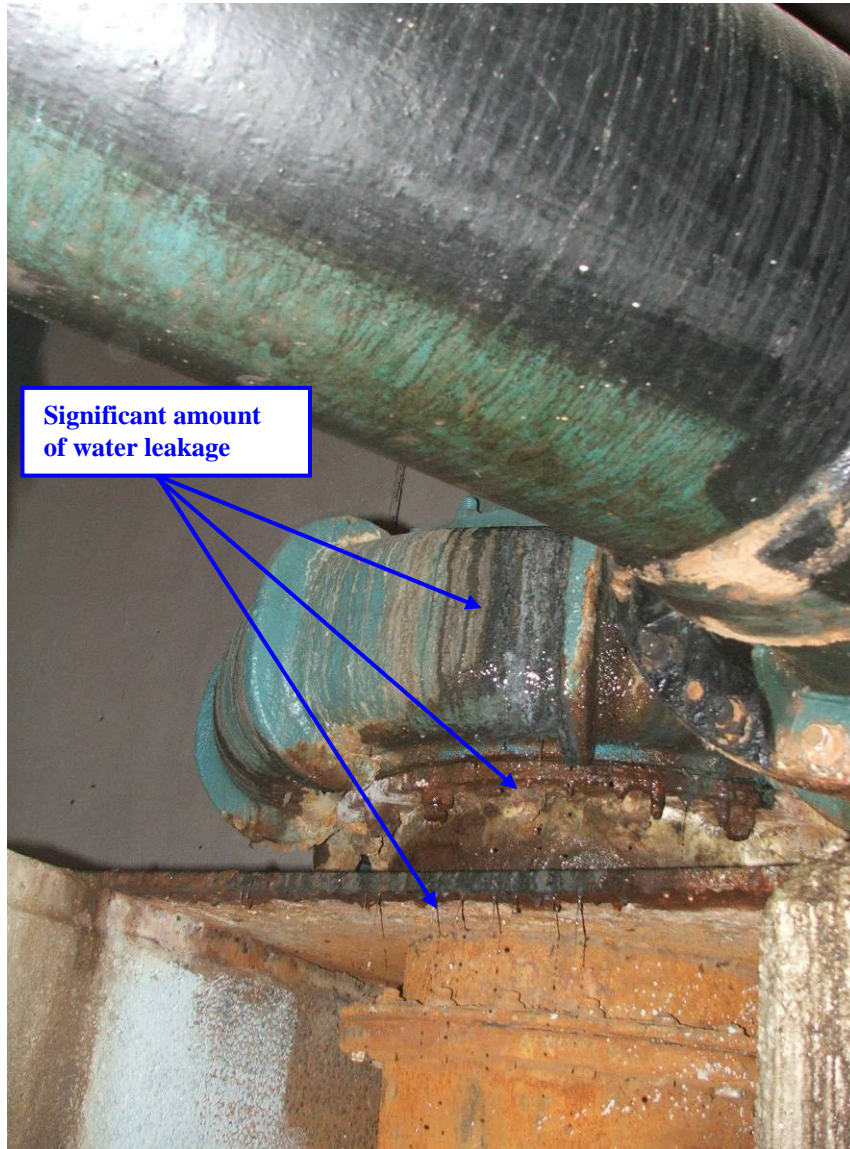
file, this pump was installed in March 2007; however, we identified significant amounts of rust and corrosion on this pump, which causes us to seriously doubt the claim this is a new pump. For example, the excessive amount of rust and grease around the nuts and bolts area is highly suspect for a “new” pump installed approximately 8 months ago (Site Photo 19). Also, the significant amount of water leakage from this pump causes us to believe this pump is either not new or not properly installed. A newly and properly installed vertical pump should not suffer from the significant water leakage we witnessed (Site Photo 20).

Site Photo 20. Significant water leaking witnessed from the 350 mm vertical pump
