# **AFRL Solid Propellant Laboratory Explosive Siting and Renovation Lessons Learned**

*Daniel F. Schwartz*  
*Air Force Research Laboratory Propulsion Directorate,*  
*10 E. Saturn Blvd. Edwards AFB, CA 93524-7380*  
*Phone: (661) 275-5791*  
*Fax: (661) 275-5435*  
[daniel.schwartz@edwards.af.mil](mailto:daniel.schwartz@edwards.af.mil)

13. SUPPLEMENTARY NOTES <b>See also ADM002313. Department of Defense Explosives Safety Board Seminar (34th) held in Portland, Oregon on 13-15 July 2010, The original document contains color images.</b>

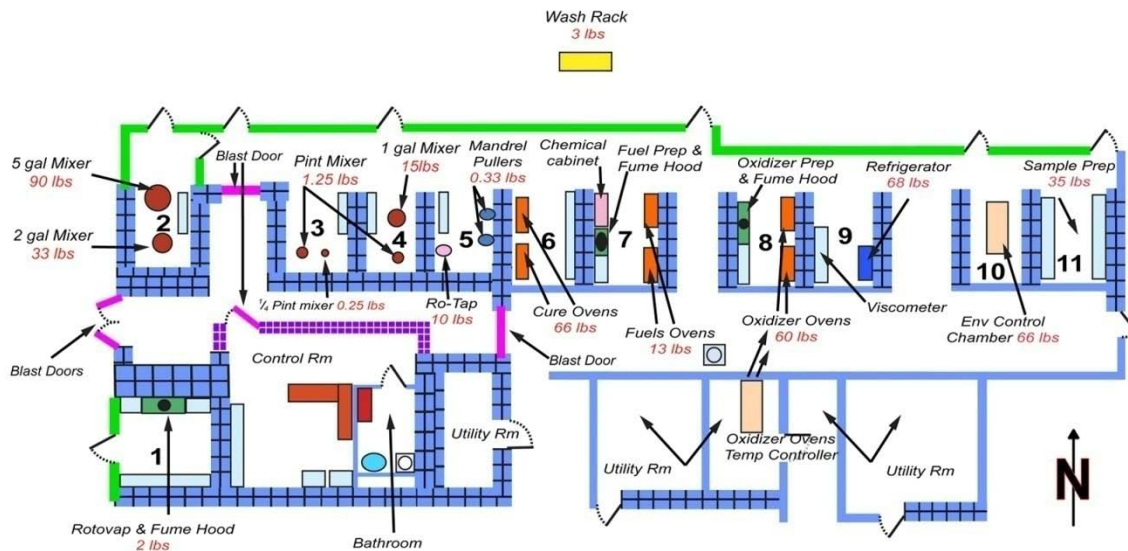
**Figure 3. Bldg 8473 Post-Renovation Layout**

After the renovations, the remote operations (cells 2-5) will be controlled from the hardened control room using an Allen-Bradley programmable logic controller (PLC) system. The post-renovation layout showing the operations and HD 1.1 quantities for all cells is shown in figure 3.
