FIRE STATION CONSTRUCTION AINKAWA, IRAQ

SIGIR PA-06-036
APRIL 12, 2006

SUBJECT: Report on Project Assessment of the Fire Station Construction, Ainkawa,
Iraq (Report Number SIGIR-PA-06-036)

Fire Station Construction, Ainkawa, Iraq

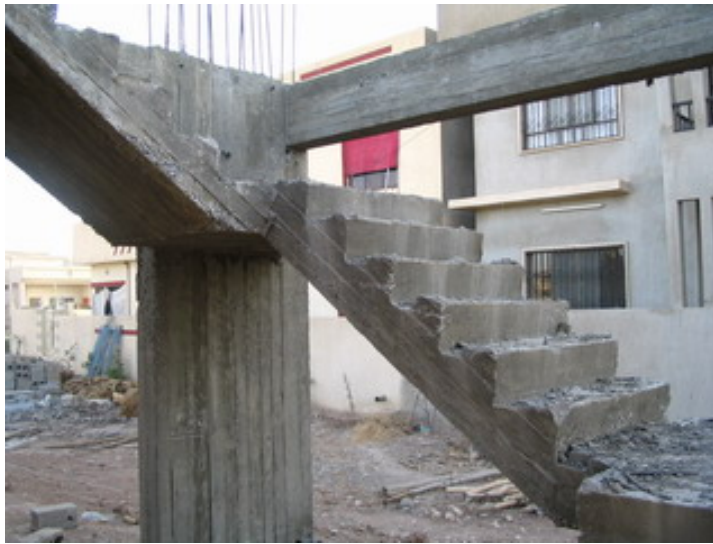
The design required two reinforced concrete staircases on each side of the fire station, serving levels 1-4. Reinforced concrete walls support the staircases, which are connected at each staircase landing. At the time of our assessment, the structural elements of the staircases were completed, but finish work had not started. Site Photo 10 shows the staircase connections to the shear walls.

**Site Photo 10. Staircase construction and supporting shear wall.
Photo provided by USACE.**
