SHEILE PRIMARY SCHOOL  
DAHUK, IRAQ

**SIGIR PA-06-038**  
**APRIL 5, 2006**

SUBJECT: Report on Project Assessment of the Sheile Primary School in Dahuk, Iraq  
(Report Number SIGIR-PA-06-038)

## Sheile Primary School in Dahuk, Iraq

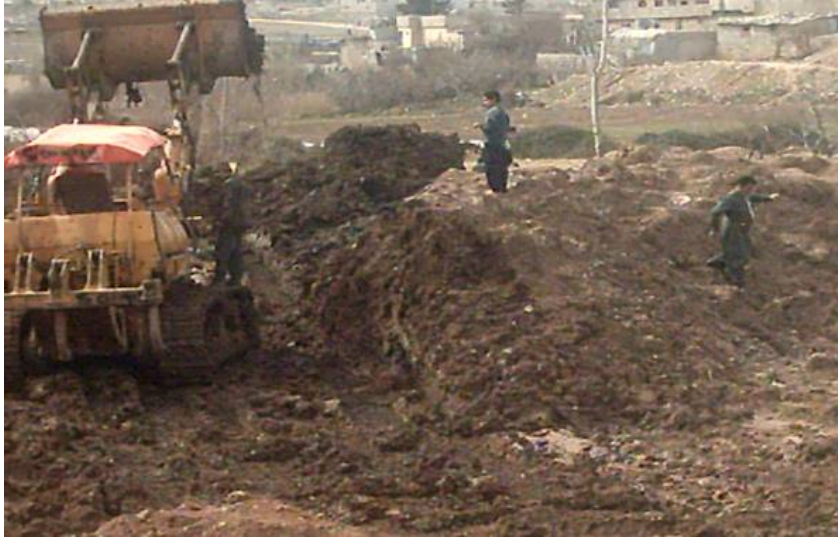
The school is being built on a vacant lot that was donated by the Dahuk Governorate. The land was previously used as a small agriculture site and required grading, removing unsuitable soil, excavation, and trenching around the school boundary. Based on the GRN site reports, groundwater in the area was high and required a filter layer to divert the flow of the ground water under the school building. Soil testing was completed to determine the type of soil at a depth of three meters and remove unsuitable material. Site Photo 1, taken from the USACE February 19, 2005, Quality Assurance Report, shows the early site preparation work.

**Site Photo 1. Initial site preparation work – Photo provided by USACE**

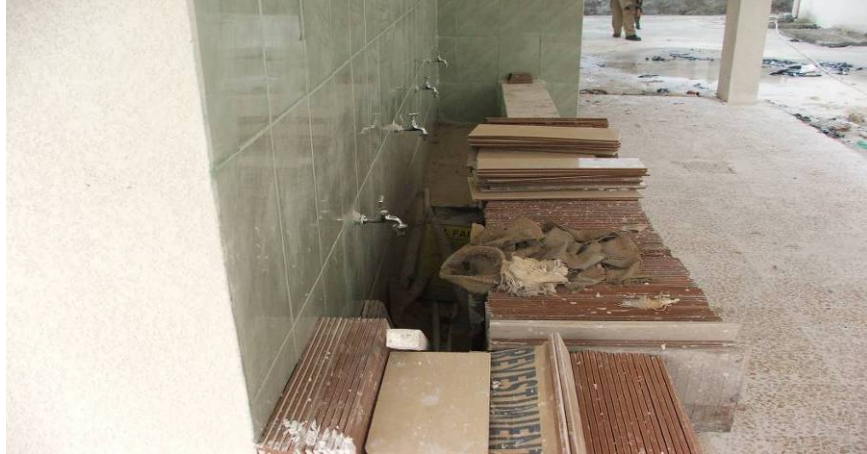
**Site Photo 5. Handwash stations outside boy's bathroom**

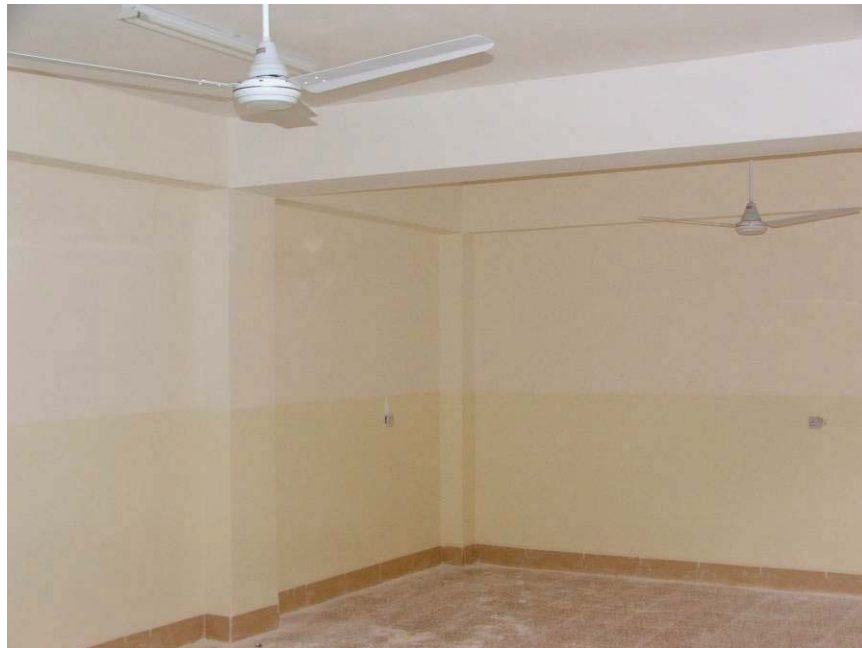
The interior classrooms and the assembly room were complete. Terrazzo tile flooring was installed and walls were gypsum plastered and painted. Electrical outlets, light fixtures, and ceiling fans were installed in each classroom and workroom as shown in Site Photo 6.

**Site Photo 6. Ceiling fan installation**

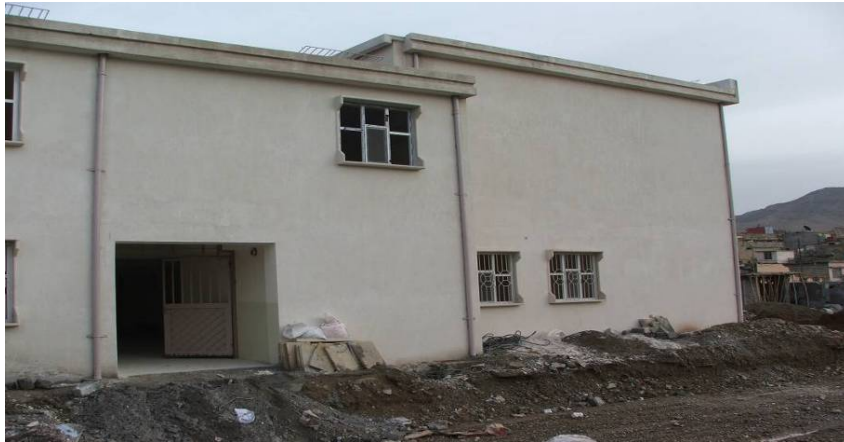
The exteriors of the main school and auxiliary buildings were finished and painted. Workers were doing touchup work on the paint and rain gutters at the time of the site assessment. Perimeter sidewalks and the main entryway were constructed of concrete and were complete. Landscaping had not started. Examples of the building exterior are shown in Site Photos 7 and 8.

**Site Photo 7. Exterior showing painted cement finish**

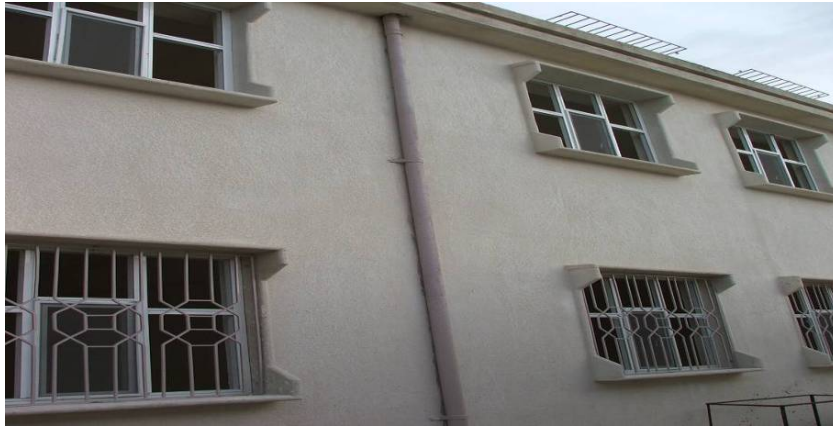
**Site Photo 8. Exterior showing painted cement finish and windows**

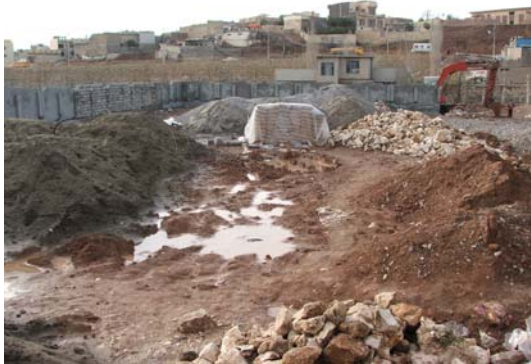
The play yard and garden were still being excavated at the time of our assessment. The area was being used as a material staging area. Site Photos 10 and 11 show the garden and play yard status respectively.

**Site Photo 10. Garden area location**

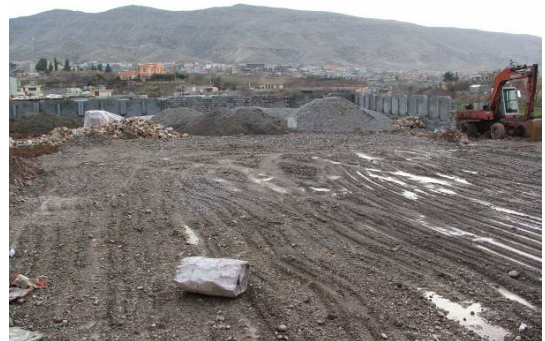
**Site Photo 11. Play yard area site location**

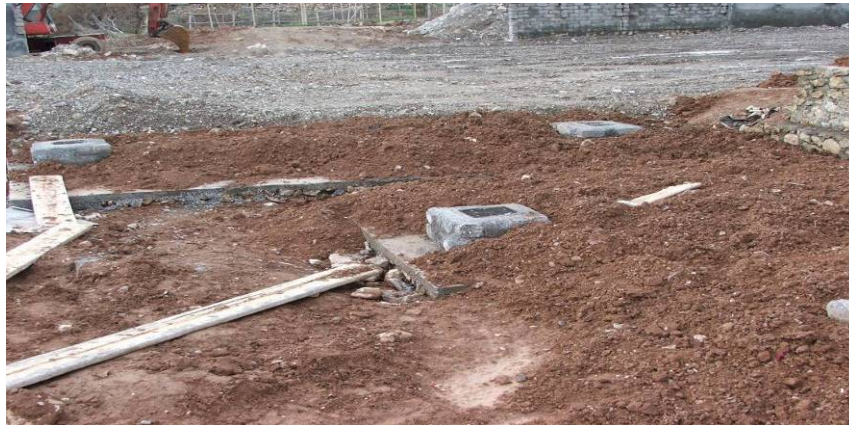
The contract required construction of two septic tank systems, one for the main school building and the other for the latrines in the auxiliary building. The septic tank systems were substantially complete with buried sanitary sewer lines already connected. The main school building septic system is located near the front entrance of the building beneath the garden as shown in Site Photo 14. The other separate septic tank system has also been constructed and is adjacent to the auxiliary building.

**Site Photo 14. Septic tank location and manholes in front of school**
