AL BALDA POLICE STATION
HILLA, IRAQ

SIGIR PA-05-015
JANUARY 27, 2006

Project Assessment of the Al Balda Police Station in Hilla, Iraq

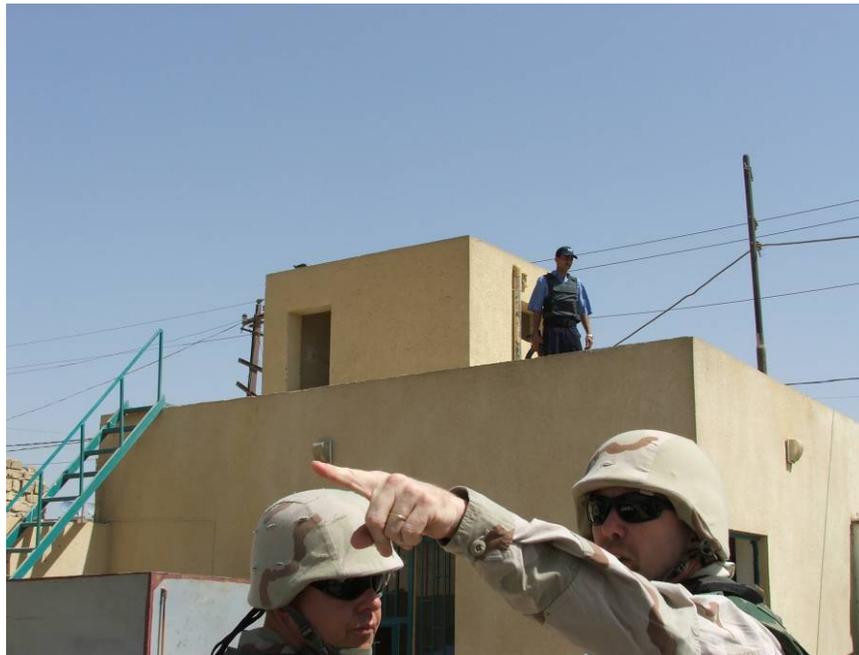
The contract's BOQ required new construction, repair, and upgrade (height) of the perimeter wall; construction of four corner guard towers; supply and installation of 250 meters of concertina barbed wire; installation of 300 square meters (M²) of paved parking area; installation of 150 M² of sidewalks; and installation of an entry gate. During our site visit, we observed that the perimeter walls were in place and were painted, and that four corner guard towers were complete. Concertina barbed wire was located on top of all perimeter walls and on the Police Station's roof. The parking area was paved with asphalt and concrete sidewalks were located around the police station buildings. The upgrade of perimeter security appeared consistent with contract requirements.

Site Photo 1. Corner Guard Tower

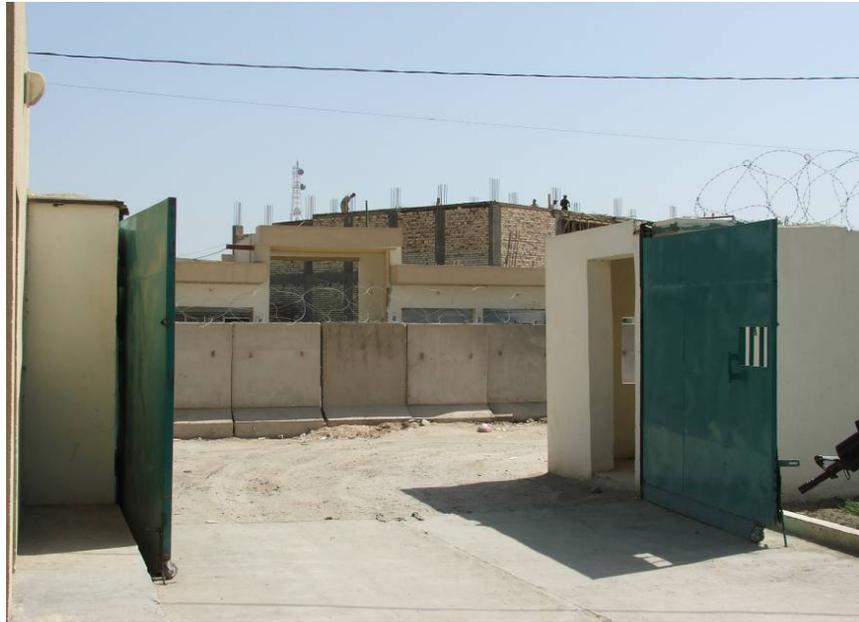
Site Photo 2. Main Entry Gate

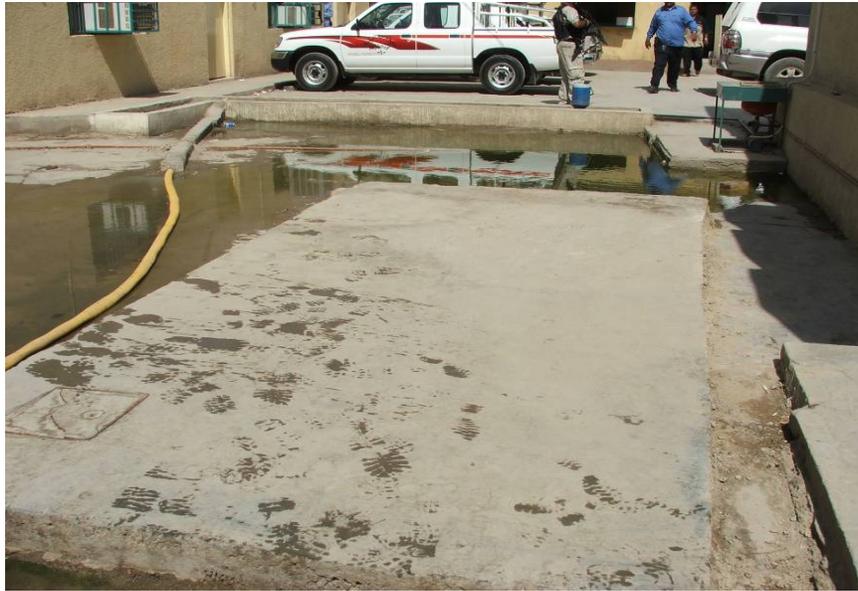
The contract's BOQ required the installation of a septic tank and the repair of an existing septic tank. The site visit verified the septic tank location. The ground level surface of the septic tank (concrete slab) did not appear to have adequate drainage based on observed standing water in the area. After discussions with the USACE QAR, we learned this tank is not connected to a leach field or city wastewater collection system. This system was designed as a holding tank, requiring sewage to be pumped out on a recurring basis. A yellow drain pipe was observed leading from the new cafeteria building to the septic tank manhole. This line was partially encased in concrete and partially exposed. The installation/rehabilitation of the septic system appeared consistent with the contract requirements. During the rainy season, there may be water drainage problems. For an illustration of the concrete cover of the septic tank and the standing water above the concrete pad, see Site Photo 3.

Site Photo 3. Septic Tank Cover with Un-drained Water

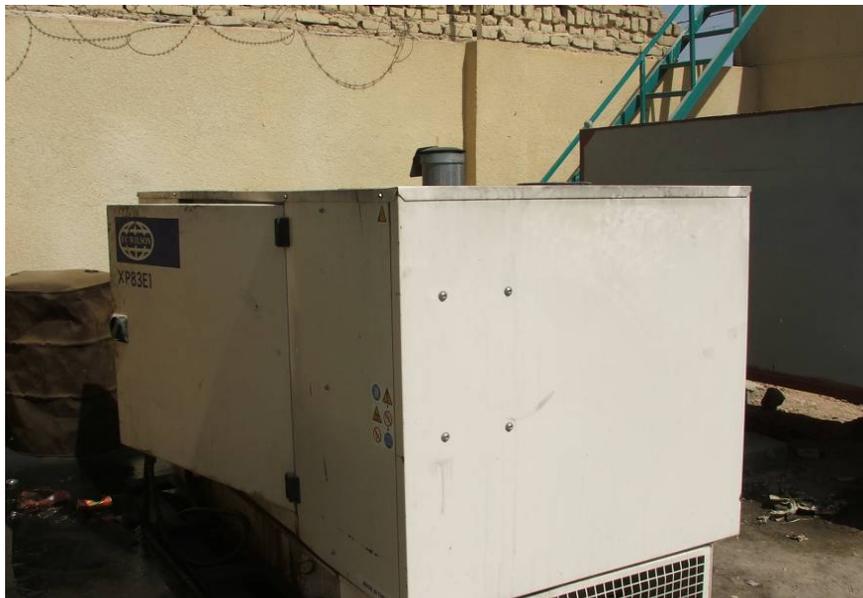
Contract Modification #P0001 required the supply and installation of a generator and a fuel tank. The contract did not specify the size of the generator required. The generator and fuel tank were on site and located to the right of the inside perimeter main gate. The generator factory nameplate lists the following information: company name - FG Wilson (Engineering) Ltd, Model - XP83E1, Serial Number - FGWPEP03ED0A24307, Year of Manufacture - 2004, Rated Power - 82.5 kilo Volt Amp (kVA), Rated voltage - 400/230 V, Rated Frequency - 50 Hz, and Rated Current - 119 A. For an illustration of the generator housing, and the 82.5 kVA generator inside the housing, see Site Photo 4 and Site Photo 5, respectively.

Site Photo 4. Generator Housing

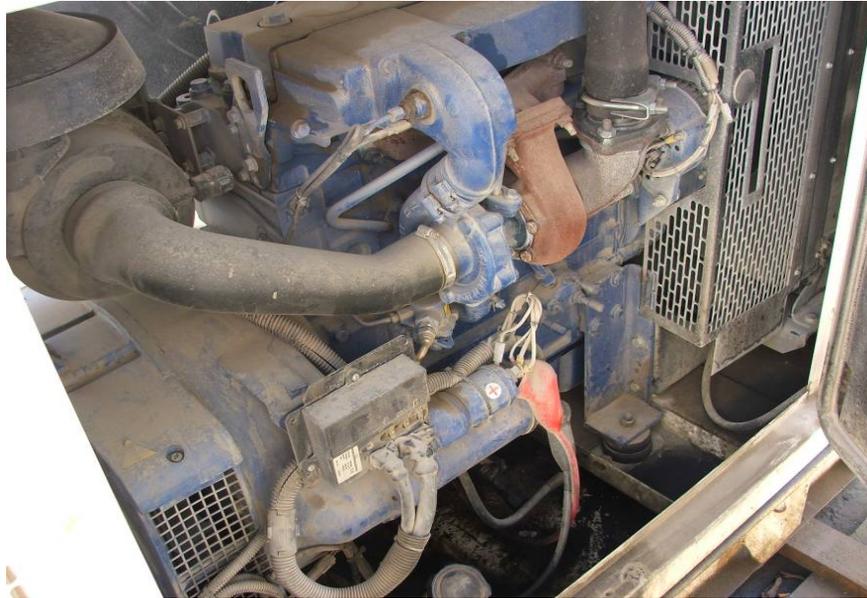
Site Photo 5. 82.5 kVA Generator

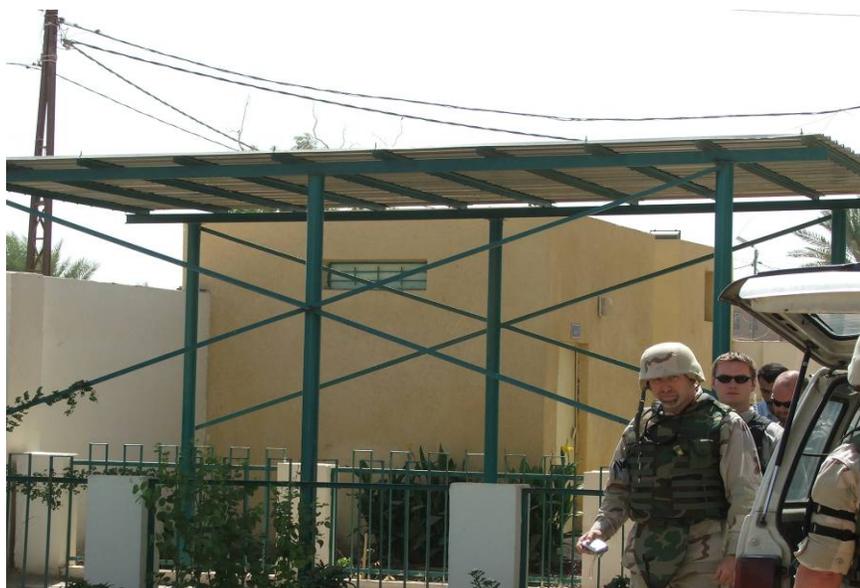
- Construction of covered entrance
Contract Modification #P0001's BOQ required the new construction of 99 M² of canopies with steel frame supports and corrugated steel sheet roofs. A new canopy was located between the pedestrian gate and the front door of the Police Station. In addition, a canopy used for automobile parking was located between the generator units and the newly constructed cafeteria building. Both canopies were composed of painted steel frames and corrugated metal roofs. During the site visit, no discrepancies were noted regarding the construction of the canopies. For an illustration of the entrance canopy and the automobile canopy, see Site Photo 6 and Site Photo 7, respectively.

Site Photo 6. Entrance Canopy

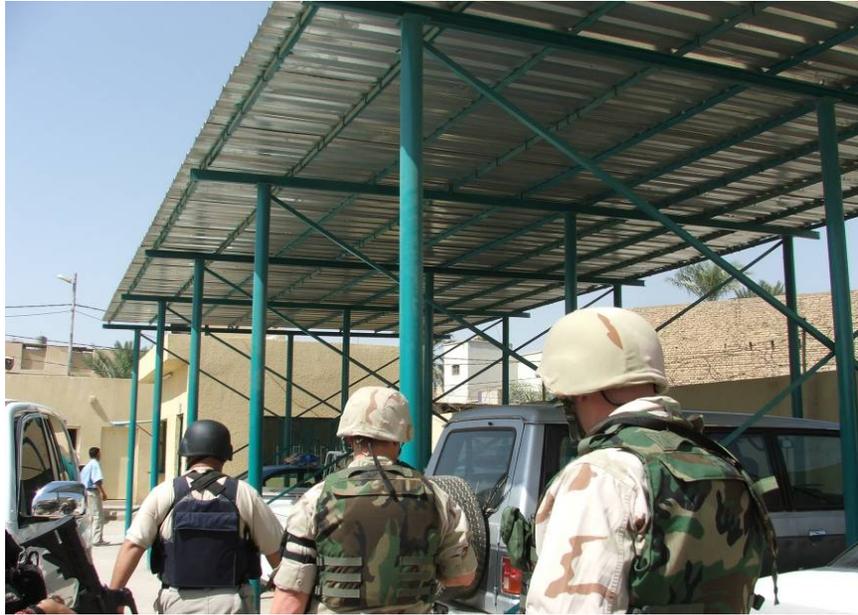
Site Photo 7. Automobile Parking Canopy

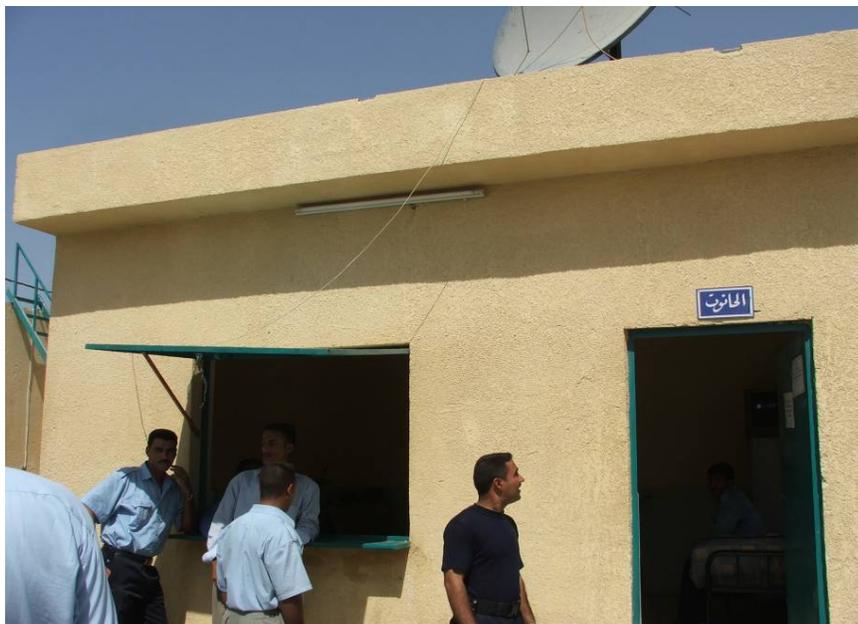
- Construction of four small building
The contract's BOQ required the construction of four small buildings with specific dimensions: (1) a dormitory building (4M x 9M), (2) a cafeteria building (4M x 5M), (3) an information building (4M x 6M), and (4) an arms storage facility building (4.11M x 5.62M). The site visit verified the buildings were constructed and were currently in use. For an illustration of the cafeteria building's exterior front, see Site Photo 8; the exterior of the information building can be seen in Site Photo 9. The buildings appeared to be consistent with the contract's requirements.

Site Photo 8. Exterior View of the Cafeteria Building

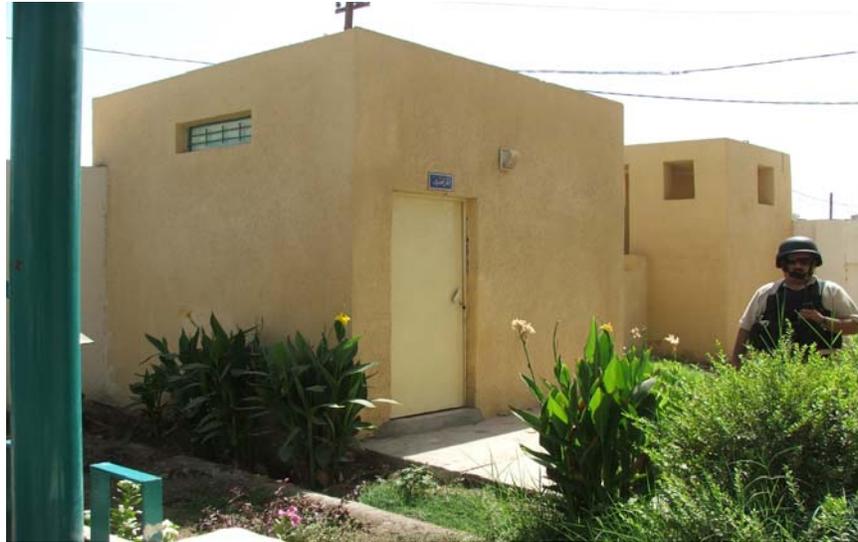
Site Photo 9. Exterior View of the Information Building
